# **11 years of Performance of Alberta Transportation's First Bonded Concrete Overlay**

In 2004, Alberta Transportation constructed its first bonded concrete overlay in the City of Lethbridge. The bonded concrete overlay was constructed to address a chronic rutting problem in one of the left turn bays at the signalized intersection of highways 3 and 4. Because the rutting was requiring yearly maintenance resources, the department was seeking a more sustainable medium to long term solution and therefore opted to construct its first trial of a bonded concrete overlay.

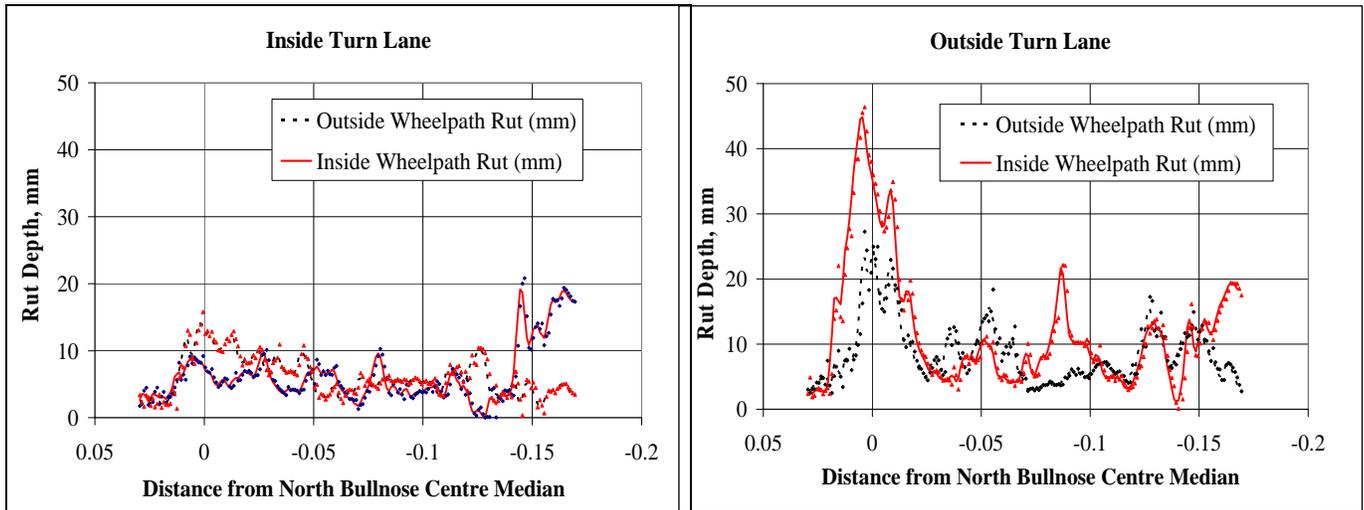
**Figure 1 – Rut Depth Measurements in Pre-Existing Asphalt Concrete Pavement**

As part of the pre-design investigation, rut data were collected on the existing asphalt pavement in the turning lanes. Figure 1 presents the measured rut data graphically. Rutting was most severe in the outer turning lane where it ranged from 0 to over 45 mm. In the inner lane, rut depths ranged from 0 to

approximately 20 mm. The rut depth data was collected at a one metre interval using the same laser based data collection process used for the department’s highway network but with a modified reporting distance.

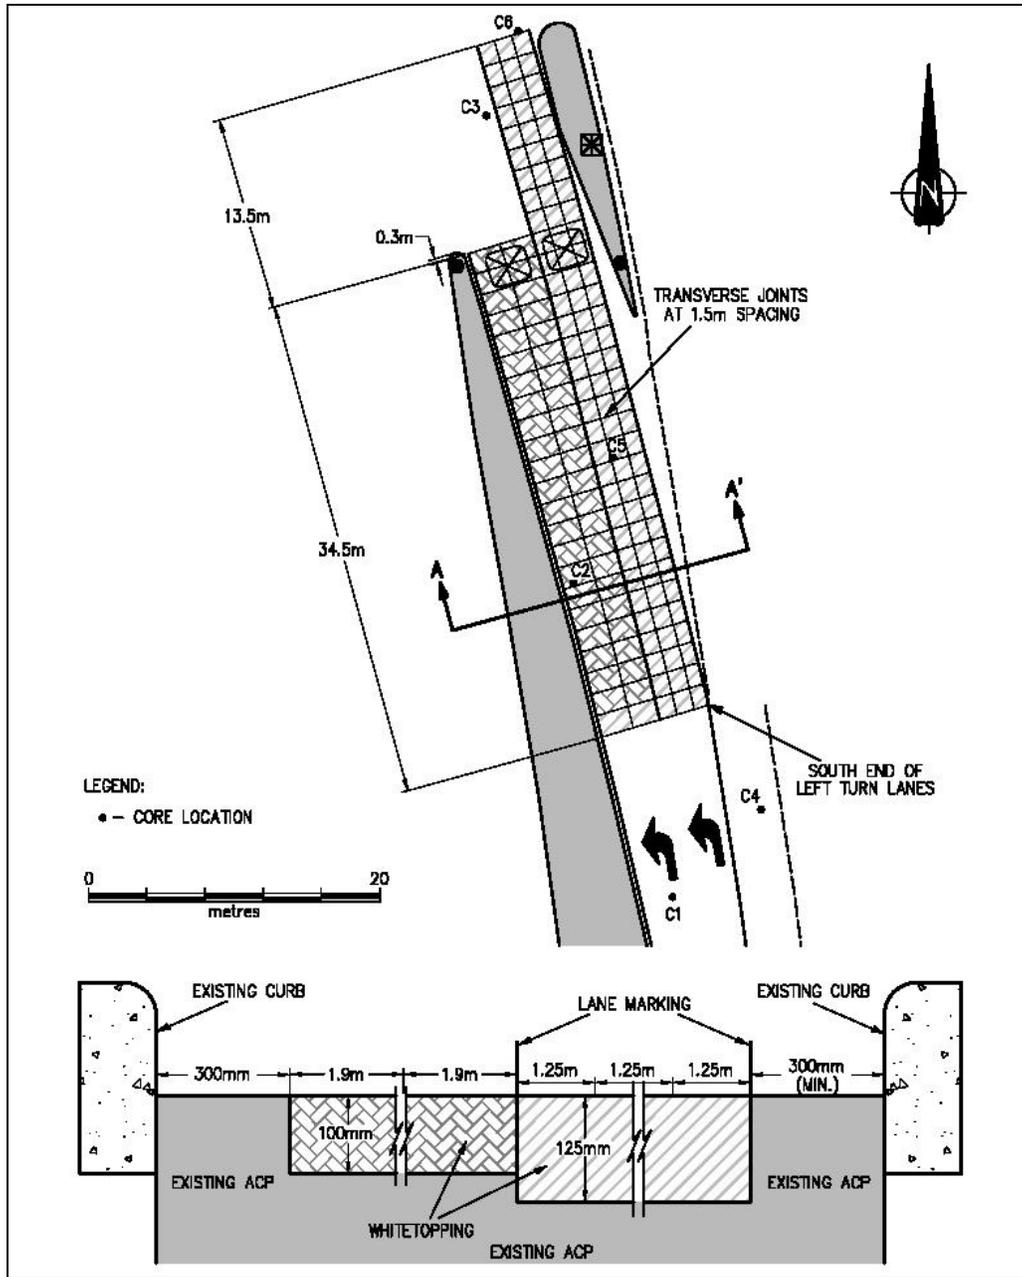
Figure 2 – Bonded Concrete Overlay Initial Core Locations and Design Details

Because neither the department nor the City of Lethbridge had as-built information for the turning lanes, coring was undertaken to confirm the existing ACP thickness in the turning lane and to ensure an adequate post-milling depth given that a minimum of 75 mm of ACP should remain underneath the PCC of a BCO. A plan view of the core locations as well as some of the BCO design details are provided in Figure 2. As reported in Table 1, the cored thickness of the asphalt in the turning lanes was variable, ranging from 175 to 314 mm, with an average of approximately 220 mm. These thicknesses corresponded well to the 225 mm of asphalt from department’s as-builts of the through lanes.

Due to a verbal miscommunication, the jointing was done incorrectly. Because the poured inner lane was 4.5 m wide, it was decided to cut three panels across instead of the two as shown in the design drawing (Figure 2). However, instead of three panels of approximately 1.5 by 1.5 metres, four panels of approximately 1.1 metres wide and 1.5 metres long were saw cut across the lane resulting in longitudinal joints near the wheel paths.

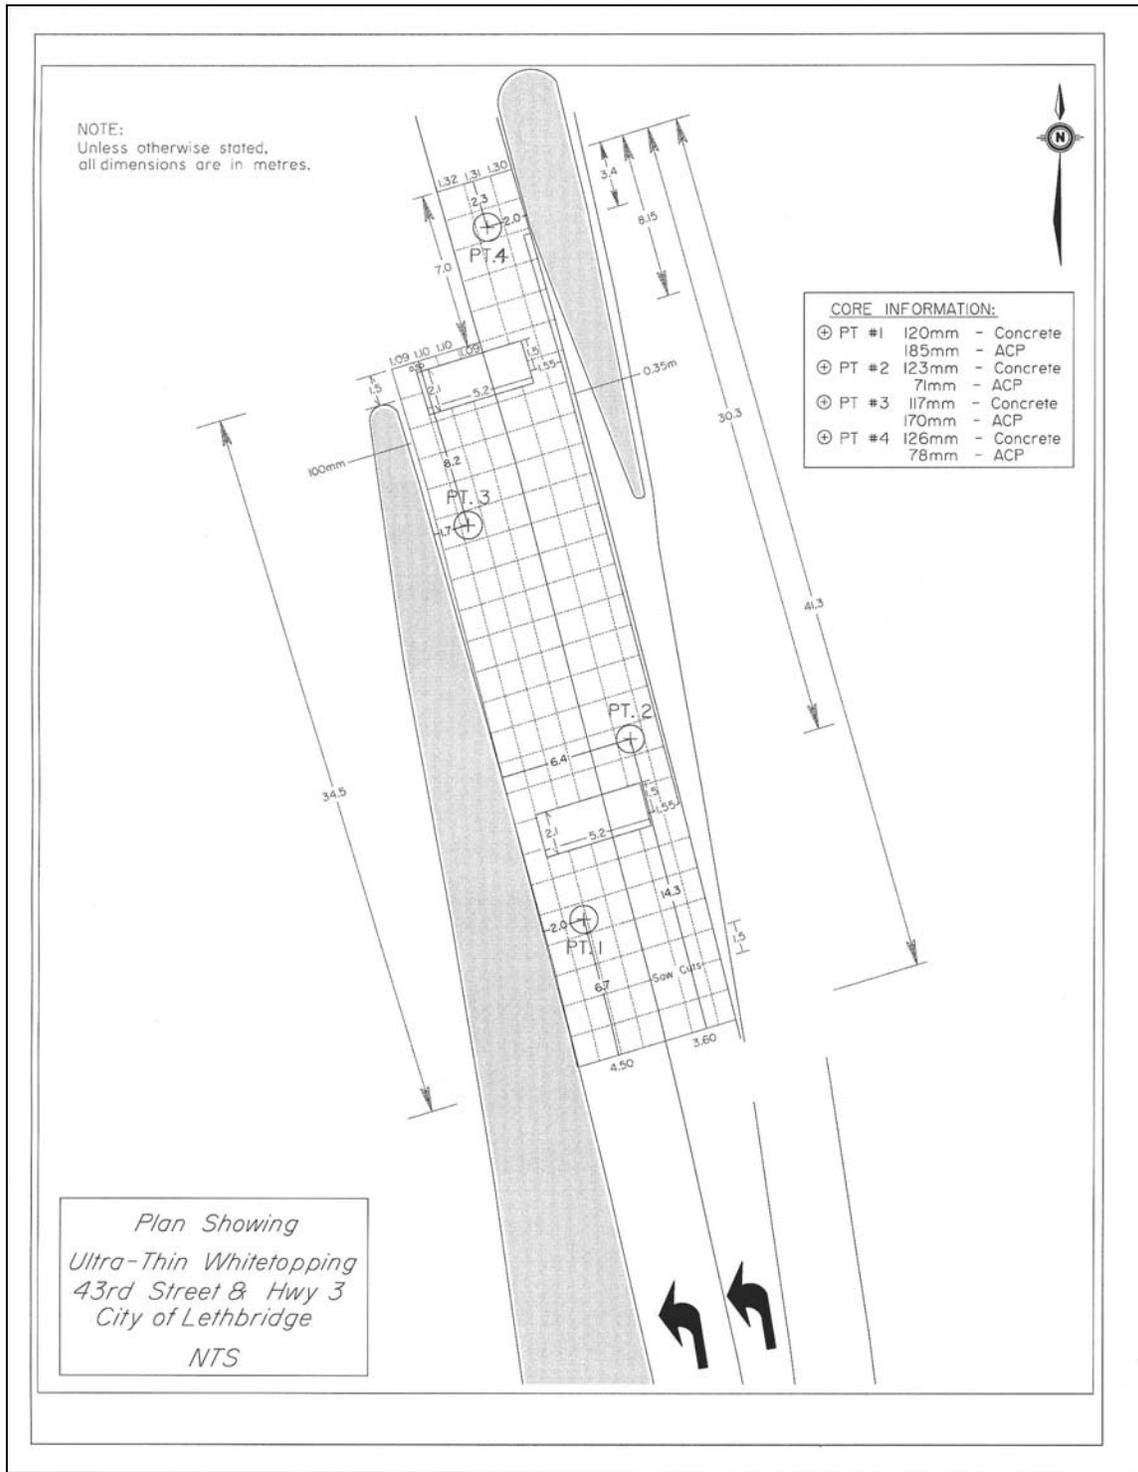
Figure 3 – As-built Ultra-Thin Whitetopping, 43<sup>rd</sup> St. and Hwy. 3 in Lethbridge

Before opening to traffic, the pavement was cored to verify the concrete thickness, to take extra measurements of the asphalt thickness, and to verify the bond between the asphalt and concrete. Two cores per lane were taken and Figure 3 shows the core locations and measured thicknesses. Despite the different thicknesses designed for the inner and outer lane, the cores indicated the concrete thickness was consistent and averaged 122 mm in both turning lanes. The remaining asphalt thickness averaged 178 mm in the inner lane but only 75 mm in the outer lane.

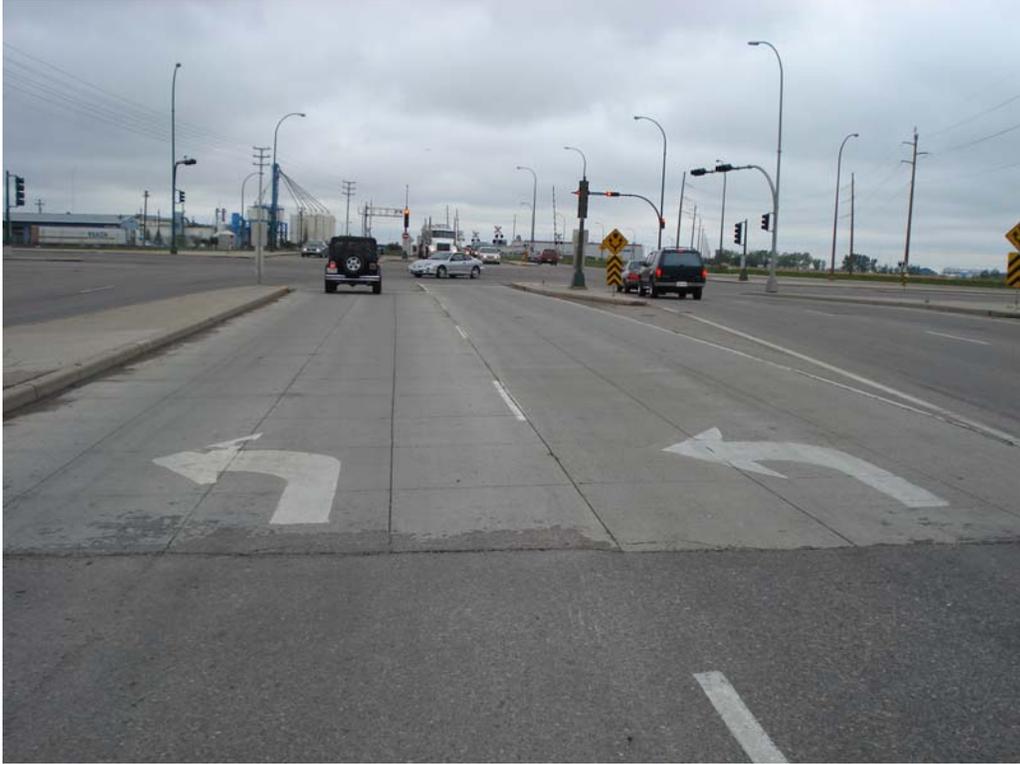
**Figure 4 – June 2007 photo of BCO**

The performance of the BCO has been monitored regularly since construction in 2004. Despite the initial appearance of one panel edge cracking shortly after construction, the long term performance of the BCO has exceeded expectations with no other cracking issues until just recently. In April 2015, a site inspection noted one failed panel and a handful of other panel cracks. Figures 4 to 7 document some of

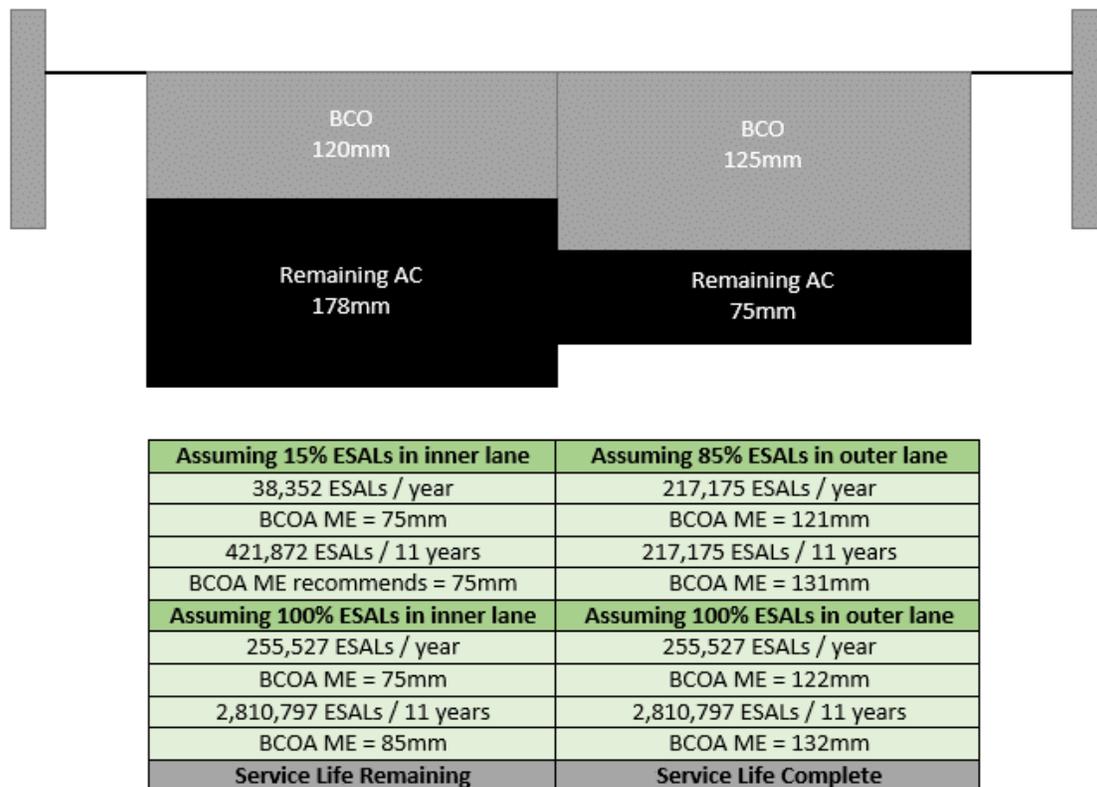
Figure 9 – BCOA-ME Service Life Predictions

As noted previously, because of the advancements in BCO design methods, BCOA-ME was also used to re-evaluate the service life for both the inner and outer lanes. As shown in Figure 9, the results from this analysis indicate that the outer lane is at the end of its service life while the inner lane has remaining service life. This correlates well to the in-field performance observations that show the outer lane is starting to experience some failures and is nearing the end of its service life at 11 years whereas the inner lane remains in excellent condition.
