**A Discussion of Road Safety Issues at Airport
Terminal Pick-up and Drop-off Areas**

Jeffrey Lo, Designer EIT, MMM Group Limited

Paper prepared for presentation
at the Active Transportation Safety Session

Of the 2015 Conference of the
Transportation Association of Canada
Charlottetown, PEI

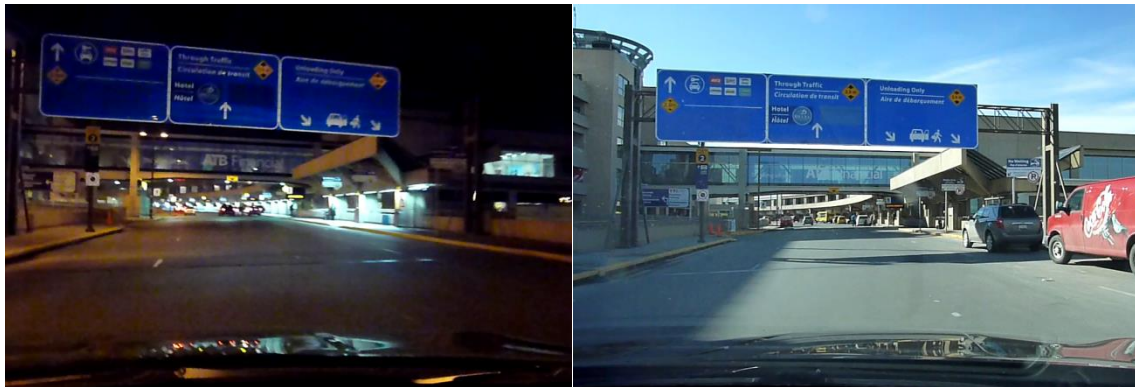
Figure 5.1 – Night and Day Comparison of Signage Readability (Driver's Perspective)

While many of the signs appeared to be easily readable during daylight hours, the situation changes considerably at night. It was observed that much of the signage used was not reflective; this includes signage restricting waiting or stopping and some of the car rental directional signage. Figure 5.1 shows the difference between day and night conditions from the perspective of the driver. While the facility is equipped with lighting, the lighting is generally aimed vertically downwards or mounted below the signage level and are unable to adequately illuminate the signage. That being said, standard roadway signage for crosswalks, traffic control and overhead gantry indicating lane use were reflective and readable at night, though modification panels affixed to the gantry are not reflective.

Signage improvements should be considered throughout, which is currently underway with a full replacement program to coincide with the opening of the international terminal in 2016. An important first step would be to upgrade all signage to either backlight signage or to reflective signage. This can

help to reduce driver confusion imposed by the signage by allowing drivers to easily read and recognize signage from a further distance. TAC recommends reflective signage and provide guidelines as part of the MUTCD (TAC, 2014).

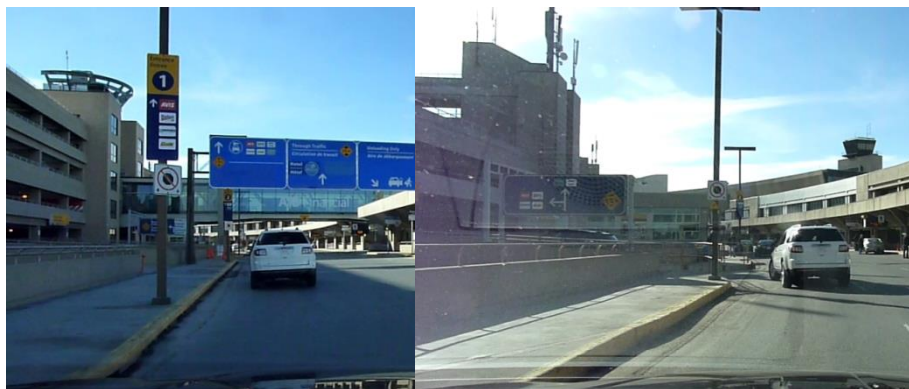
Figure 5.2 – Examples of Car Rental Return Signage (Driver's Perspective)

In addition, issues were noted with the signage for the car rental returns. Upon entry to the Departures level, two relatively small (and unreflective) signs direct drivers to either one of two entrances, which are identified as 1 and 2. While it was not possible to measure the signage and text sizes to verify the sizes, they did appear to be too small for the speeds at which vehicles tend to be traveling at immediately after reaching the top of the entrance ramp. The following signage at the entrances are also difficult to read as the logo images showing the rental companies are at the far left of the sign and relatively small given the distance from the travel lane. Furthermore, the signage at the entrances themselves do not refer to the entrance numbers shown on the initial set of signage, which can contribute to driver confusion. Photographs of the aforementioned signage is shown in figure 5.2.

Finally, consider modifications to the directional signage to the car rental return facility. The signage can be replaced such that directional information is made larger and moved closer to the roadway. The existing signage that refers to entrance numbers should be removed, or have the entrance numbers incorporated into the signage at each entrance.

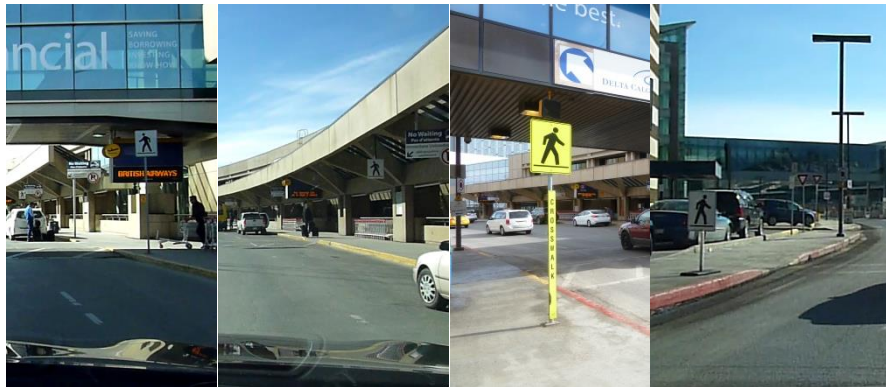
Figure 5.3 – Examples of Crosswalk Signage

It was also observed that drivers were failing to yield to pedestrians, particularly at the level crosswalks. This may be due to the design of the crosswalks themselves. While four crosswalks were raised, it is important to note that two were not. The previous raised crosswalks can form a driver expectation that all crosswalks are raised, thereby making the level crosswalks easily missed.

The signage of crosswalks is also of possible concern. There were varying types of signage used to show crosswalks, such as standard white crosswalk signs mounted on sign poles of varying height, some were mounted to the canopy structure and one crosswalk had fluorescent yellow signage on poles with fluorescent strips (refer to figure 5.3). The differences in signage are also against driver expectation and can cause drivers to be unaware of the signage, particularly given the workload situation. The mounting of the white crosswalk sign to the canopy structure can be confusing as the canopy has other signage mounted to it at a similar height with a similar background colour.

Crosswalk signage should be made consistent throughout the Departures level. Consideration can be given towards mounting signage away from the other similar signage on the canopy structure. While alternative colours are not normally recommended, the fluorescent green used at one of the crosswalks does provide a clear visual distinction from other signage that may be beneficial in this case.

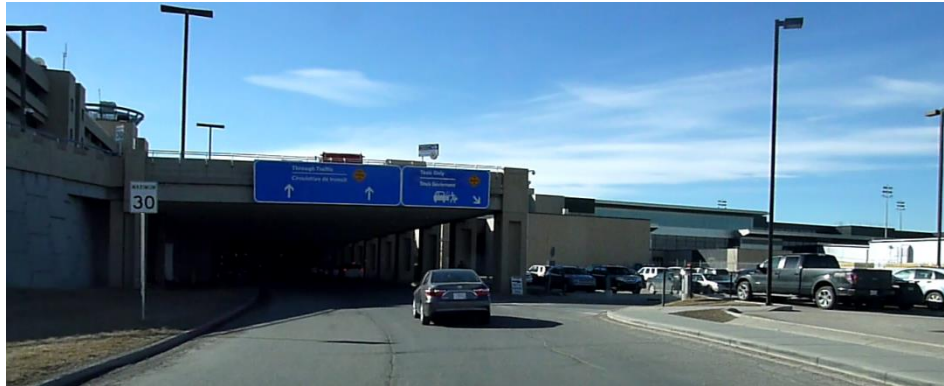
Figure 5.4 – Light Level Difference Upon Entry (Driver's Perspective)

From the site observations, it was evident that the Arrivals level may suffer from significant lighting issues. Contrary to expectations, the issue is during the daytime conditions rather than nighttime. As

the Arrivals level is fully covered, it tends to be a dark area. Supplementary lighting is provided even during daylight hours, however there is no transition period for one's eyes to adjust when entering on road as seen in figure 5.4. This can result in drivers missing signage and/or hazards while their eyes adjust to the darker conditions.

In the site observations, the lighting issue was the most visually apparent. As drivers enter the Arrivals level which is underneath the Departures level road deck, the lighting condition can change drastically within seconds from bright sunlight to a covered roadway. A suggested improvement will be to provide transition lighting, not dissimilar to systems in tunnels, to allow the driver's eyes time to adjust to the reduced light levels. Figure 6.2 shows an example of such a system, where intense lighting is provided near the entrance that transitions over a distance to lower levels provided in the remainder of the tunnel.

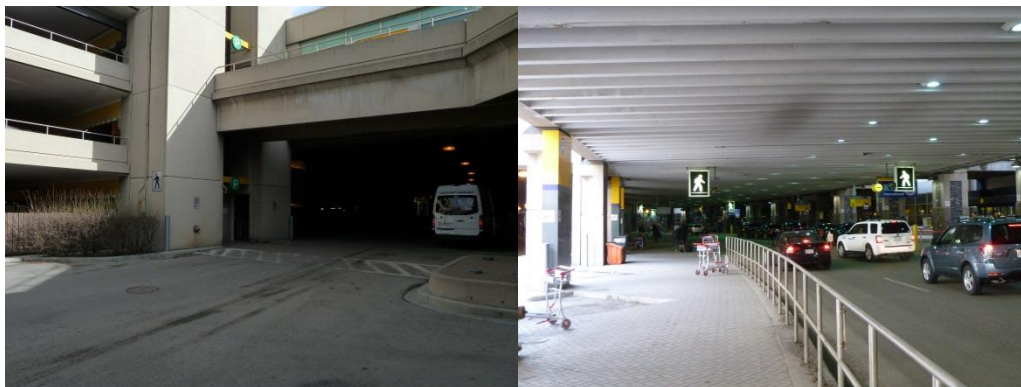
Figure 5.5 – Dark Area near Rental Car Centre (Bus Facility left, Roadway right)

In addition, to the lighting adjustment at the entrance, the lighting levels appeared inconsistent. As the majority of the roadway is open on both sides between the road deck and the terminal as well as the road deck and the parkade, sunlight does filter down from the upper level. However, the amount of sunlight changes due to the curvature of the roadway and surrounding buildings. Furthermore, near the Rental Car Centre, both sides are infilled with structures, resulting in a dark area where no sunlight filters down. This lighting level change greatly affects both the Arrivals roadway and even more so the bus facility as evidenced in figure 5.5. This area is of greater concern than the initial transition as these areas are busier with pick-up traffic and crosswalks whereas the former area had fewer conflicts.

Furthermore, it is suggested that YYC review and take steps to improve the lighting uniformity on the Arrivals level. YYC can consider installing a supplementary lighting system that provides additional infill illumination to areas where natural sunlight is obstructed and unable to reach the roadway or bus facility. Such a system may benefit from automatic photosensitive control to adjust the supplementary lighting to only what is necessary to provide and maintain lighting uniformity and prevent over lighting such as during night time or on overcast days.

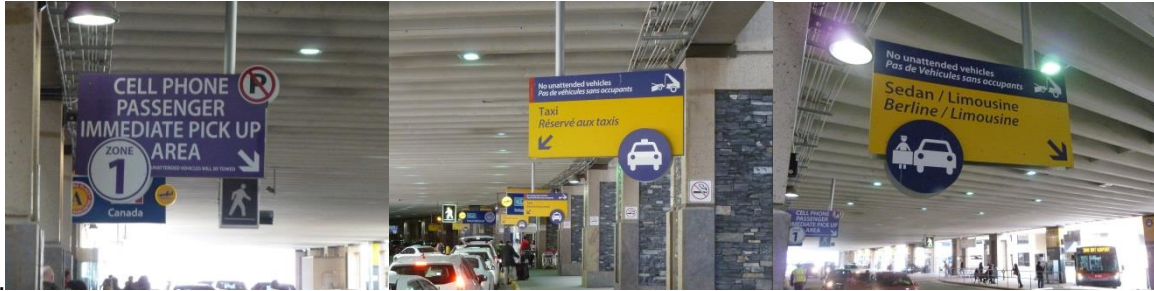
Figure 5.6 – Examples of Pick-up Signage

Similar to the Departures level, much of the directional signage on Arrivals is not reflective, again with the exception of regulatory signage. This is particularly important on Arrivals as the curb space is split between Taxis, Sedans, Cell Phone Pick-up and general pick-up areas therefore drivers need to read much more of the signage. An example is shown in figure 5.6.

As mentioned previously, YYC will undergo a signage replacement program coinciding with the opening of the international terminal in 2016. It is suggested that YYC consider upgrading signage to be backlit or reflective in addition to removing signage or simplifying messages wherever possible similar to the discussion for Departures in section 6.1.1. As curbside signage on Arrivals is more complex due to the reserved portions of the curb, it may be beneficial to utilize different colours on portions of the signage to help drivers who only have a moment to glance at the signage.

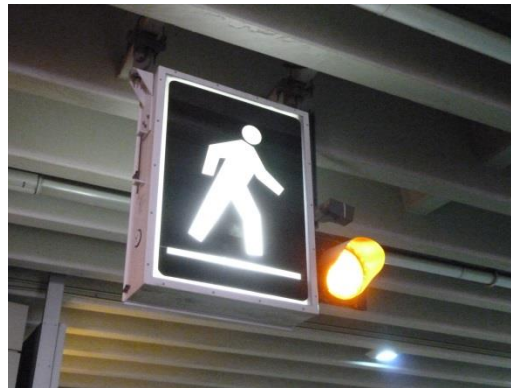
Figure 5.7 – Backlit Overhead Pedestrian Sign

One substantial difference however is that pedestrian crosswalk signs are mounted overhead, are oversized, inverted coloured and backlit (refer to figure 5.7). Interviews with staff and observations suggest that these signs are very visible and readable.

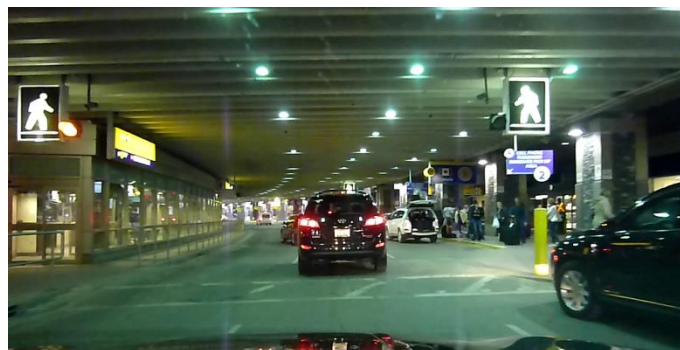
Figure 5.8 – Crosswalk with Flashing Warning Signal

Potentially adding to the driver workload are the greater number of conflict points on Arrivals. Over the course of the effective frontage, there are also 13 access points from the bus facility and 7 crosswalks demanding attention. Each crosswalk is also equipped with automatic flashing lights which are automatically actuated (refer to figure 5.8), however the actuation appears unreliable. This translates into 14 flashing lights over the effective frontage, which start and stop regularly and adds to the level of distraction in addition to a larger volume of vehicles merging both to and from the curbside as well as from the bus facility on the left.

During the course of the site observations, it was noted that the current system of flashing pedestrian warning lights affixed to the crosswalk signage may be a distraction, particularly as the actuation system is unreliable resulting in false positive and negatives. YYC can consider making improvements to the system to improve the accuracy. Other alternative options can also be considered to draw attention to the crosswalks more passively in lieu of flashing lights. Possible alternatives may include supplementary lighting to highlight the crosswalk, installing coloured lighting strips on the ceiling structure above the crosswalk and/or embed coloured lighting into the pavement.

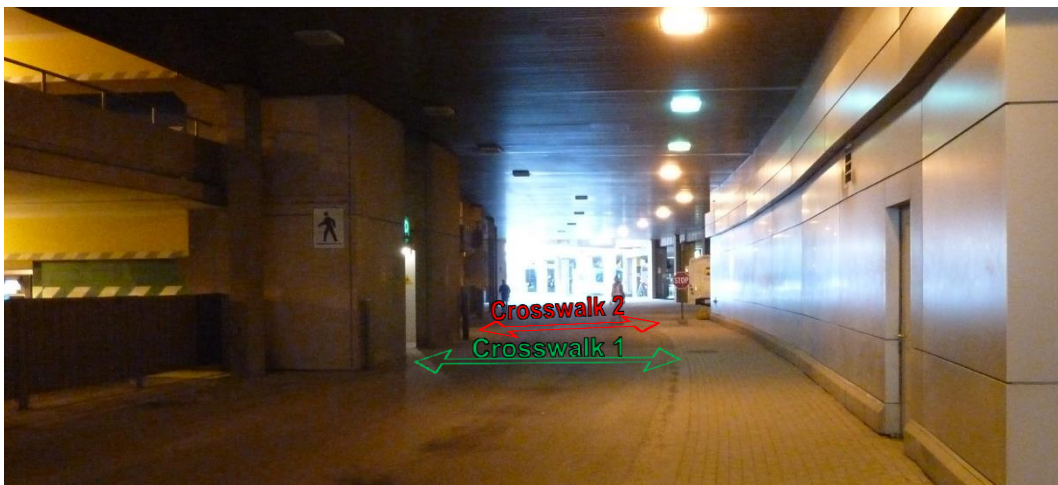
Figure 5.9– Example Poor Crosswalk Placement

In addition, there was a potentially hazardous situation observed. Behind the Rental Car Centre, there is a crosswalk exiting the parkade at a 90° angle. However, approximately 7 m further, there is a second crosswalk that is unlikely to be expected by drivers (refer to figure 5.9). Furthermore this crosswalk is at a 60° angle where pedestrians exiting the parkade face away from traffic and are obscured from view by the fire stair structure. Pedestrians walking towards the parkade are obscured from view by the Rental Car Centre building until they enter the crosswalk area. This crosswalk has been a concern to YYC for a period of time and a stop sign has been installed for the bus as a mitigation measure. However, from interviews and observations driver compliance with the Stop sign was poor.

A study of the existing crosswalks can be undertaken to determine if there are design deficiencies or improvements that can be made. For example, the angled crosswalk behind the Rental Car Centre, (refer to in section 5.2.8) may benefit from relocation to the opposite side of the stair structure to cross in the opposite direction as shown in figure 6.3. This may help to improve sight lines for vehicle operators as they would then be afforded a view of pedestrians approaching from the terminal and parkades, as well as forcing pedestrians coming from the parkade to face oncoming traffic.

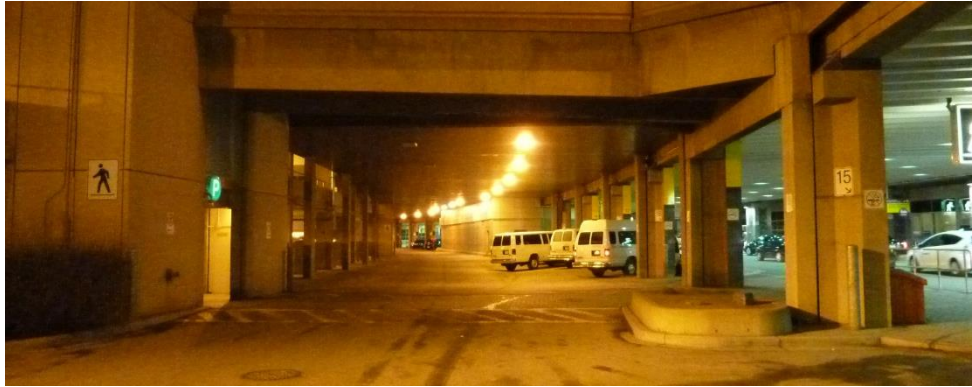
Figure 5.10 – Parkade Exiting Directly to Driveway

There are five crosswalks originating from the parkade that are of concern. Due to the fire stair structure, there is no opportunity for the pedestrian or busses in the bus facility to see each other prior to the pedestrian stepping foot onto the driveway itself (refer to figure 5.10). YYC has taken steps to mitigate the issue by playing an automatically actuated audible warning message upon leaving the parkade and an amber rotating beacon activates on the driveway side to help reduce the risk. However, due to the limited space, it is likely impossible to further improve on these aforementioned measures.

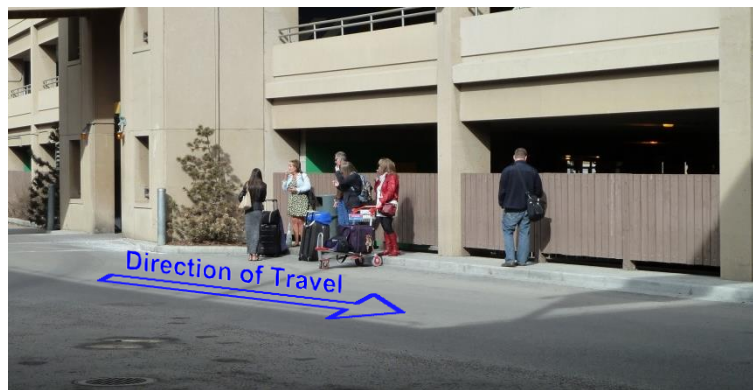
Figure 5.11 – Smoking Area on Driveway

Finally, the location of some smoking areas on this level is a cause for concern. Figure 5.11 shows an example of several smoking areas are located alongside the parkade on the edge of the driveway of the bus facility and are only accessible by walking on the bus facility's driveway near the stair structures. While these locations benefit from the crosswalks at the stairwells, they are sometimes located on the driveway resulting in smokers being obscured from view by the stairway structure.

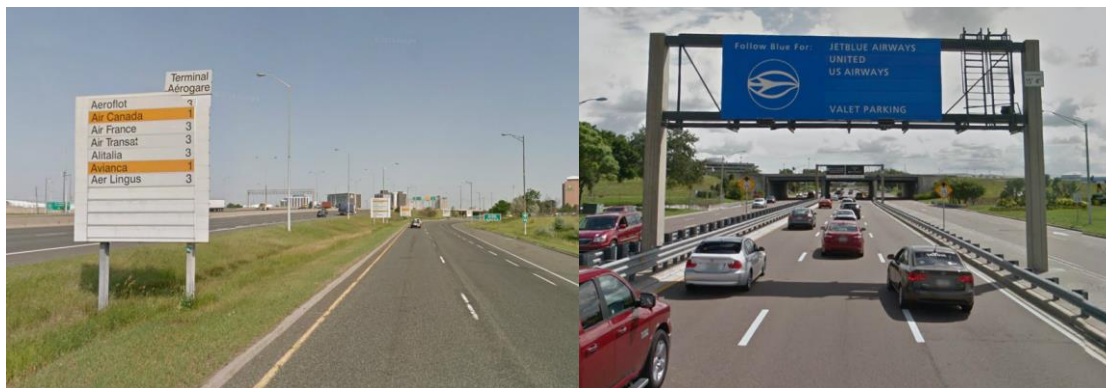
Figure 6.1 – Example of Advance Signage (Google Maps, 2015, 2015)

Many airports around the world choose to provide directional information to passengers well in advance of arrival at the terminal. Often these take the form of road side signage approaching the airport and group drivers into following simpler instructions, such as proceeding to a certain entrance, zone or terminal. Figure 6.1 shows examples of such an implementation approaching Toronto Pearson International Airport where drivers are directed to different terminals, and Tampa International Airport direction drivers to different drop-off and pick-up zones.

YYC can consider such infrastructure as well given that many vehicles approach from Airport Trail NE which has a long stretch with little signage or distractions. Drivers can be advised ahead of which area to proceed to, which can be made consistent with the concourse and gate lettering system used within the terminal. Therefore as drivers approach they already have an idea of their destination and can follow a simple letter or colour coding rather than reading airline information at the curb. In order to implement this option, consistent and highly visible lettering will need to be shown at the curbside as well. Finally, this suggestion may also assist in the door crowding issue as some drivers will be encouraged to stop at any door for their area letter, rather than depending on and stopping at one location.

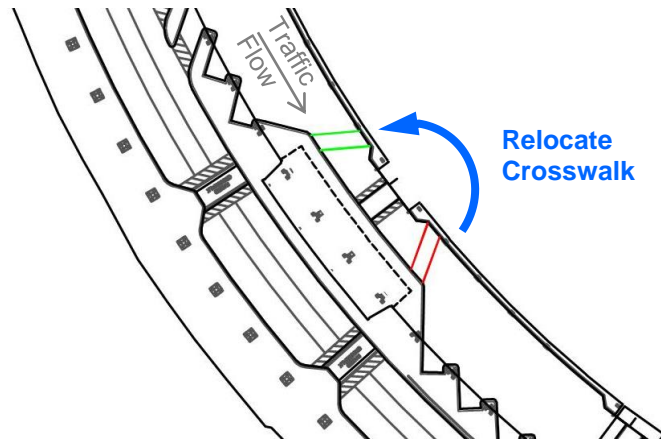
Figure 6.3 – Diagram of Possible Crosswalk Reconfiguration

YYC may wish to review existing crosswalks to determine whether all of them are warranted. Due to the close spacing of some crosswalks, it may be beneficial to close and reduce the number of crosswalks. A study into whether the crosswalks require positive control may be beneficial as well. These efforts can help to reduce driver frustration due to the volume of crosswalks and pedestrians, create additional curb space and reduce the number of crosswalks needing patrolling or control by security staff.
