Rectangular Rapid Flashing Beacons (RRFB) Pilot Project

Nominated for: The City of Calgary

Category: Road Safety Engineering Award

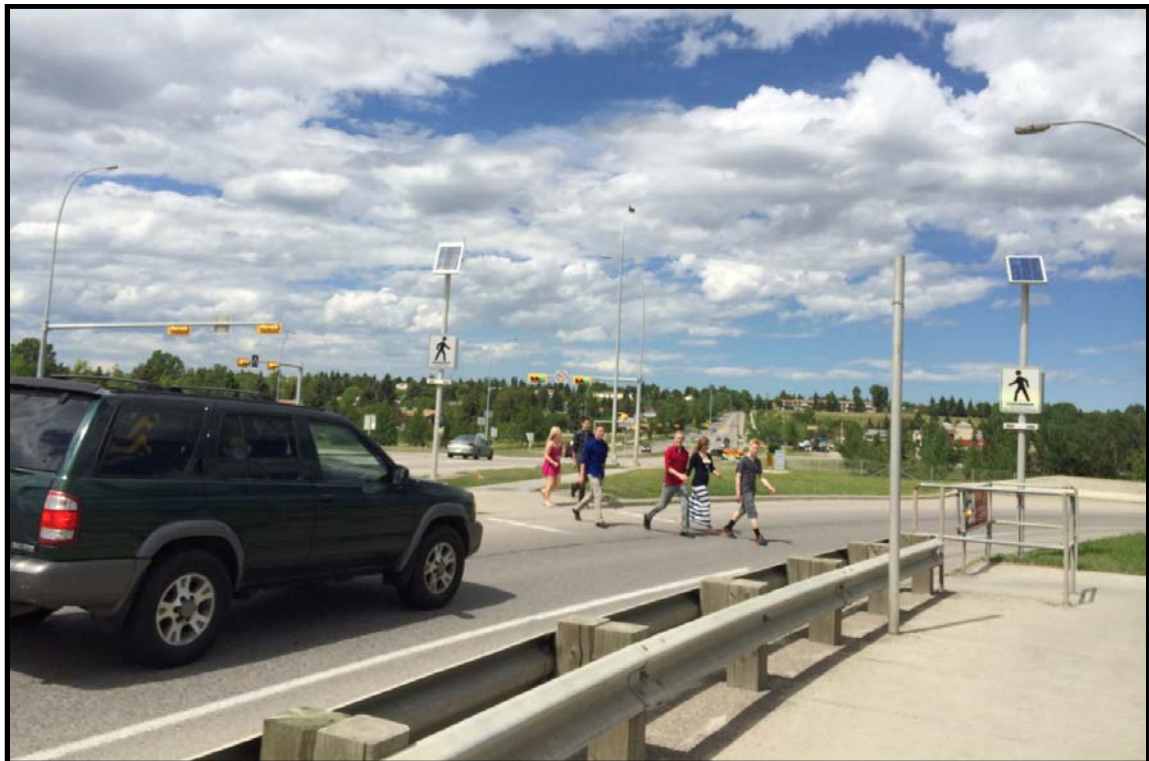
Figure 2: RRFB installed at Glenmore Tr/18 St SE ramp

Products from four different vendors were used in the Phase 1 pilot. All of these installations were solar powered. Figure 2 to Figure 4 show various types of RRFB devices installed in Calgary. To continue the dialogue with suppliers regarding the emerging technologies and the performance of solar powered batteries, The City of Calgary conducted a number of vendors' forum following the Phase 1 installations.

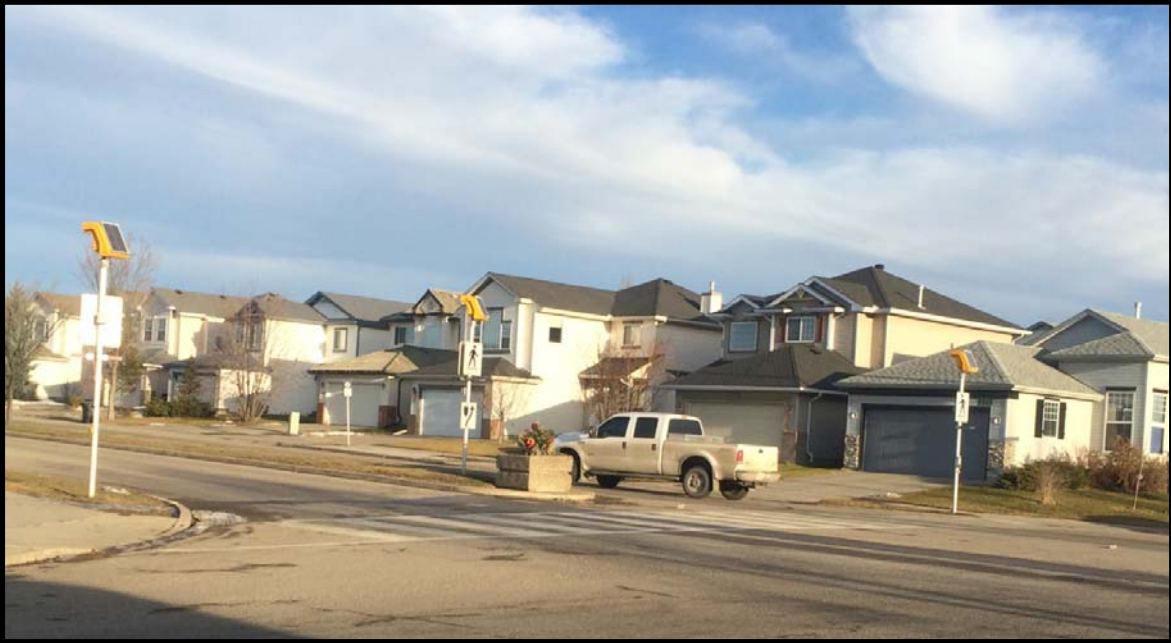
Figure 3: RRFB installed at Douglasdale Bv/Douglasridge CI SE

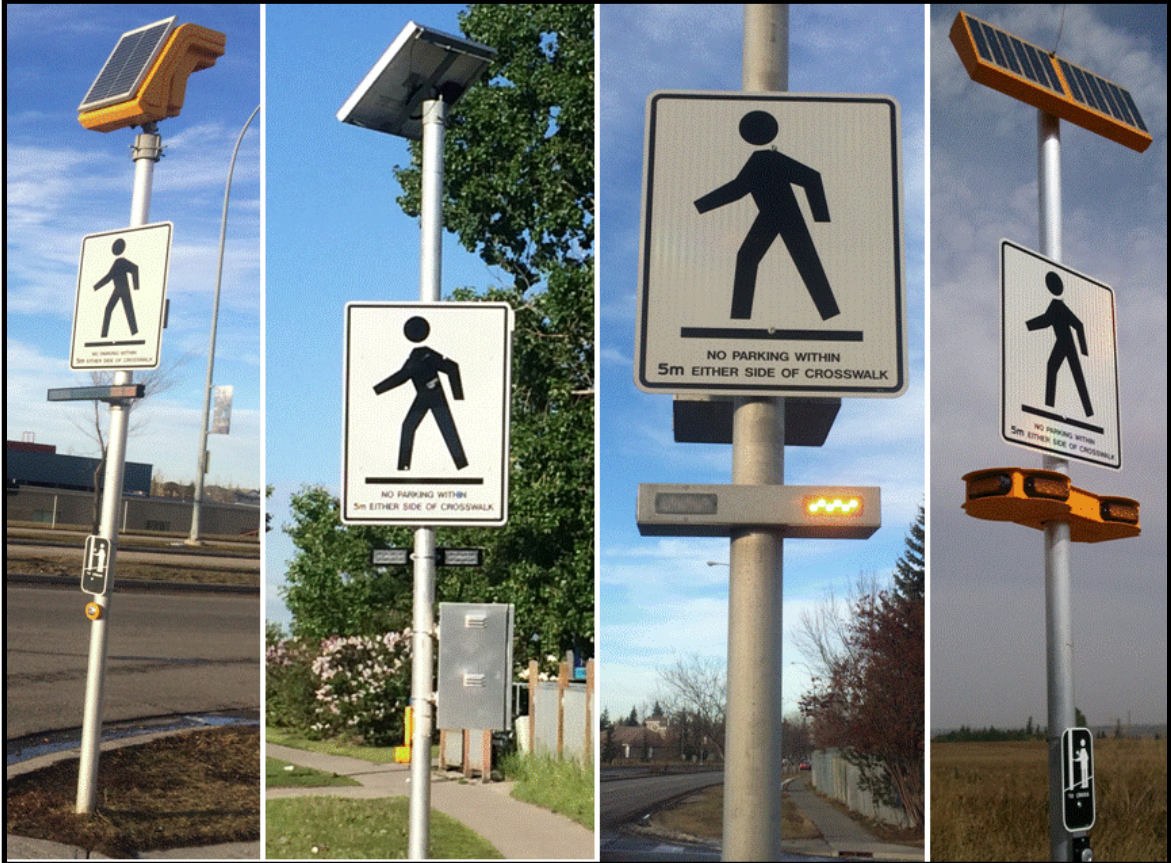
Figure 4: Various types of RRFB devices used in Calgary

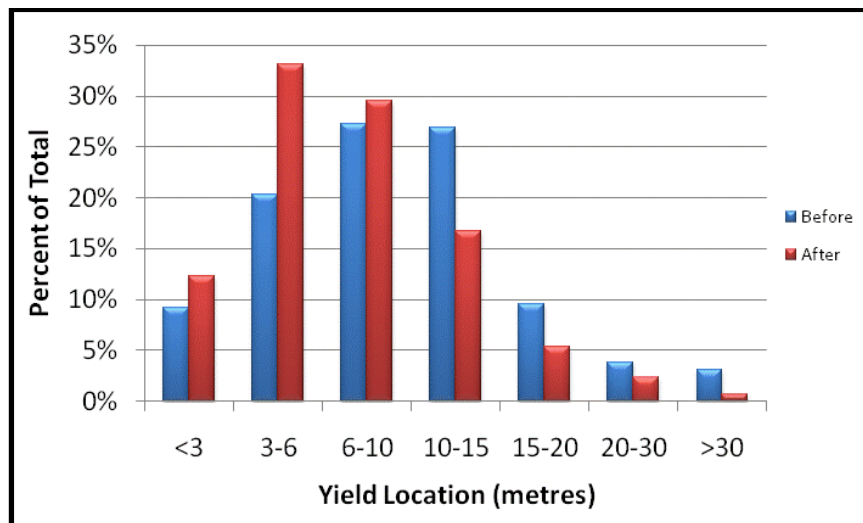
Figure 6: Yield distance

Yield distance graph (Figure 6) indicates that yielding within 10 m of the crosswalk increased by 18% after the installation of the RRFB devices. The highest increase from 20% to 33% occurred in the 3-6 m category. The increase in percentage of vehicles yielding within 10 m was evident in all single lane approaches. However, the same trend was not noticed in the multi-lane approaches. Based on the observations, the shift in yielding location was likely due to drivers making the decision to stop when in closer proximity of the crosswalk with the presence of an RRFB as compared to the baseline condition when the drivers at those situations would proceed without stopping. The increase in yielding within 10 m of the crosswalk with a single lane approach is not likely to pose significant safety concerns to pedestrians.

The stopping location is of most concern with the multi-lane approaches when the stopped vehicle blocks the sight lines between a pedestrian and a vehicle in the adjacent lane. However, yielding within 10 m of the crosswalk decreased in the after period along multi-lane approaches which further improves the safety of pedestrians.

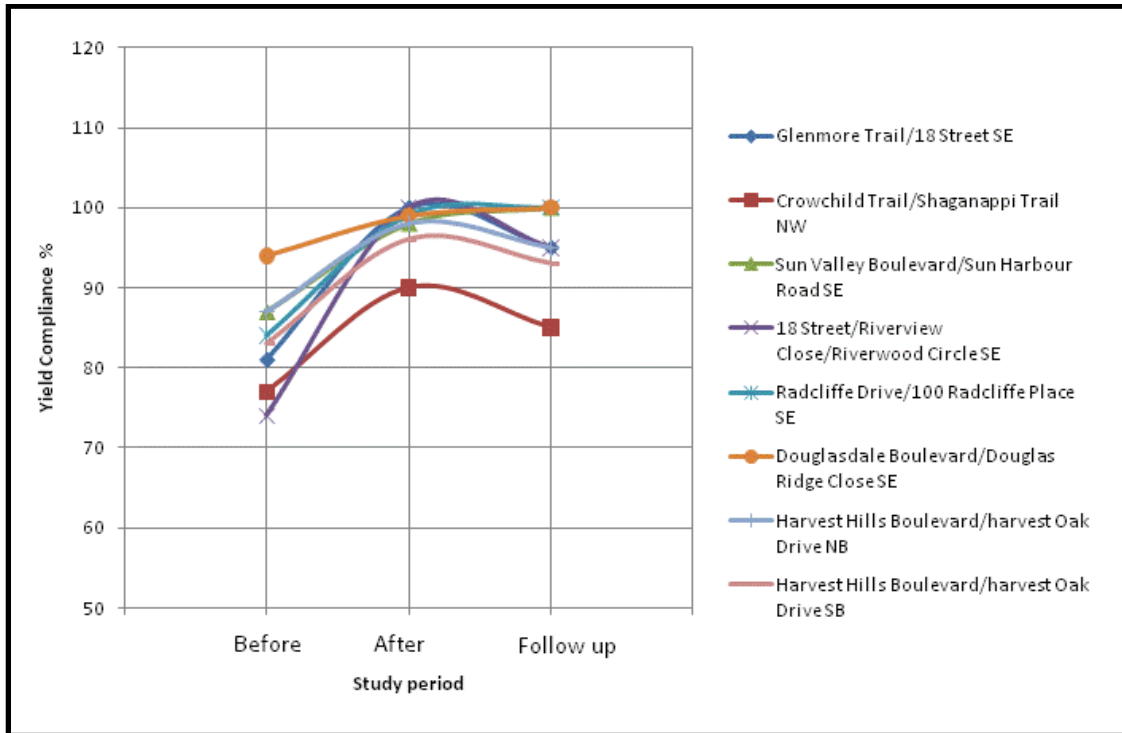
Figure 7: Graphs indicating Yield compliance percentage by motorists

Results: Study results indicated that the devices improved the yielding behaviour in all cases to between 90% and 100% (Figure 5 – Figure 7). The majority of locations where the driver

yielding behavior to pedestrians were already high (mid 70% to 90% in most cases), experienced a consistent increase to over 90% (up to 100% in some cases).

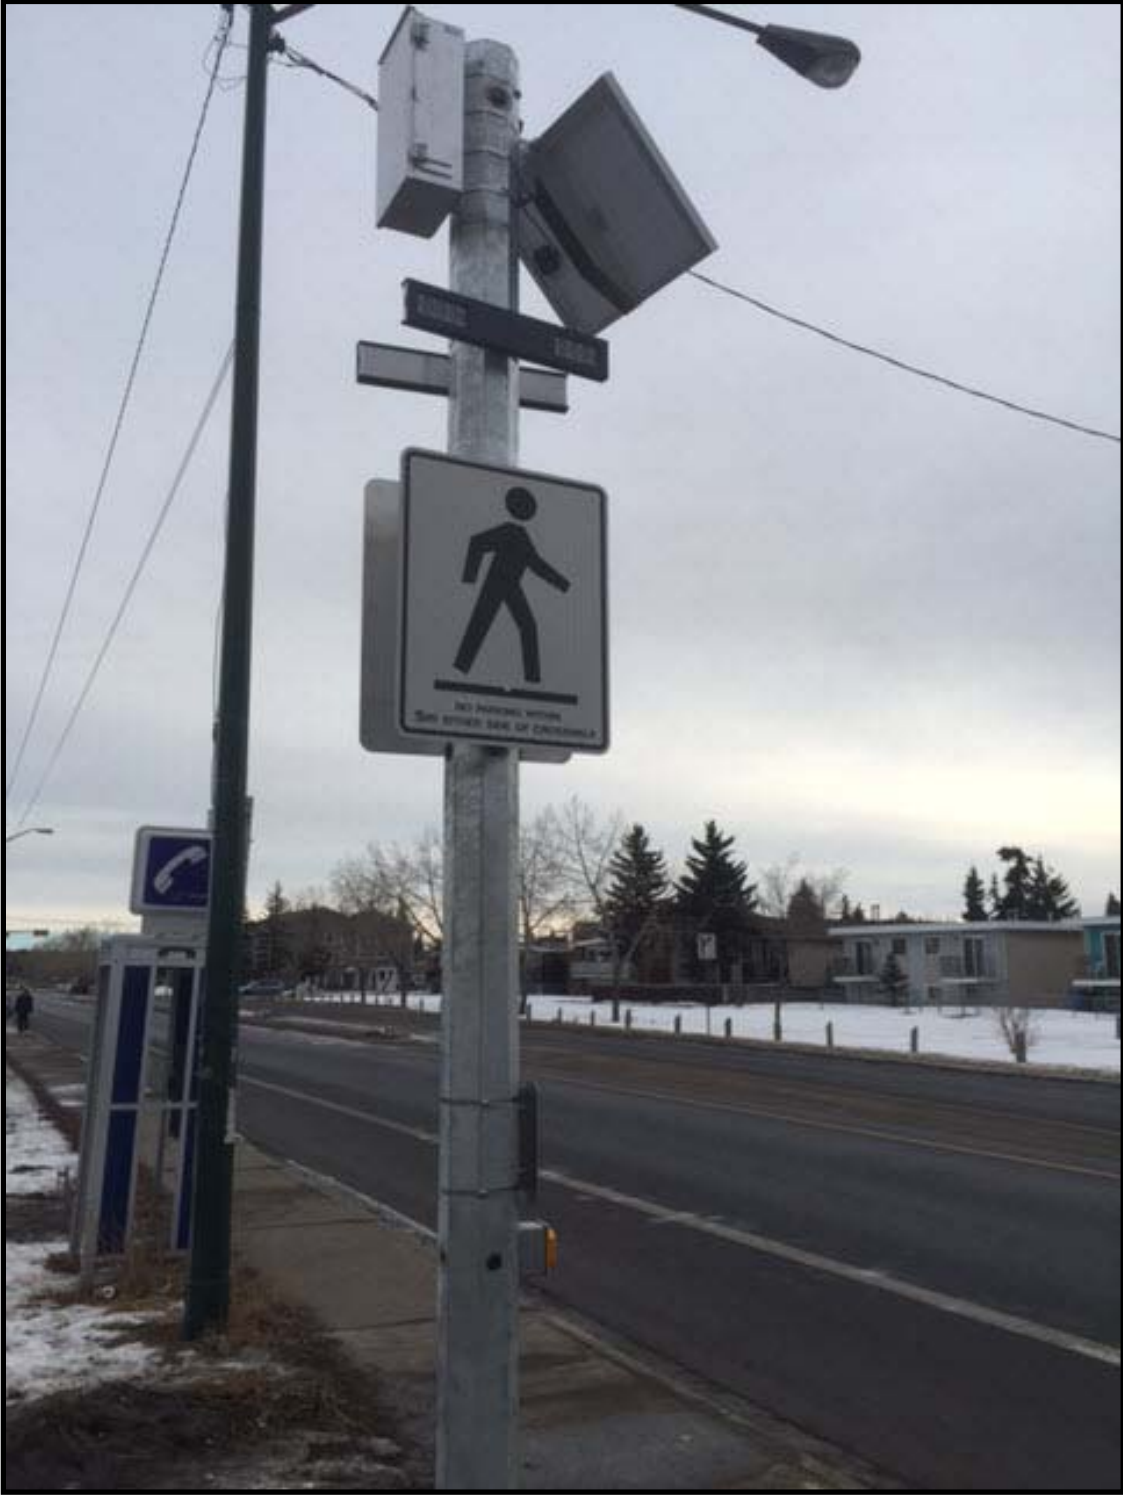
Figure 9: New RRFB installation on Bowness Rd NW as part of Phase 2 Pilot). Please note - The flashers are placed above the sign as opposed to below the sign in previous installations)

After presenting the Phase 1 report to the City Council in 2013, City of Calgary decided to extend the pilot to total 25 locations by 2015. The positive results from Phase 1 study also garnered attention and support from the City Councillors and concerned citizens. A few installations have already been completed as part of the Phase 2. Figure 9 shows a new installation at Bowness Road NW.

One of the main differences of the new RRFB installations compared to the Phase 1 is the placement of the flashing beacons. Initially, the beacons were installed below the Pedestrian Crosswalk Sign (RA-4). However, the new installations have the flashing beacon above the sign.
