**Warden Avenue Road Widening
between 16th Avenue and Major Mackenzie Drive in the City of Markham –
A York Region Reconstruction Project in an Environmentally Sensitive Area**

In 2013 and 2014, Warden Avenue was transformed under a unique road improvements project that comprised of widening and reconstructing a two kilometre section of Warden Avenue between 16th Avenue and Major Mackenzie Drive (**Appendix 1**).

Appendix 4: Warden Avenue Achievements

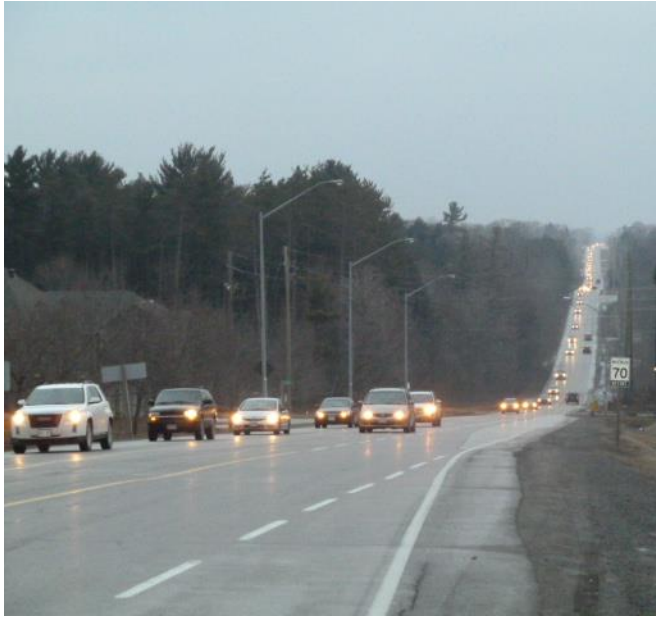
Warden Avenue before construction

Warden Avenue's two-lane rural road section between 16th Avenue and Major Mackenzie Drive no longer met the needs of the growing population as traffic volumes continued to increase from high residential development in the area. Sections of Warden Avenue within this area were also prone to periodic flooding/overtopping of the roadway during large storm events at one or more of the watercourse crossings.

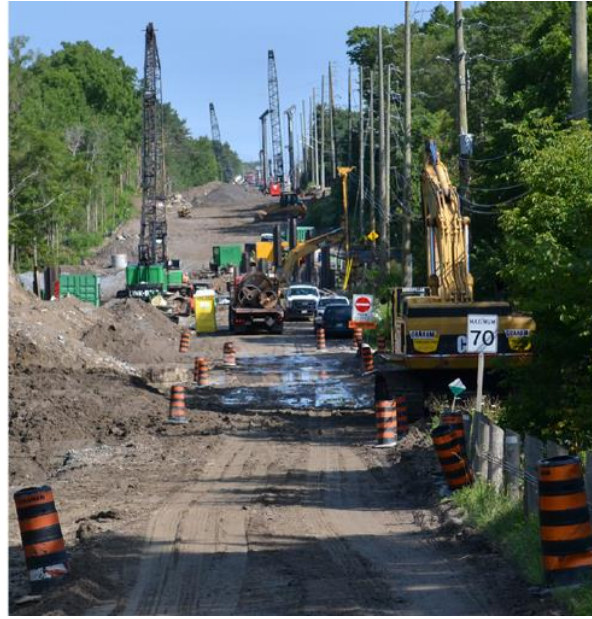
Warden Avenue during construction

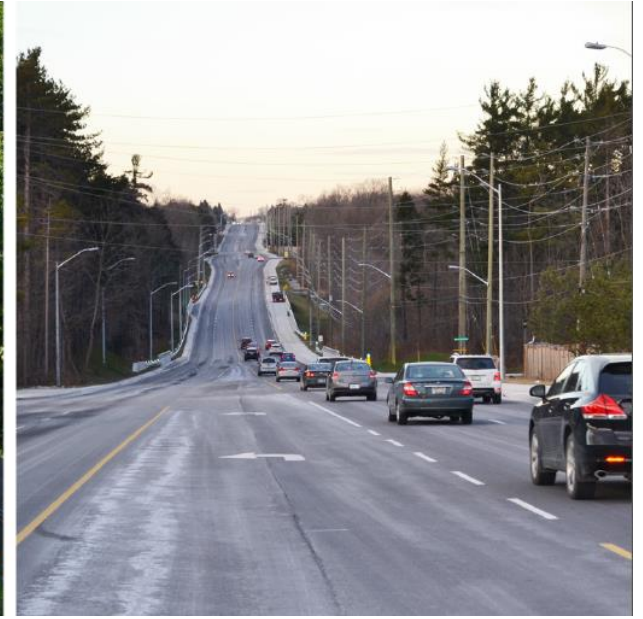
Warden Avenue after construction

York Region widened and reconstructed Warden Avenue from a 2-lane rural cross-section to 4-lane urban cross-section and installed curbs, storm sewers, retaining walls, traffic noise barriers, multi-use pathways and three bridges, with a \$22 million overall project cost. The roadway was also re-profiled to improve sightlines. Construction commenced spring 2013, included a six month road closure and was substantially completed by the winter of 2014.

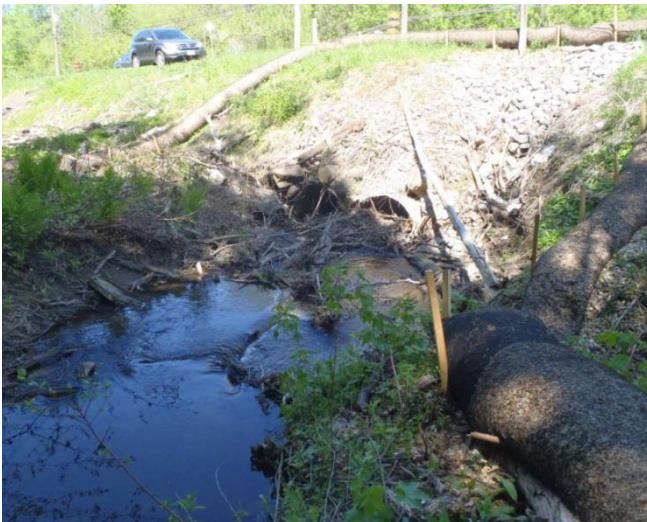
Carlton Creek before construction

Carlton Creek flows from west to east beneath Warden Avenue to where it flows into Berczy Creek, approximately 100m downstream of Warden Avenue. Prior to construction, the watercourse flowed through a twin 1500mm diameter culvert that was severely blocked at the inlet due to a large wood/debris jam and significant sediment deposit.

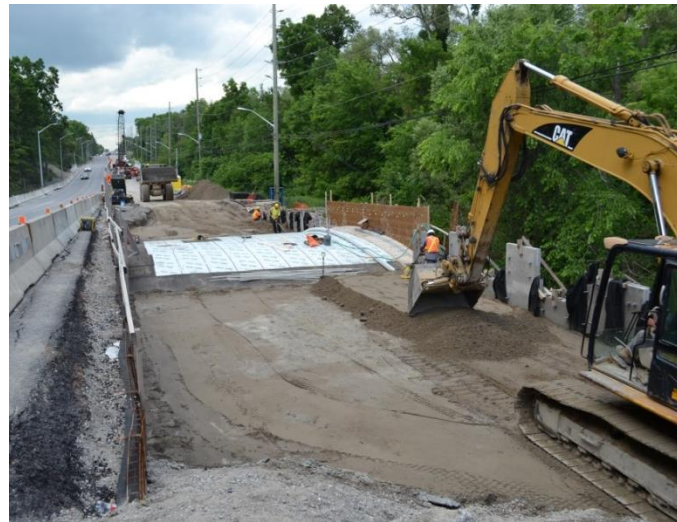
Carlton Creek during construction

At the Carlton Creek watercourse crossing, the contractor unearthed an unknown concrete box structure. Working closely with MNR, work was reorganized to remove the structure. Realignment and restoration of Carlton Creek, completion of the footings and bridge substructure was all advanced to Phase One of construction.

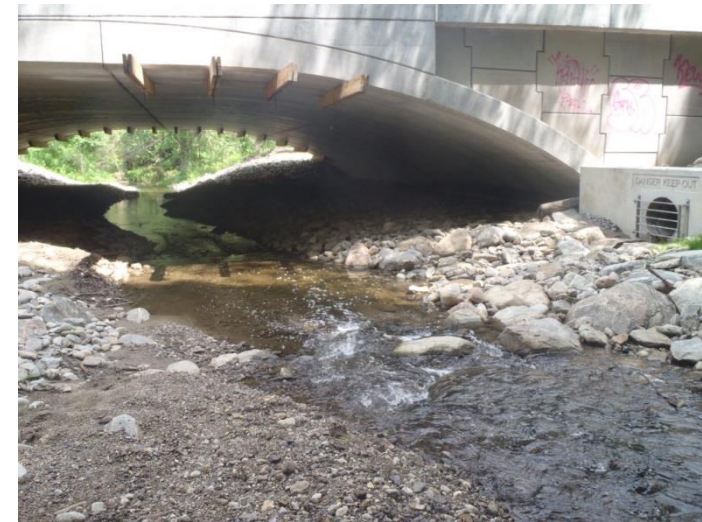
Carlton Creek after construction

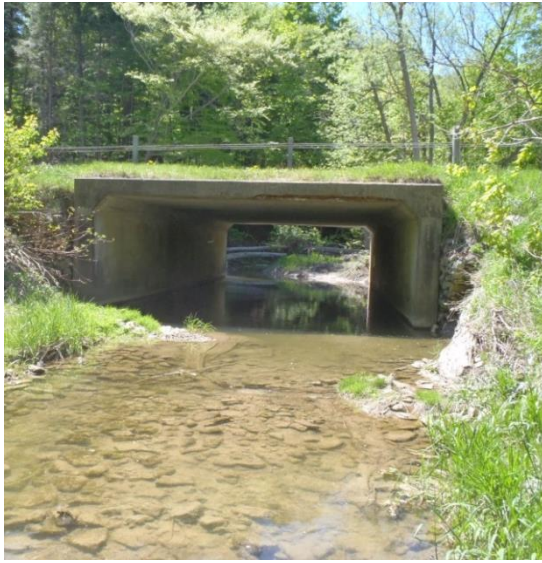
Berczy Creek South before construction

Berczy Creek South flows from west to east beneath Warden Avenue (previously via a 6 metre by 3 metre concrete box culvert). Both upstream and downstream of the Warden Avenue crossing, the creek represents pool/run/riffle channel morphology, moderate gradients, abundant in-stream cover in the form of woody debris and overhanging vegetated banks, large sediment deposits and erosion sites.

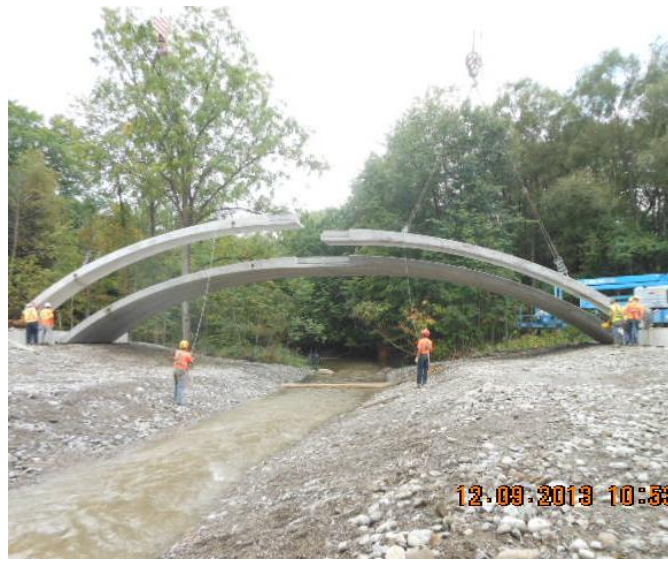
Berczy Creek South during construction

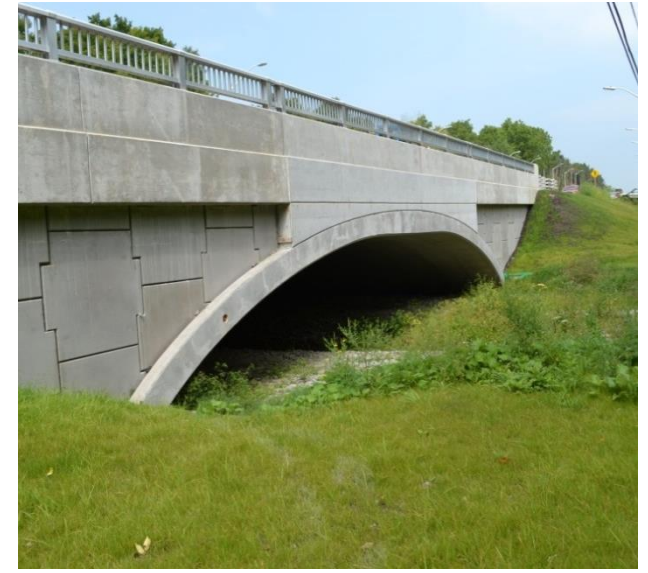
Berczy Creek South after construction

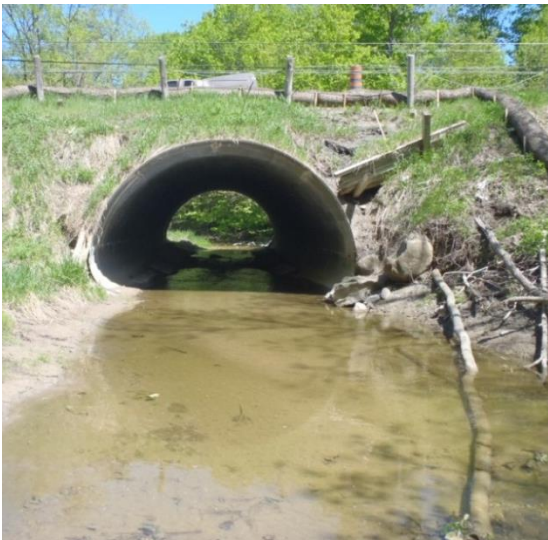
Berczy Creek North before construction

Berczy Creek North flows east to west, flowing beneath Warden Avenue (pre-construction via a 5,700 mm x 3,600 mm CSP Arch culvert). Upstream of Warden Avenue, the creek flows in a southerly direction within a forested valley with large subdivision lots backing onto it. The channel morphology consists of naturally meandering pool/run/riffle sequencing with gravel and cobble dominated substrates.

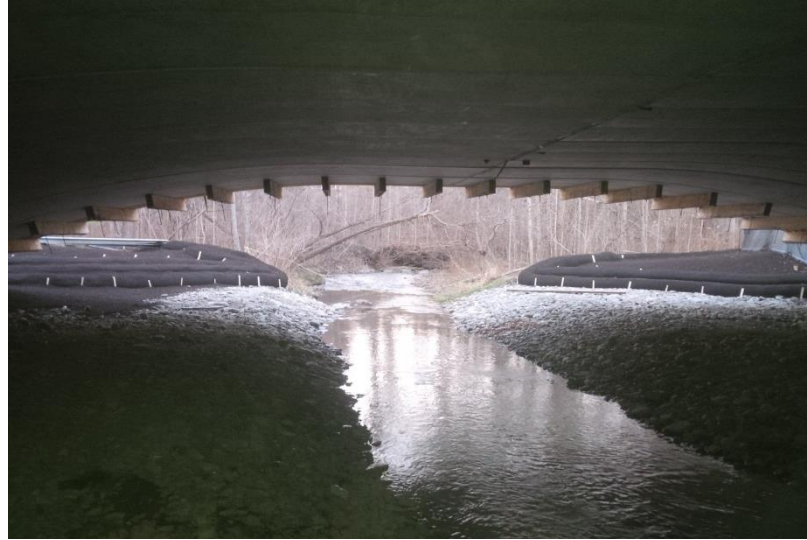
Berczy Creek North during construction

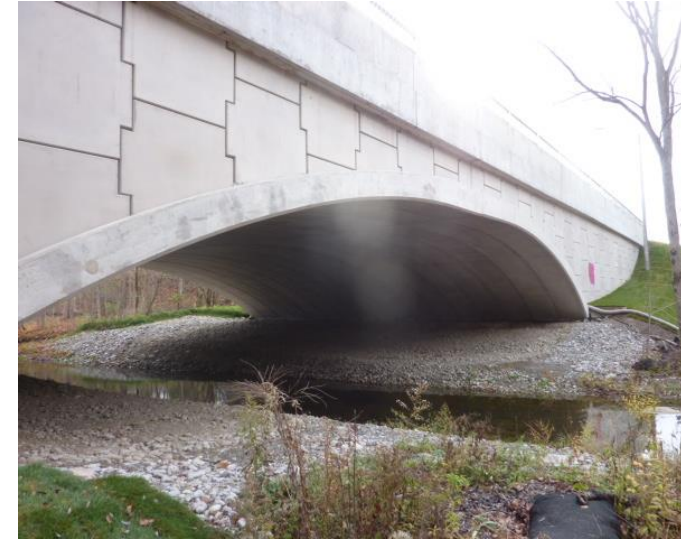
Berczy Creek North after construction

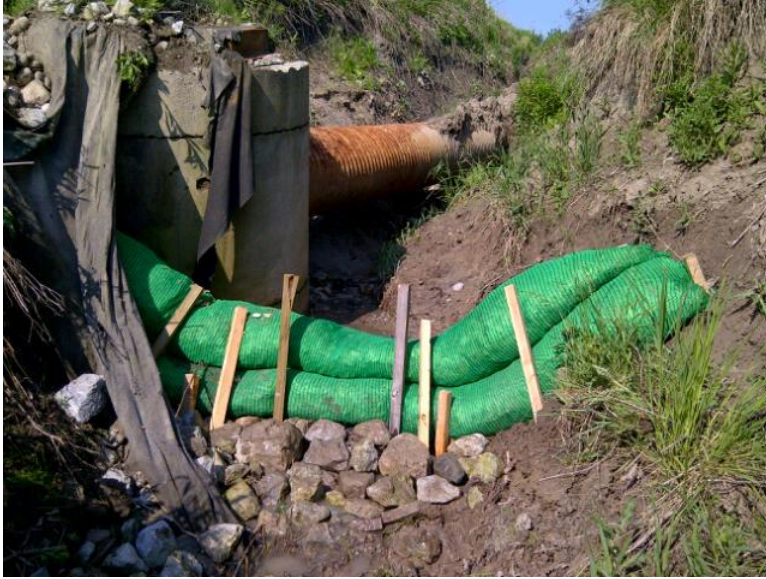
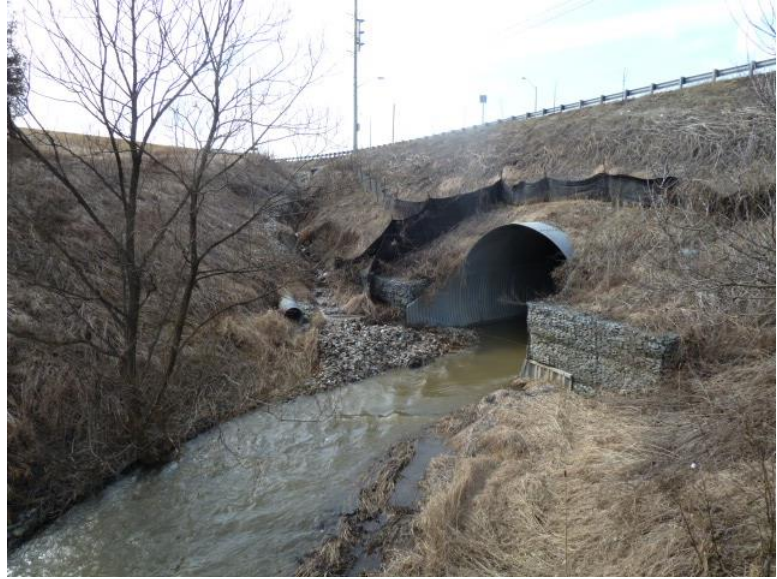
Major Mackenzie Outlet Before

During construction, a slope stabilization issue developed at the southwest corner of Warden Avenue and Major Mackenzie Drive, necessitating the need to advance the outlet restoration work on Berczy Creek outfall and a redesign of the ditch upstream from Phase Two to Phase One of construction (**Appendix 3**).

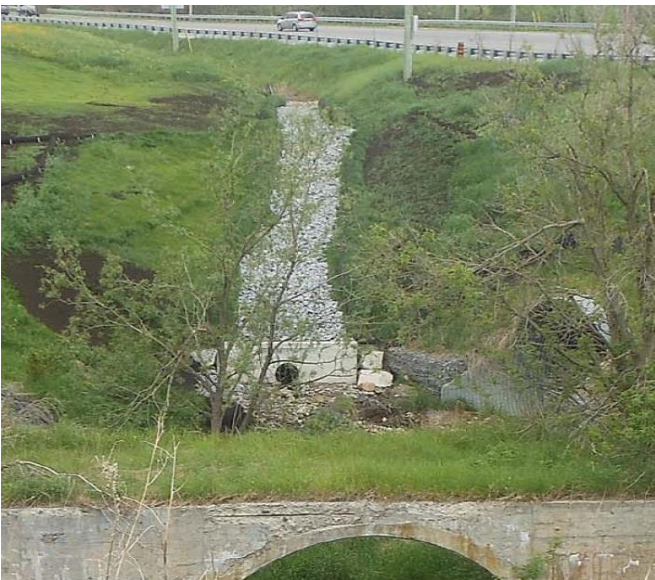
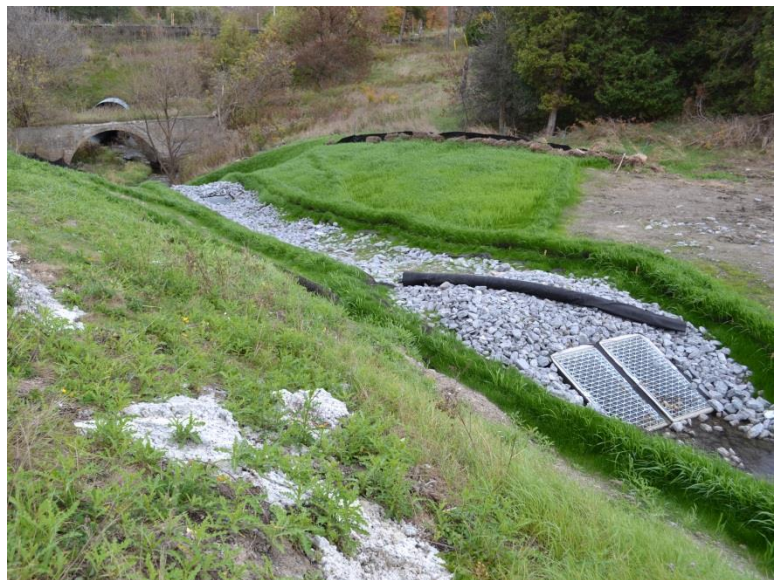
Major Mackenzie Outlet After
