**EXPERIENCE WITH FULL DEPTH RECLAMATION / STABILIZATION
USING EXPANDED ASPHALT (FOAMED BITUMEN) IN EDMONTON,
ALBERTA**

Paper prepared for Presentation
at the Recycling Materials for Use in Highway Design Session
Of the 2003 Annual Conference of the
Transportation Association of Canada
St. John's, Newfoundland and Labrador

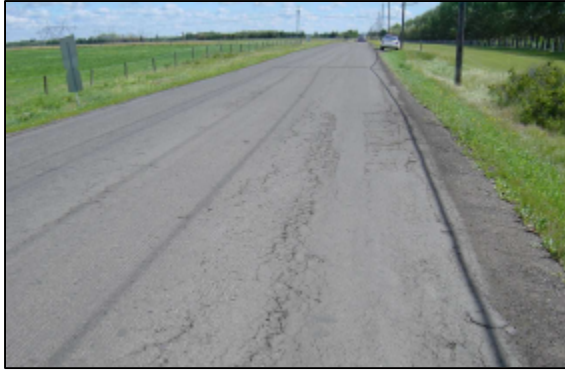
Figure 1 - Ellerslie Road Project Site

The Ellerslie road project site extended from 150 Street to 142 Street and also included a 450-meter section of Ellerslie Road West of 127 Street. The Ellerslie Road test section was an old country road, which was acquired by the City of Edmonton by Annexation in the late 1970's. The actual age of the road structure was unknown. The road section consisted of approximately 2 kilometers of two-lane, seven-meter wide, rural cross-section comprised of bitumen treated gravel overlying a high plastic lacustrian clay. The distress found along the road was mainly severe alligator cracking and deformation. Transverse and longitudinal cracking were evident in some sections possibly due to the effect of freezing and thawing of the subgrade materials. The alligator cracks are evidence of fatigue failure of the upper pavement layers due to lack of subgrade support, especially when the subgrade is excessively moist. With water ingress through these cracks the failure of the pavement was accelerated. A photo of the existing Ellerslie Road is shown in Figure 1.

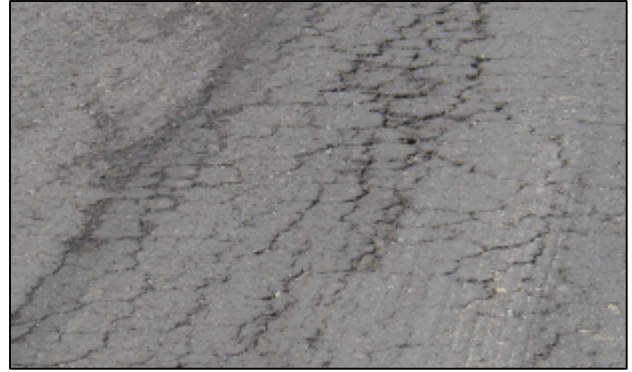
Figure 2 - 70 Avenue Project Site

The 70 Avenue project site included a section of 70 Avenue from 18 Street to 20 Street, a section of 18 Street from 70 Avenue to 74 Avenue and a section of 73 Avenue from 17 Street to 18 Street. The 70 Avenue test section was an old rural section of roadway in a light industrial area towards the eastern limits of the City of Edmonton, the construction date for this roadway was again unknown. The road section consisted of approximately 1.5 kilometers of two-lane, seven-meter wide, rural cross section comprised of bitumen treated gravel overlying a high plastic lacustrian clay. As with the Ellerslie Road project, the distress found along this road was mainly severe alligator cracking and deformation. Transverse and longitudinal cracking was also evident in some sections. The alligator cracks are again evidence of fatigue failure of the upper pavement layers due to lack of subgrade support. A photo of the existing surface of 70 Avenue is shown in Figure 2.

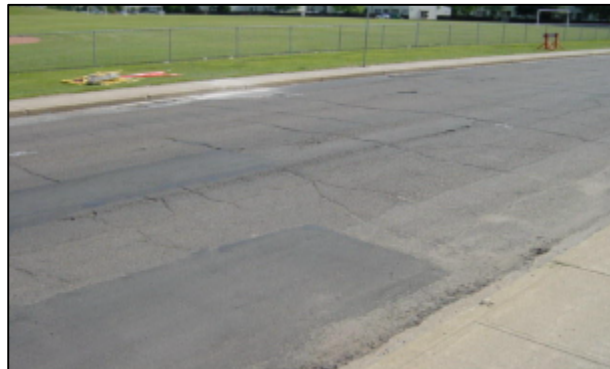
Figure 3 - 150 Avenue Project Site

The 150 Avenue project site included a section of 150 Avenue from 87 Street to 94 Street and a section of 94 Street from 144 Avenue to 150 Avenue. The 150 Avenue test section is a bus route collector roadway constructed in 1971. The road section consisted of approximately 1.3 kilometers of four-lane, 14-meter wide urban cross section comprised of 70mm of hot mix asphalt overlying 200mm of cement treated granular base over 150mm of a 63mm granular sub-base. The portion of 150 Avenue and 94 Street earmarked for rehabilitation showed large areas of block and thermal cracking. In many places this primary cracking had degenerated into alligator cracks with hydraulic displacement of fines (pumping) from the underlying base material. Numerous hot mix patches were evident over the surface of the entire section inspected. These patches had probably extended into the base of the stabilized layer (± 200 mm thick) since the modes of failure being addressed (alligator cracking / pumping / loss of support) originated from that point in the pavement. Some patches observed were old and some new, indicating that such measures are part of an ongoing maintenance routine. The areas at the bus stops exhibited severe distress in the form of deformation and shoving of the surfacing. It was clear that the pavement at these locations had received additional maintenance work with numerous asphalt patches being evident both at the bus stops themselves, and on either side. A photo of the existing 150 Avenue showing the block cracking and numerous patches is shown in Figure 3.

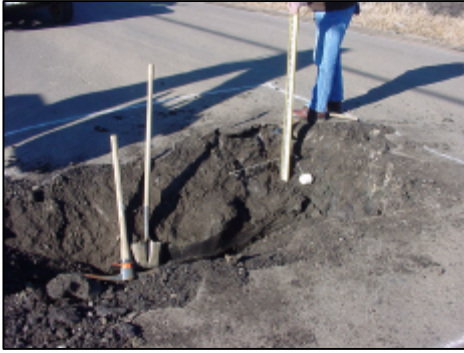
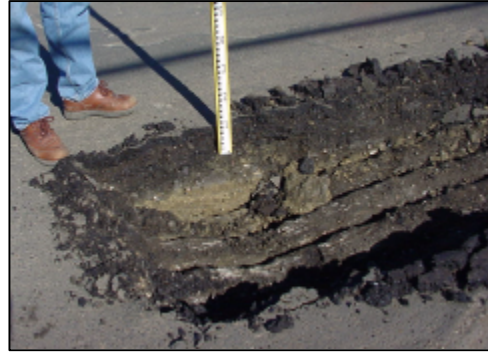
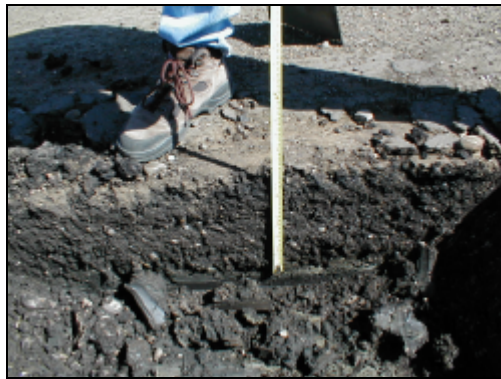
Figure 5a - Test Pit on Ellerslie

Figure 5b - Test Pit on 70 Avenue

Figure 5c - Test Pit on 150 Avenue

On March 1, 2001, several test pits were excavated utilizing a rubber tire mounted backhoe. These test pits were excavated to determine the existing pavement structure as well as obtain samples for performing mix designs. Figures 5a through 5c show photos of the test pits for Ellerslie Road, 70 Avenue and 150 Avenue respectively.

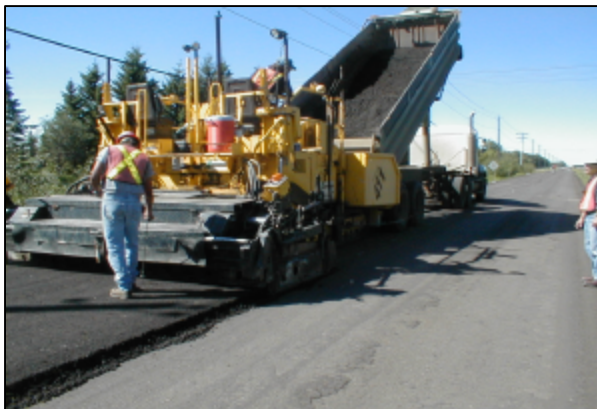
Figure 6 - Placement of 20mm Corrective Aggregate with ABG Paver, Ellerslie Road

Lafarge Construction Materials commenced construction August 20, 2001 on Ellerslie Road with the placement of 100mm of 20mm corrective aggregate placed utilizing an ABG Titan 511 Paver. See photo as Figure 6. The contractor chose to use the paver for placement of the granular material to ensure uniformity of the layer thickness. The contractor then commenced the FDR and foamed bitumen stabilization operation on August 21, 2001 at the 156 Street intersection under the guidance of Wirtgen GmbH, and AA Loudon and Partners personnel.

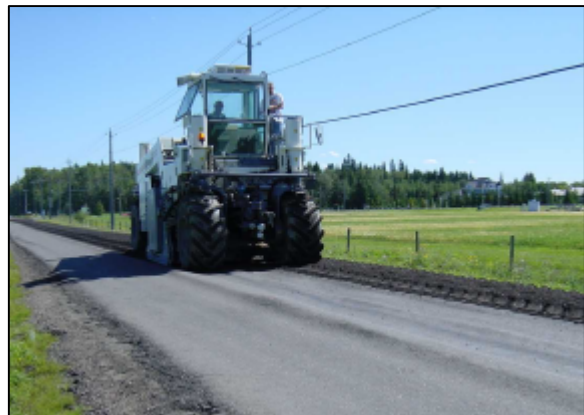
Figure 7 - Pre-pulverization of Heavily Rutted Section of Ellerslie Road

The FDR and foamed bitumen stabilization was carried out in a single operation, with the exception of one portion of Ellerslie Road, where due to excessive rutting, the roadway was pre-pulverized, shaped and compacted prior to the placement of the corrective aggregate. See photo as Figure 7.

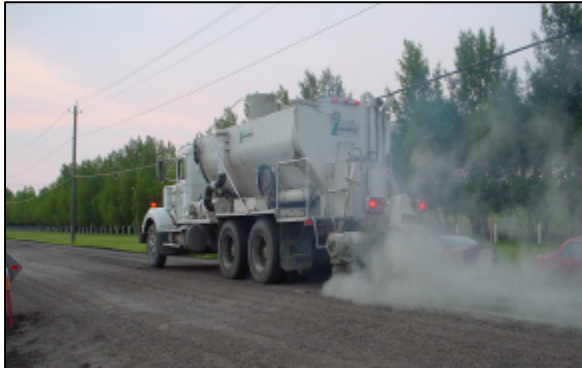
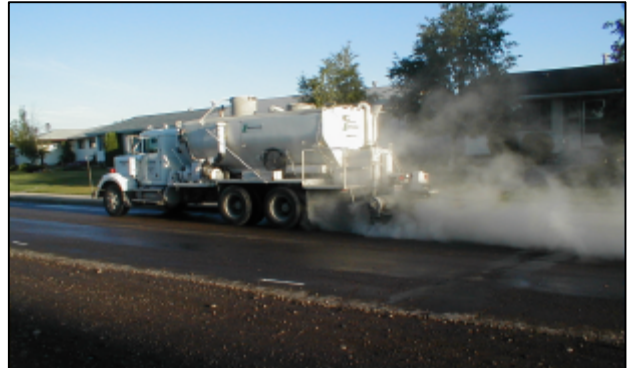
Figure 8a - Spreading of Cement on the Surface of Compacted Aggregate Ellerslie

Figure 8b - Spreading Cement on Surface of 150 Avenue

On Ellerslie Road and 70 Avenue, after the placement of the corrective aggregate and prior to the FDR and stabilization process, cement was added to the surface of the compacted aggregate. See photos as Figure 8a and 8b. On 150 Avenue the cement was spread directly on the surface of the existing roadway prior to stabilization. The cement was spread in sections no longer than 450m in front of the recycling train. It was found that pre-wetting of the aggregate surface and roadway surface prevented excessive loss of cement from the surface.

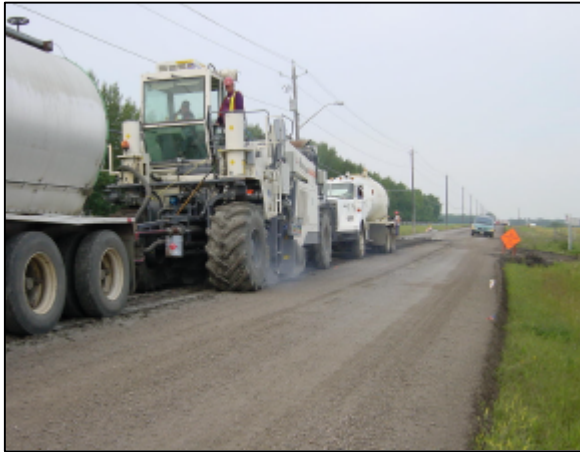
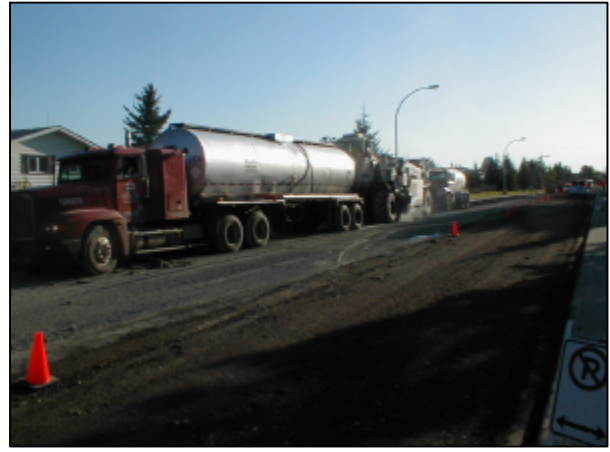
Figure 9a - Recycling Train Ellerslie Road

Figure 9b - Recycling Train 150 Avenue

The FDR and foamed bitumen stabilization operation was carried out utilizing a recycling train consisting of a Wirtgen WR2500 Reclaimer coupled to a bitumen supply tanker and a water truck. See photo as Figure 9.

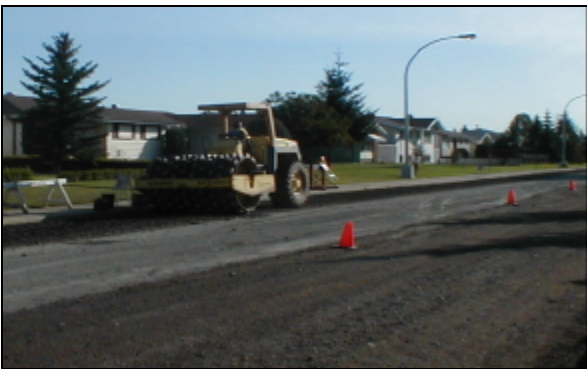
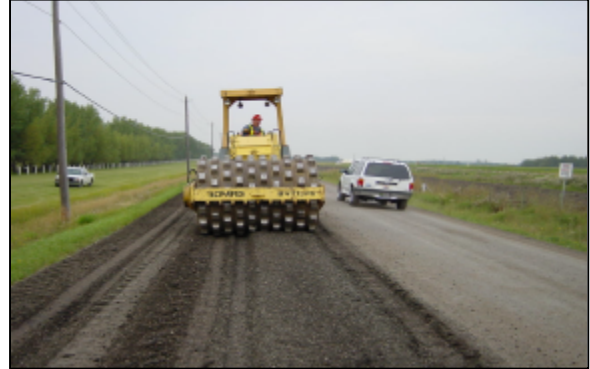
Figure 10a - Vibratory Pad Foot 150 Avenue

Figure 10b - Vibratory Pad Foot Ellerslie Road

Initial breakdown compaction of the stabilized material was carried out using a vibratory pad foot roller following immediately behind the train. See photo as Figure 10. Compaction with the vibratory pad foot roller continued until the roller walked itself to the surface of the stabilized material.

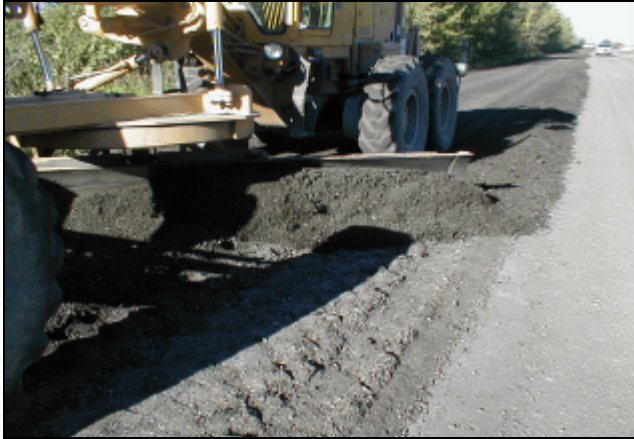
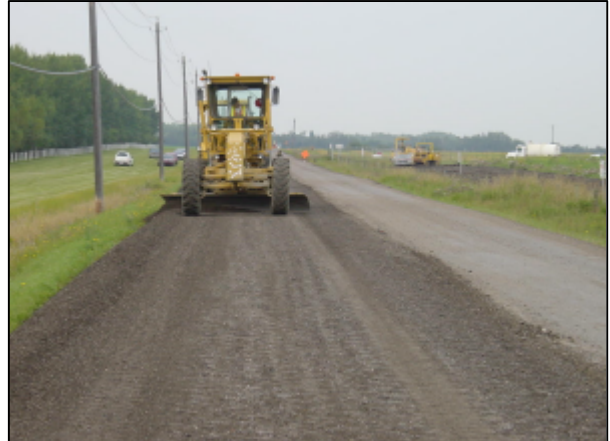
Figure 11a - Grading 70 Avenue

Figure 11b - Grading Ellerslie Road

Once the stabilized material was compacted, the surface was then cut to grade using a motor grader. See photo as Figure 11.

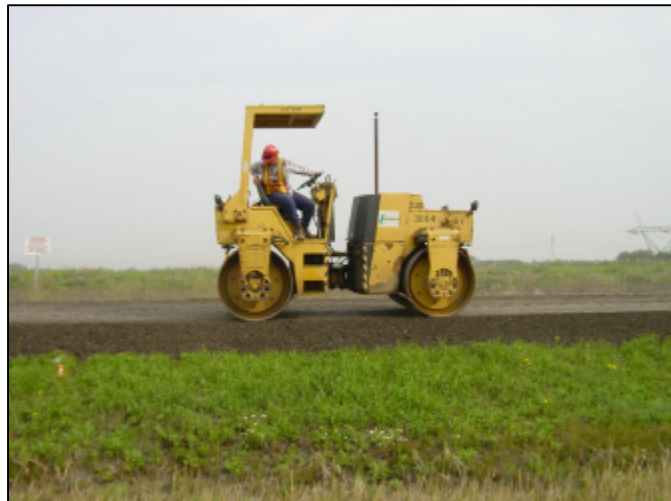
Figure 12 - Final Compaction Ellerslie Road

A double drum vibratory compactor followed the motor grader to complete the final compaction. See photo as Figure 12.

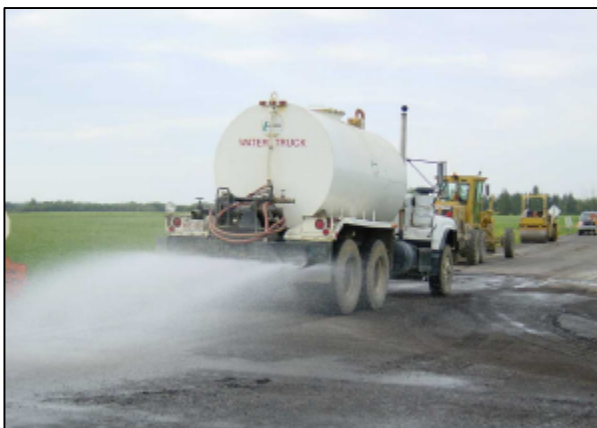
Figure 13 - Watering of Surface Ellerslie Road

Following final compaction, the surface of the stabilized material was flooded with water. See photo as Figure 13. While the surface was wet, a pneumatic tired roller was used to create a slushing effect. See photo as Figure 14. This slushing effect knitted together the finer particles in the surface and locked in the larger particles. This helped produce a surface that did not ravel.

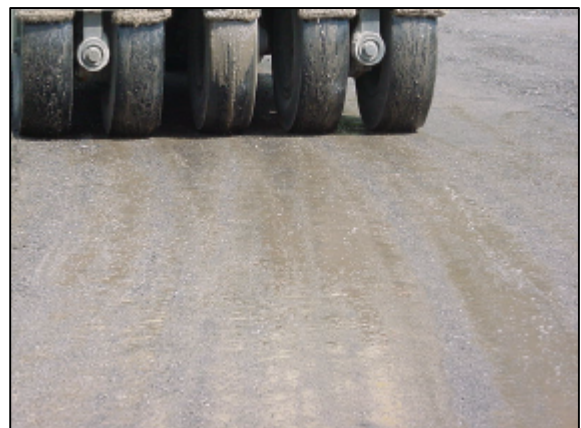
Figure 14 - Slushing with Pneumatic Roller

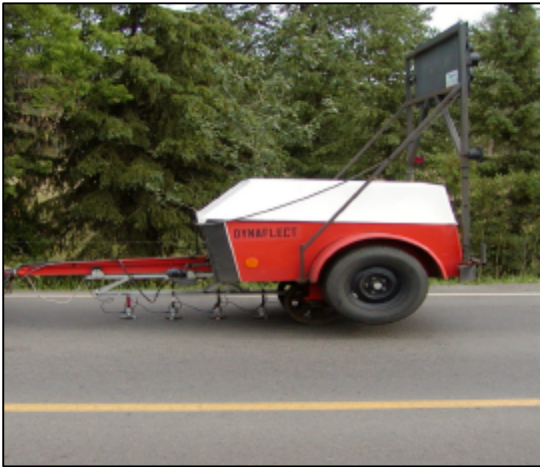
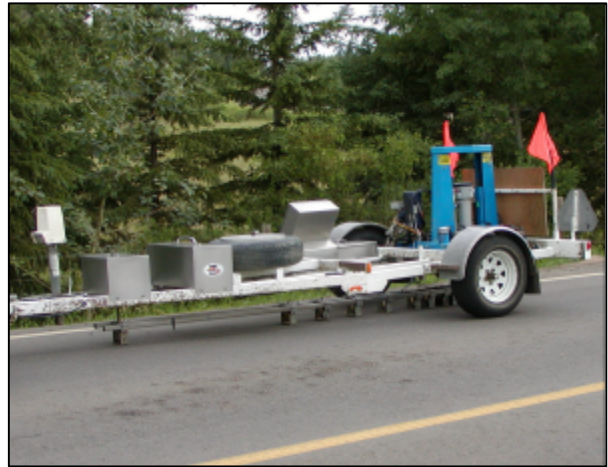
Figure 15 - Dynaflect Deflection Testing Apparatus

Figure - 16 Falling Weight Deflectometer Deflection Testing Apparatus

The performances of the three road sections reconstructed with foam bitumen stabilization techniques are being monitored on an on going basis, with the use of deflection measurements and visual observations. The deflection measurements were taken several times a year, including immediately after the foam stabilization work was performed. Figure 15 shows the Dynaflect testing apparatus utilized by the City of Edmonton for deflection testing of the demonstration projects and Figure 16 shows the Falling Weight Deflectometer apparatus also used on the demonstration projects for comparison purposes. Figures 17-19 show the Dynaflect deflections measured prior to the foamed asphalt stabilization process, three weeks after the work was carried out and approximately one-year later.

The dynamic response characteristics of the pavement structure were determined by measuring the deflection at and at specific points away from the loading point. For the FWD the surface deflections of the pavement structure were measured by a total of seven sensors, and for the Dynaflect unit, the deflections were measured by a total of five sensors equally spaced 300mm from the loading wheel. In both cases the resulting deflections and applied loading were recorded on an onboard computer for subsequent analysis. The collected deflection basin data was analyzed using back calculation software to calculate the various layer and surface moduli. All the data was processed with the actual layer thicknesses. The resilient moduli of the various layers were obtained.

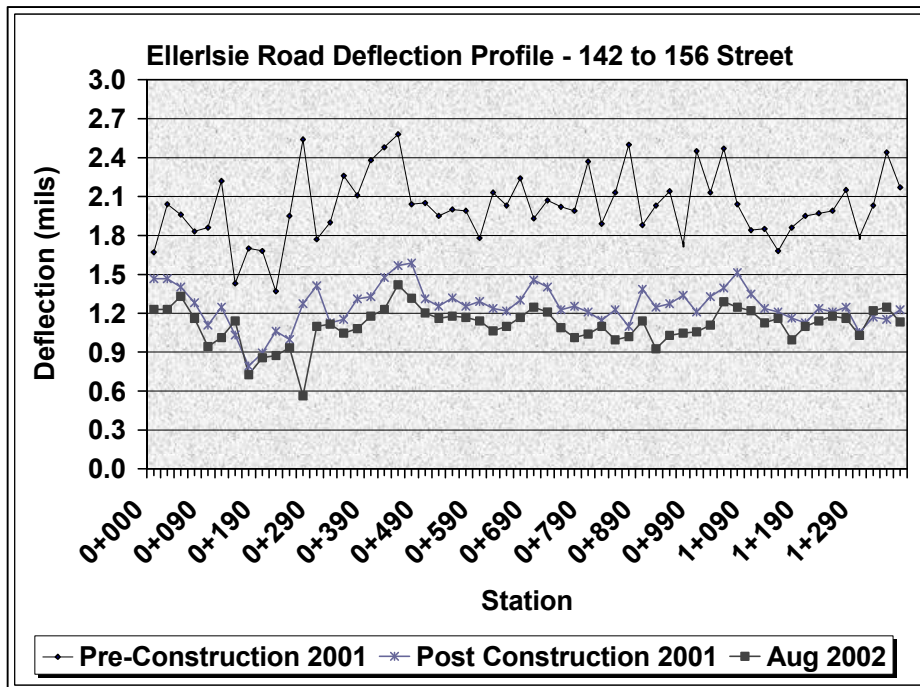
Figure 17 - Ellerslie Road – Comparison of Pre and Post Construction Deflections

For the Ellerslie Road project site, the pre-construction Dynaflect deflection results ranged from 1.84 mils (0.047 mm) to 2.70 mils (0.069 mm), averaging 2.23 mils (0.057 mm). After completion of the stabilization and overlay, the Dynaflect deflection results ranged from 1.47 mils (0.037 mm) to 0.79 mils (0.020 mm), averaging 1.24 mils (0.032 mm). This results in a deflection reduction of 44% for this roadway.

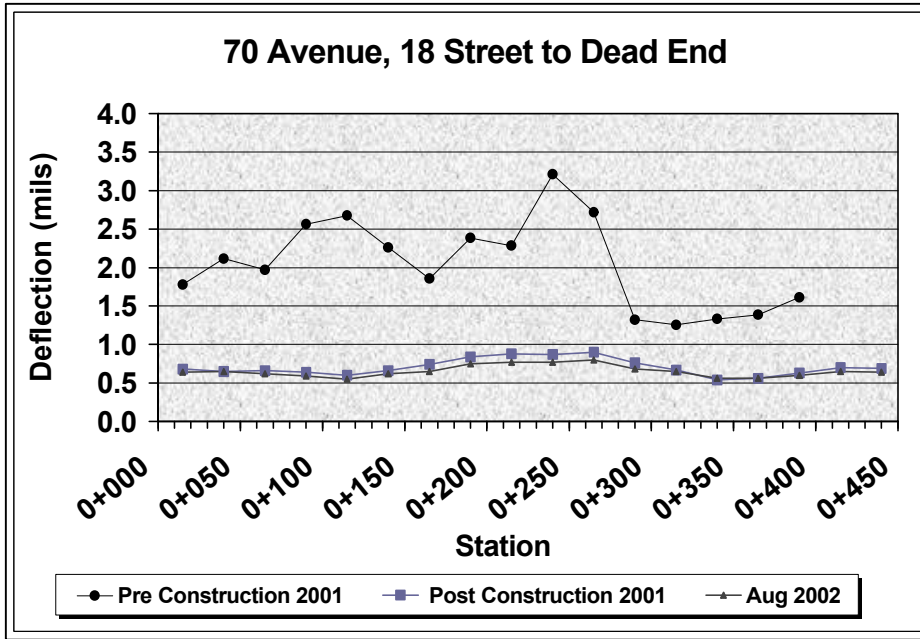
Figure 18 - 70 Avenue – Comparison of Pre and Post Construction Deflections

For the 70 Avenue project site, the pre-construction Dynaflect deflection results ranged from 1.25 mils (0.032 mm) to 3.21 mils (0.082 mm), averaging 2.05 mils (0.052 mm). After completion of the stabilization and overlay, the Dynaflect deflection results ranged from 0.55 mils (0.014mm) to 0.91 mils (0.023mm), averaging 0.72 mils (0.018mm). This results in a deflection reduction of 65% for this roadway.

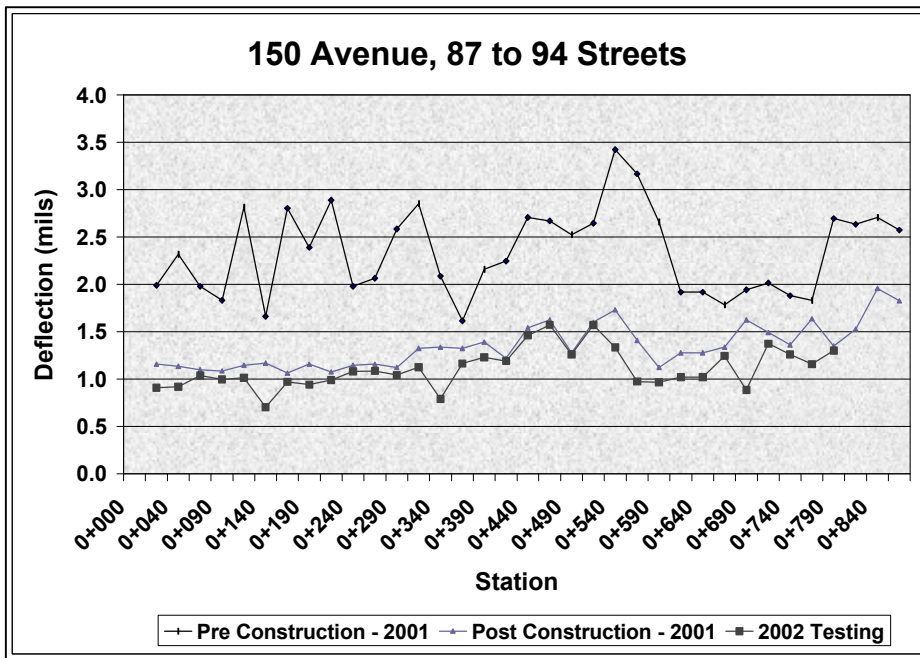
Figure 19 - 150 Avenue – Comparison of Pre and Post Construction Deflections

For the 150 Avenue project site, the pre-construction Dynaflect deflection results ranged from 1.61 mils (0.040 mm) to 3.42 mils (.087 mm), averaging 2.34 mils (0.059 mm). After completion of the stabilization and

overlay, the Dynaflect deflection results ranged from 0.70 mils (0.018 mm) to 1.68 mils (0.043mm), averaging 1.19 mils (0.030mm). This results in a deflection reduction of 49% for this roadway.
