Evaluation of Alternatives for
Extending the Service Life of
Interstate Route 480 Viaduct Substructure
Omaha, Nebraska

Sam Fallaha, Deputy State Bridge Engineer,
Nebraska Department of Roads

David Whitmore, Vice President,
Vector Corrosion Technologies

May 25, 2004

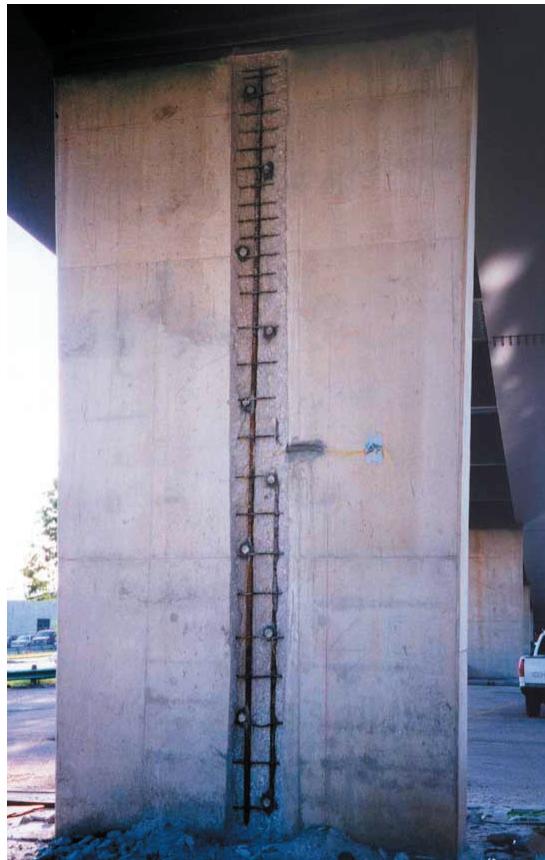
Figure 6: Embedded Galvanic Anodes Installed in I-480 Pier

For the piers with limited concrete damage and low chloride concentrations, embedded galvanic anodes were installed below or next to the reinforcing steel and as close as practical to the edge of the repair area to provide the greatest protection to the surrounding concrete. This practice prevented the initiation of new corrosion activity around the concrete patches. (See Figure 6: Embedded Galvanic Anodes Installed in I-480 Pier)

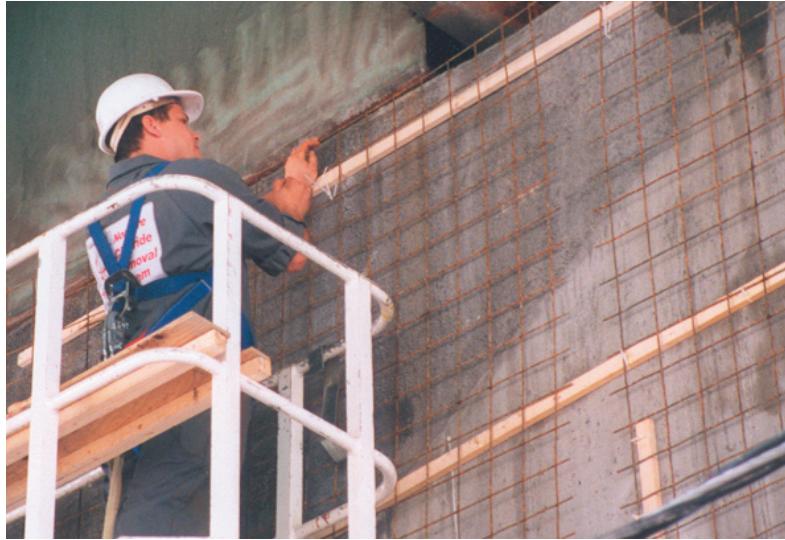
Figure 7: Electrode Mesh Installed on Surface of Piers

The Electrochemical Chloride Extraction (ECE) system was applied to piers with the highest chloride contamination levels. Approximately 9 weeks was required to install the ECE system. The ECE treatment involved installing a temporary steel mesh anode to the surface of the piers. (See Figure 7: Electrode Mesh Installed on Surface of Piers)

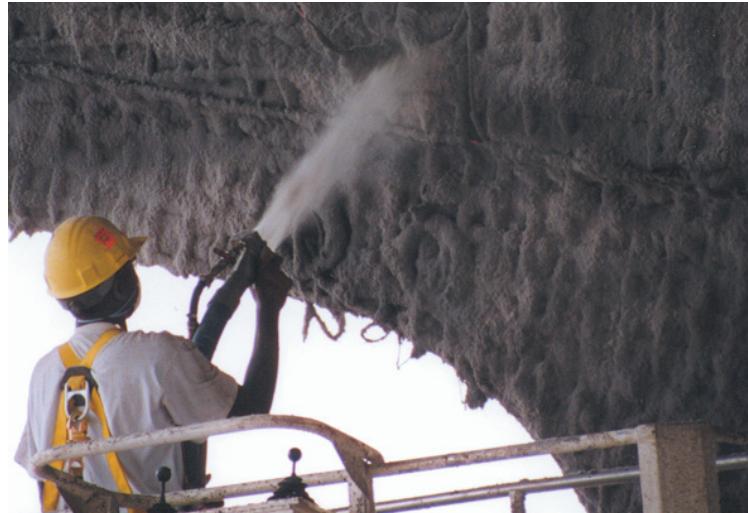
Figure 8: Cellulose Fiber Mixture Sprayed onto Surface of Concrete

The mesh was then encapsulated in a cellulose fiber that acted as a conductive media, which distributed the current supplied by a rectifier uniformly over the concrete surface. (See Figure 8: Cellulose Fiber Mixture Sprayed onto Surface of Concrete).

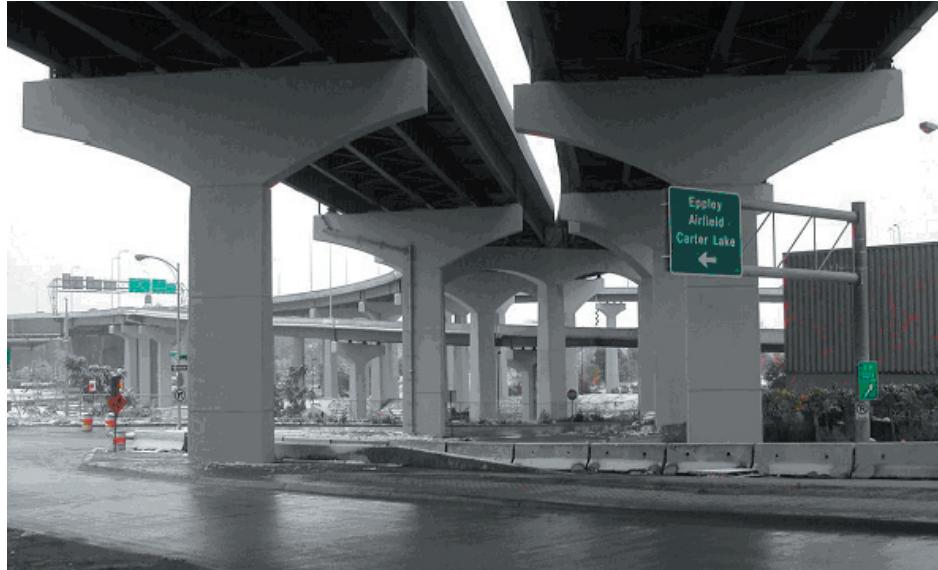
Figure 9: Completed Repair And Rehabilitation of I-480 Viaduct Substructure

The substructure rehabilitation concluded with concrete coatings applied to the sixty-six large hammerhead piers. The coating provided valuable protection against re-contamination by future chlorides. (See Figure 9: Completed Repair And Rehabilitation of I-480 Viaduct Substructure)
