Application of Flax Straw in Subgrade Strengthening

Zvezdan Lazic
Regional Preservation Planner, Central Region
Saskatchewan Highways and Transportation
Saskatoon, Saskatchewan

Ron Gerbrandt, P.Eng.
Preservation Engineer, Central Region
Saskatchewan Highways and Transportation
Saskatoon, Saskatchewan

Paper prepared for presentation at the *Environmental Benefits of In-Situ Material Recycling and Strengthening* Session
of the 2004 Annual Conference of the Transportation Association of Canada
Quebec City, Quebec

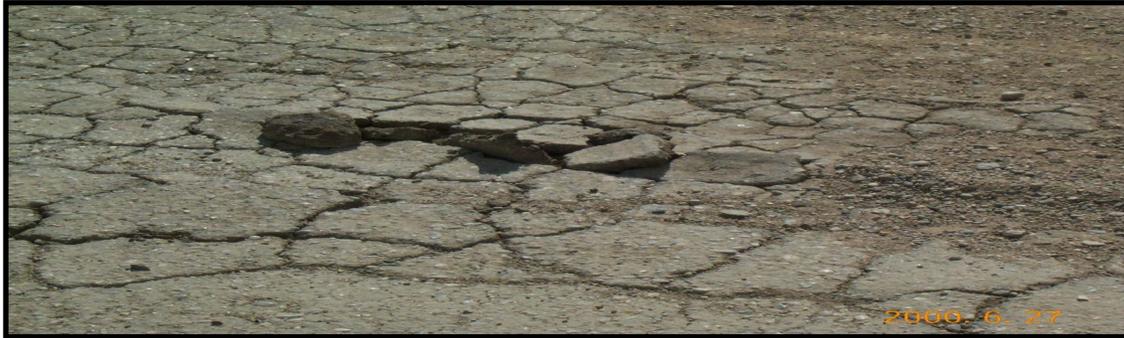
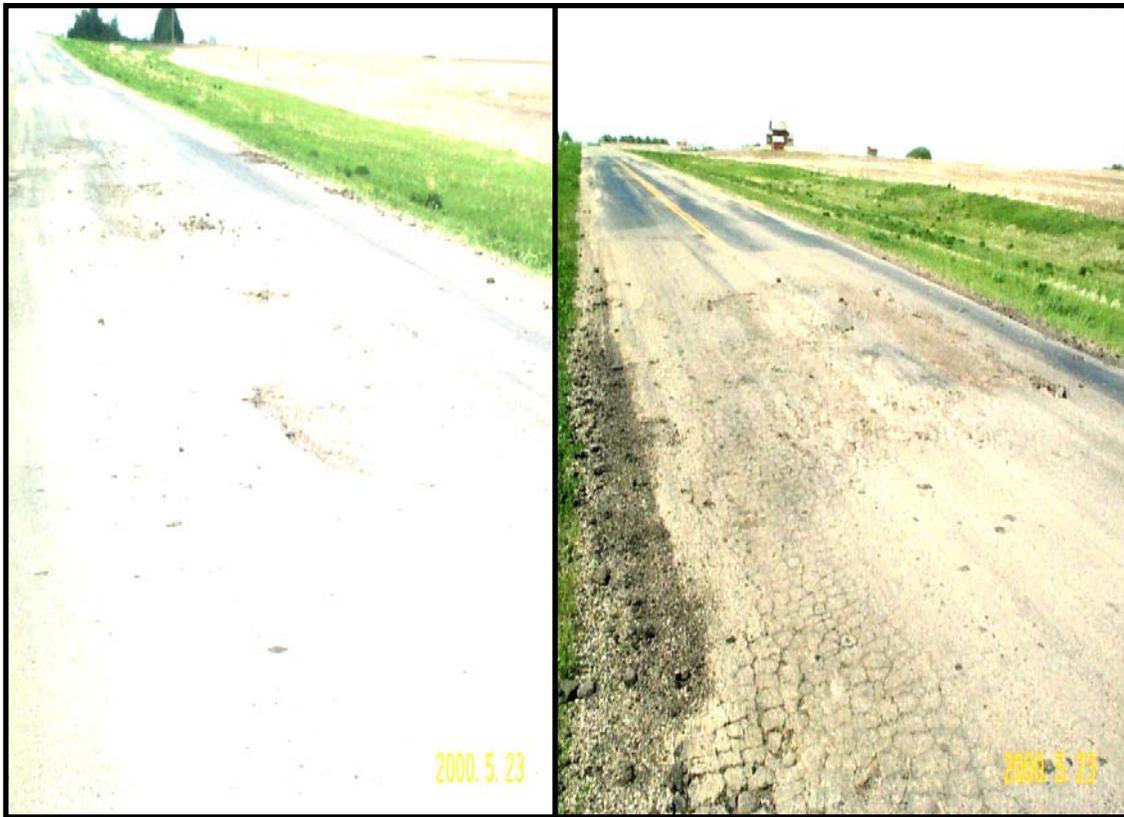
Figure 1 – Surface Failures on TMS Highway 19

time. In addition, DHT had also adopted road maintenance strategies that were relatively successful in providing an adequate level of service to the traveling public on the TMS road network. However, due to the recent developments affecting the transportation systems in Saskatchewan such as rationalization of the grain handling facilities, economic diversification, increased value-added production, abolishment of the Crow Rate, consolidation of railway branch lines and introduction of bigger truck configurations, DHT has been struggling to provide a desirable level of service on its TMS road network. This has occasionally resulted in less than acceptable and unsafe road surface conditions as illustrated in Figure 1.

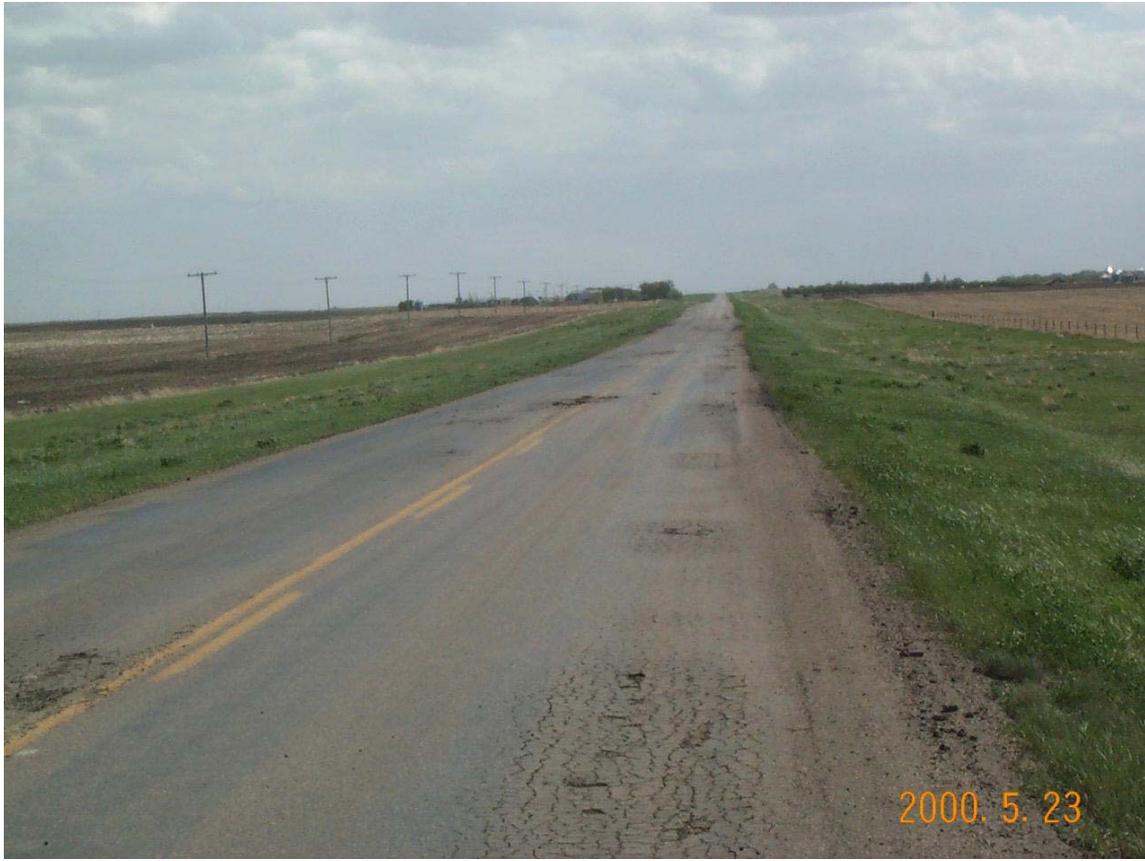
Figure 4 – Pre-construction Road Condition on Highway 19

Road surface condition data were collected in the fall of 1999 as part of the DHT annual asset management data collection process. The following surface distresses were observed on Highway 19-06 from kilometer 22.5 to kilometer 27.1 prior to the construction: 1.) rutting – good (overall score slight - S). Over 90% of manual rutting measurements (using a straight edge bar and a calibrated wedge) were between 5 and 10 mm which is identified as slight in the DHT asset management rating protocol. The remaining 10% were measured as less than 5 mm which is classified as non-existent rutting; 2.) International Roughness Index (IRI) – poor (4 mm / m). This is considered as very rough in DHT asset management; 3.) Cracking – poor (overall score Extreme - X). Figure 4 illustrates typical road surface conditions on Highway 19-06 before construction.

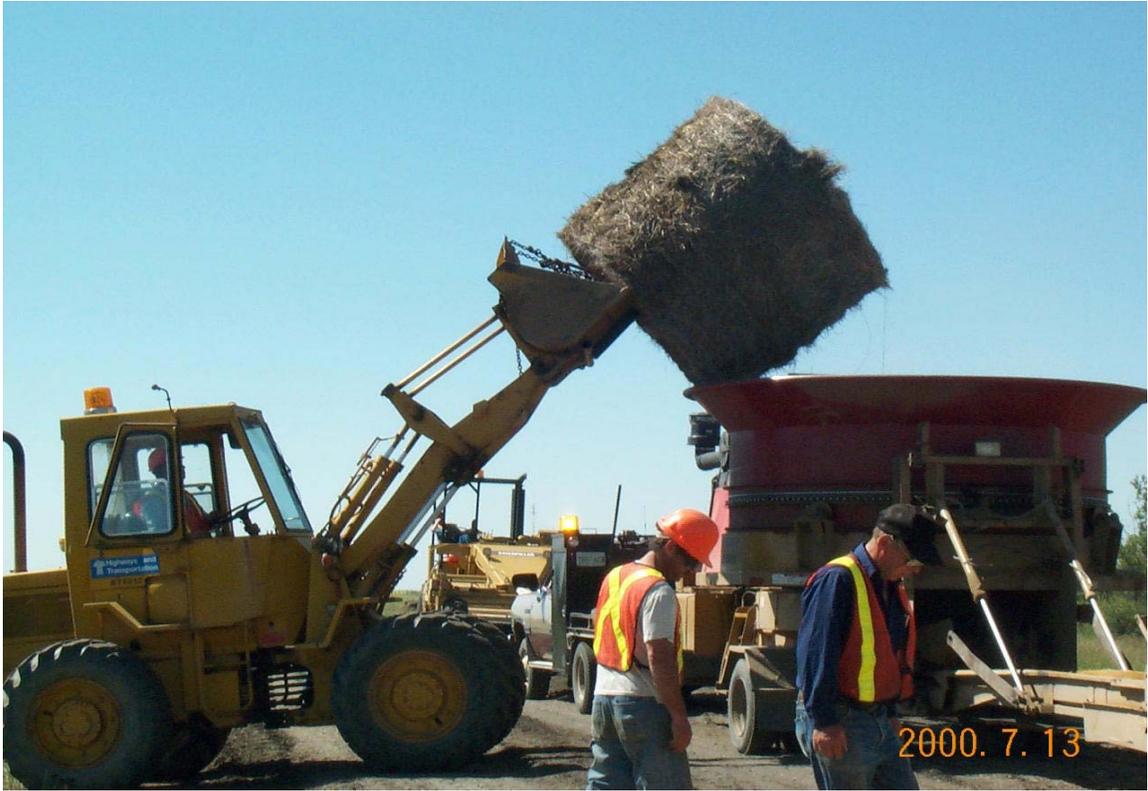
Figure 6 – Mulching of Flax Straw

The flax straw test segment #92 was constructed by first processing the flax straw bales through the tap grinder into smaller stem pieces (5 to 10 cm long) as seen in Figure 6 and then spreading it across the entire road width as illustrated in Figure 7. This procedure resulted in the flax straw fibers being somewhat unevenly spread. For this test segment the amount of flax straw added was based on 0.5% of soil weight. The flax straw was then rotomilled into 150 mm of subgrade with the road reclaimer as shown in Figure 8. The result was a geocomposite consisting of randomly oriented flax straw fibers, subgrade soil material and old asphalt mat. Figure 9 illustrates this mix. Rotomixed material was then bladed off using the motor graders, water was sprayed down on the road, material was put back and compacted until no further settlement was apparent and the particles were well keyed into place. Figures 10, 11 and 12 illustrate those construction procedures. The segment was left like this for few weeks to be further compacted under traffic. The final step in the construction was to lay down 100 mm of base aggregate material and compact it as presented in Figure 13. High float emulsion (HF-250) was sprayed on top of the compacted base layer and graded aggregate seal (total thickness of 25 mm) was added as a final surface as seen in Figure 14.

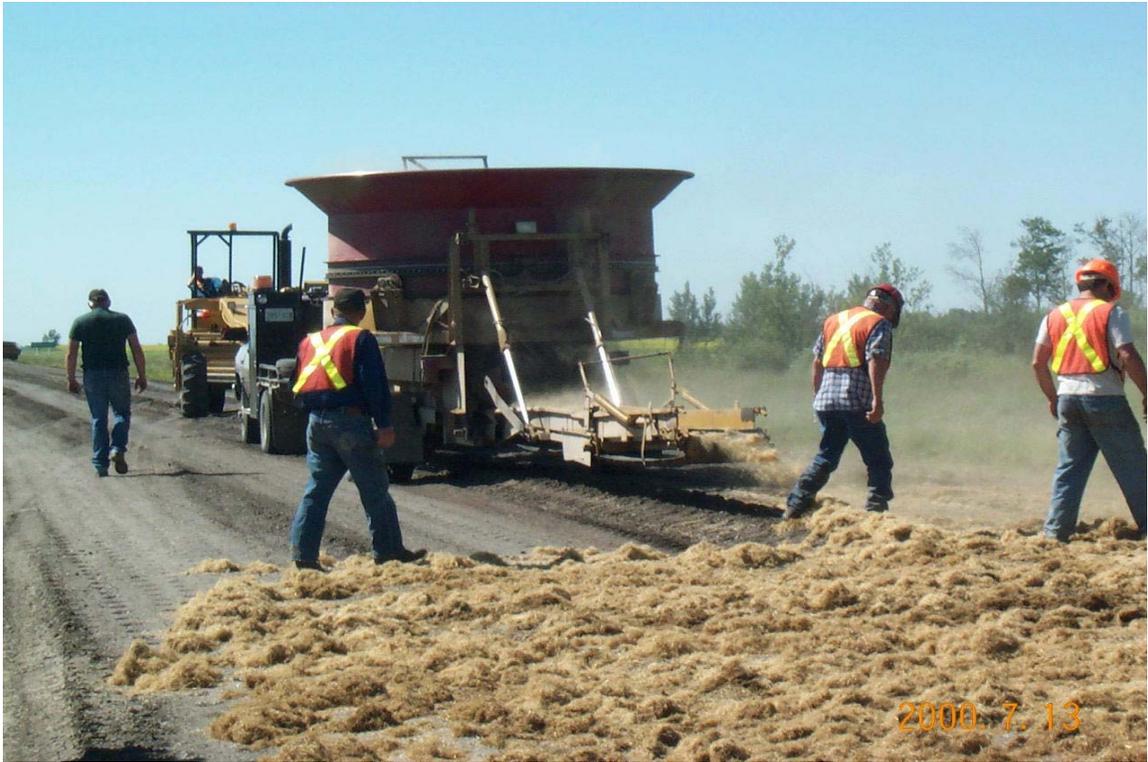
Figure 7 – Spreading of the Flax Straw Pieces

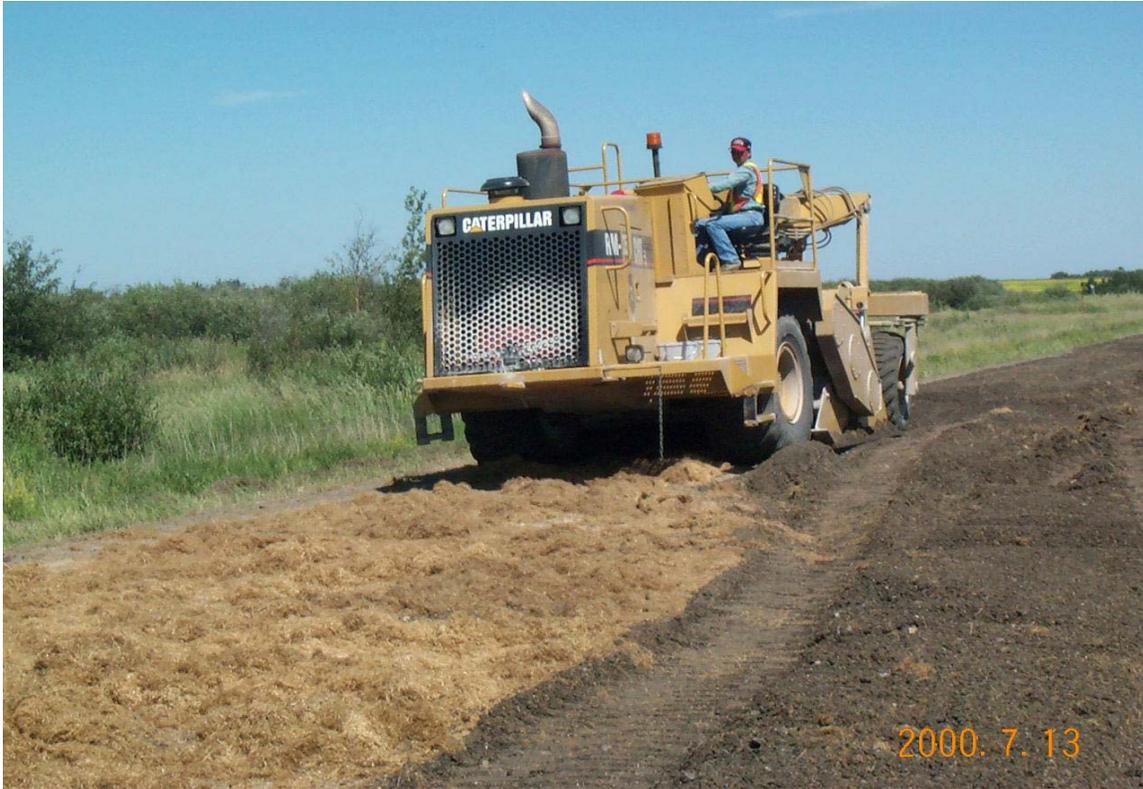
Figure 8 – Rotomixing Flax Straw Into Subgrade

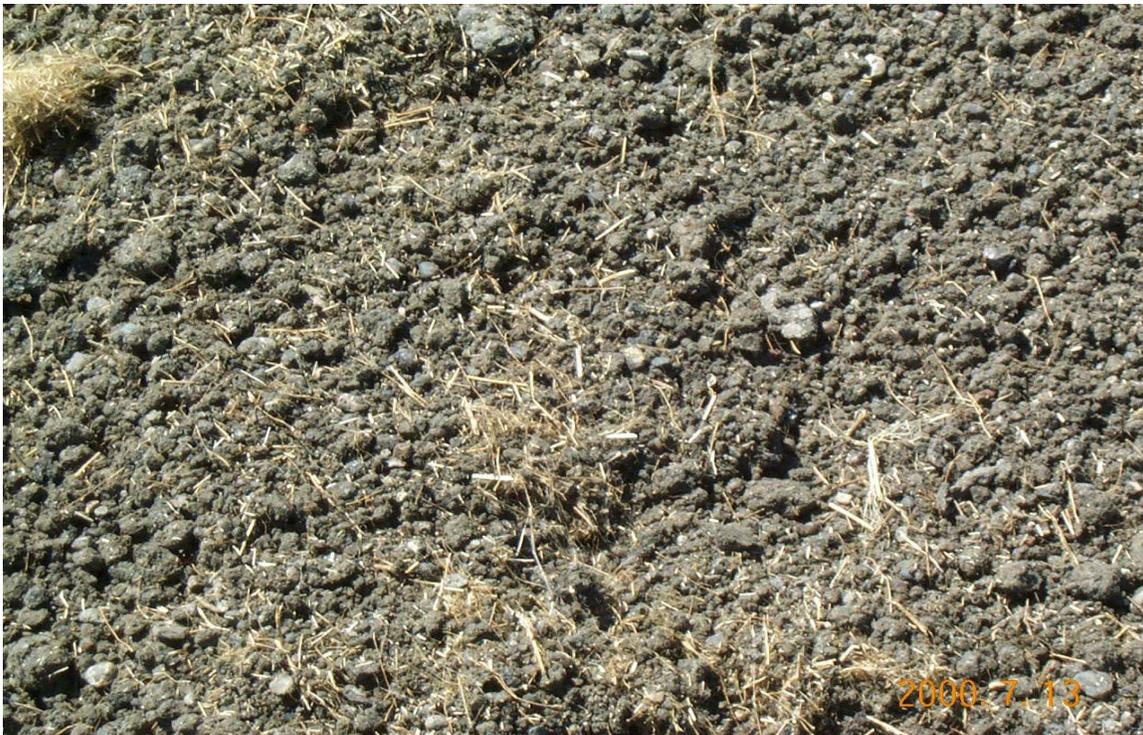
Figure 9 – Geocomposite of Flax Straw and In Situ Material

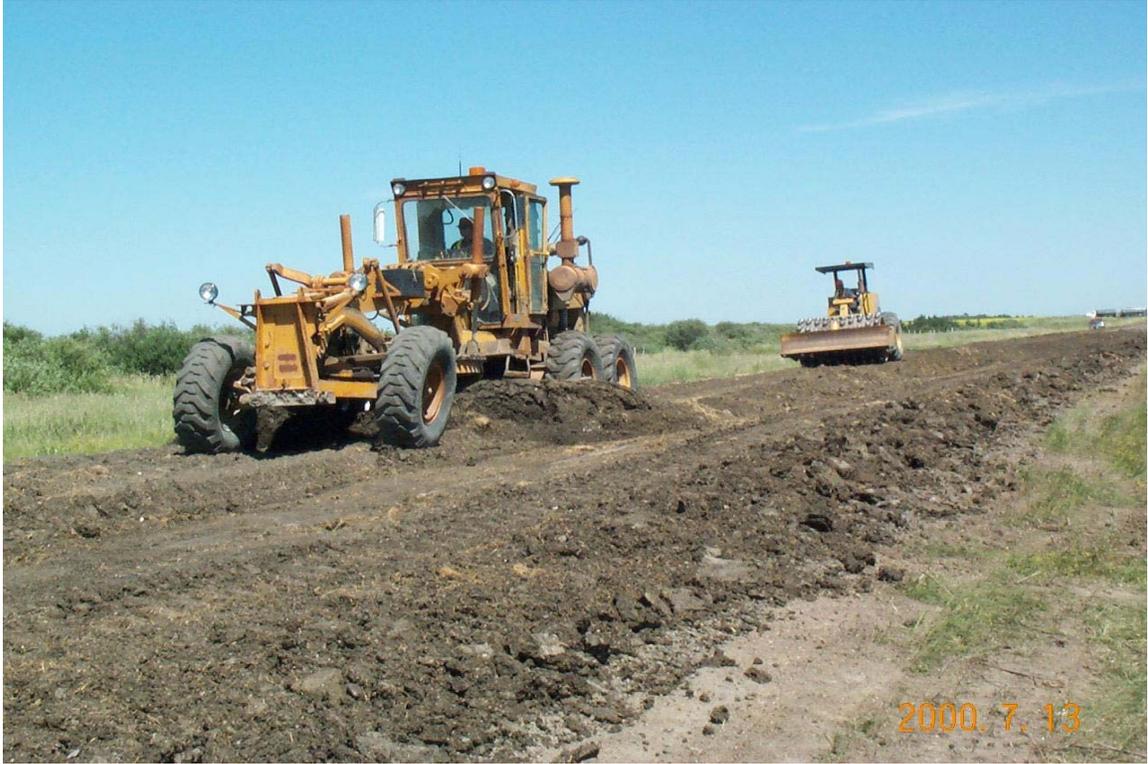
Figure 10 – Blading Off Geocomposite

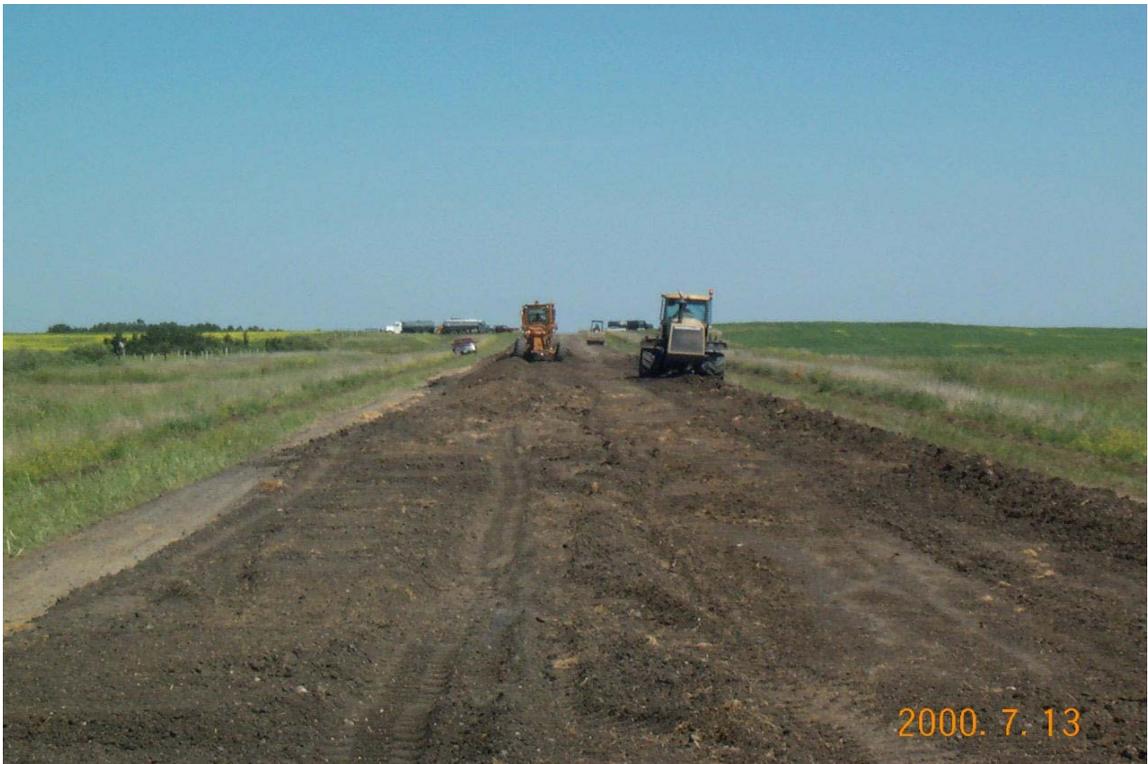
Figure 11 – Blading, Water Spraying and Compaction Procedure

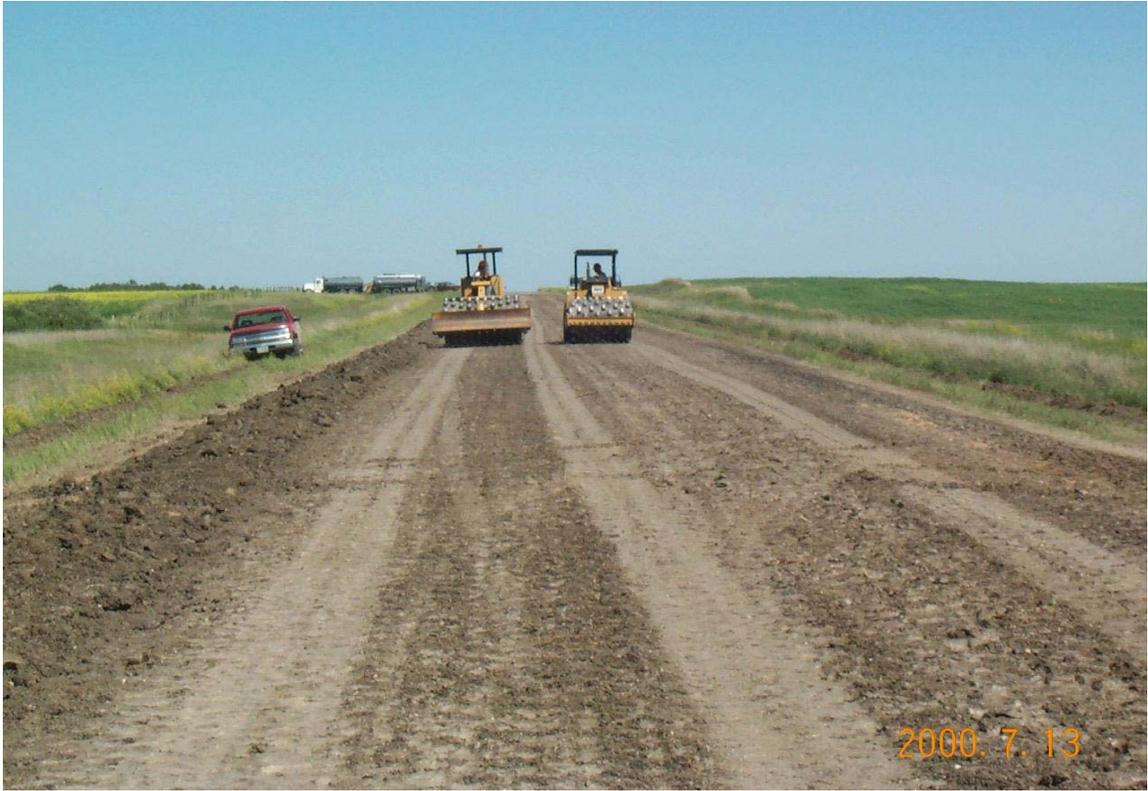
Figure 12 – Road Compaction Procedure

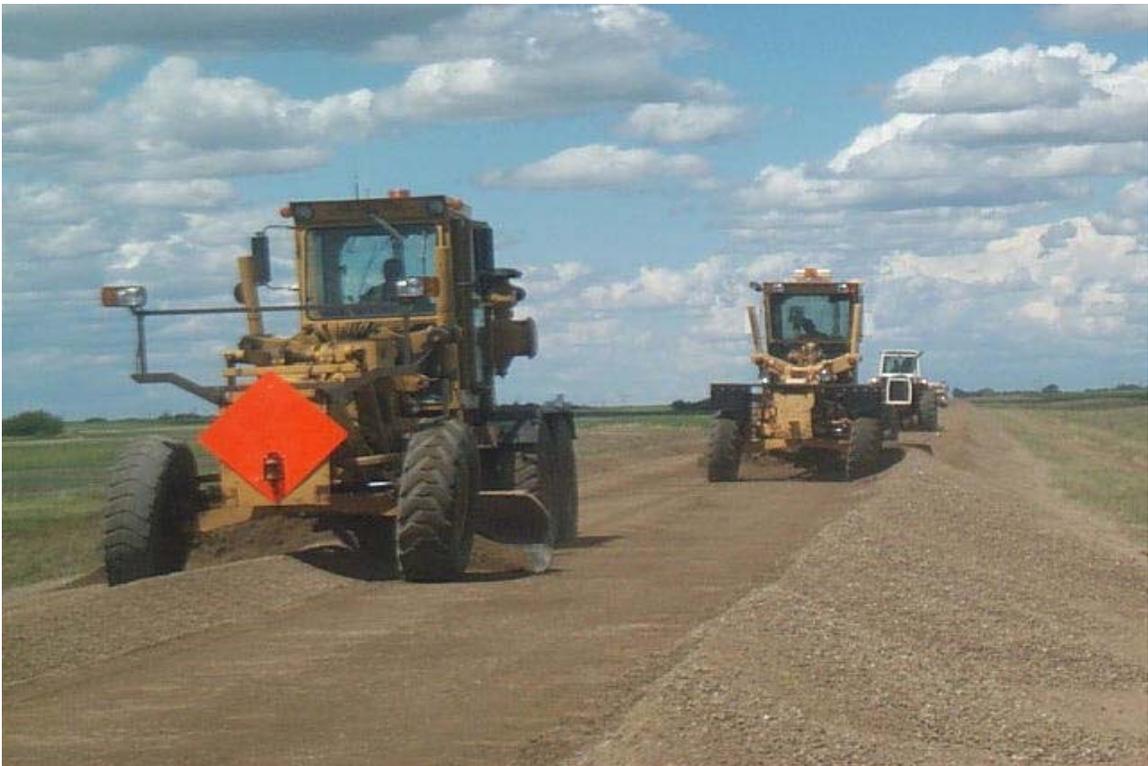
Figure 13 – Base Aggregate Overlay

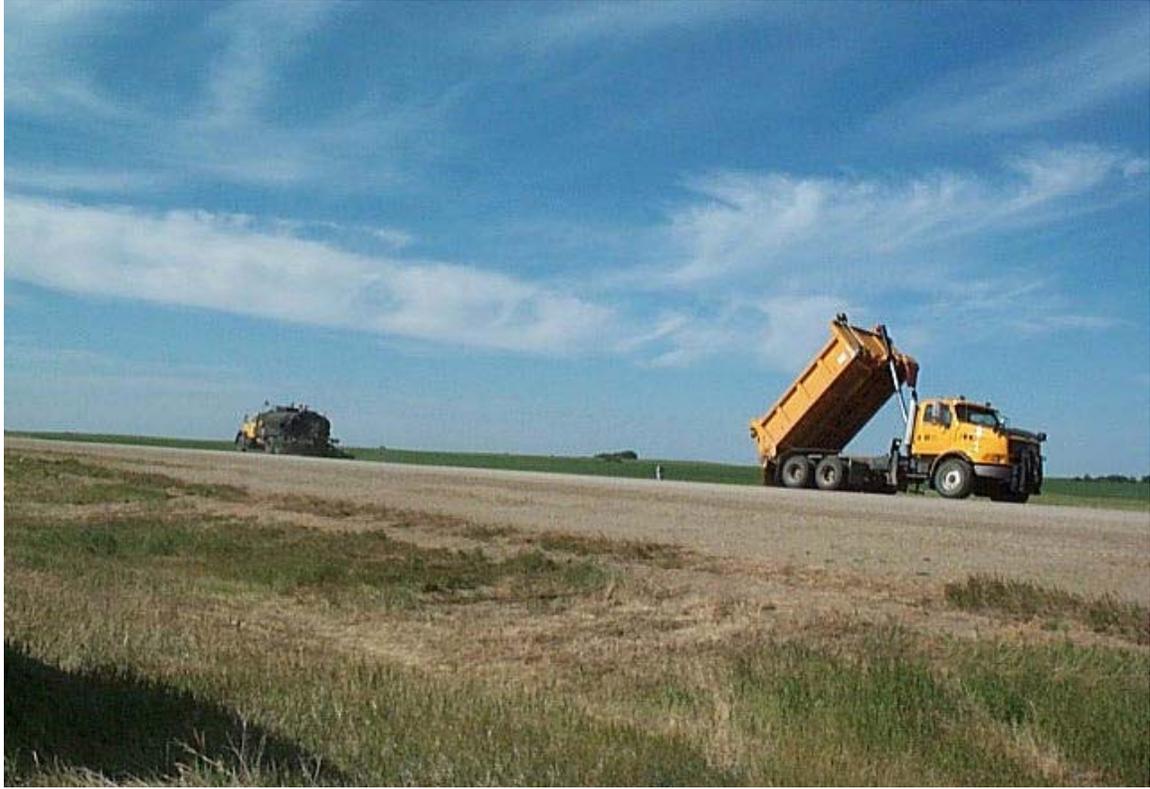
Figure 14 – Sealing Operation
