Constructability of the North Saskatchewan River Bridge

**Paper prepared for presentation
at the "Innovations in Bridge Engineering (B)" Session
of the 2005 Annual Conference of the
Transportation Association of Canada
Calgary, Alberta**

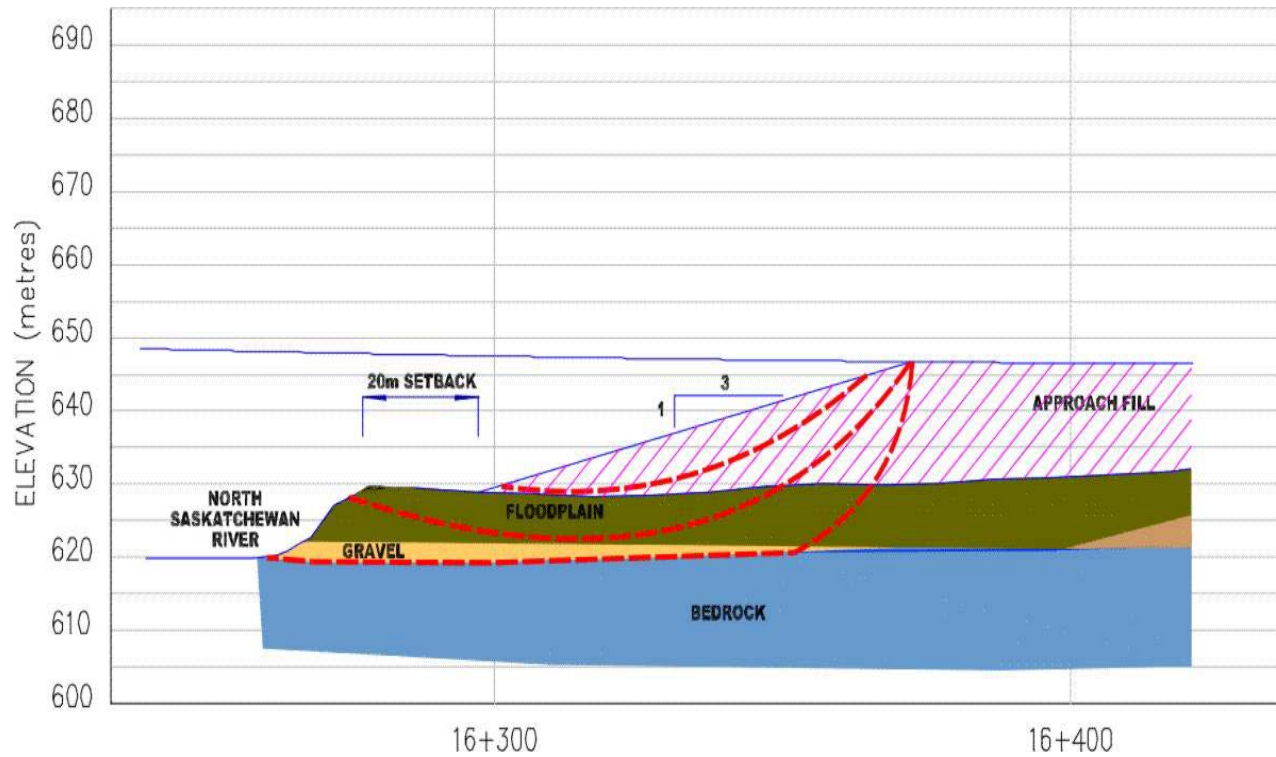
Figure 2

Figure 2: Typical Failure Surfaces at South Approach

Preliminary investigations of the subsurface soil conditions uncovered a slide-prone layer of soil sandwiched between the clay-shale bedrock and the overlying gravel layer. The slip plane was found to slope toward the river beneath both banks, and it was feared that the additional weight of the large approach fills would cause a slide beneath the approaches, as shown in **Figure 2**. To prevent the approaches from sliding, large tangent pile walls, which are shown in **Figure 3**, were constructed beneath the toe of both approach fills, effectively anchoring the overlying clay till and gravel into the bedrock below the slip plane.

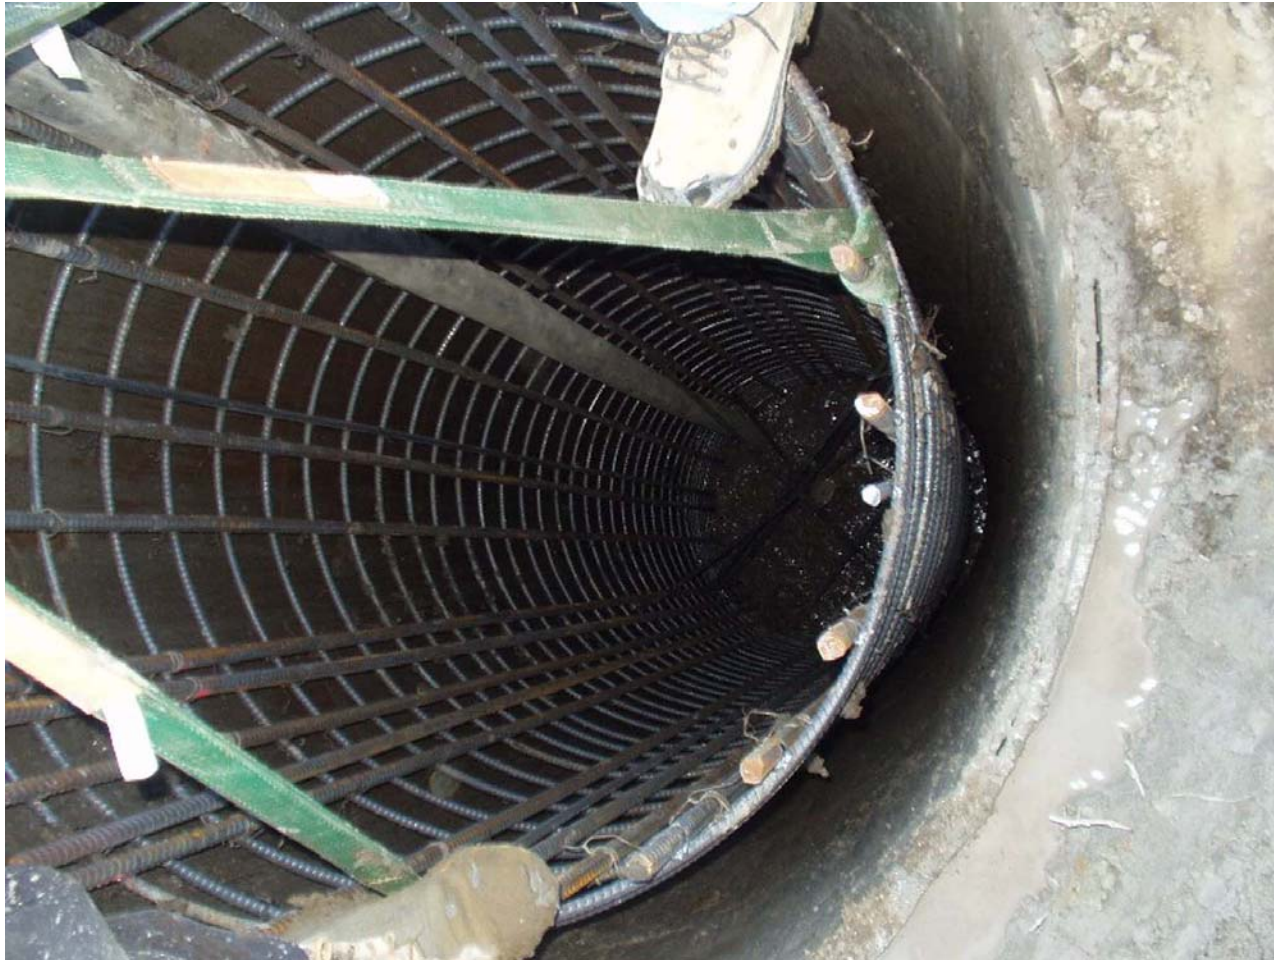
Figure 3

Figure 3: SCC is Being Poured into The Tangent Pile

In NSRB, SCC was used to eliminate the need to pump or consolidate the pile concrete. The specifications for the pile concrete were as follows: Minimum Compressive Strength

The concrete could be dumped directly from the truck chute into the hole. A special trunk hose or other means had to be used to guide the concrete so that it fell straight down the middle of the reinforcing cage. To prevent segregation, care had to be taken to ensure that the concrete did not hit any support bars as it was falling to the base of the pile.

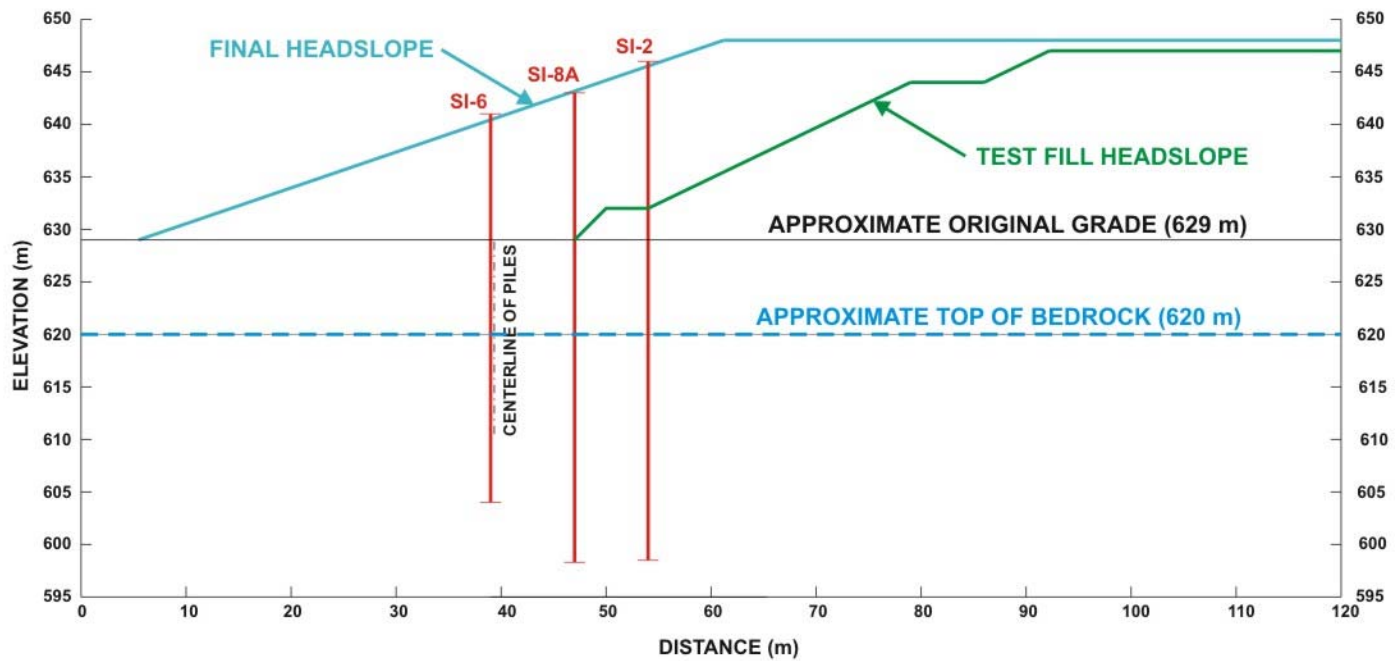
Figure 5

Figure 5: Layout of Slope Inclinometers Beneath the South Headslope

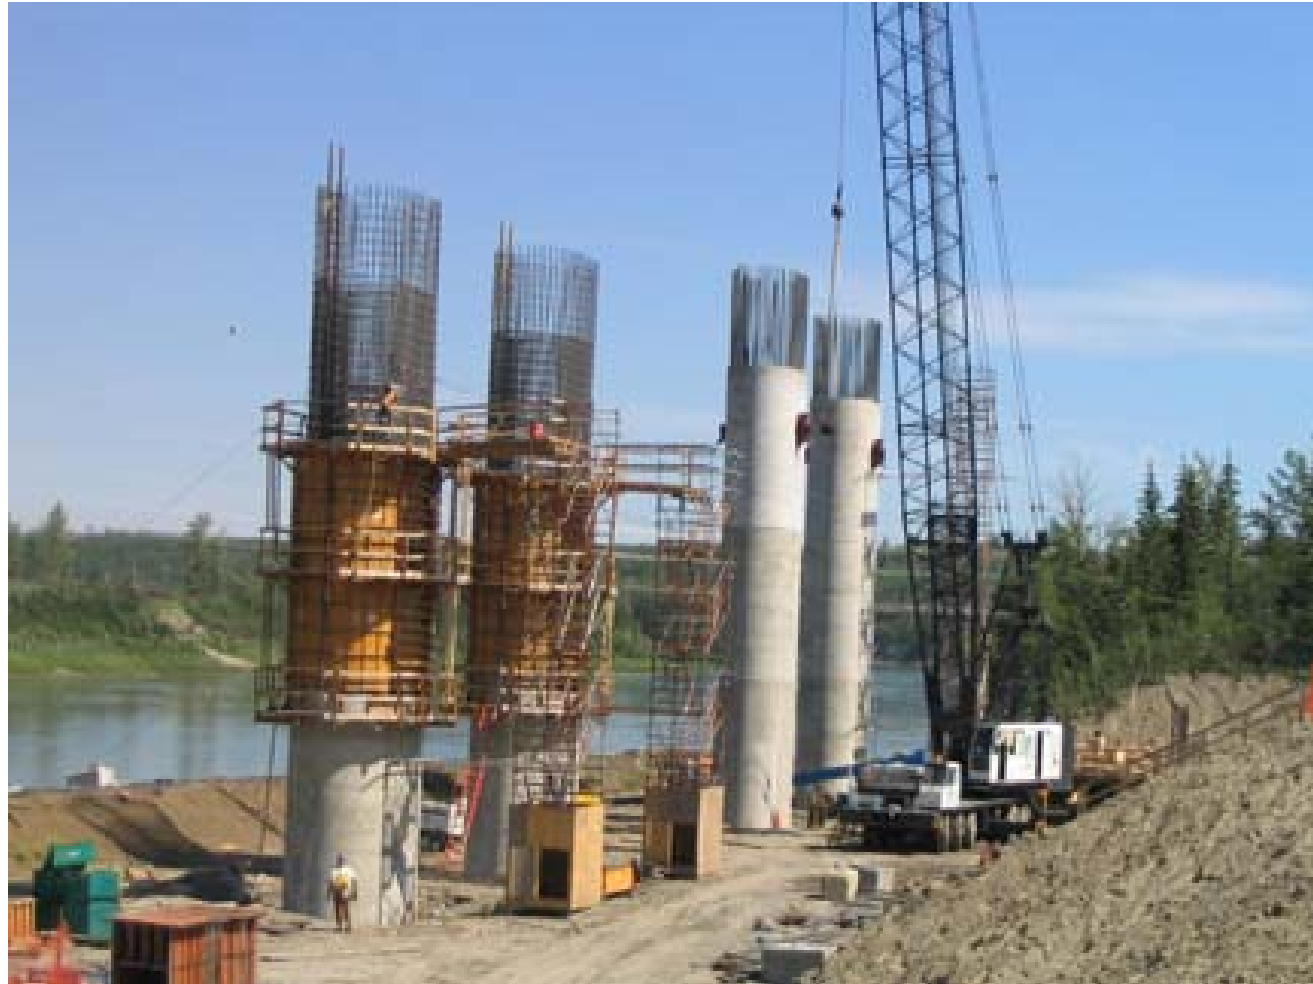
Figure 9

Figure 9: NBL Pier Shafts Completed and Preparing to Pour Second Lift on the SBL Pier Shafts at Pier 3

A sketch of the NSRB piers is presented in **Figure 8** and a photo during the construction of Pier 3 is shown in **Figure 9**. Each pier consists of two pier shafts joined at the top by a pier cap. The pier foundations consist of a 3.0 metre diameter caisson, embedded in bedrock for the bottom 16 to 20 metres of the foundations. A 4.6 metre diameter caisson, placed on the top of the 3.0 metre caisson, extends to the foundation to ground level. Oval shaped pier shafts are tied into the 4.6 metre diameter caisson with steel reinforcing dowels. The contractor's construction sequence consisted of pouring the caisson concrete

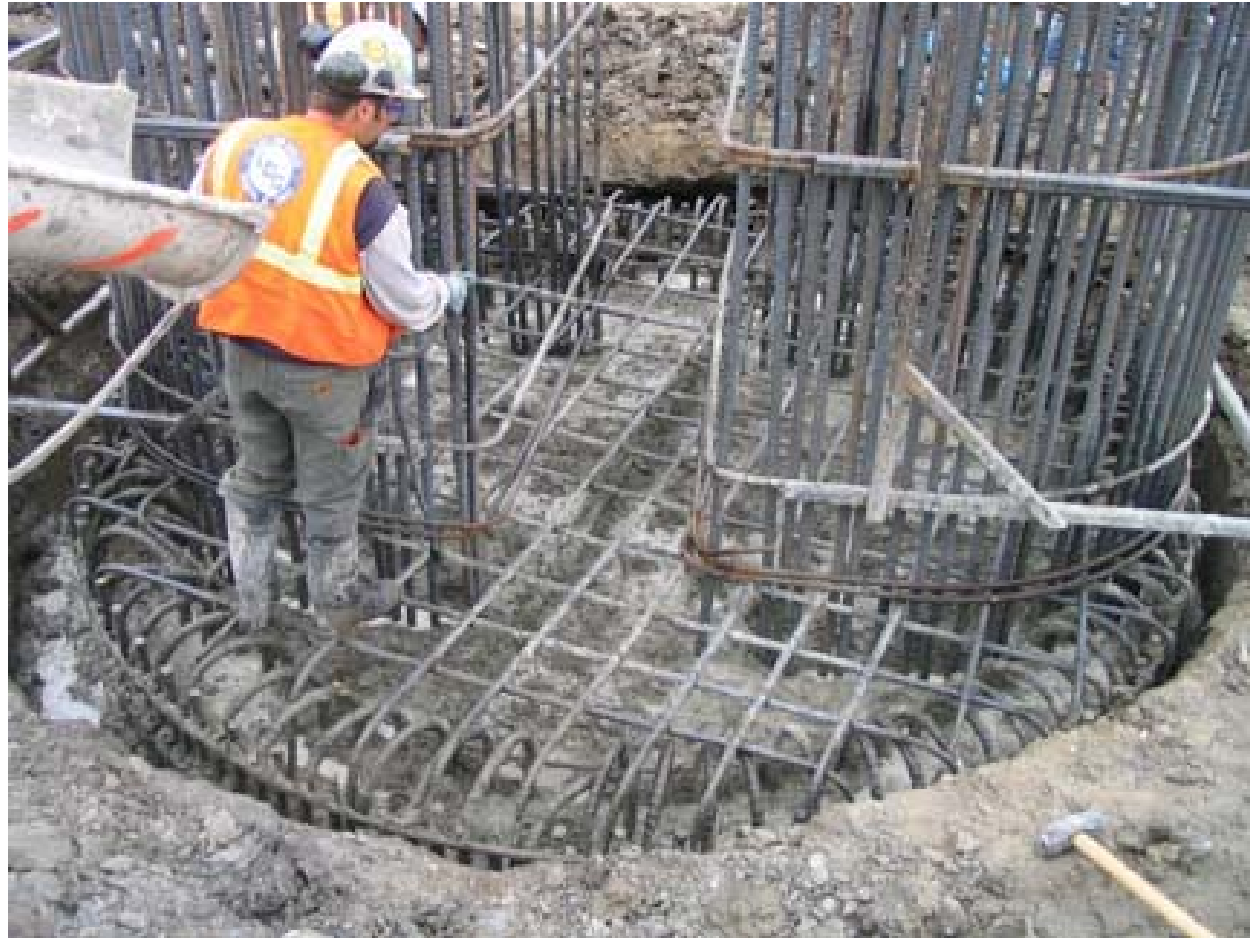
Figure 10

Figure 10: Dowels are Put in After The Pour When The Concrete is Still Fresh.

to final elevations and then setting the dowels in the wet concrete using a template as shown in **Figure 10**. Pier shafts were then poured in four segments each, followed by the pier cap and cross beam (SBL only).

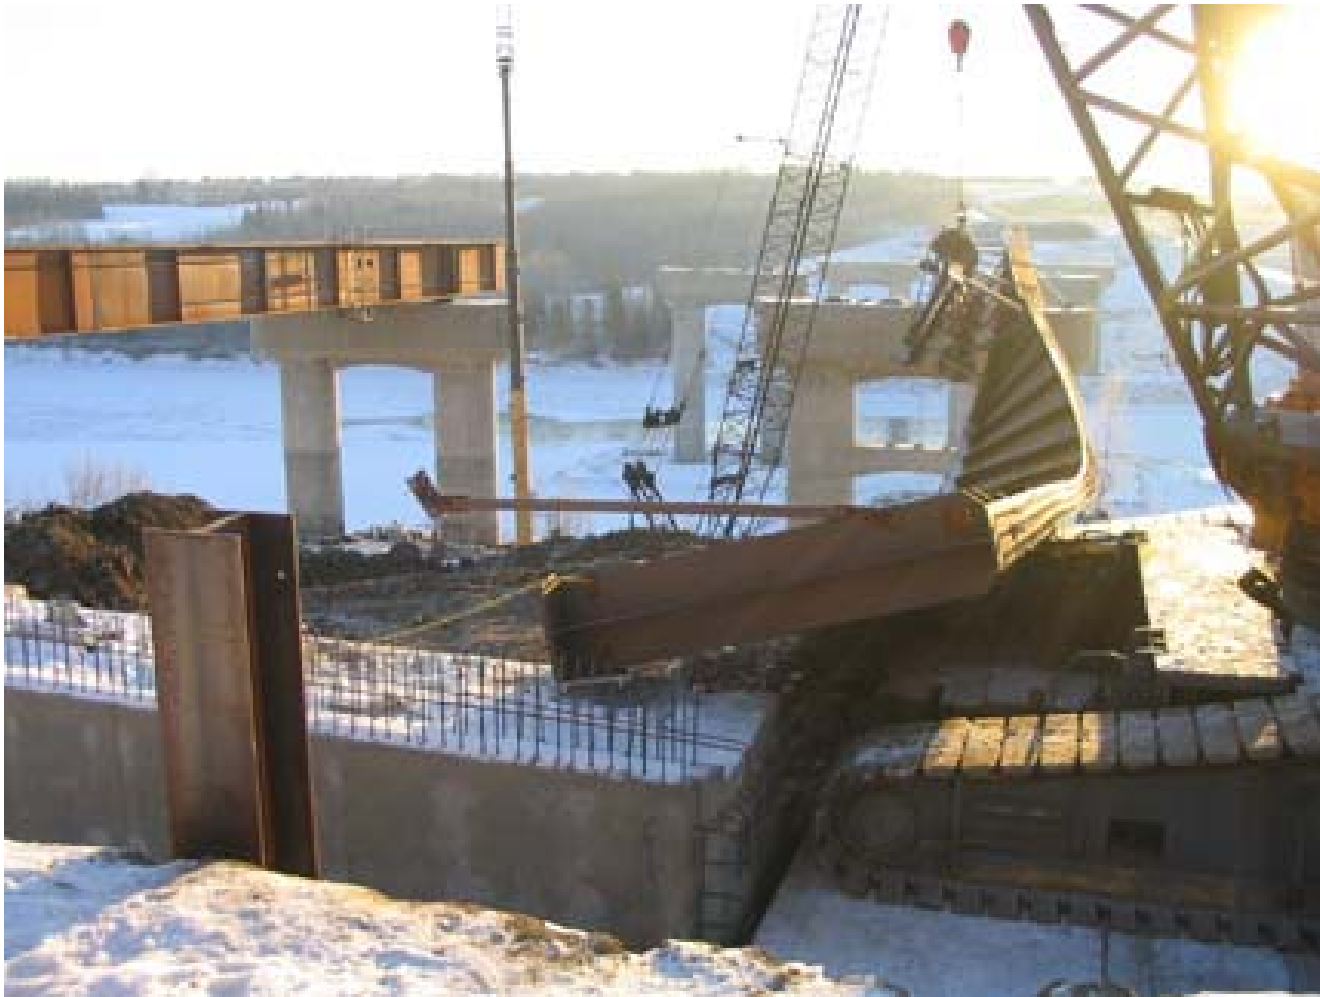
Figure 11

Figure 11: Girder Collapse

On 14 December 2003, the first girder line on span 1 of the SBL collapsed as shown in **Figure 11**. This occurred after all girders for the NBL span 1 had been erected successfully. It appeared that the girder rotated counter to the curvature of the bridge and collapsed due to bending failure about its minor axis. The cause of the collapse is still being investigated by the erection firm's insurer, and has not yet been revealed.

It appears that the proposed erection method, while stable, was new to the erection firm's ironworkers. This unfamiliarity could have led to a situation where changes made during the erection procedure were not fully evaluated, nor were the implications thereof understood.

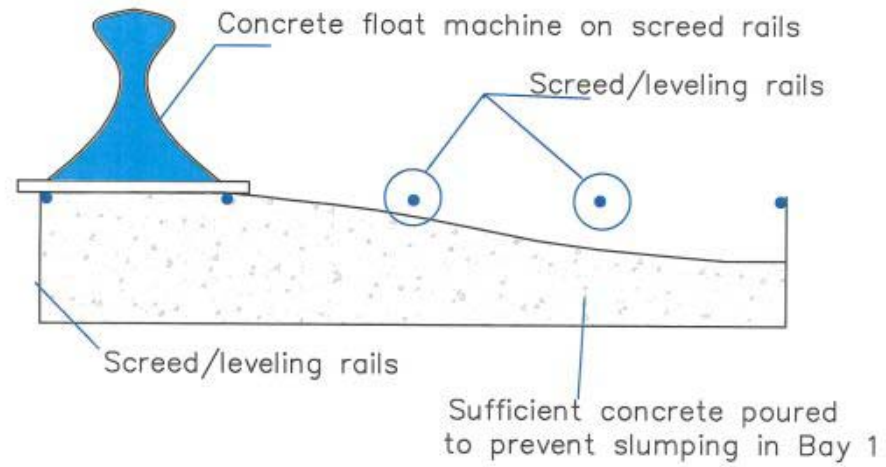
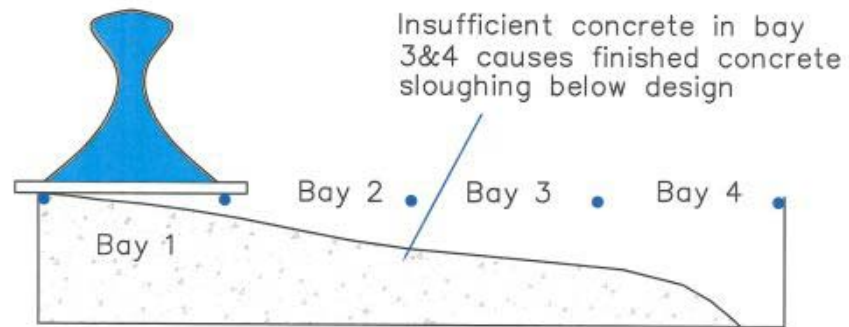
Figure 12

Figure 12. Pouring Actual and proposed sequence

After the first pour it was noted that the slab top surface had settled visibly, by approximately 50 mm, as shown in **Figure 12**. This was not picked up during the pour as the levelling screed rails were removed immediately after the relevant bay was complete.

Initially it was assumed that the formwork had settled, however the contractor found that he had to wait until concrete filled three adjacent bays before he could screed the first bay to its final elevation. The vibrating activities during concrete placement in the adjacent bays caused the completed bays to slump, resulting in additional finishing work; and the distance (more than 6 meters) affected by this vibration was greater than expected. Accordingly, the authors recommend that when using screed rails in large slabs, the rails be kept in place as long as possible to ensure that the concrete does not slump when adjacent bays are poured.
