## COTTON CREEK CULVERT REPLACEMENT

### Integrating Mobility with Environmental Innovation

This submission documents an innovative and creative design for the Cotton Creek culvert crossing located within the Moyie Bluffs project limits. The following few pages will highlight the key features of the culvert design and demonstrate the environmental enhancements on Cotton Creek that resulted from the creative application of engineering principles and environmental science.

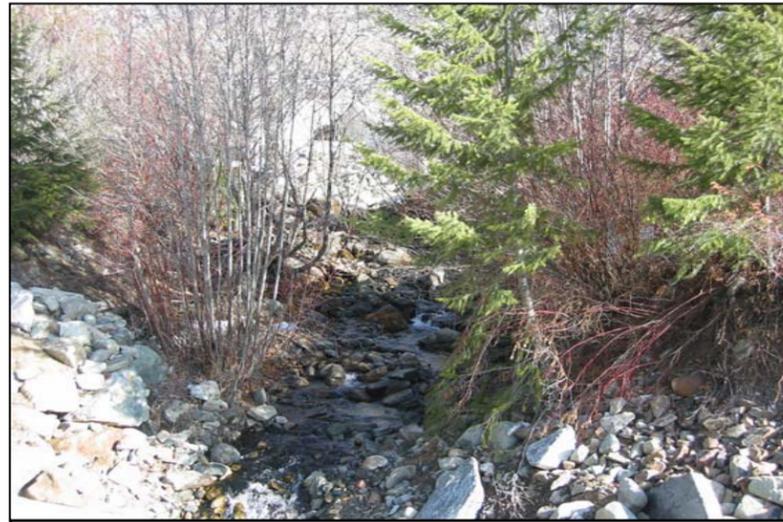
Channel Downstream of Highway with Headwall in Background

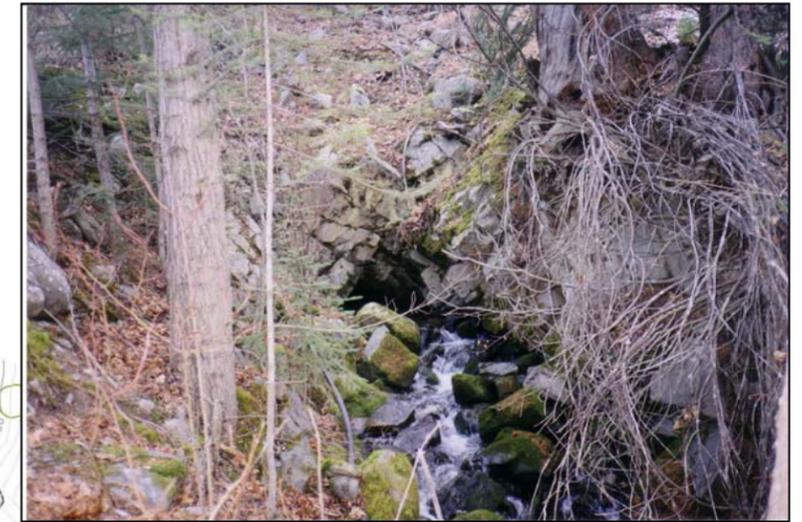
Natural Cave Inlet Upstream of Highway

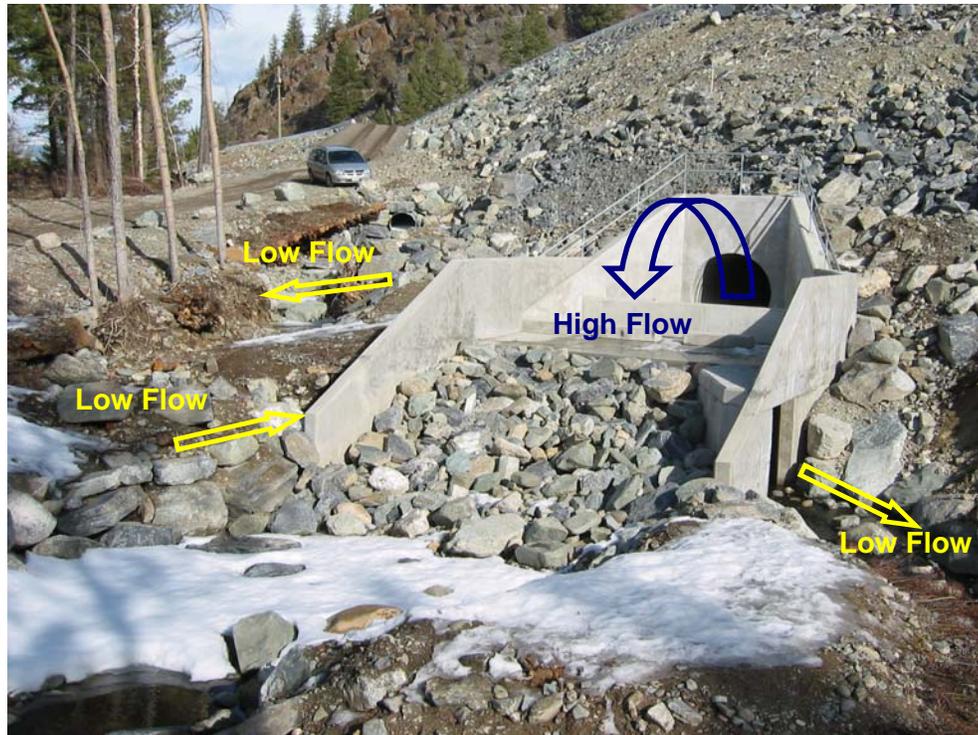
**PHOTO 2 – OVERFLOW OUTLET PROTECTION FOR SPAWNING CHANNEL**

- A combined outlet headwall with construction of a box culvert under the apron separated flows protecting the spawning channel from erosion (see Photo 2);
- Embedded box culvert provides good shade during summer and is an excellent wintering location for fish;
- Construction of 75 m of spawning channel habitat that includes a mixture of pools, riffles, runs and overhangs;
- Planting of indigenous tree and shrub species on both banks of the new spawning channel to provide shade and overhead cover;

Through innovative environmental engineering the spawning habitat at Cotton Creek was restored. Flow is maintained during times of drought while the habitat is protected from erosion during flood events, a key concern for any spawning channel. Providing a flood path that is physically separated from the spawning channel ensures protection of the investment for future generations.
