**PERMAFROST DEGRADATION AND ADAPTATIONS OF AIRFIELDS AND ACCESS ROADS
NUNAVIK, QUEBEC, CANADA**

Low-volume Roads – Beyond the Boundaries (A)
Transportation Association of Canada
2006 Annual Conference & Exhibition
Charlottetown, Prince Edward Island

**PAPER SUBMITTED FOR
2006 STUDENT PAPER AWARDS**

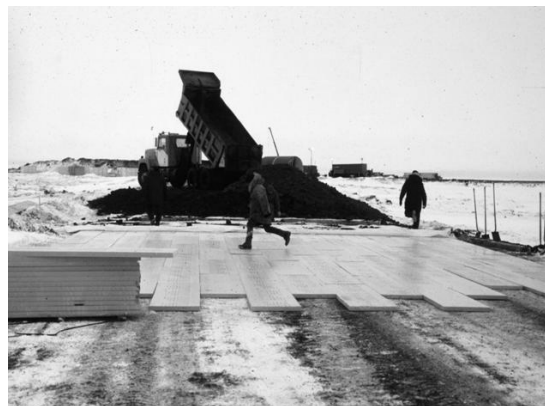
Figure 7 : Insulation installation (Courtesy of John Zarling)

The use of insulation in embankments is aimed to reduce the heat flow into the permafrost and prevent frost heave (Figure 7). Permafrost temperatures during summer remain low instead of increasing even if no insulation has been installed. During winter, insulation does not allow permafrost to cool and permafrost temperatures increase because insulation does not permit evacuation of ground heat. Depending of the thermal balance over the year and the mean annual surface temperature (MAST), the increase of permafrost temperature during winter can be in most cases ignored if the MAST remains below 0°C. On the other hand, if the MAST is positive, insulation alone is not efficient and some other methods would have to be integrated in the design. Often, insulation is used with a granular pad that is thick enough to avoid the effects of a positive MAST.

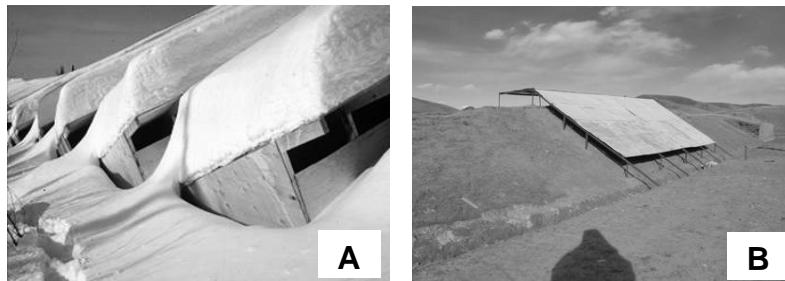
**Figure 9 : Snowsheds in Bonanza Creek, Alaska (A) and Sunsheds, Qinghai-Tibet Roadway (B)
(Courtesy of John Zarling (A) and of Professor Ma, Lanzhou, China (B))**

Sunsheds or snowsheds let the cold air circulates during winter to protect embankment slopes from snow insulation. In summer, they can eliminate direct solar radiation on the embankment slopes. At Bonanza Creek, Alaska, an experimental embankment was built with snowsheds along the slopes. The mean annual slope surface temperatures were reduced from a normal slope value of 3,9°C to a value of -2,3°C beneath the sheds (Esch, [11]). Figure 9 illustrates sunsheds used in Alaska and China. In spite of good performance, the use of sheds was not considered practical in Alaska for safety reasons. Guardrails are required along the embankment to prevent hazards for vehicles accidentally leaving the road (Esch, [8]). In addition, sheds required a high-maintenance cost and lacked durability, but are a low cost deployable system compared to other methods.

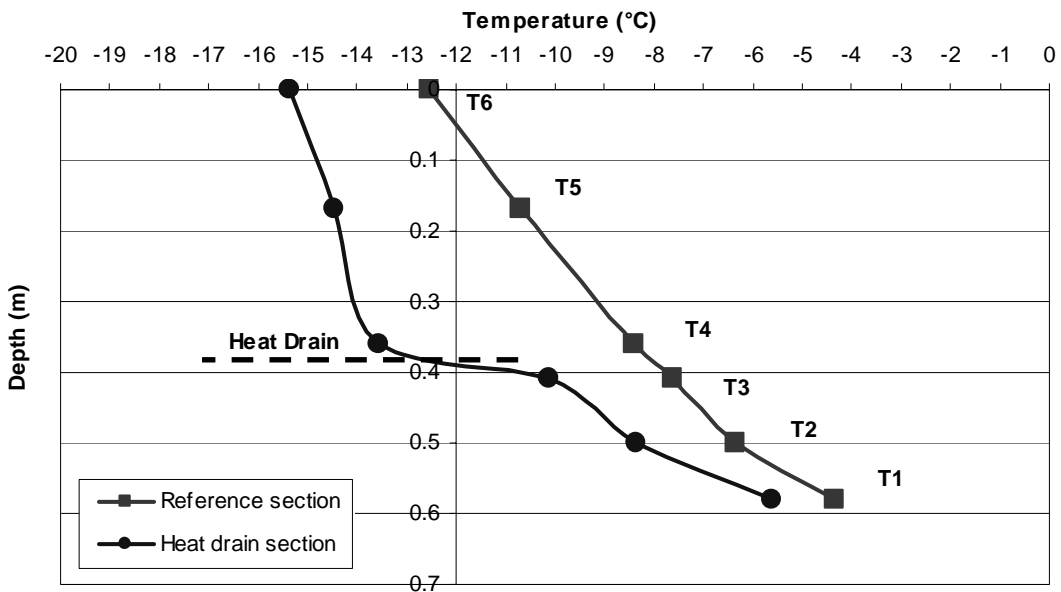
Figure 15 : Thermal profiles plotted when the final steady state was reached for the test between 0°C and -20°C

Figure 15 presents a thermal profile for the test between 0°C and -20°C when the final steady state was reached. On the chart, the heat drain effect was observed between thermistors T3 and T4. The temperature difference between these two thermistors was 3,41°C for the test between 0°C and -20°C. In addition, it was observed that the heat drain had really evacuated the heat inside the SSE because the heat drain section temperatures were colder than the reference section temperatures. Temperature variation of 5,14°C for thermistor T4 was observed between the reference and the heat drain sections for the first and second test. As a result, the heat drain tested in laboratory had a significant effect to reduce the ground temperature.

In conclusion, it was possible to prove the effectiveness of the heat drain by laboratory tests. The results showed that it is possible to lower significantly ground temperature if a heat drain is installed in the embankment.
