# **STREAMBANK STABILIZATION USING BIOENGINEERING AND BIOTECHNICAL METHODS**

Roger Skirrow, M.Sc., P.Eng., Alberta Infrastructure and Transportation

Paper prepared for presentation

Of the 2006 Annual Conference of the  
Transportation Association of Canada  
Charlottetown, Prince Edward Island

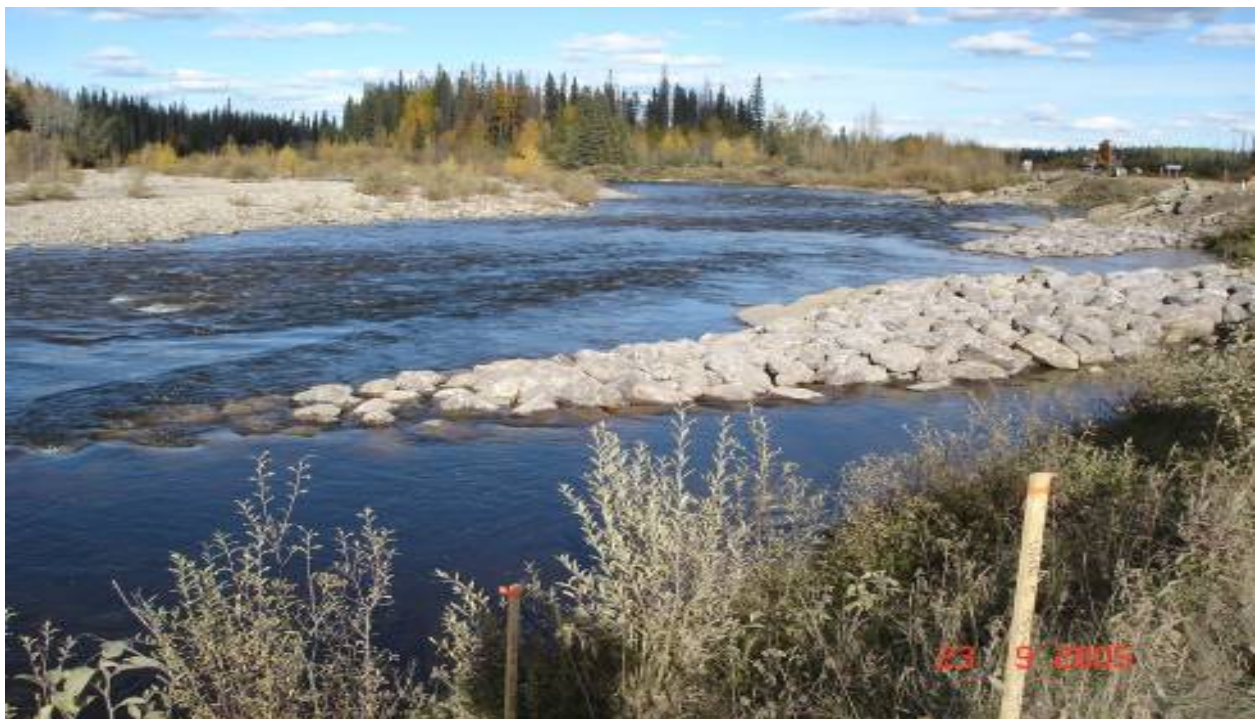
Photo 3 Construction of Redirective Vanes

In mid-September, the construction contract was awarded to Farlinger & Associates. They mobilized to site and began site preparations a week or so in advance of the field training session. Much of the hard armour portion of the design was installed prior to the training course; this consisted of installation of redirective vanes in the river (Photo 3) and resistive measures, such as longitudinal peaked stone toe protection (LPSTP) (Photo 4). Turbidity monitoring (Photo 5) was done during placement of the instream works. If turbidity levels increased during instream work, the work was halted. Generally, the placement of the resistive vanes was done with little adverse effects on the river turbidity. The design for Site #1 involved removal of the previous spurs. It was assumed that these were composed of large rocks, however, the spurs were actually made up of a mix of rock and silt, making removal problematic and time consuming. However, with diligent monitoring, the work was done without containment.

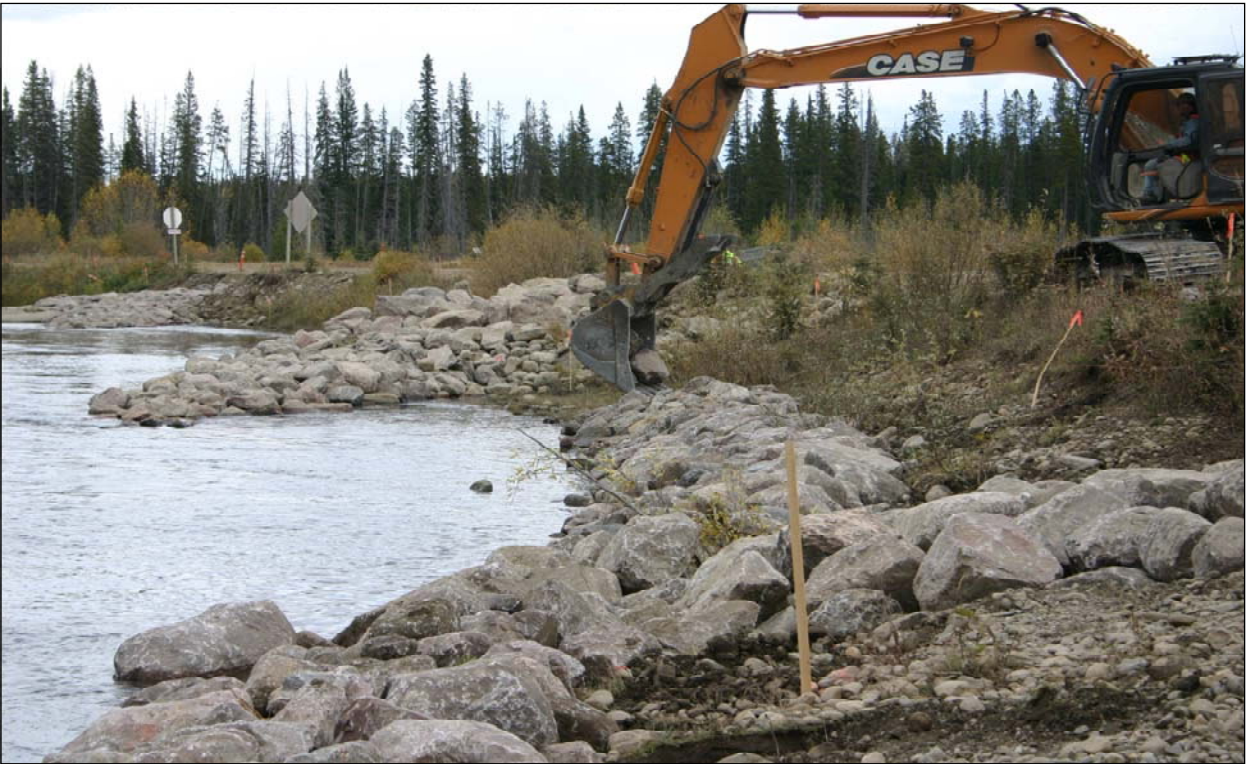
Photo 4 Construction of Longitudinal Peak Stone Toe Protection

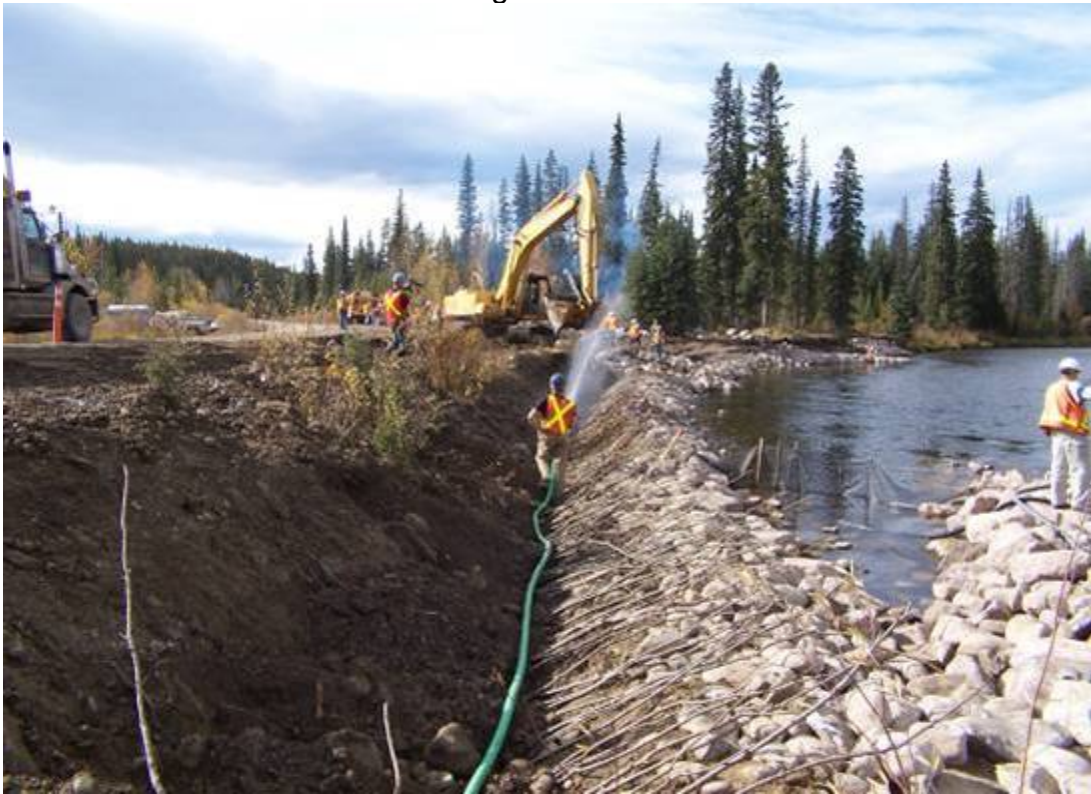
Photo 5 Live Siltation Implementation

- Live siltation – Installation of willow cuttings along a trench, excavated at the water's edge. The cuttings are inclined to overhang the river, with soil placed back in the trench. This method increases the bank roughness, which encourages deposition and reduces bank erosion.

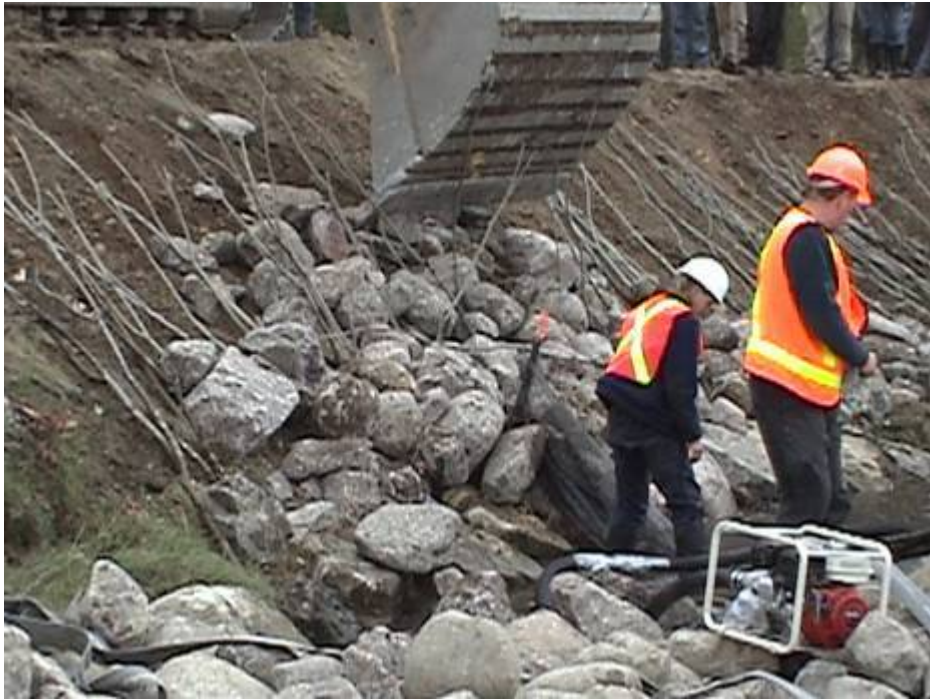
Photo 6 Vegetated Riprap

- Vegetated riprap (bent pole method/willow bundle method) – Willow poles or cuttings are placed at an incline, against a prepared slope, and a layer of stone and/or boulder armouring is placed on top of the willow cuttings and poles. The willows are woven up through the rock mat during the placing of the rock.

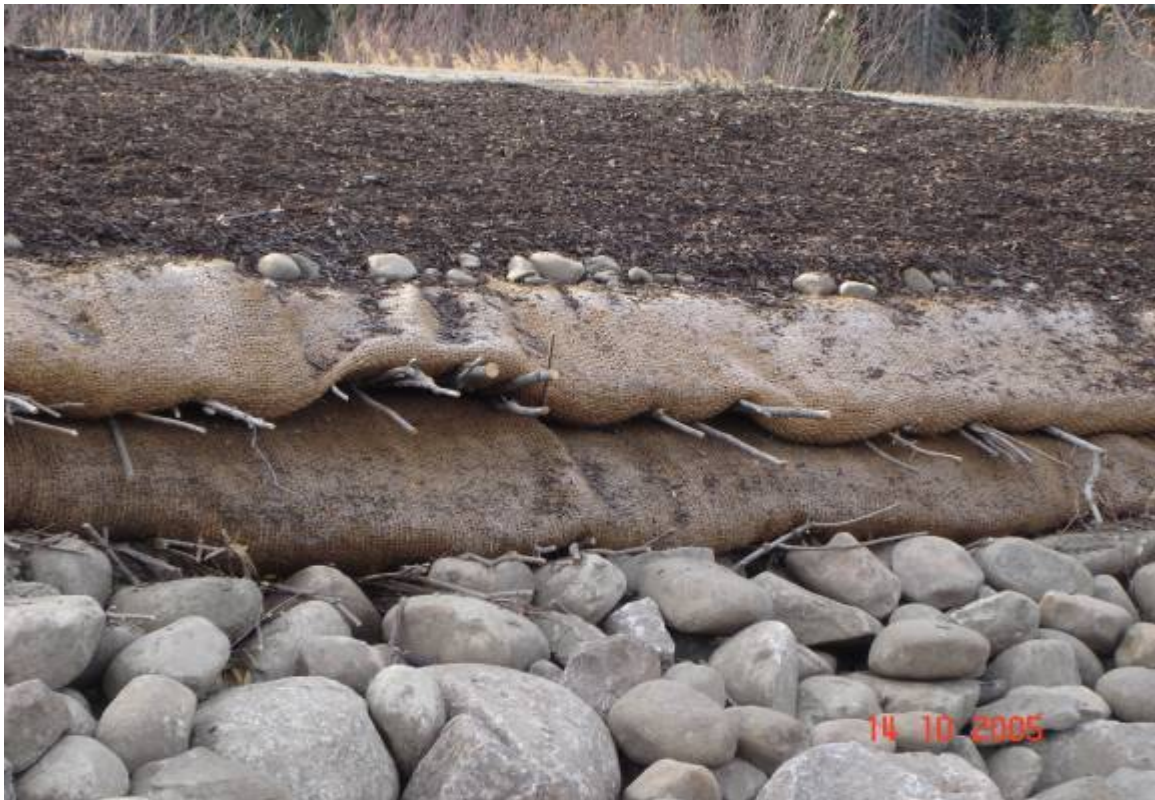
Photo 7 Vegetated Mechanically Stabilized Earth

- Vegetated mechanically stabilized earth (VMSE) – consists of alternating layers of live willow cuttings with soil wrapped in natural fabrics, TRMs or geogrids. Several offset layers are built up to make the stream bank.

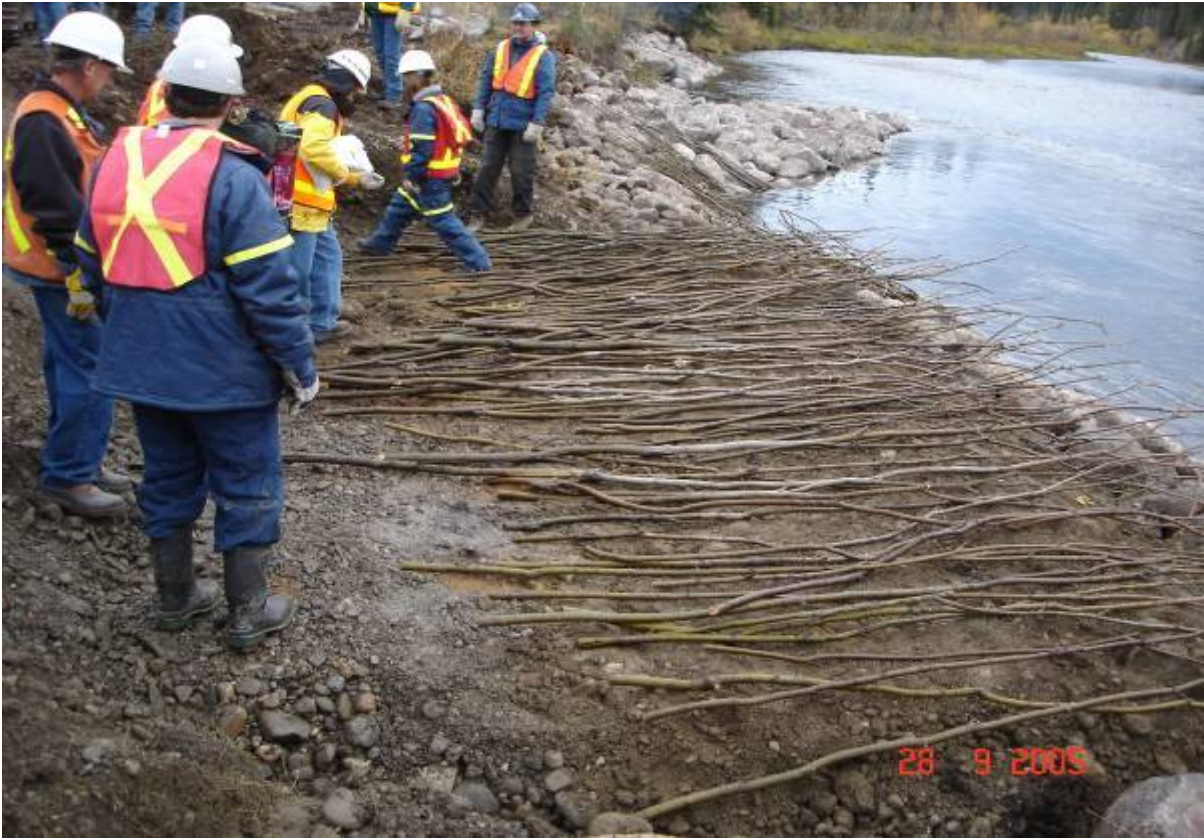
Photo 8 Brush Layering

- Branch layering – Live brush layers are layers of live willow cuttings that alternate with successive lifts of soil fill. Several layers are built to reinforce the slope or embankment.

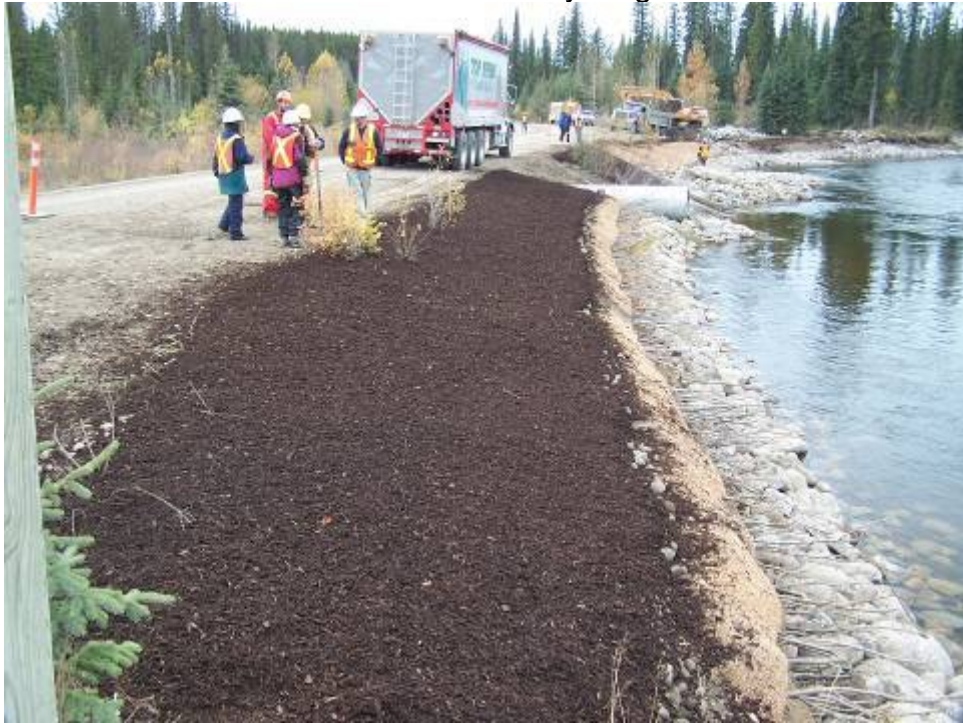
Photo 9 Sprayed compost blanket

On Days 2 and 3 of the training, participants were shuttled to and from the field training site in school buses. The optimal number of participants for a course such as this, according to John McCullah, was about 35. Since there were twice that number in the field it, was necessary to divide the group into manageable numbers and divide the work accordingly. The first duty was to cut willow branches from the surrounding area, using the prescribed technique, and ensuring the willow cuttings were placed in water to prevent drying. Once a sufficient number of willows were obtained, the course participants installed the various biobased ESC measures, such as live siltation (Photo 5), vegetated riprap (Photo 6), vegetated mechanically stabilized earth (VMSE) (Photo 7) and brush layering (Photo 8). Finally, to complete the site repair, erosion control BMPs were applied on all disturbed land – consisting of seeding, and straw and coir erosion blankets. The application of compost blankets, berms and logs (Photo 9) was a highlight of Day 2 activities.

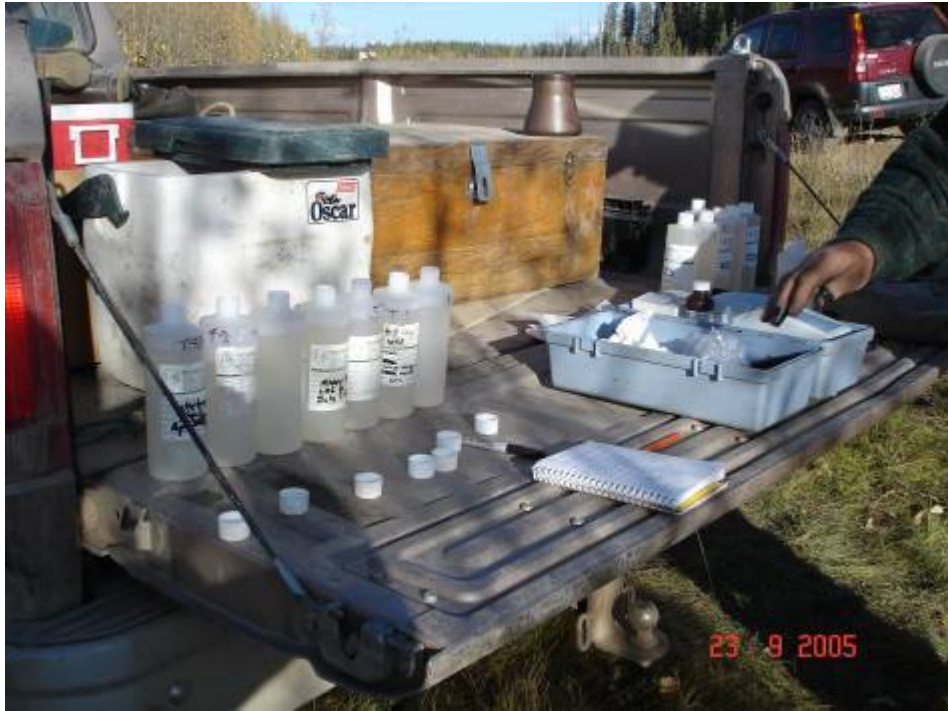
Photo 10 Turbidity monitoring

were mitigated, by having all course participants take the contractor's mandatory Site Hazard Assessment and review of OH&S issues, prior to going to the site. Two registered first-aiders were onsite full-time. The hospital in Hinton was notified of all activities, and an evacuation plan was prepared. The field site was a dead zone for cell phones, so a satellite phone had to be used. Potable water, portable toilets and a warm up trailer were provided. Waders, life jackets, safety ropes and first aid kits were onsite. A waiver was signed by each attendee, in order to protect the department against possible injury liability. Environmental issues were mitigated through diligent water quality monitoring, which was a requirement of the DFO permit. Water quality monitoring was provided by a professional fish biologist, who monitored water turbidity and sediment deposition during construction (Photo 10).
