Instrumentation and Real Time Monitoring of a Landslide on Highway No. 302 Near Prince Albert, Saskatchewan

R. Allan Widger, Saskatchewan Department of Highways and Transportation
awidger@highways.gov.sk.ca, (306) 787-4858 – Bus., (306) 787-4836 – Fax
P. Jorge Antunes, Saskatchewan Department of Highways and Transportation
jantunes@highways.gov.sk.ca, (306) 787-4640 – Bus., (306) 787-4836 – Fax
Allen J. Kelly, Clifton Associates Ltd.
allen_kelly@clifton.ca, (306) 721-7611 – Bus., (306) 721-8128 – Fax
Hung Q. Vu, Clifton Associates Ltd.
hung_vu@clifton.ca, (306) 721-7611 – Bus., (306) 721-8128 – Fax
A. Wayne Clifton, Clifton Associates Ltd.
wayne_clifton@clifton.ca, (306) 721-7611 – Bus., (306) 721-8128 – Fax

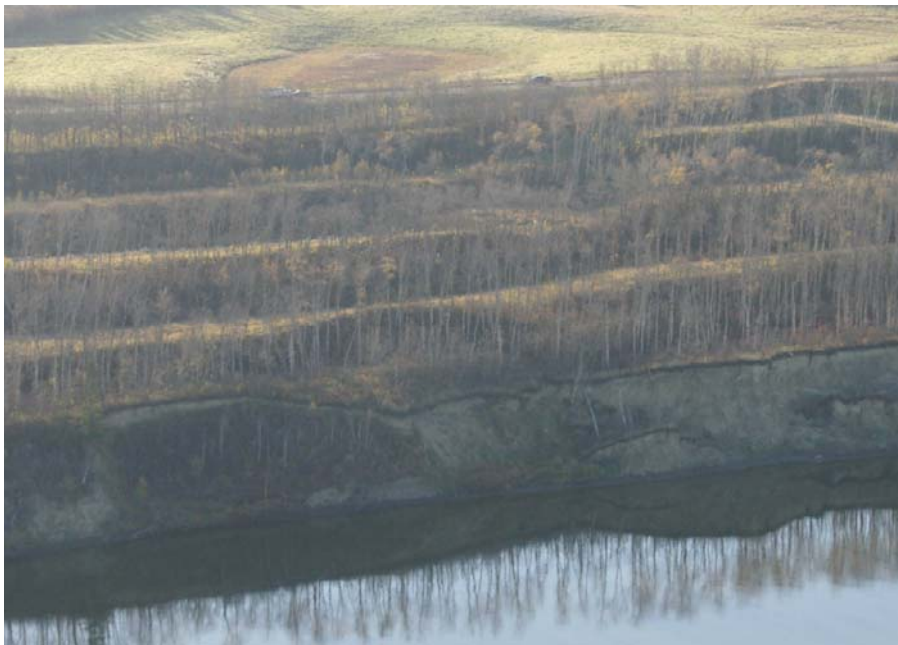
Figure 2. Photograph showing multiple landslide blocks.

Multiple retrogressive landslides, located adjacent to the North Saskatchewan River about 4.5 km west of Prince Albert, Saskatchewan, are impacting a 420 m section of Provincial Highway No. 302-02. Figure 1 shows the location of the landslide site where Provincial Highway No. 302-02 approaches within 250 m of the river. The slide mass extends 260 m from the river to the headscarp and is seated on a shear zone located at a depth of 50 m., Figure 2. A risk assessment assigned the landslide to the urgent risk category as there were threats to public safety and a significant impact on infrastructure, Figure 3.

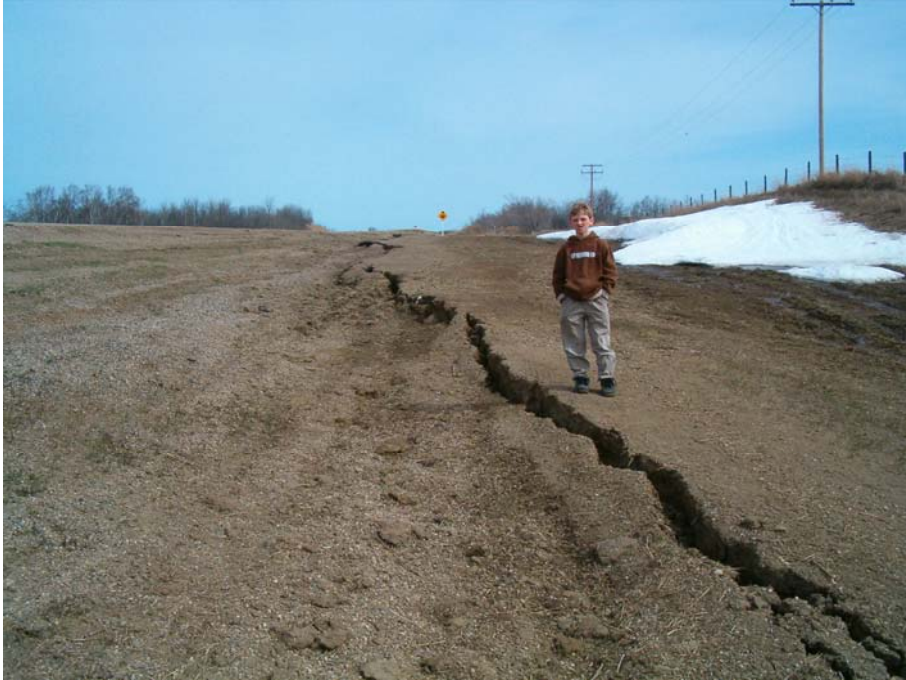
Figure 3: Landslide head scarp in upslope highway ditch (Photo taken on 16 April 2006).

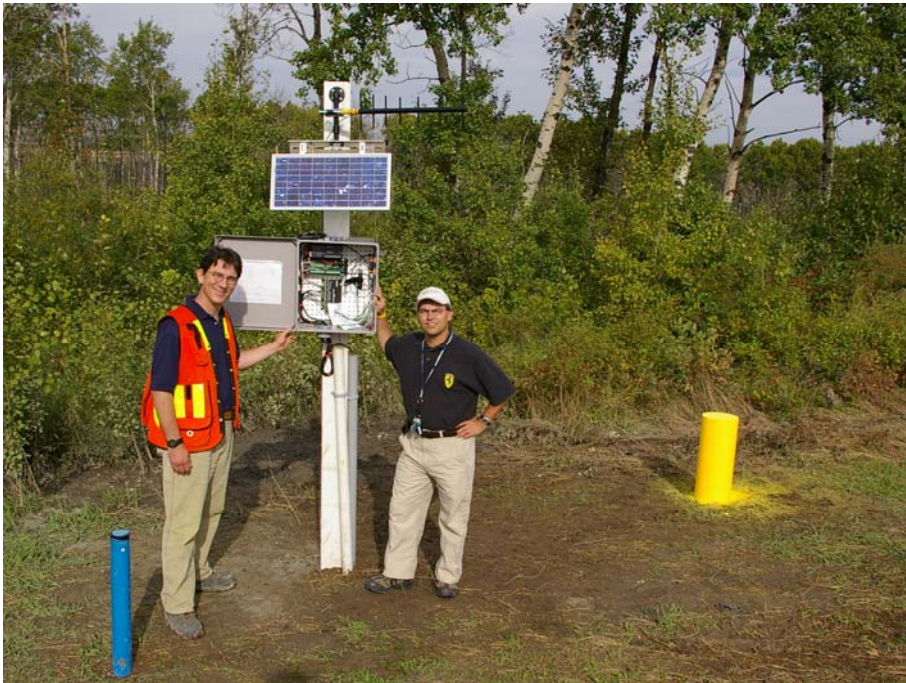
Figure 5. Photograph showing instrumentation nest near the highways

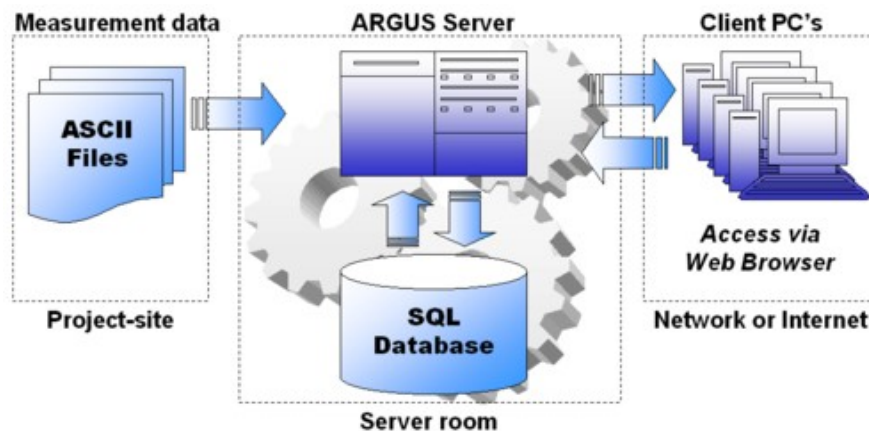
Figure 6. Schematic of ARGUS monitoring software

ARGUS processes the readings collected from sensors at the project site and makes the resulting data available on the internet. Users access the data and graphs via their web browsers. Data files from the project site are forwarded to ARGUS. ARGUS scans the files for alarm conditions and then stores the data in a project database. The data are available wherever there is an internet connection, and anyone who needs the data has immediate access (Figure 6).

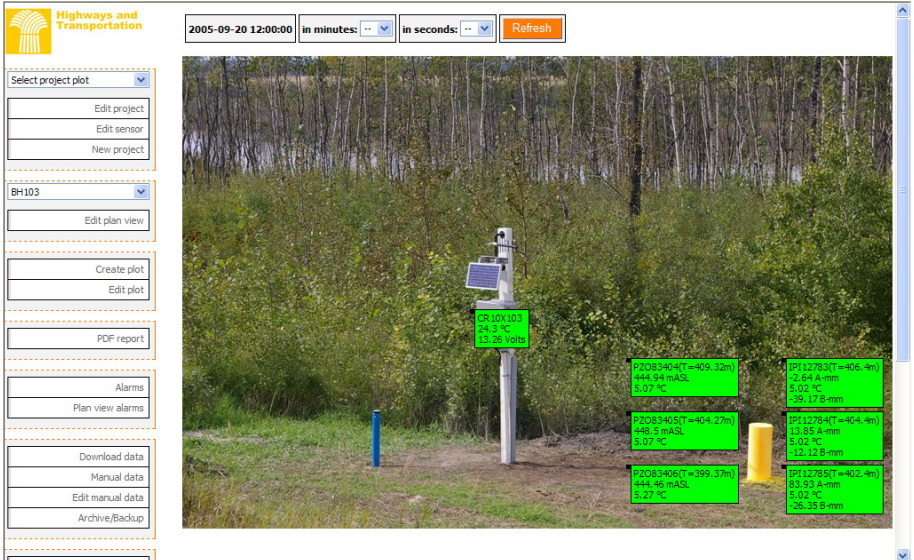
Figure 8. Photograph showing instrumentation nest adjacent to the highway and their current readings

Figure 8 presents a photograph showing instrumentation nest adjacent to the highway and their current readings.

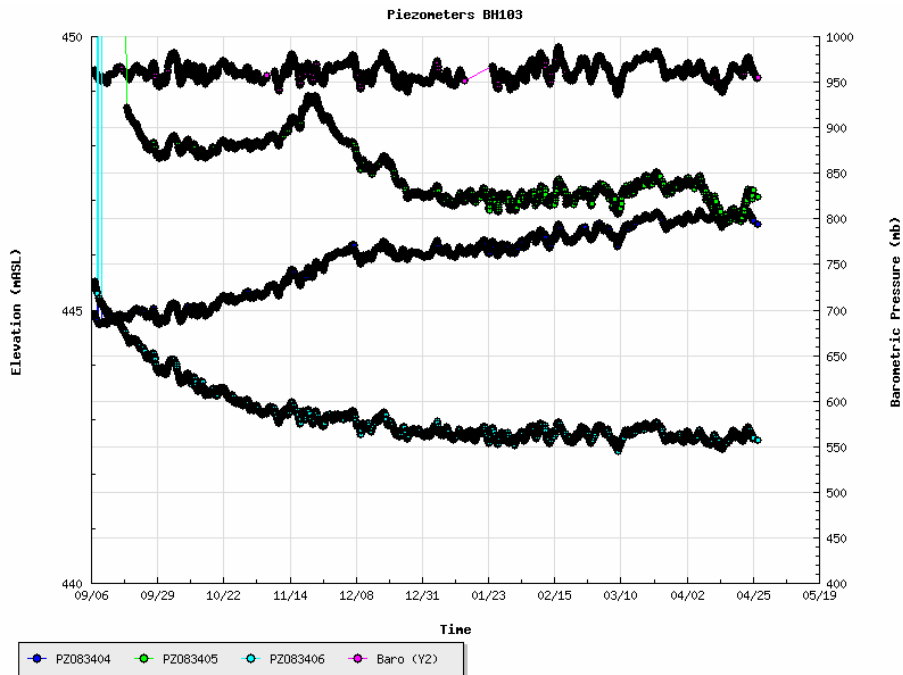
Figure 9. Time plots of piezometric levels and barometric pressure at the highway location

Trend Plots including time plots, profile plots, and correlation plots, can be printed or included in reports. An example of the trend plots is shown in Figure 9.

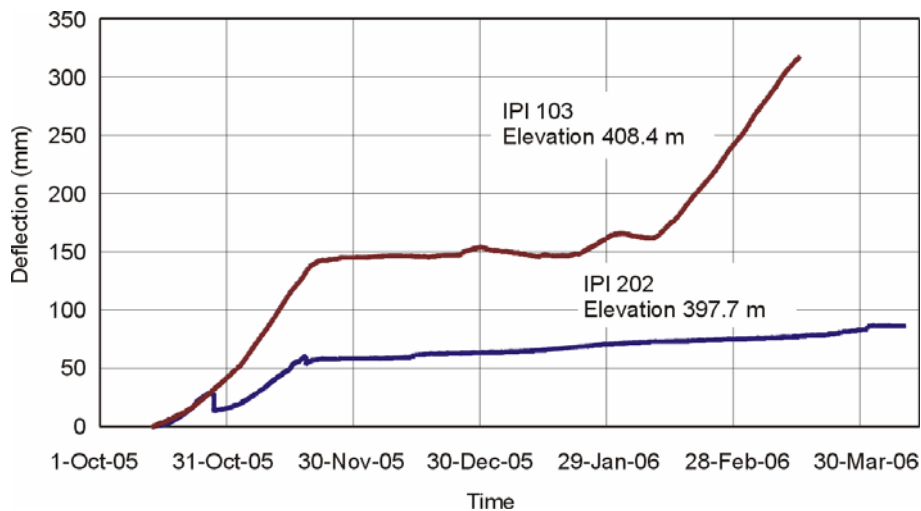
Figure 10. Cumulative resultant movement recorded by In-Place-Inclinometers

Data Downloads provide access to raw or processed data required for further analysis in spreadsheets. Figure 10 shows a plot of cumulative resultant movements recorded by In-Place-Inclinometers; raw data were downloaded from the website.
