Speed Reduction While Accommodating Emergency Vehicles with Small Inner
Track Widths

Sharla Cote, Engineer-in-Training
City of Regina

of the 2007 Annual Conference of the
Transportation Association of Canada
Saskatoon, Saskatchewan

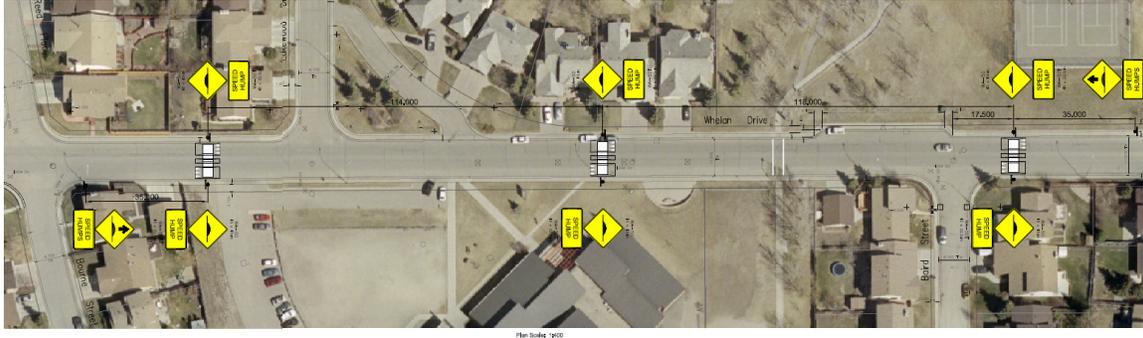
The final design of the speed cushions are shown in Figure 2, with a more detailed description described at the end of this section. The recommended layout of the three sets of speed cushions are shown in Figure 3.

Figure 3 – Layout of Speed Cushions on Whelan Drive

- As per TAC guidelines (3)
- Distance between sets of speed cushions – approximately 115 m
 - Placement of the three sets of cushions worked out well, spaced at least 30 m from intersections. The centre hump was spaced exactly between the front lawns of two houses so it was as far away from the driveways as possible.
- Signage – Speed hump WA-50 signs (Figure 4) installed in both directions at each set of speed cushions. “Speed hump ahead” signs (Figure 5) installed 35 m in advance of first set of speed cushions in both directions. The decision to use speed hump signs over speed cushion signs was based on not wanting to create unnecessary confusion over a new term. Since the speed cushions have a similar purpose and appearance to speed humps, it was decided that they would be referred to as speed humps.

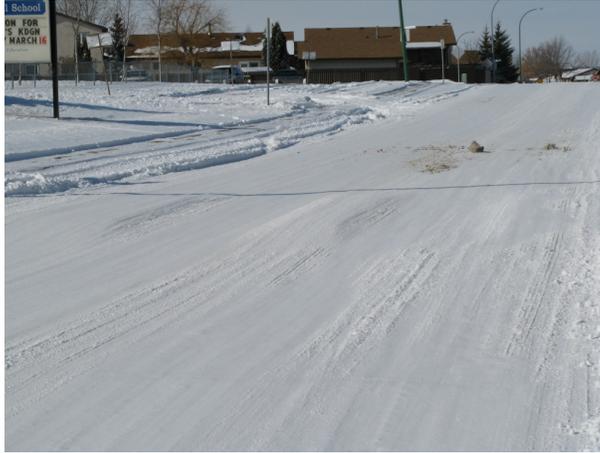
Figures 6 - 8 show images of what the speed cushions look like in the winter, and how drivers look while using the speed cushions properly and improperly.

Figure 6 – Speed Cushions During Winter

- There was no snow in the gaps of the speed cushions; it is naturally packed down by drivers
- The snow on top of the speed cushions was packed similar to the snow on the road
- The road had been graded, however there was snow in the parking lanes, which could make drivers prefer to drive more towards the centre of the road
- There were no conflicts or confusion between drivers and pedestrians
- There were no “close calls” involving a driver taking the centre cushion when another vehicle was approaching in the oncoming direction
- There was sufficient traffic in both directions to make people not want to take the centre cushion
- A large truck parks in front of one house every day at the middle set of speed cushions, likely making vehicles want to drive closer to the centre of the road

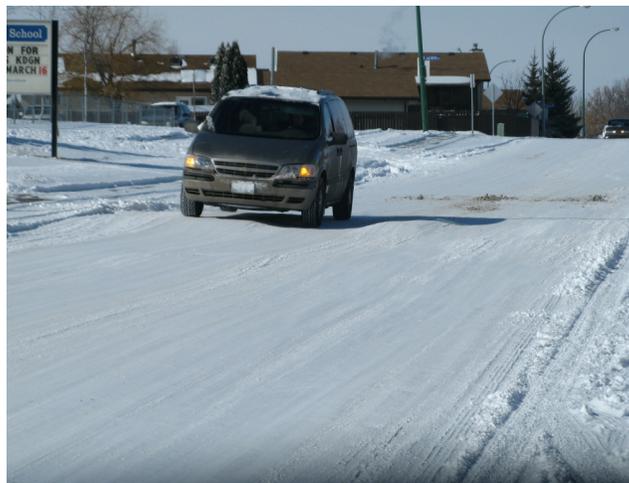
Figure 7 – Proper Use of Speed Cushion

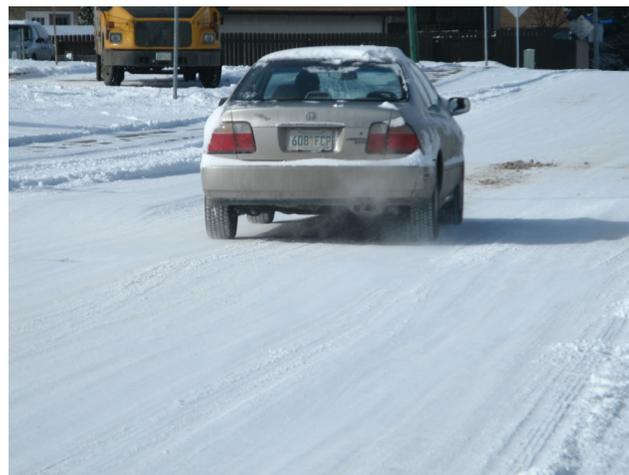
Figure 8– Improper Use of Speed Cushion

Analysis of the details of which centre cushion(s) drivers took shows that of the drivers that drove over a centre cushion, 86% of them took the centre cushion from the middle set, which is located directly in front of the school. A possible explanation for this is that most on-street parking happens in front of the school near the middle set of cushions, so drivers feel compelled to drive closer to the centre of the road to avoid potential conflict with parked cars.

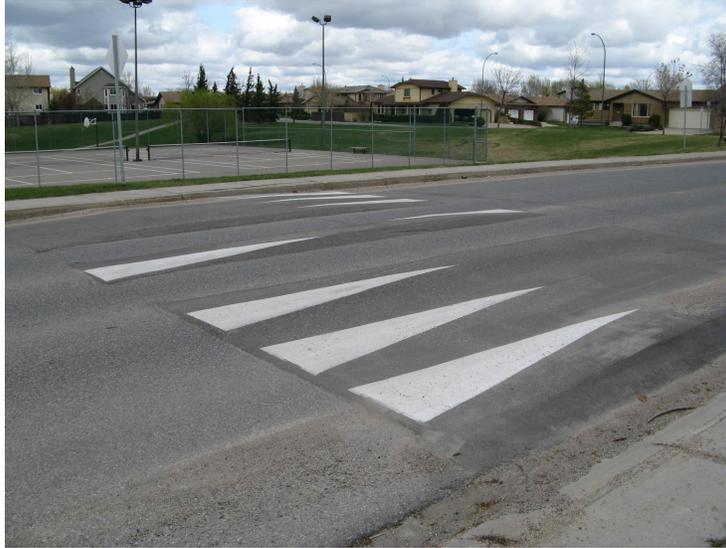
Figures 9 - 12 show images of what the speed cushions look like in ideal, dry conditions and how drivers look while using the speed cushions properly and improperly.

Figure 9 – Speed Cushion During Dry Conditions

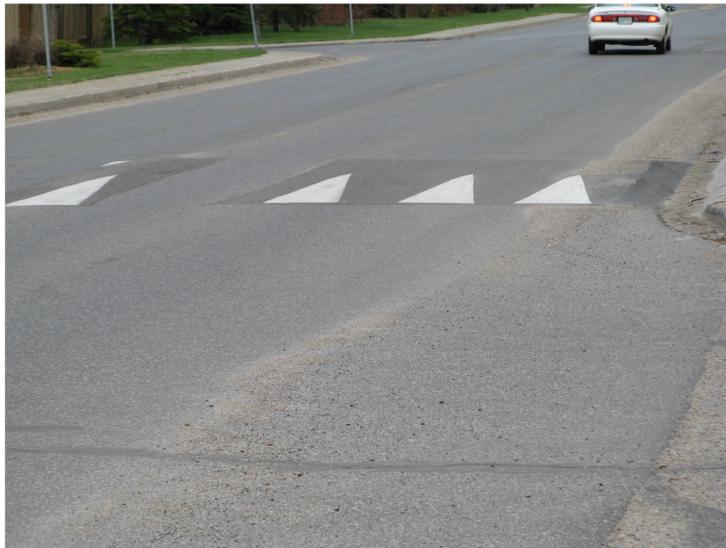
Figure 10 – Speed Cushion During Dry Conditions – Alternate View

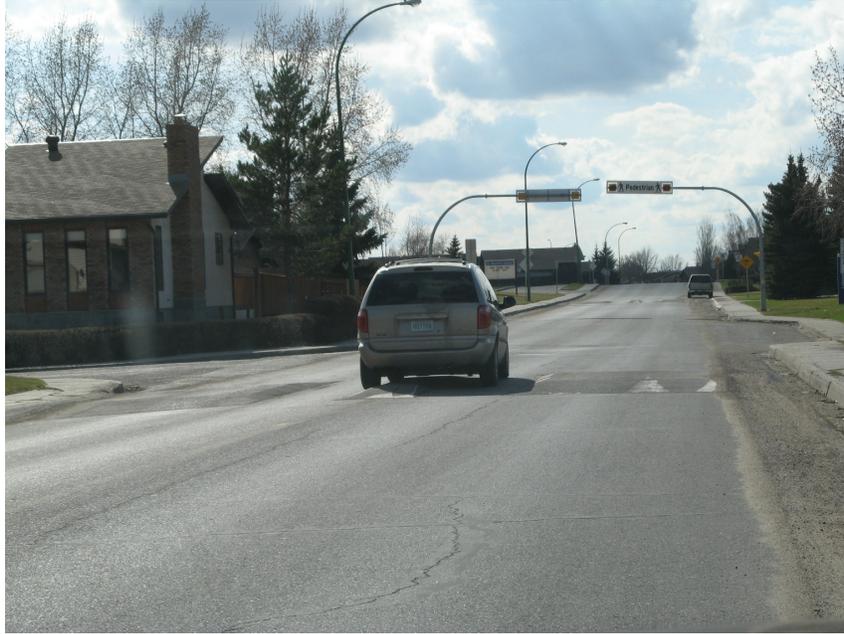
Figure 11 – Improper Use of Speed Cushion – Dry Conditions

The results show that a higher number of people drive over the centre cushions during dry, ideal conditions than during winter conditions. However, the difference is surprisingly low. On average, only 13% of drivers use the centre cushion; just 1% higher than the upper range observed during the winter. These results are promising, in that 87% of drivers are using the speed cushions responsibly.

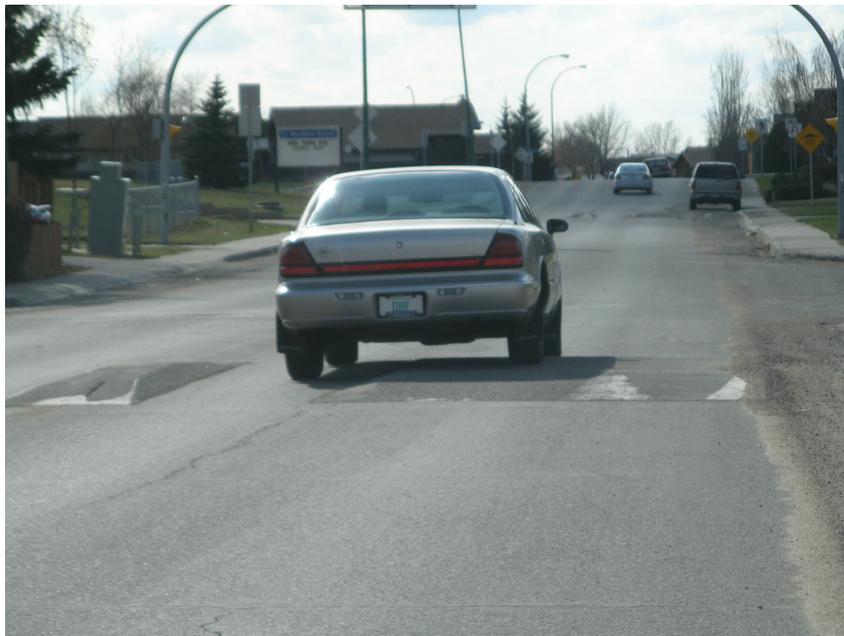
Figure 12 – Proper Use of Speed Cushion – Dry Conditions
