Short Term Performance of
Innovative Precast Concrete Slab Repairs
on Highway 427, Toronto

Becca Lane, P.Eng., Ministry of Transportation Ontario
and
Tom Kazmierowski, P.Eng., Ministry of Transportation Ontario

Paper prepared for presentation at the
“Cost-effective Assessment / Rehabilitation of the Condition of Materials” Session
of the 2007 Annual Conference of the
Transportation Association of Canada
Saskatoon, Saskatchewan

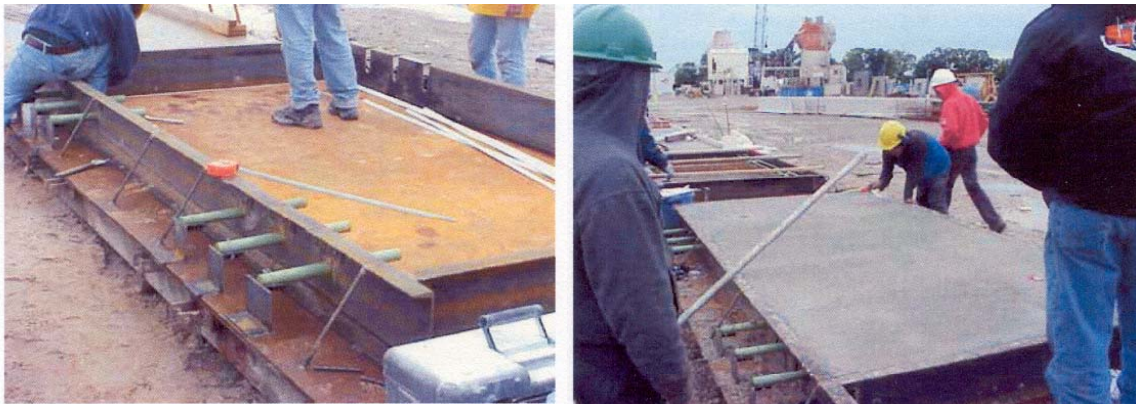
Figure 2. Fabricating Michigan Method slabs.

In the Michigan Method, 2 m long by full lane width concrete slabs are fabricated off-site with three dowel bars per wheel path cast into the slabs at 300 mm spacing (Figure 2). To install the precast slabs, the deteriorated concrete pavement is first removed by sawcutting the perimeter and lifting out the concrete. Slots are then cut into the existing pavement to accommodate dowel bars cast into the slabs. The underlying base may be partially excavated with a backhoe to accommodate the precast slab. A cementitious flowable fill levelling material is placed on the base prior to setting the precast slab. Once the slab is set, the exposed dowel bars are grouted in their slots to connect the precast slab to the adjacent concrete pavement.

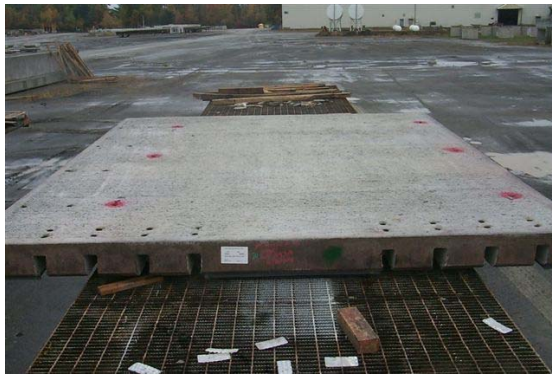
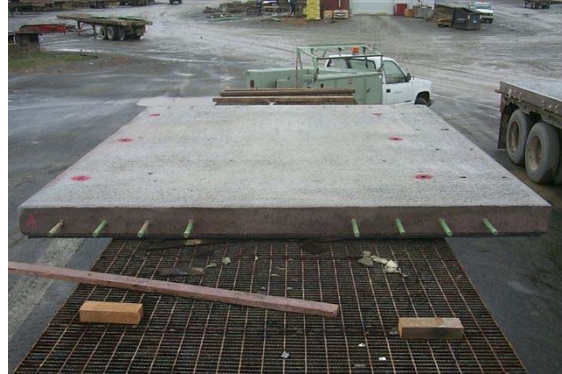
Figure 3 a) Four block-outs per wheel path are cast into the Fort Miller slabs **b)** dowel bars and block-outs are cast alternately into Fort Miller Continuous slabs.

In the Fort Miller Intermittent Method, 2 m long by full lane width concrete slabs are fabricated off-site with block-outs cast into the slabs to accommodate four dowel bars in the wheel paths (Figure 3a). In the same manner as the Michigan Method, the deteriorated concrete pavement is removed by sawcutting the perimeter and lifting out the concrete. The underlying base may be partially excavated with a backhoe, then crusher screenings are placed on the existing base, precision graded and compacted. Four dowel bars per wheel path at 300 mm spacing are drilled and epoxied into the adjacent concrete. Once the slab is set, the dowel bars are grouted through ports in the precast slab to connect it to the adjacent concrete. Finally, bedding grout is injected through interconnected ports and channels in the bottom of the slab to fill any voids beneath the concrete.

In the Fort Miller Continuous Method, dowel bars and block-outs are cast alternately into a set of 4 m long by full lane width concrete slabs, which fit together like puzzle pieces (Figure 3 a & b). Following removal of a continuous section of deteriorated concrete pavement, the underlying base may be partially excavated with a backhoe, then crusher screenings are placed on the existing base, precision graded and compacted. The first slab and last slab placed are dowelled into the existing pavement at each end of the excavation, in between the slabs are connected to each other. All slabs in the continuous repair are tied into the adjacent lane with drilled and epoxied tie bars. Once the slabs have been set, the dowel bars and tie bars are grouted through ports in the precast concrete slabs to connect the slabs to the existing pavement and to each other. Finally, bedding grout is injected through interconnected ports and channels in the bottom of the slabs to fill any voids beneath the concrete.

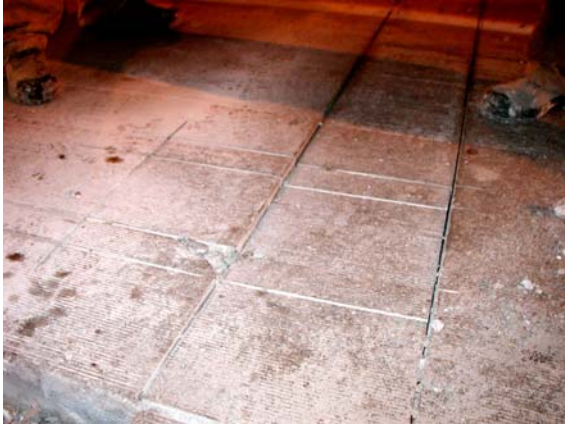
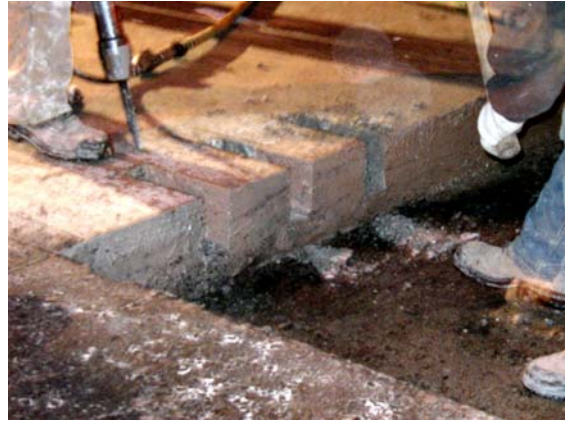
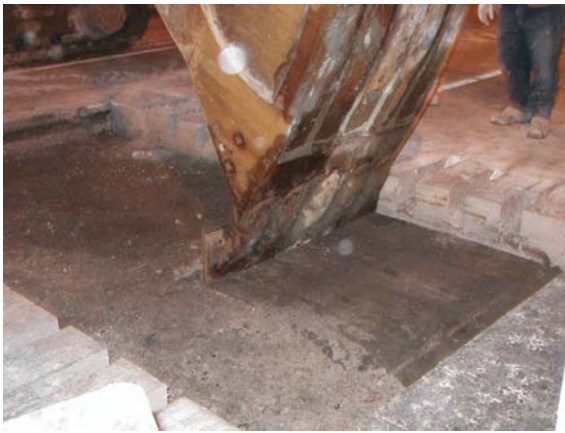
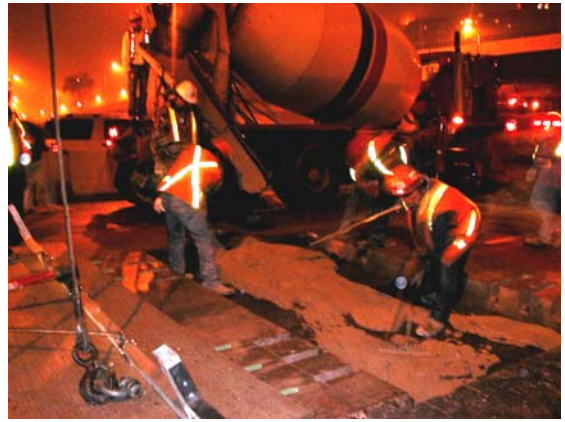
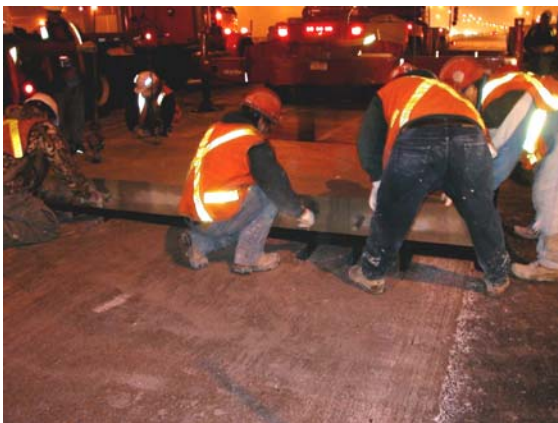
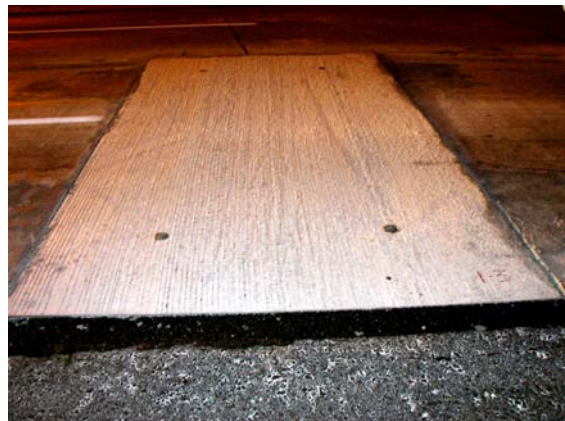
Figure 5. Construction sequence for Michigan Method precast slab installation: a) perimeter sawcuts and sawcuts for dowel slots made the previous night, b) removal of dowel slots by jackhammer, c) scraping of CTB using a modified backhoe bucket, d) placement of flowable fill, e) lowering of precast slab, and f) final product (slab 3).

Excavation of the dowel bar slots was not carried out with a desirable level of care. Dowel bars were not centered in the dowel slots and where the dowel bars were resting against the walls or base of the dowel slots it would be difficult to get full encasement with grout. Some of the dowel bar slots were spalled down to the base and there were also cracks extending from some dowel slot removal areas into the existing concrete. This method requires good workmanship to ensure that the removal area is precisely delineated and the dowel bars slots are carefully chipped out without damaging the existing concrete.

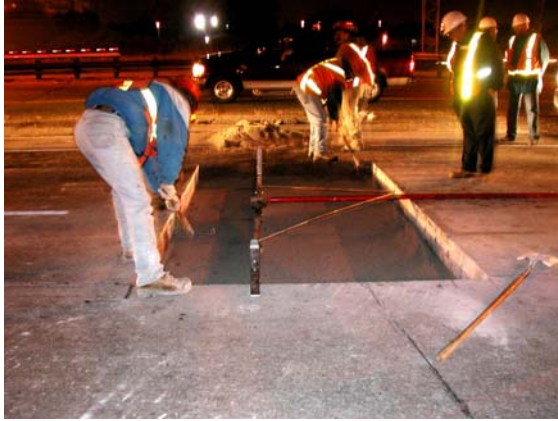
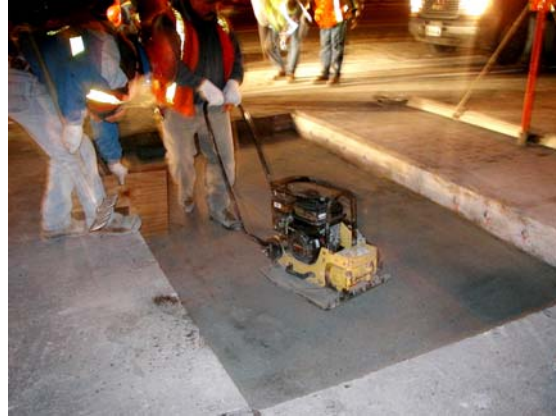
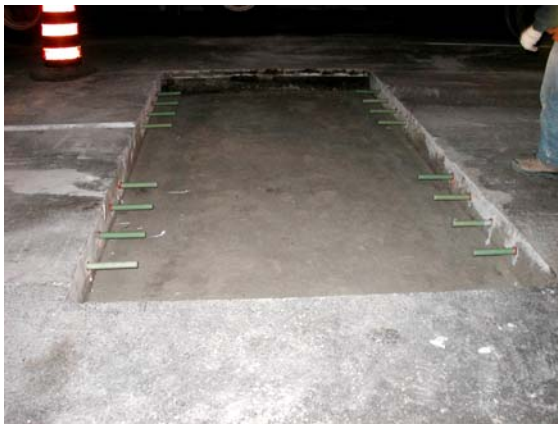
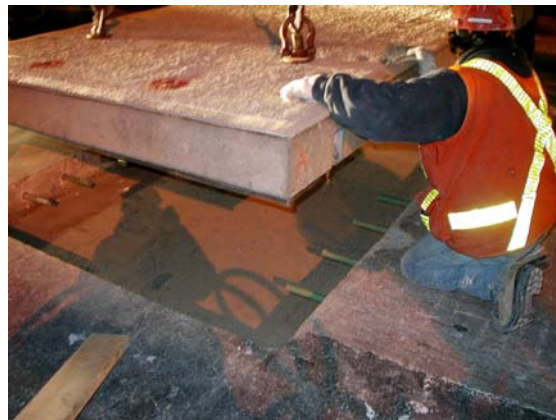
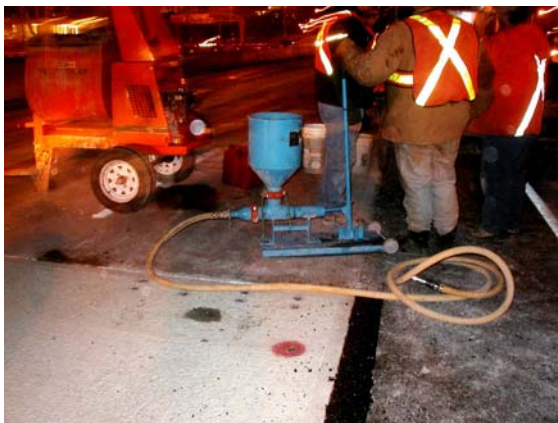
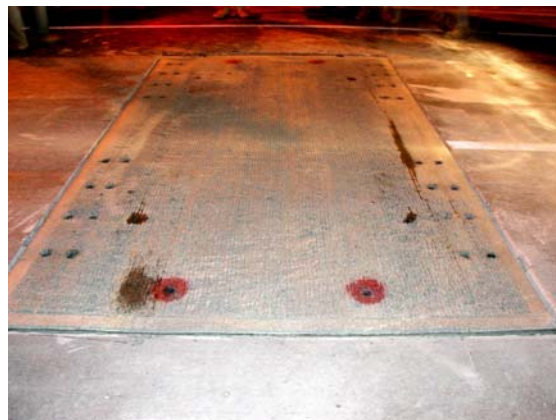
Figure 6. Construction sequence for Fort Miller Intermittent precast slab installation: a) using full lane width leveling screed to fine grade crusher screenings, b) compacting crusher screenings using plate packer, c) dowel bars installed, ready to place precast slab, d) lowering precast slab, e) grout pump for grouting dowel bars, and f) final product, prior to grouting.

The ride over all three Fort Miller Intermittent slabs is good, although the third slab, which was not grouted, did settle slightly overnight.

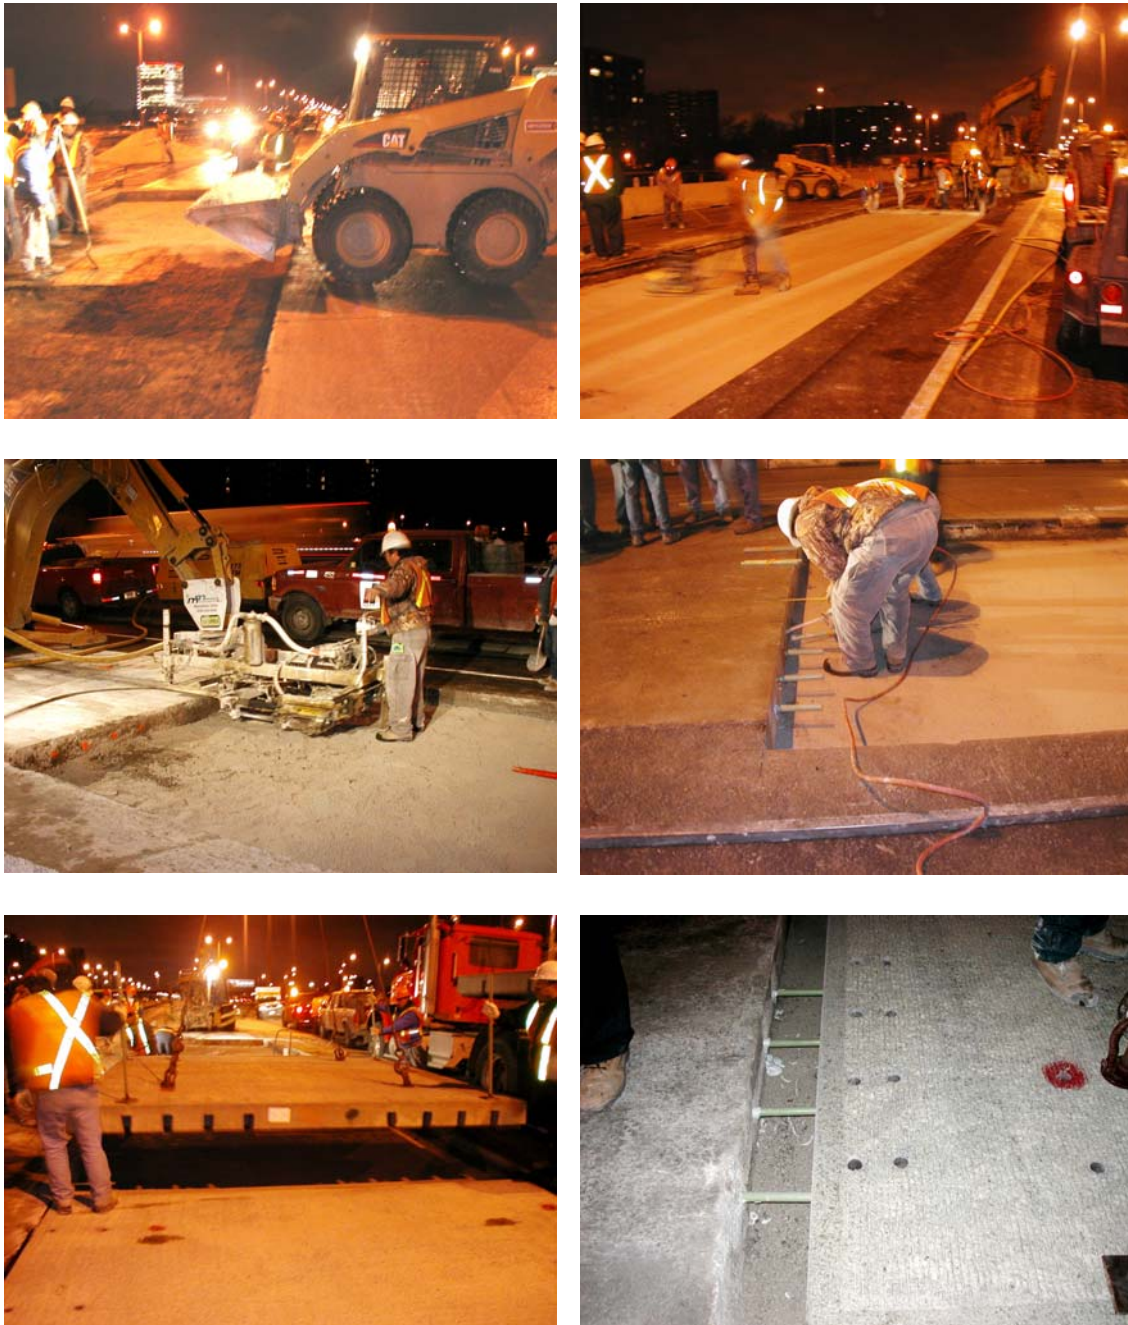
Figure 7. Construction sequence for Fort Miller Continuous precast slab installation: a) placing screenings, b) compacting, c) gang-drilling dowel bar locations, d) fixing dowel bars with epoxy adhesive, e) lowering precast slab, f) 180 mm gap between slab 6 and existing concrete.

Three attempts were made to place the third slab, which would not sit flush with the longitudinal joint between lanes 2 and 3. The fourth and fifth slabs were placed without incident. Due to over-excavation, a gap of 180 mm was left between slab 6 and the existing concrete. The Contractor mixed grout with pea gravel to temporarily fill the gap. This area was repaired in 2005 with a fast-track repair.

The ride over the six Fort Miller Continuous slabs is uneven. The slabs do not match flush with each other and do not meet surface tolerance requirements. Diamond grinding would improve the ride.

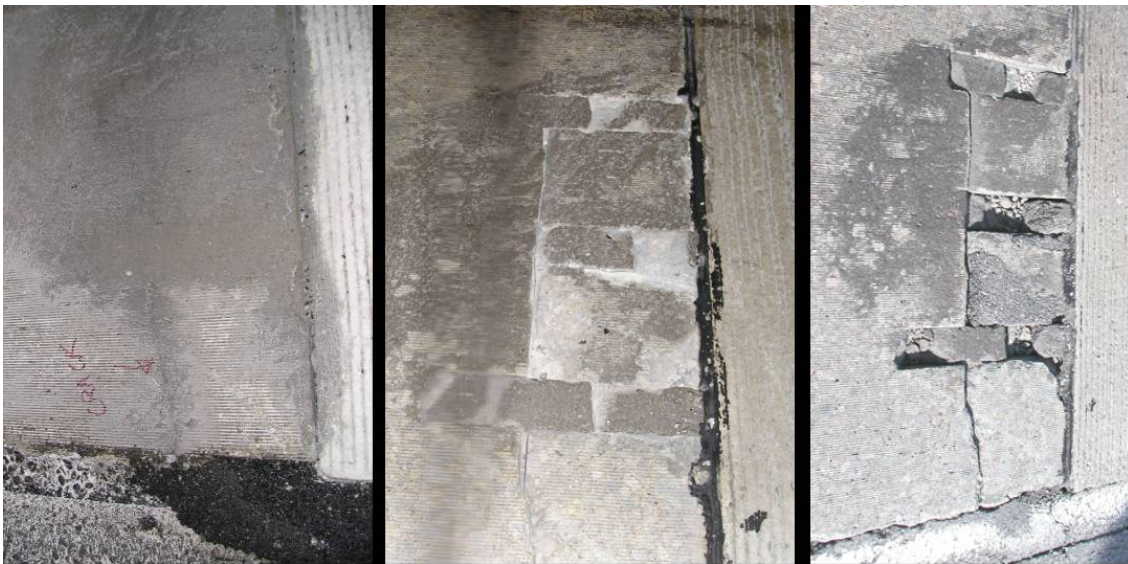
a. **b.** **c.**
Figure 9. Michigan Method Slab 2 **a)** during construction in November 2004 **b)** June 2005 at one-year field review **c)** May 2006 in second year field review.

It is likely that cracking and spalling at the dowel bar slots is the direct result of the removal method, which included over-cutting the slots and jack-hammering to remove concrete from the slots. The Ministry is confident that an improved method of excavating the slots, such as use of gang-saws, light-weight chipping hammers and sand-blasting to clean the slots will improve performance of the Michigan Method.

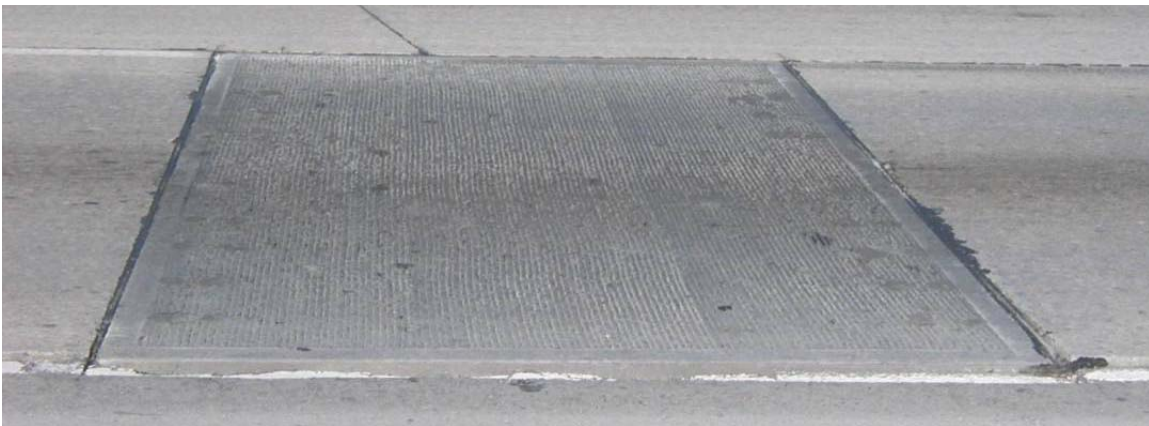
Figure 10. Fort Miller Intermittent Method precast slab, May 2006.

The Fort Miller Intermittent Method slabs are performing very well (Figure 10). In the June 2005 field review no defects were observed in any of the intermittent slabs. In the May 2006 field review, the only distress that could be detected was very minor cracking a few locations over the dowel bars (Figure 11).

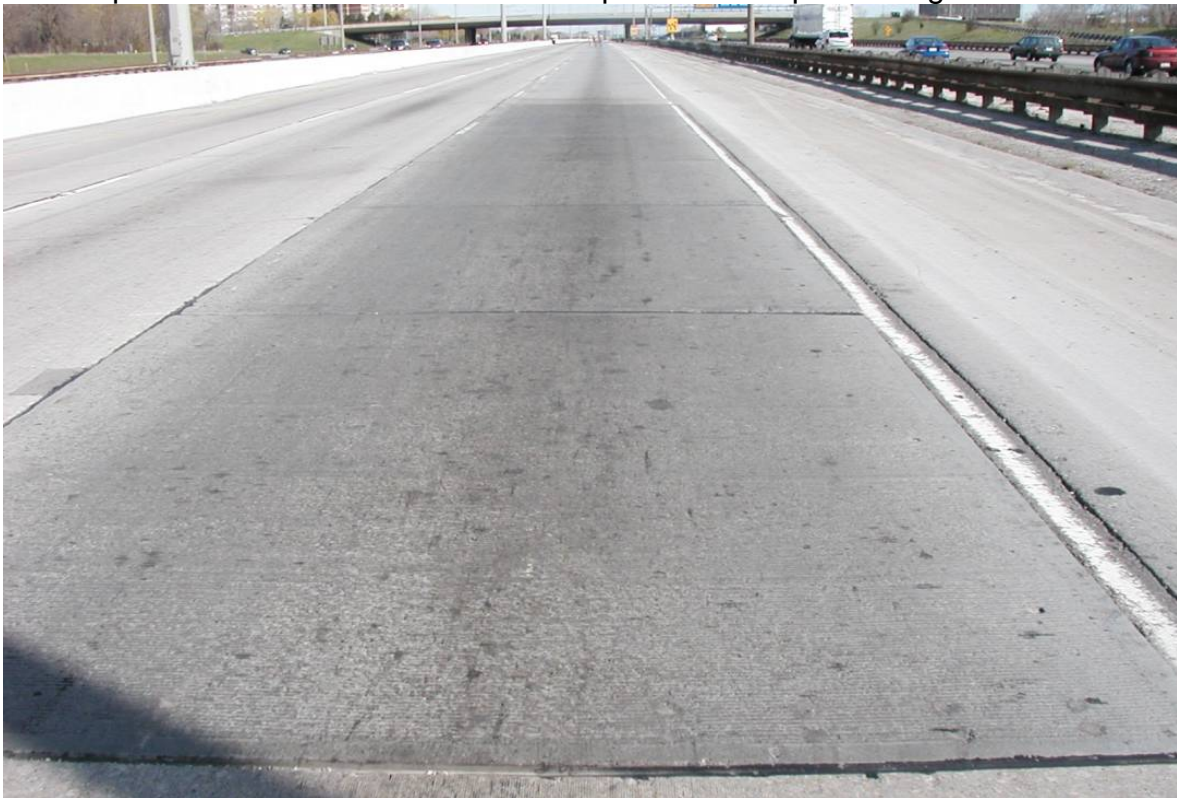
Figure 11. Performance of Fort Miller Continuous Slab repairs, May 2006.

The Fort Miller Continuous Method slabs are performing very well (Figure 12). No cracking or spalling was observed in any of the six continuous slabs during the June 2005 and May 2006 field reviews. The gap resulting from over-excavation during concrete removal at the end of the continuous slab replacement area had been repaired with a fast track concrete repair and was performing well.
