Myra Canyon Trestle Reconstruction

Abstract

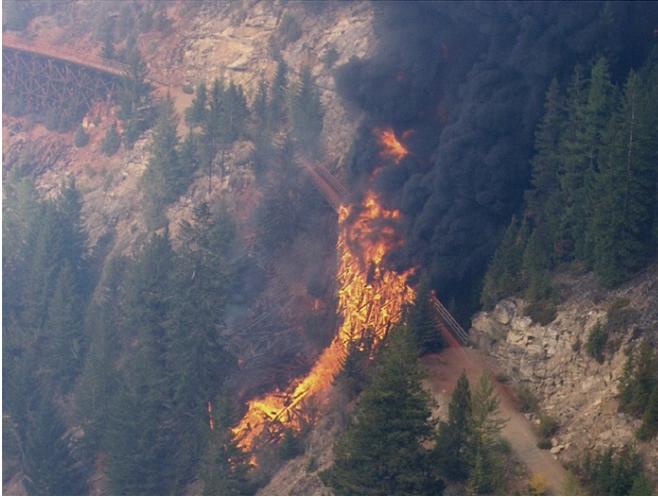
Figure 2. Trestle 13 – September 4, 2003

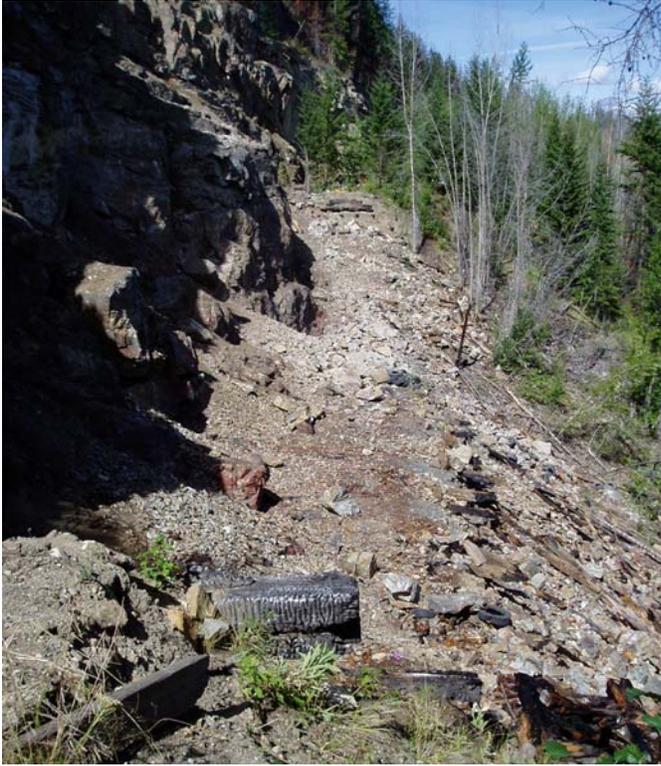
Figure 8. Trestle 3

Trestle 2 is situated on a steep side slope with a combination of loose granular material and fractured rock. Trestle 3 sits partly on the side of the mountain and partly on top of a large timber and rock crib wall that retains small boulder

- A timber crib wall at Trestle 15 badly burned by both the fire and fire-fighting activities had failed, undermining a nearby concrete foundation as well as compromising the slope stability near several proposed timber mudsills.
- A timber crib wall at Trestle 11 was both decaying and burned. The integrity of the crib relative to the steep terrace was in question.
- Most of the piles at Trestle 4 had burned completely to ground level and the suitability of the piles for re-use to support a new structure was in doubt.
- The outside crib wall face at Trestle 3 had been incinerated. The integrity of the material that the crib wall had retained was a concern.

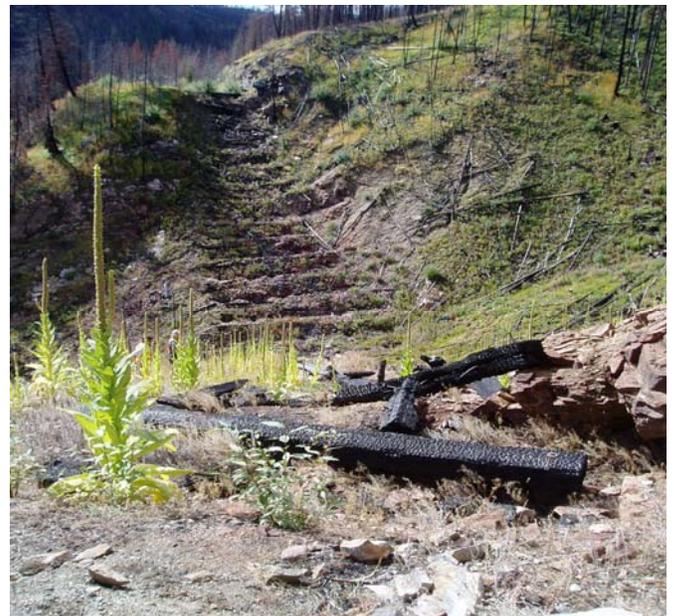
Figure 9. Trestle 4

Trestle 4 crosses a small canyon and is mostly supported on timber piles driven into the softest material found along the line. It is also the tallest timber trestle at 130 feet high and is over 500 feet long.

Trestle 4, with its piled foundations, made for an interesting challenge. The condition survey of the piles showed that a significant number of them were decaying, and that replacement piles would be necessary. Installation of new timber piles using conventional means was not practical. The contractor could not install new piles as the bridge progressed because a) the rig would not be able to reach out horizontally far enough to reach the bottom of the tallest bents (70 feet wide at the base) and b) keeping a piling rig on site to work only one day a week for 4 months was not economical. The terrain of the area also precluded use of a piling rig for installing piles in advance of trestle construction. The solution was to use micro piles that provide the required capacity without requiring large equipment. All major equipment could be set up at an abutment, and hydraulic lines could be run to the drilling apparatus at each location. Because of the slender nature of the micro pile, and the fact that many of the piles extended several feet above ground level, the piles were sleeved above ground level and grouted solid to improve the pile stability.

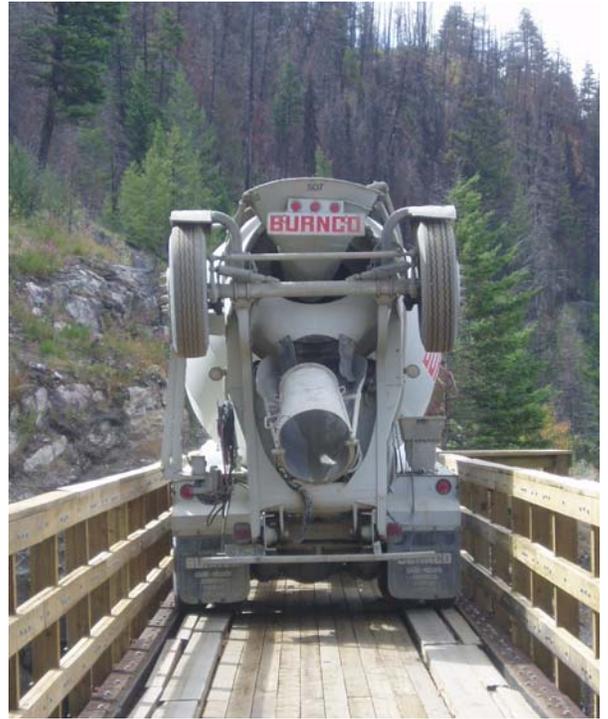
Figure 11. Concrete delivery to trestle 11

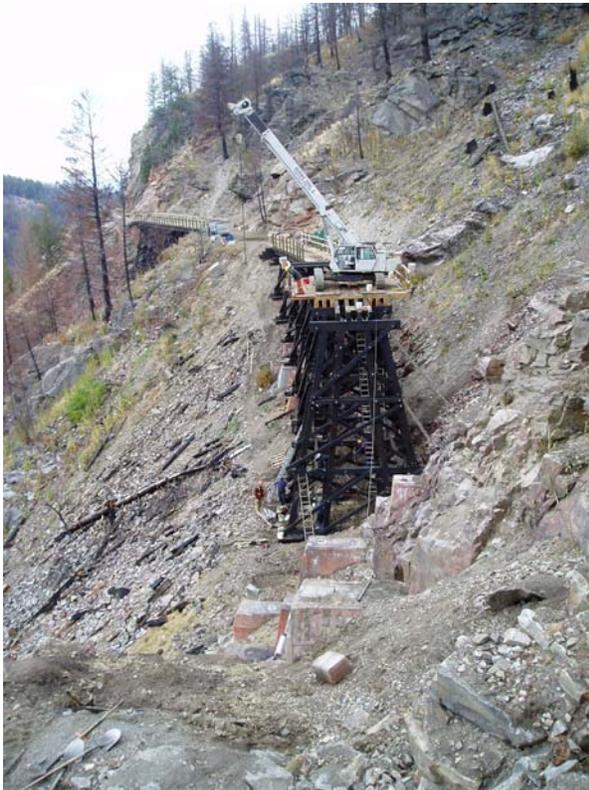
Figure 12. Tracked crane on trestle 14

Contractors faced significant construction challenges due to the difficult locations and limited access. Rubber tired and tracked cranes were used to assemble the timber components of the trestles for the majority of the contractors. However, two trestles were constructed using high-lines to ferry materials into the site from its staging area.

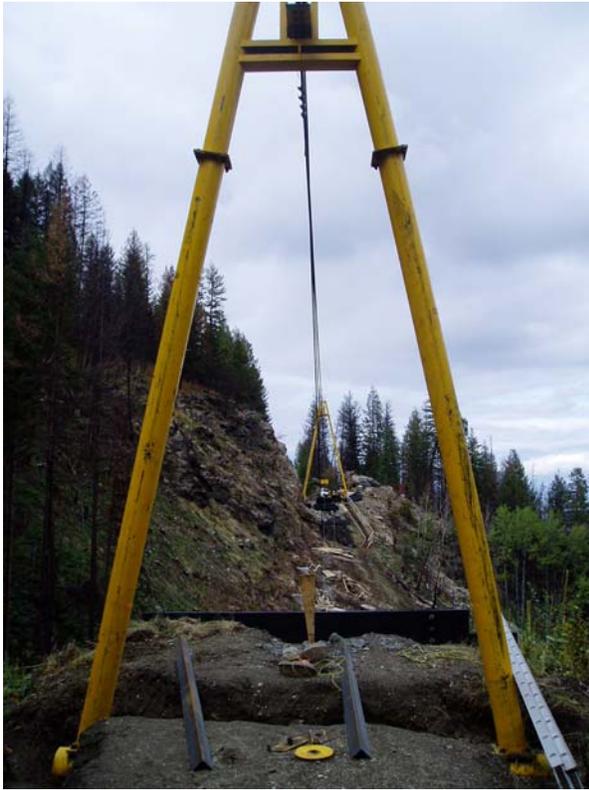
Figure 14. Highline on tangent trestle 2

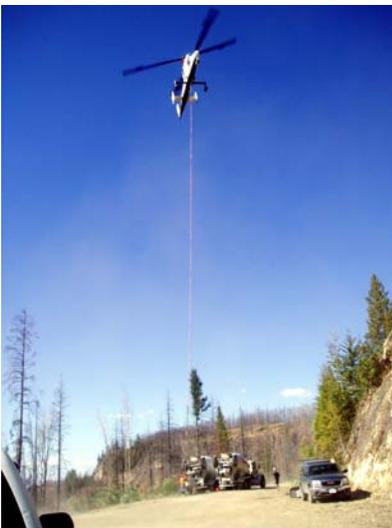
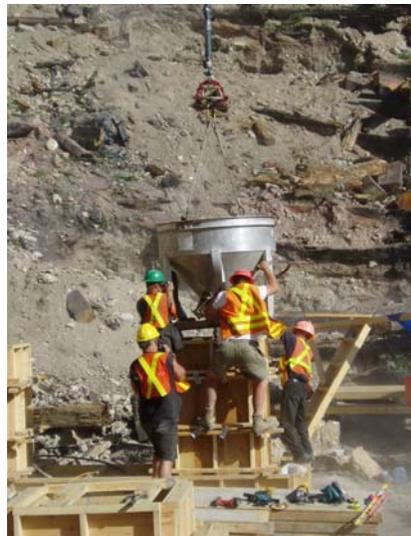
Figures 16, 17.
Placing concrete by
helicopter at trestle 11

- Construction of concrete foundations where no concrete foundations previously existed.

- Approximately 400 cubic yards of concrete were required for foundations. Concrete was either placed by helicopter or by inline pump.

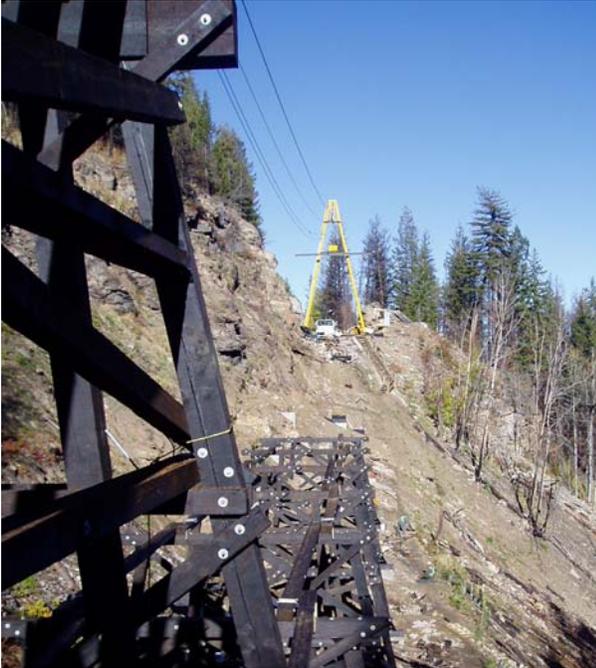
Figure 18. Assembling bent with highline at trestle 2

- A very small work area at the trestle. Bents pre-assembling into structure components at staging area.

- Crane or highline was used considerably for handling timbers during bent assembly.

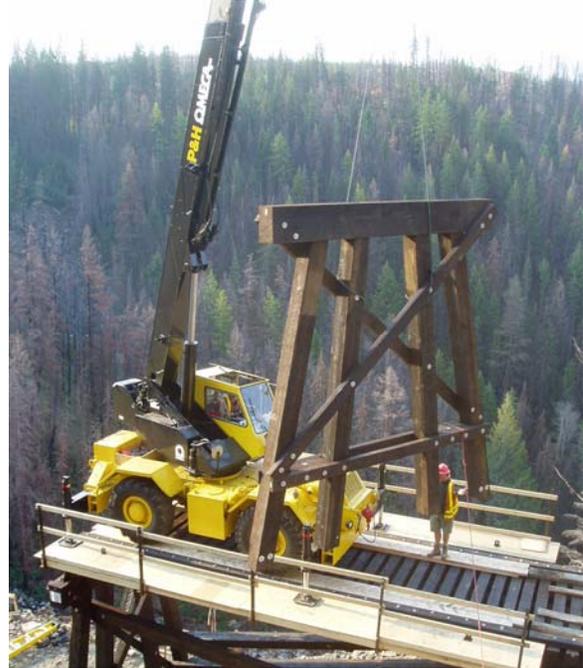
Figure 19. Placing bent sections with crane at trestle 11

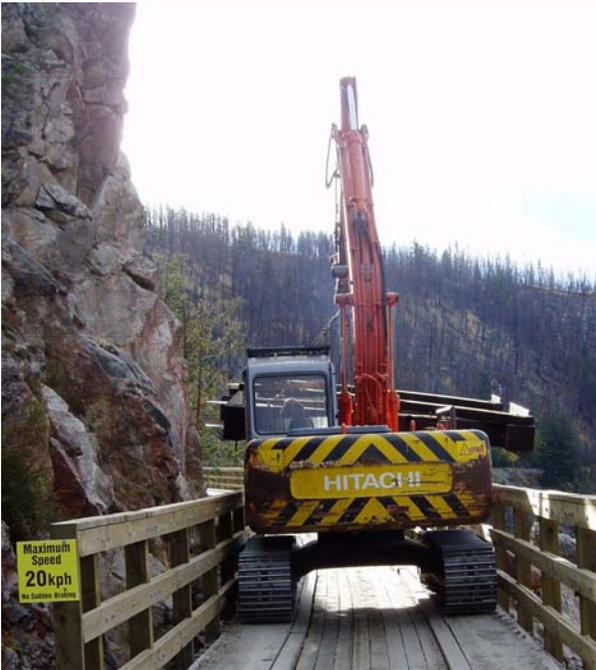
Figure 20. Delivering bent sections to trestle 15 from staging area

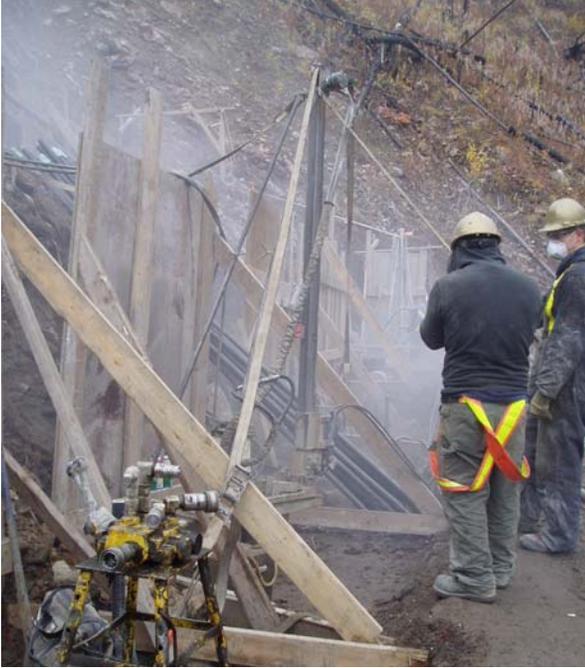
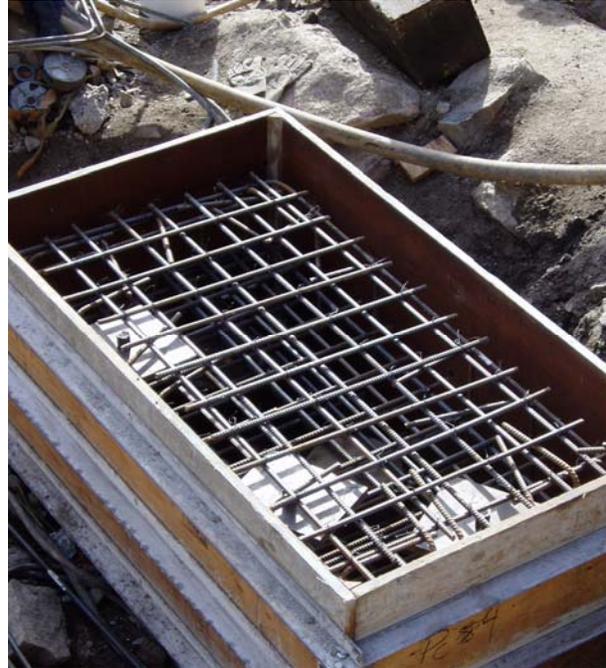
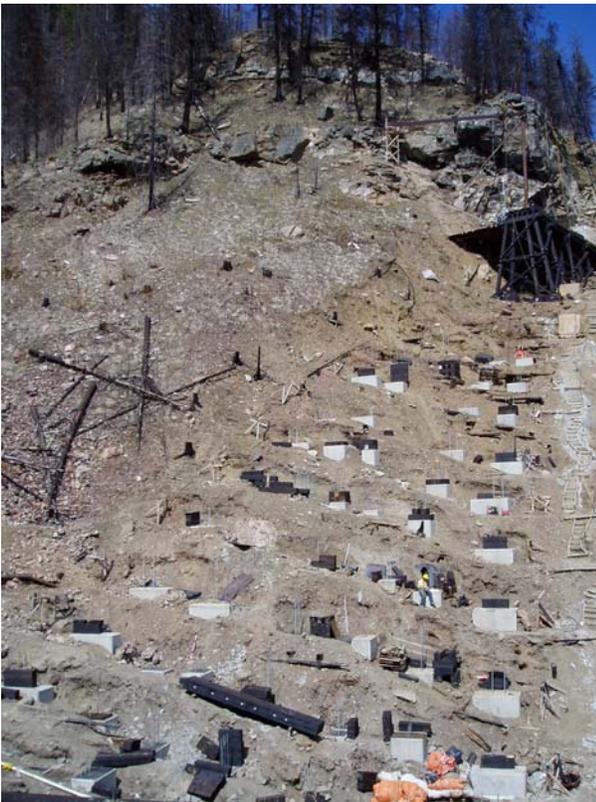
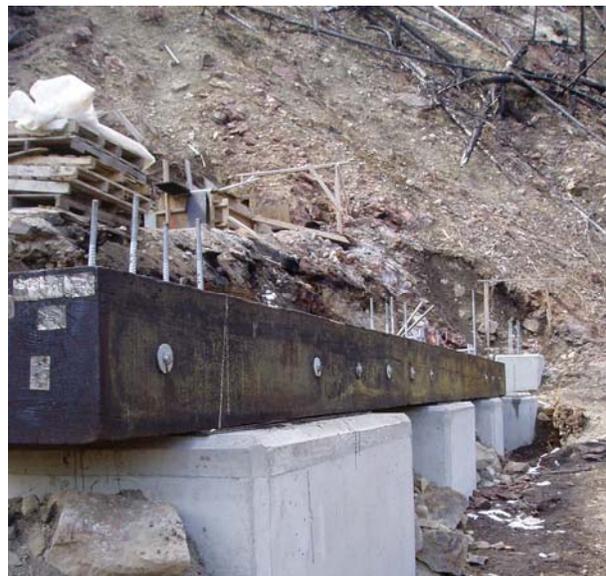
Figures 22, 23, 24, 25. Trestle 4 required the installation of over 150-25' long micropiles – all placed using portable equipment

- Existing timber piles destroyed at trestle 4 and limited equipment access.

- Micropiles and concrete pile caps were incorporated into foundation design.

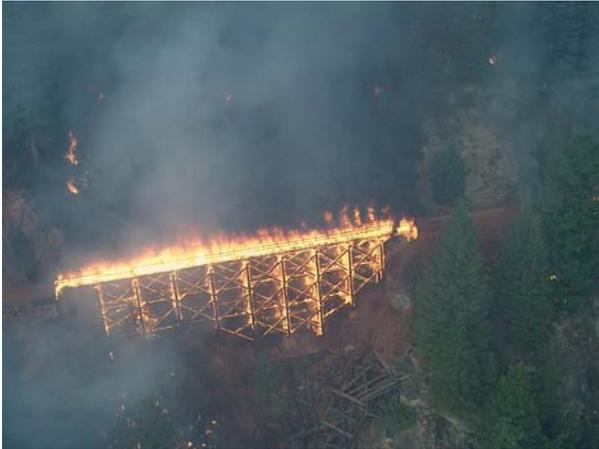
Figure 26. Trestle 15 burning

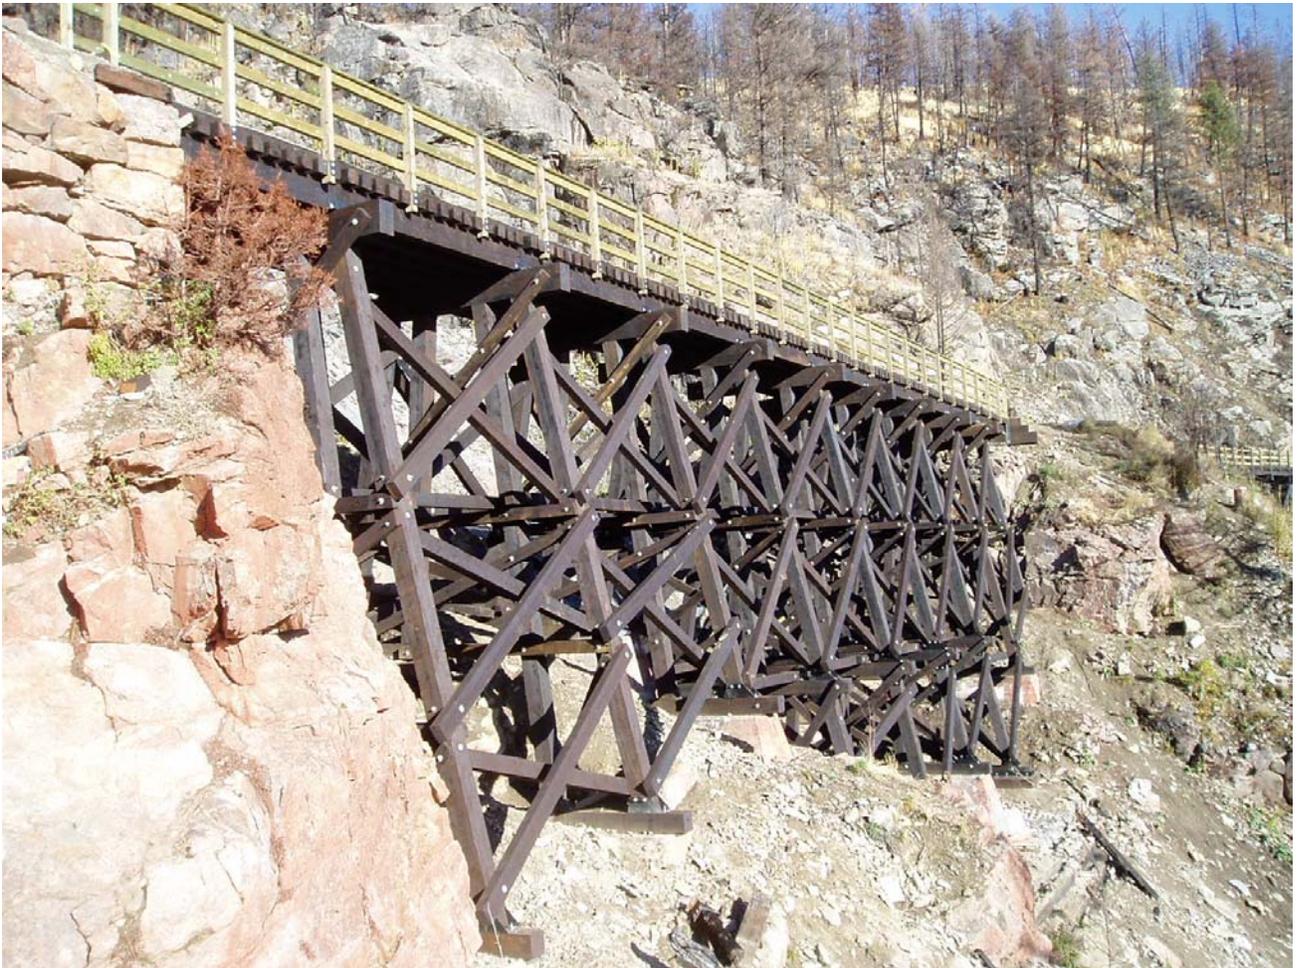
Figure 27. Reconstructed Trestle 15

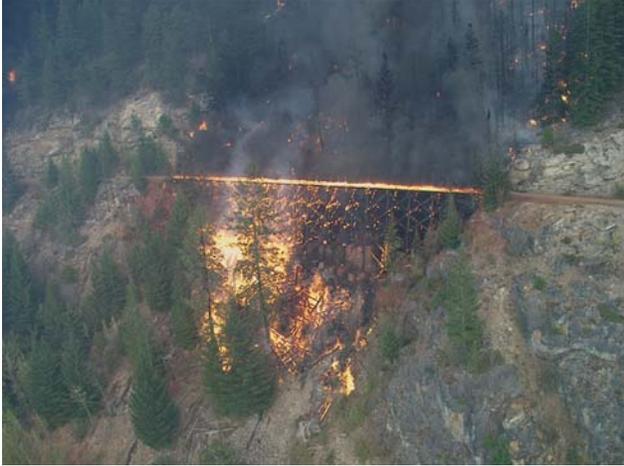
Figure 28. Trestle 13 burning

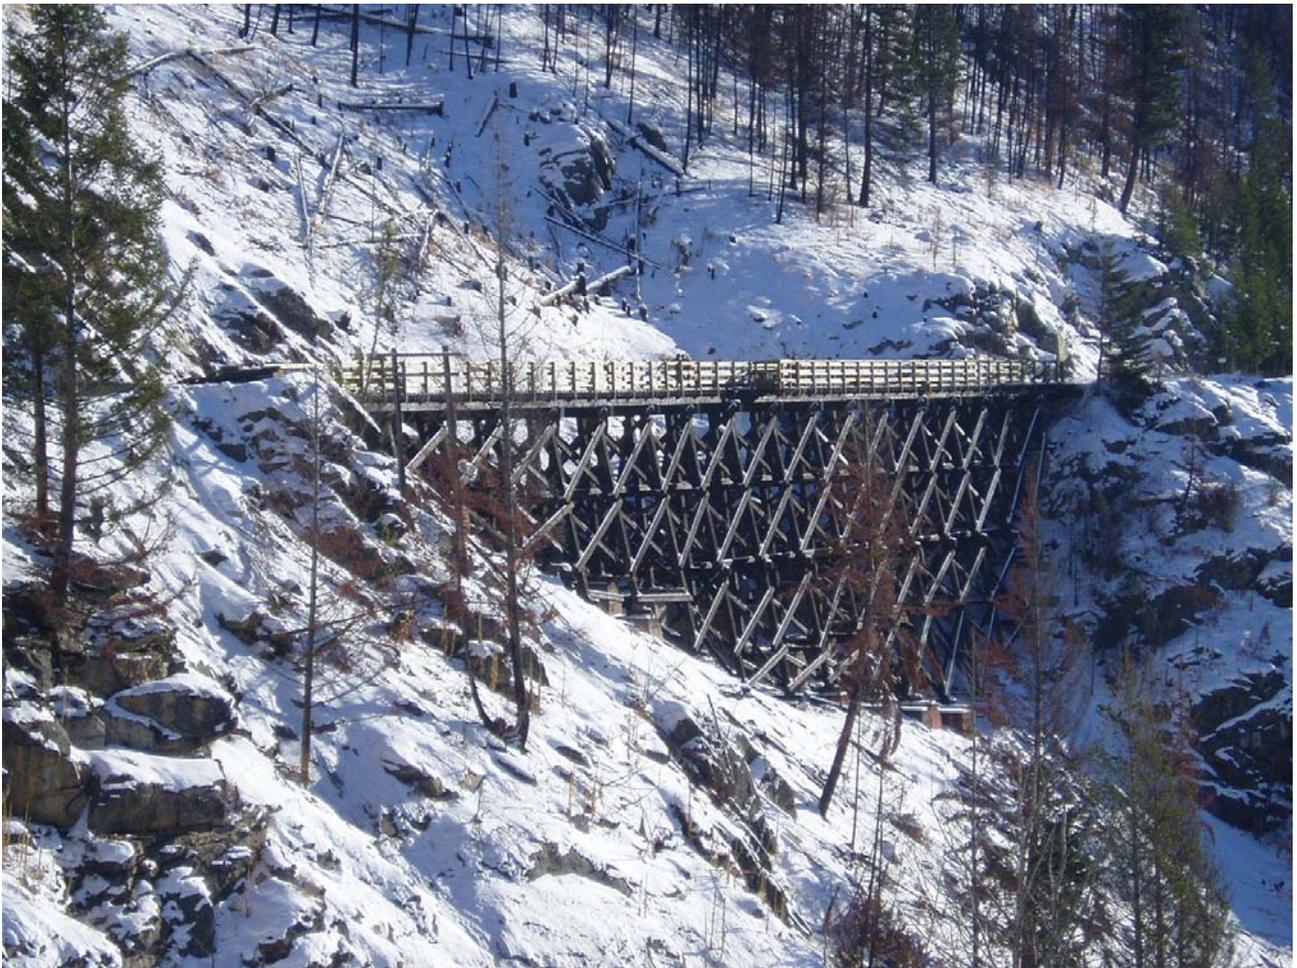
Figure 29. Reconstructed Trestle 13

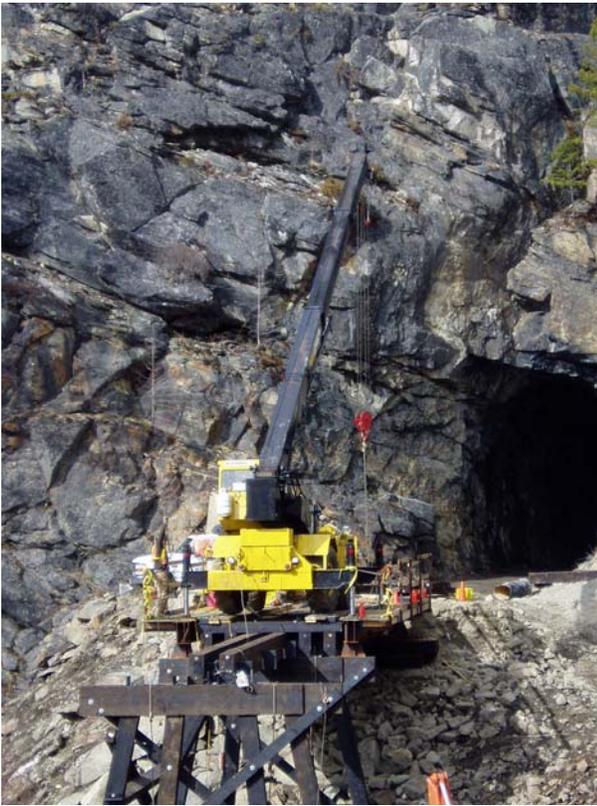
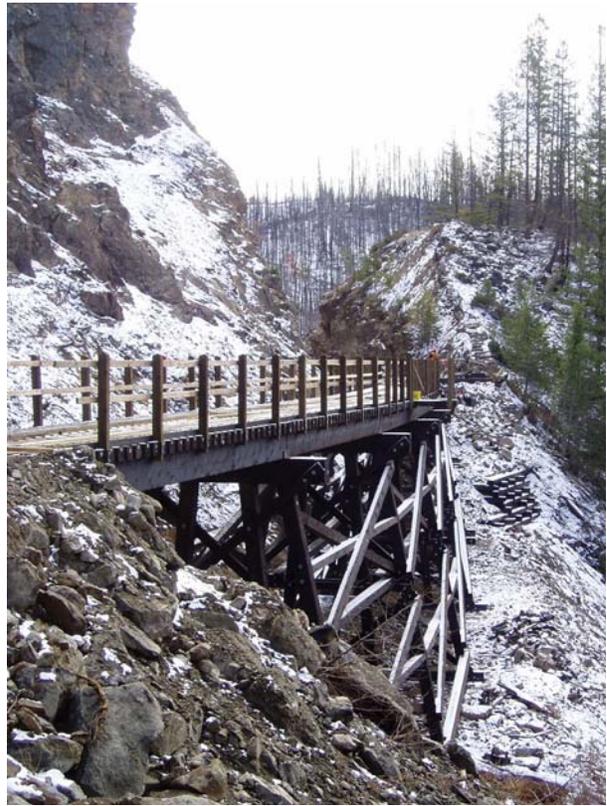
Figure 30, 31. Reconstructing Trestle 10

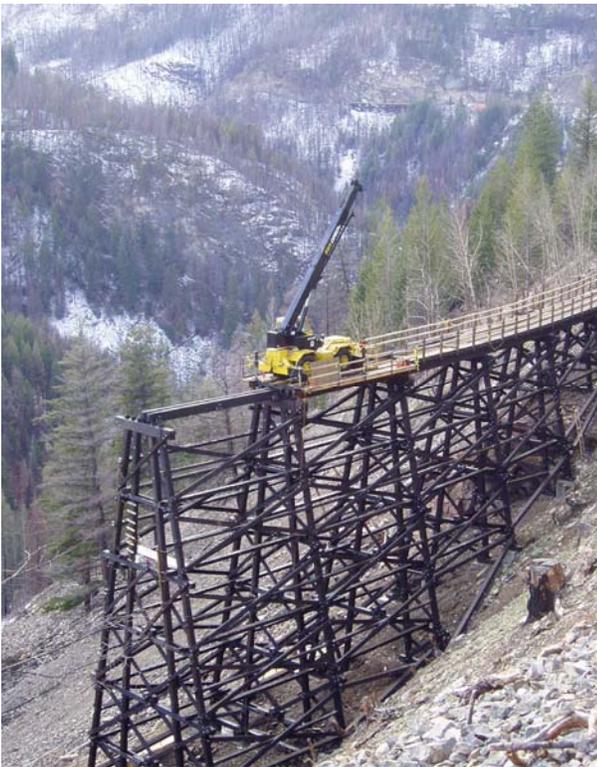
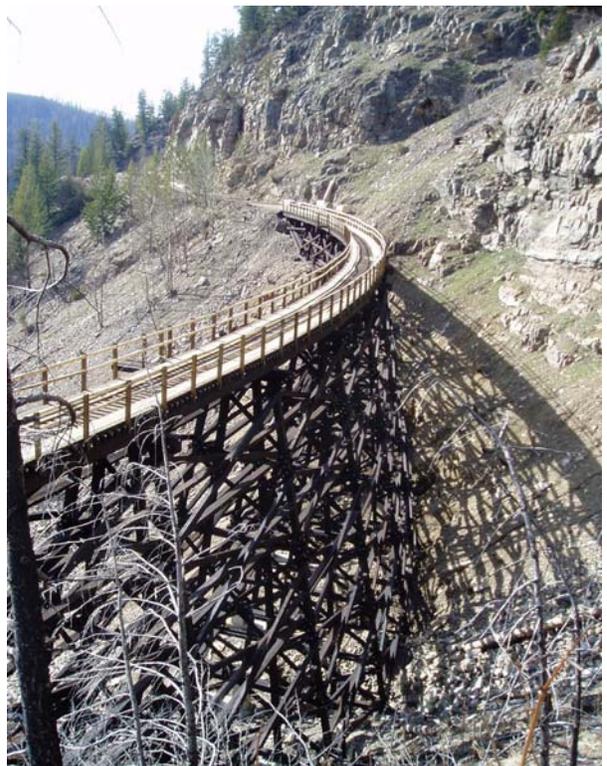
Figure 32, 33. Reconstructing Trestle 11

Trestle 11 faced a similar difficulty where the timber cribbing was decaying and damaged. The prospect of rebuilding the crib wall using hand tools was considered to be too difficult on the steep embankment and the fill was not considered stable enough to support the proposed bent. Again, micro piles were the solution best suited for this situation. The piles would take the load off of the fill, and the fill would provide stability to the piles.
