Sustainable Rehabilitation of Carling Avenue using Rubblization

Submitted as a Candidate for the 2006 TAC Sustainable Urban Transportation Award

PART 1 – PROJECT DESCRIPTION

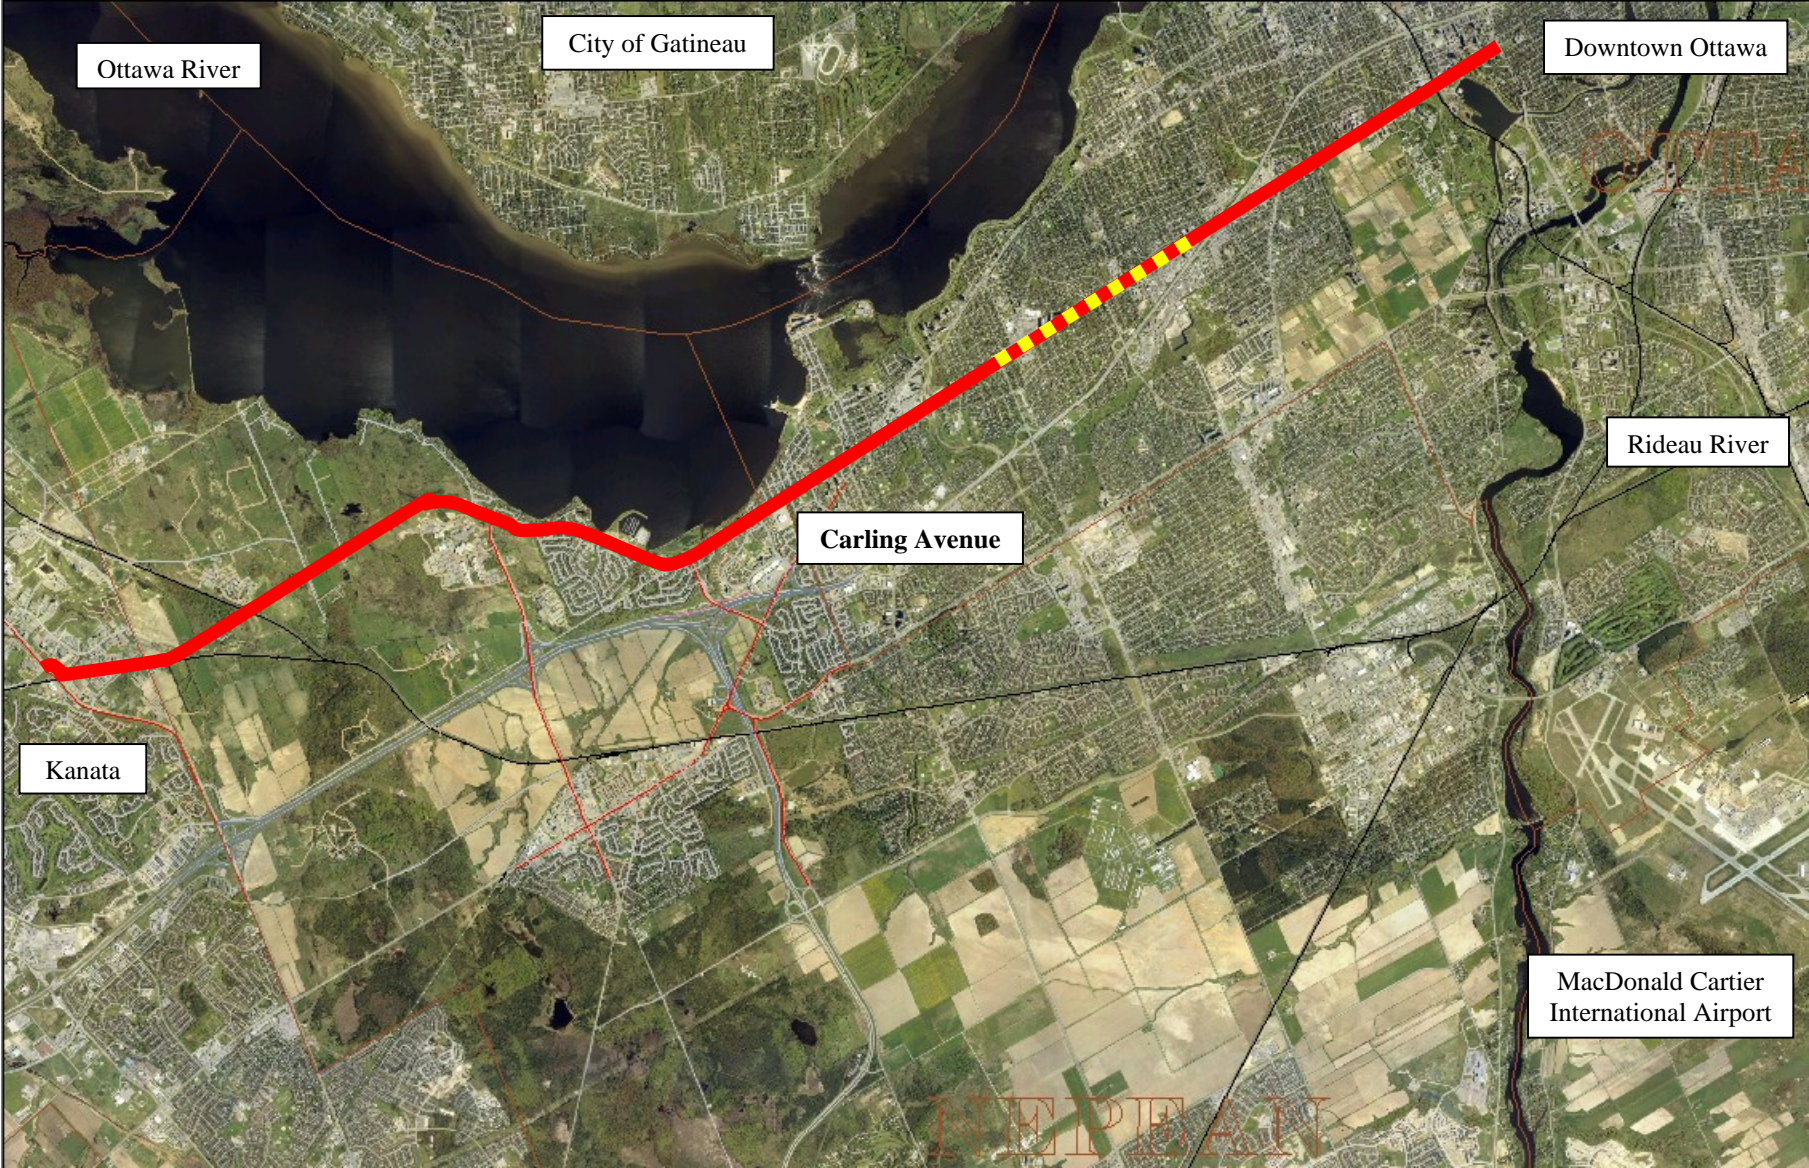
**Figure 1: Aerial View of Carling Avenue from Kanata to Downtown Ottawa
(Project Limits shown as dashed line)**

As illustrated in Figure 1, Carling Avenue (Ottawa Road #38) is a 19 kilometre east-west corridor connecting the former City of Kanata (at March Road) with the downtown core (at Bronson Avenue). With the exception of a small section of its western length, Carling Avenue is 4 to 6 lanes wide with concrete curb and sidewalk.

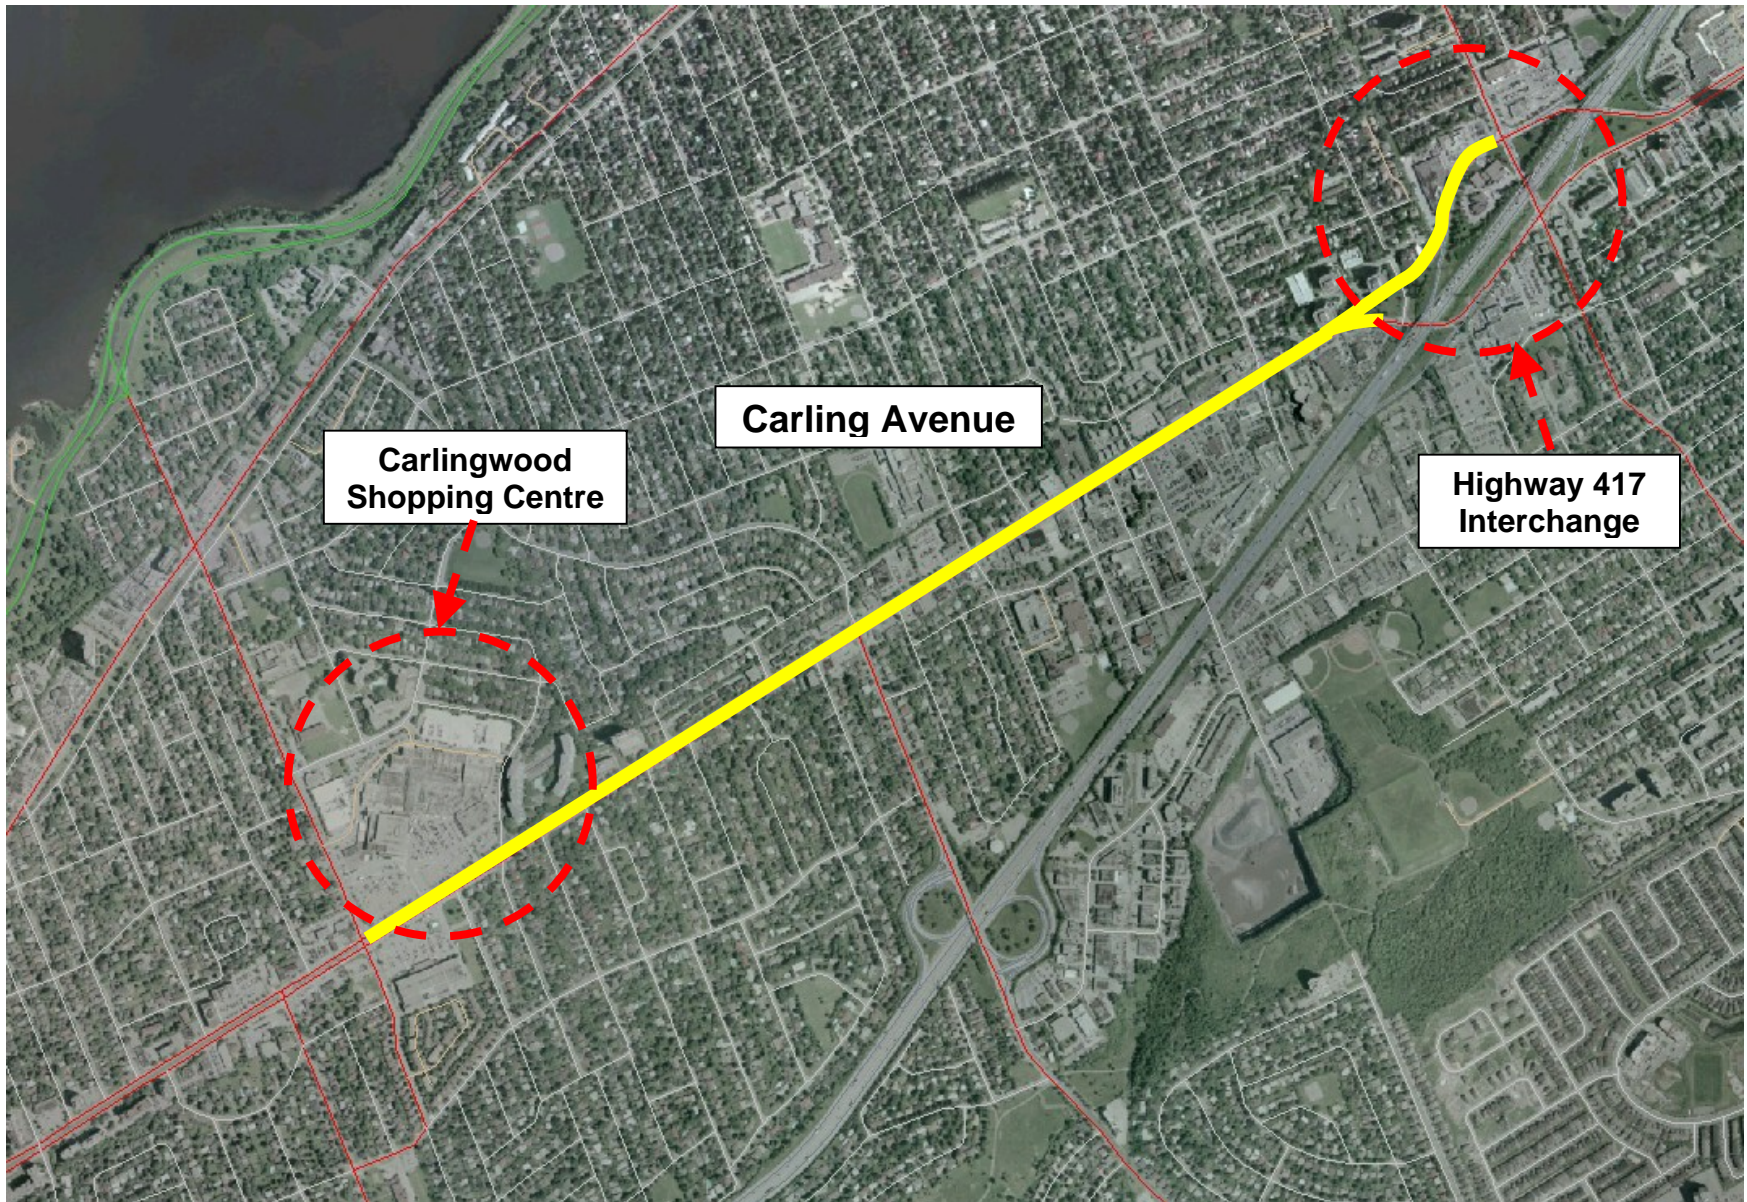
Figure 3: Aerial View of Carling Avenue Project Limits (Woodroffe Avenue to Kirkwood Avenue)

While \$3.9 million sounds like a lot of money to the average citizen, it is important to recall that at 6 lanes wide (21 m) and 3.2 km in length, the pavement surface to be rehabilitated was over 67,000 square metres – an area greater than 42 NHL hockey rinks or 11 Canadian football fields. As shown in Figure 3, the western limit of the project provides access to a major shopping centre, while the eastern limit of the project is an interchange from provincial Highway 417. As such, the high traffic density within the project limits required considerable traffic control measures, further reducing the funds available for the actual rehabilitation effort.

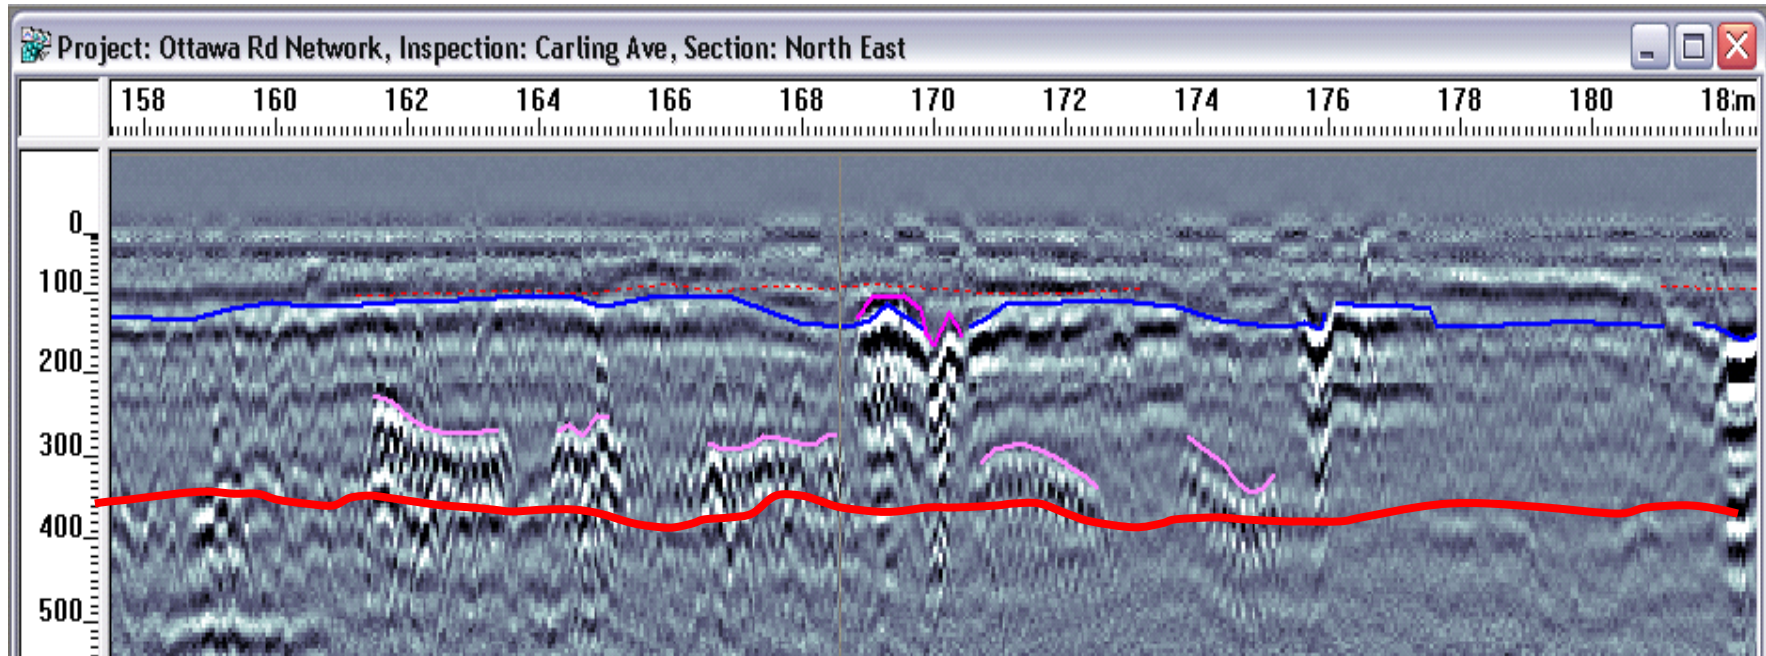
Figure 4: Example Ground Penetrating Radar (GPR) “Radargram” displaying Layer Thickness Data

Blue Line represents Bottom of Asphalt Layer/Top of Concrete Layer

Red Line represents Bottom of Concrete Layer

Purple Line shows areas where Reinforcing Steel were Located

The composition of the road – most importantly the thickness of the existing asphalt and concrete layers – were determined using Ground Penetrating Radar (GPR). GPR sends electromagnetic waves into the pavement and a portion of these waves reflect back when they strike the interface between two different materials (such as asphalt and concrete). Unlike coring, which only provides layer thickness values at a discrete point, GPR provides layer thickness information for the entire length of the project. GPR is also very effective for identifying the presence or absence of reinforcing steel in concrete, as well as locating utilities under the pavement. An example GPR “radargram” is shown in Figure 4. GPR is conducted at normal travelling speed and is very cost effective for the amount of data collected (only \$1500 for Carling Avenue).

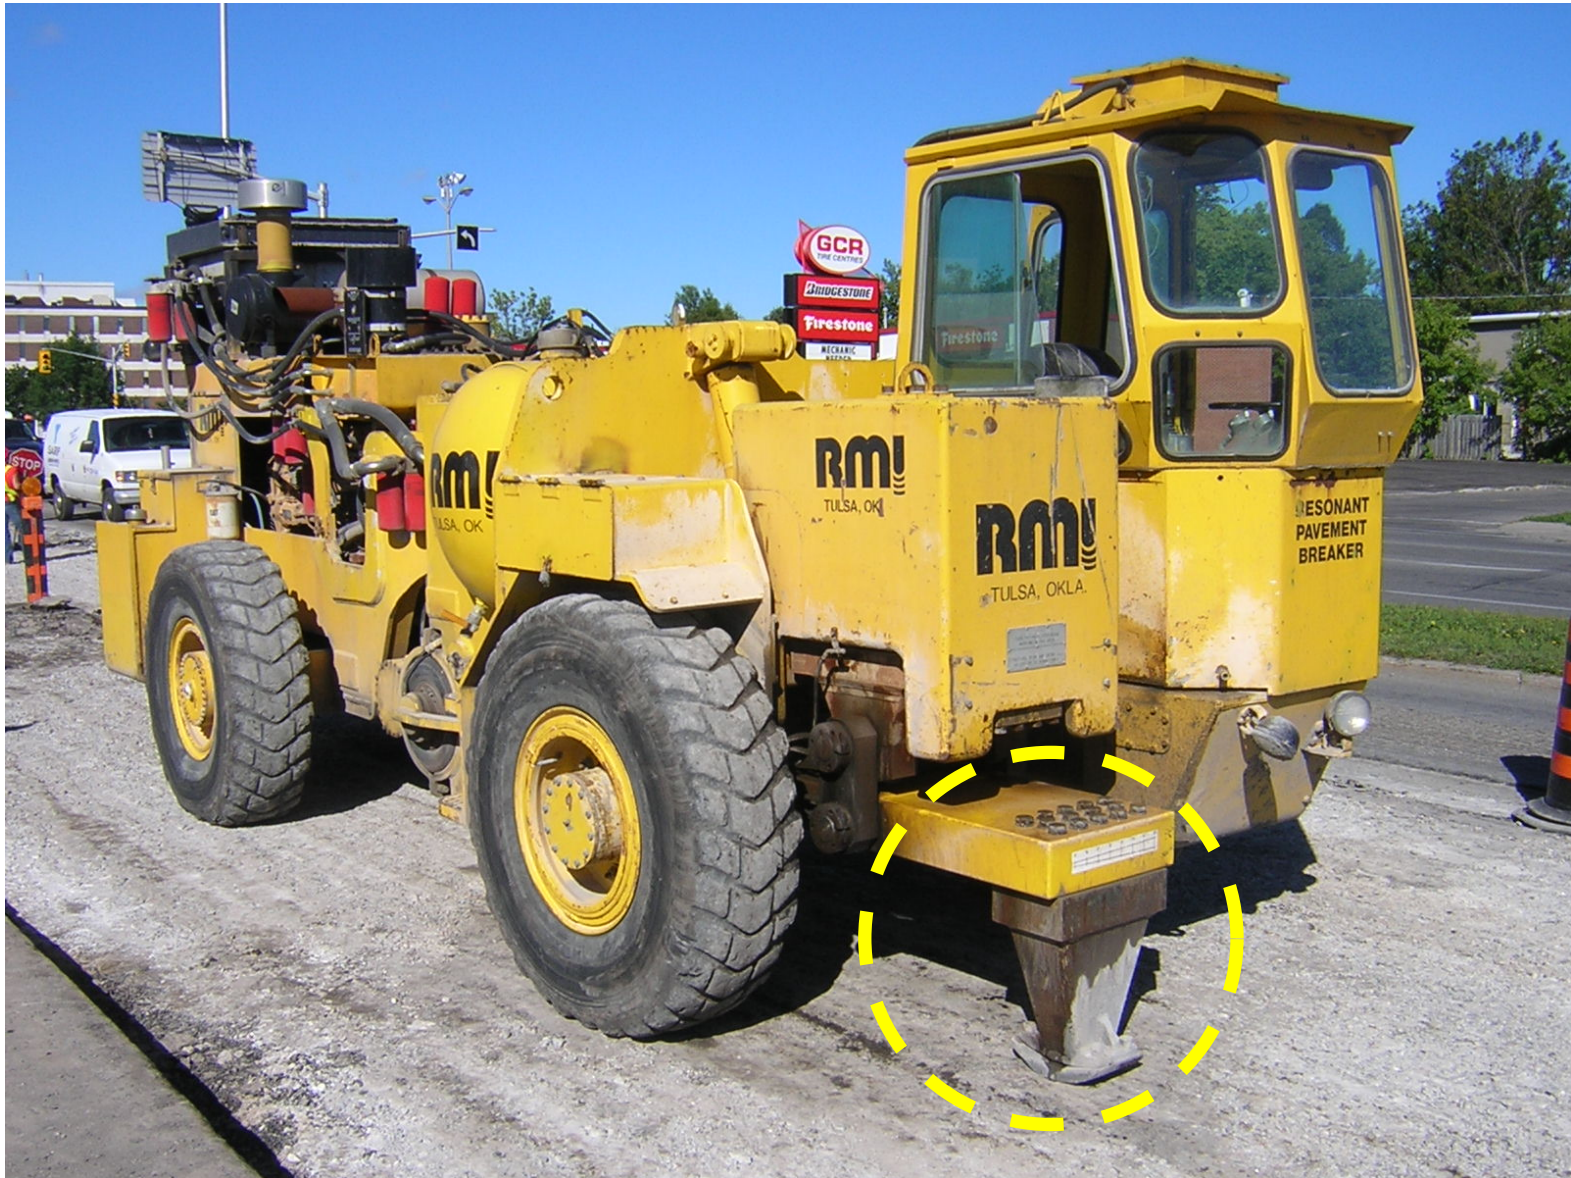
Figure 6: Rubblizer (Dashed Circle highlights single Resonant Breaker Head)

Whereas the DBR process prevents joint faulting by connecting the individual slabs together and preventing vertical movement, rubblization prevents faulting by completely removing the discreet joints and cracks. Rubblization may be accomplished with a resonant breaker (Figure 6) that vibrates the concrete at high frequency (approximately 44 Hz) and low amplitude until it shatters into small pieces (Figures 7 and 8). Other methods are available, but the use of resonant breakers prevents damage to the underlying utilities – a critical concern on Carling Avenue given the presence of watermain, sewer, cable, fibre optic communication lines, electrical and gas utilities. The existing asphalt layer must be removed prior to rubblization to prevent excessive damping of the vibration energy.

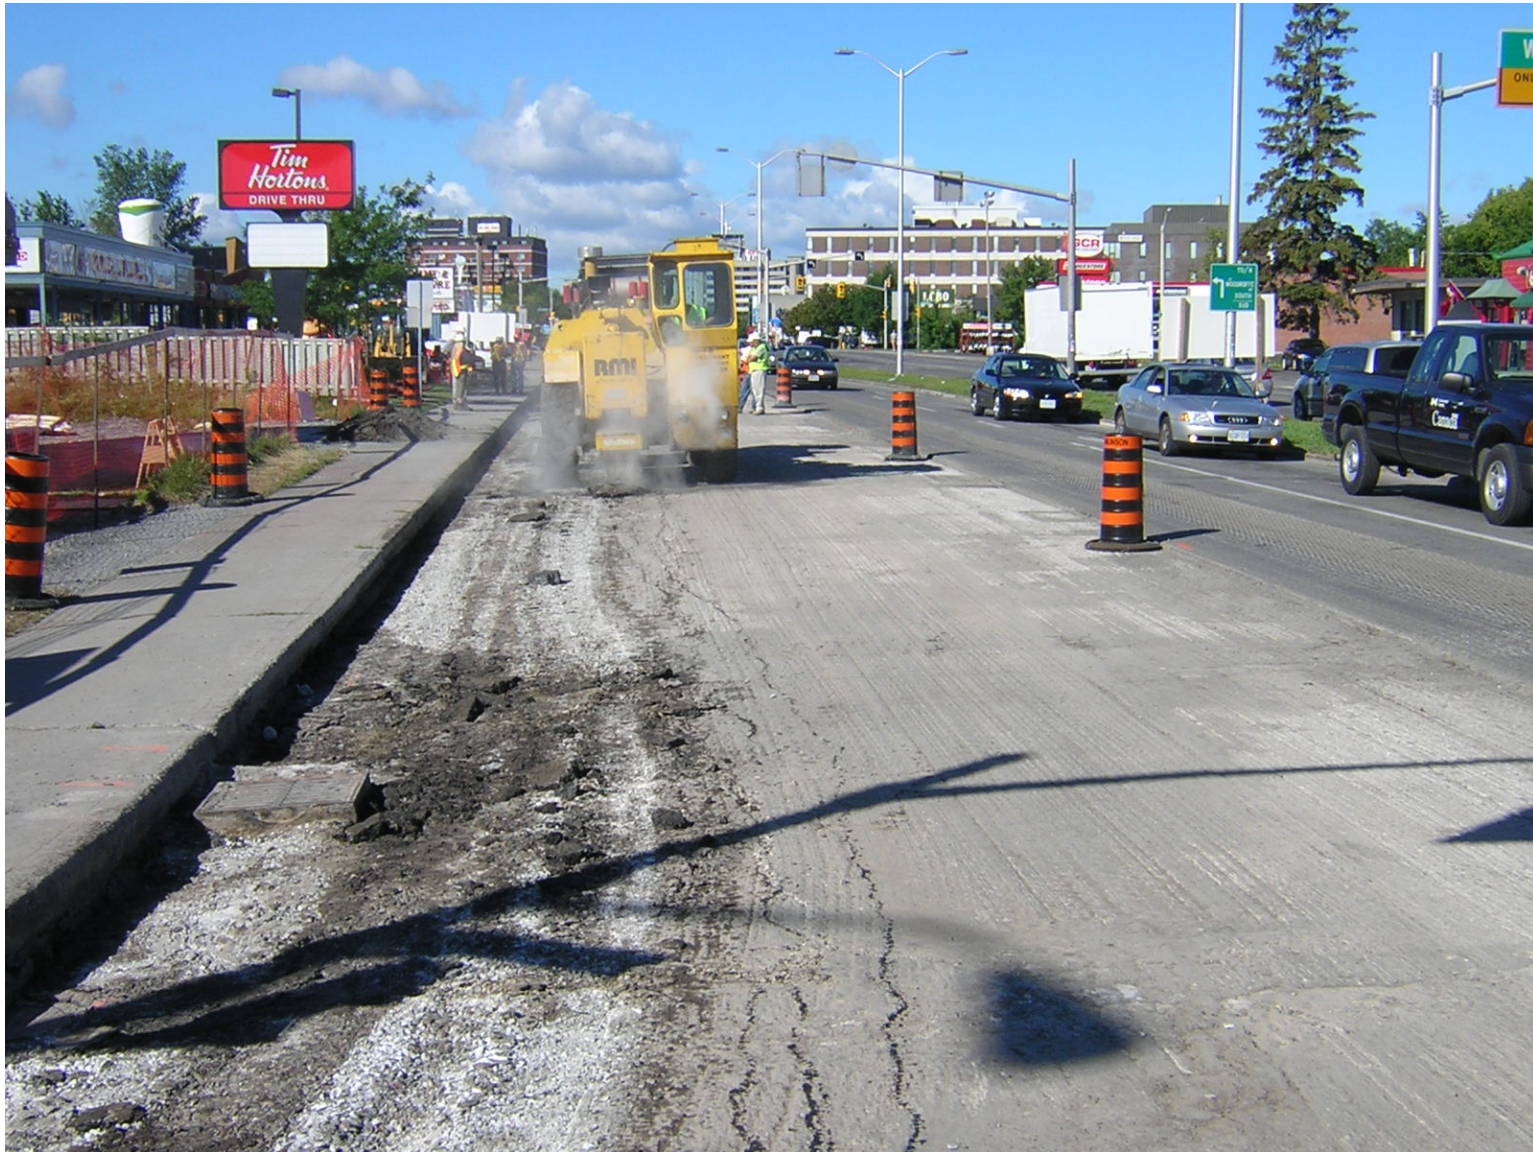
Figure 7: Rubblizer in Action on Carling Avenue

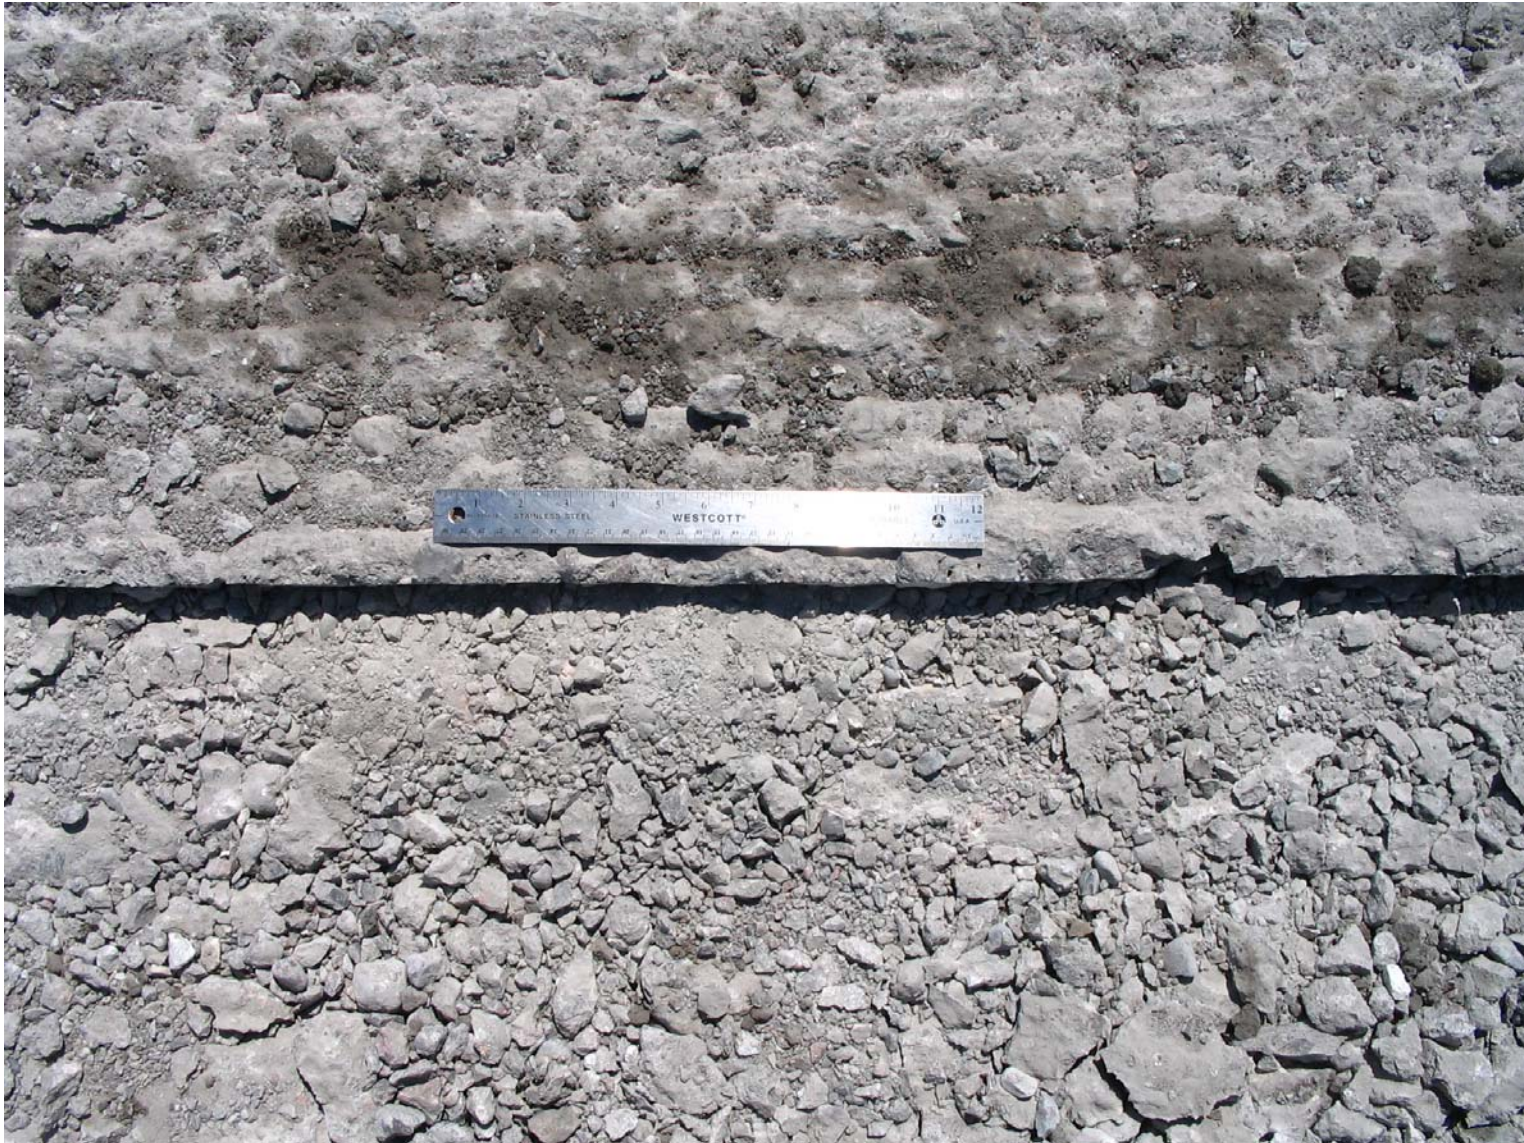
Figure 8: Comparison of Intact and Rubblized Concrete Surface (Plan View)

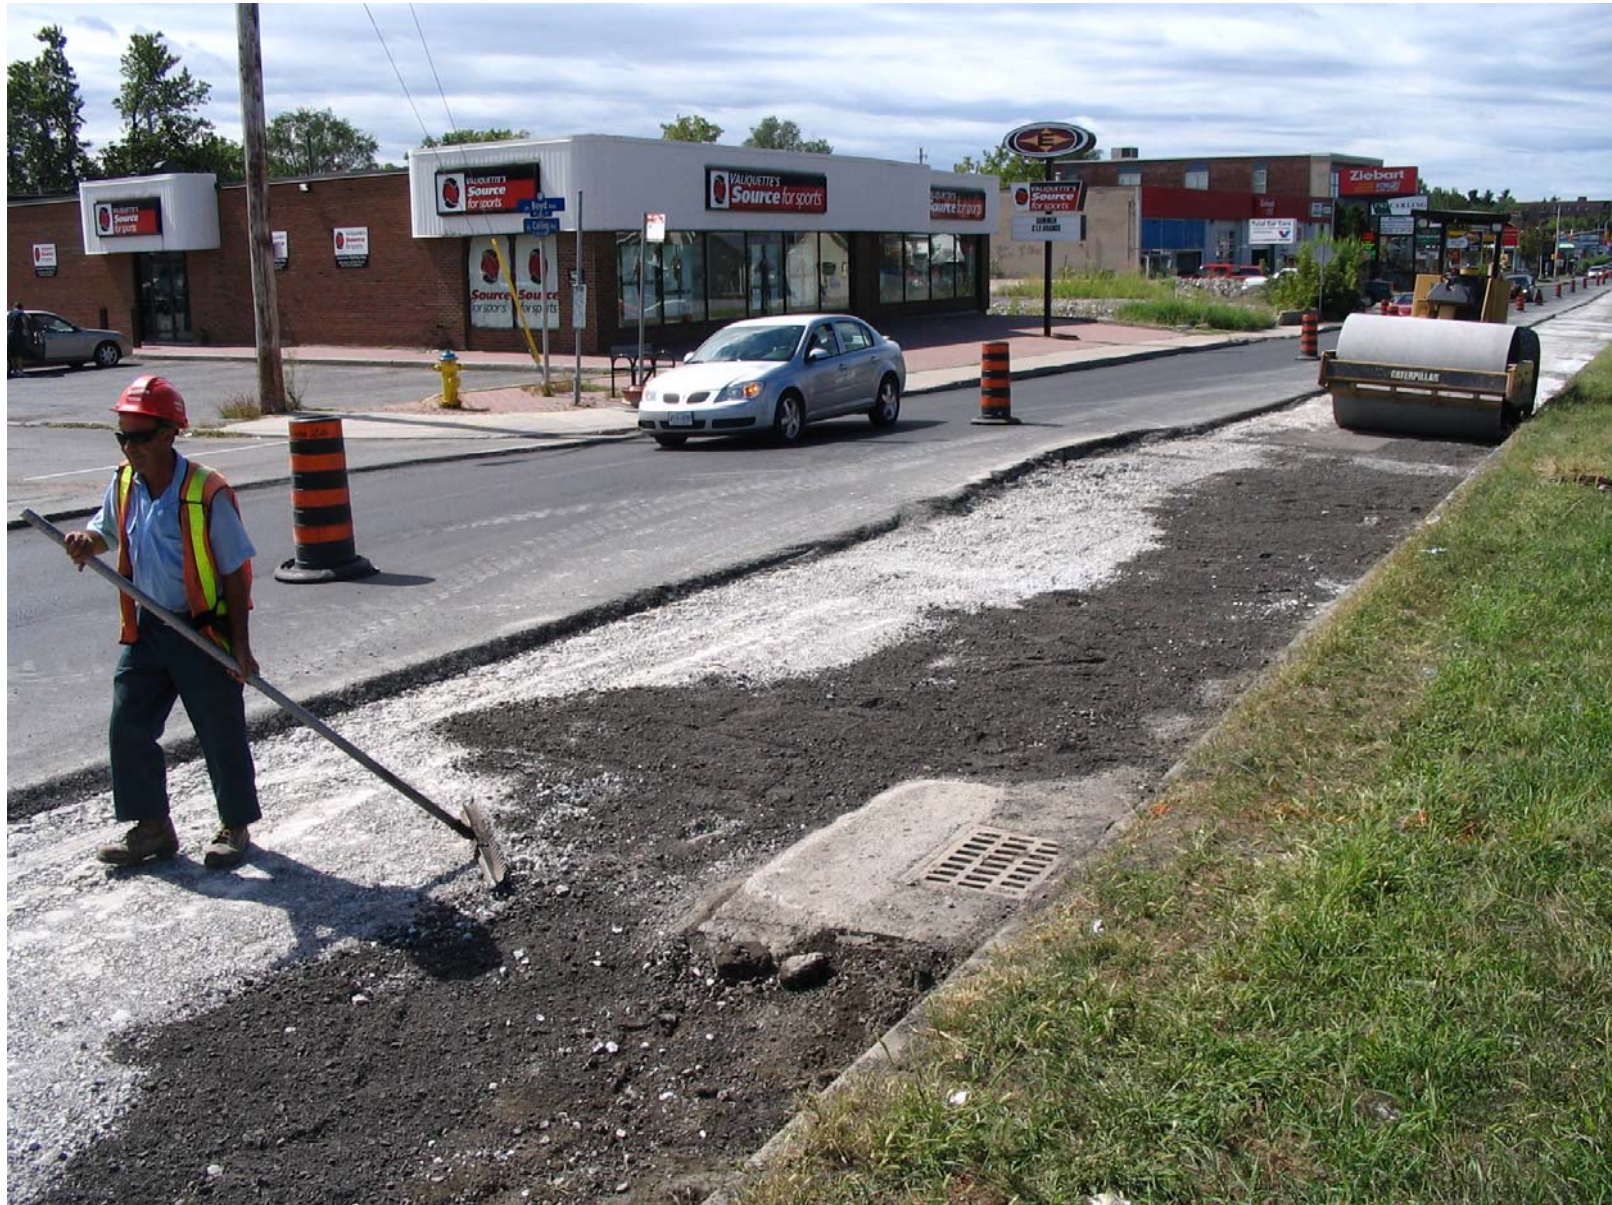
Figure 10: Levelling the Grade and Profile with Granular A and Compacting the Rubblized Surface

Once rubblized, a small amount of granular material may be added to correct the profile and grade and then the particles are locked into place using heavy rollers (Figure 10). New asphalt is then placed and compacted on the rubblized surface.

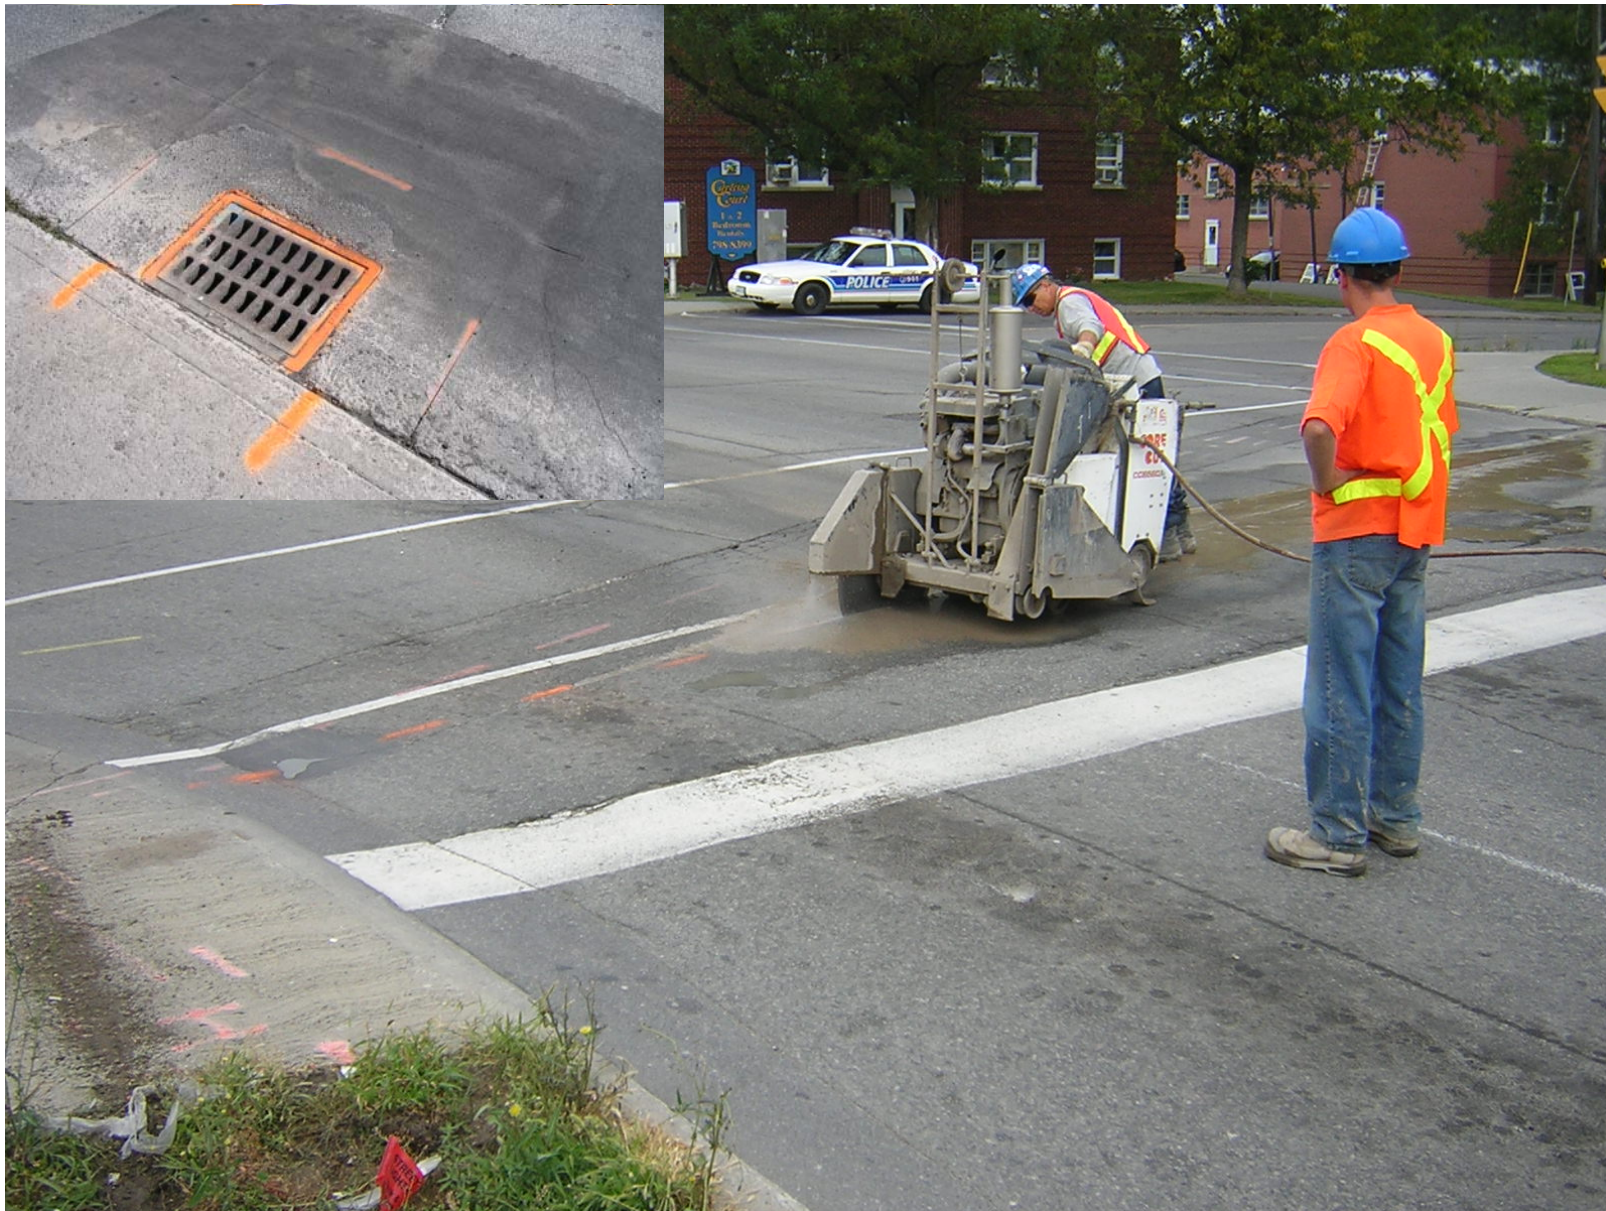
Figure 11: Saw Cutting to Separate Curbs, Intersections, Catchbasins and Manholes

Rubblization requires some specialized geotechnical testing to identify areas of saturated soils that may liquefy under vibratory energy. In the case of Carling Avenue, no such issues were identified. Furthermore, infrastructure such as curbs must be detached from the concrete pavement by sawing to prevent damage during the rubblization process (Figure 11).

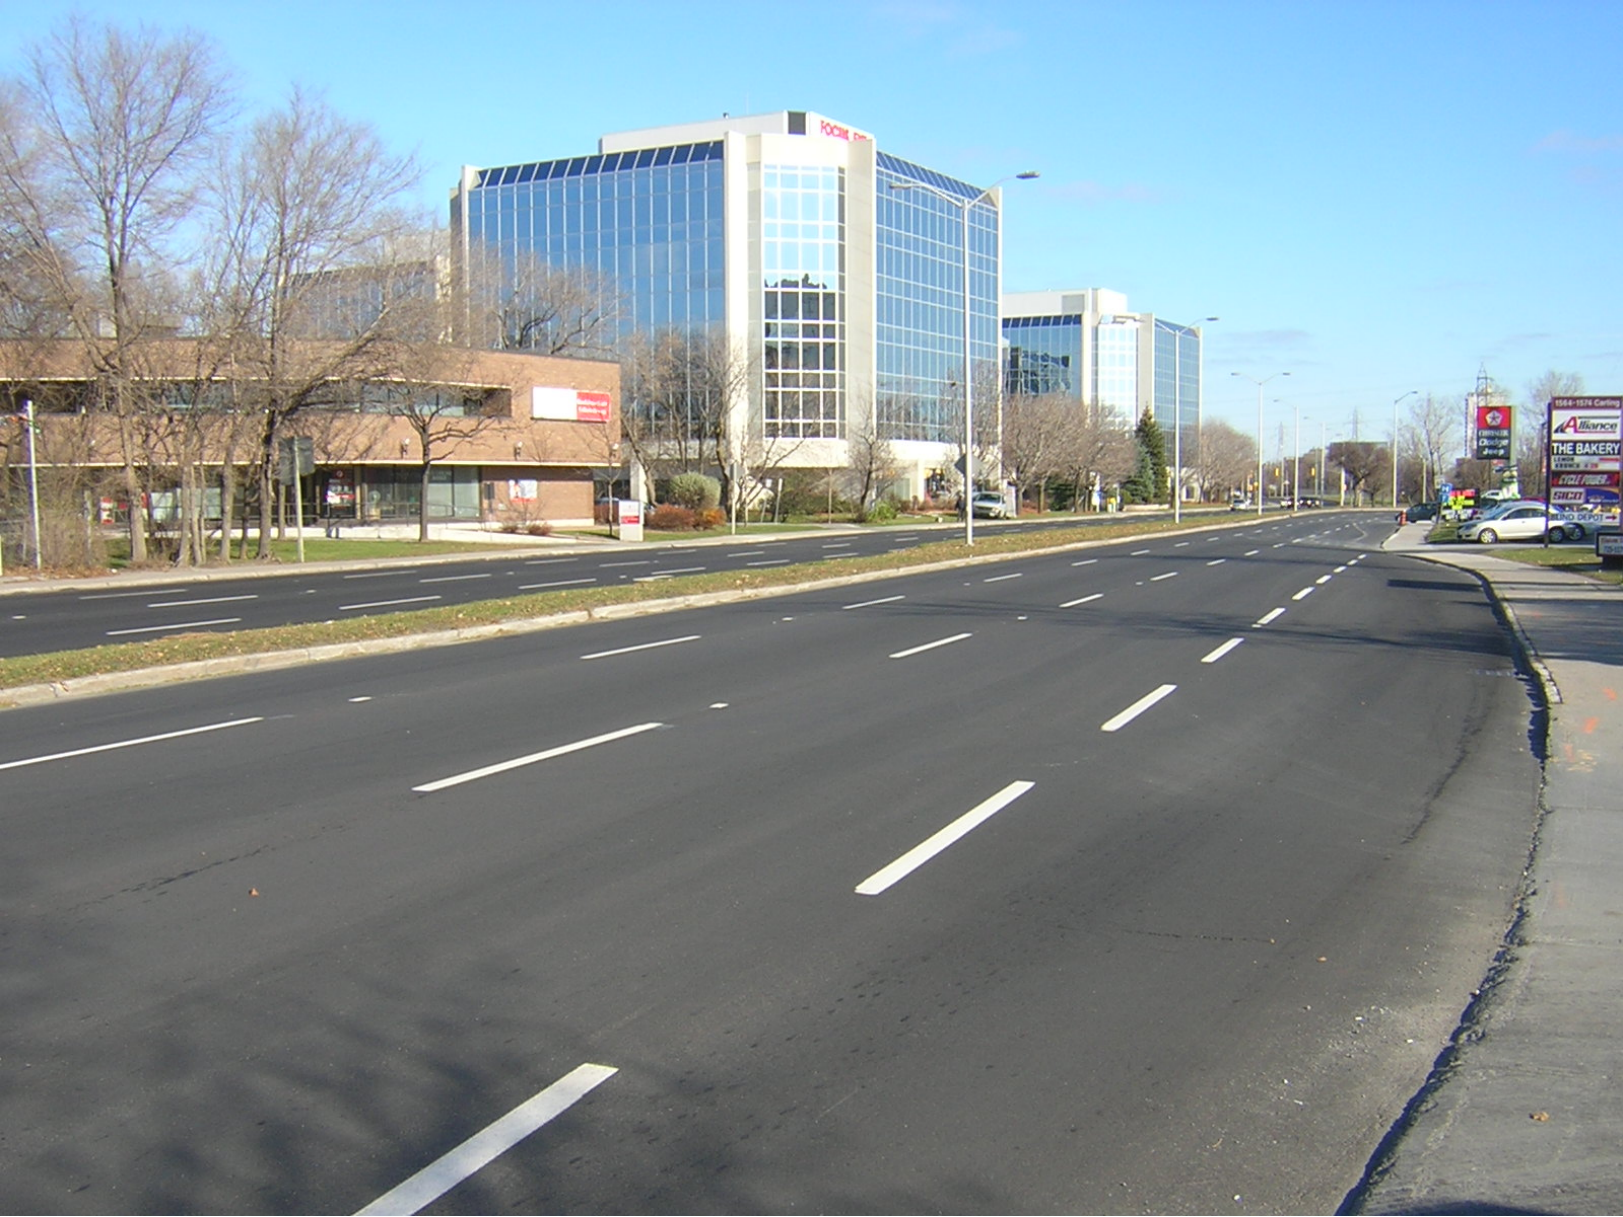
Figure 12: Completed Project - Carling Avenue with Superpave Asphalt on Rubblized Concrete Layer

Superpave was selected for the base and surface hot mix asphalt. The City has used Superpave since 2002 and assisted the Municipal Engineers Association (MEA) and MTO develop the latest specifications for Ontario. A picture of the completed project is provided as Figure 12. A video camera survey of the sewers after project completion confirmed that no damage was imposed by the rubblization effort.
