**FISH HABITAT COMPENSATION
ON THE TRANS CANADA HIGHWAY PROJECT
IN NEW BRUNSWICK**

**Duane Clowater, P. Eng
Trans Canada Highway Project Company**

**Mike Phillips, P. Eng.
New Brunswick Department of Transportation**

**Paper prepared for presentation at the
“Fish Habitat Compensation – A Requirement for Some Transportation Projects” Session
of the 2008 Annual Conference of the Transportation Association of Canada
Toronto, Ontario**

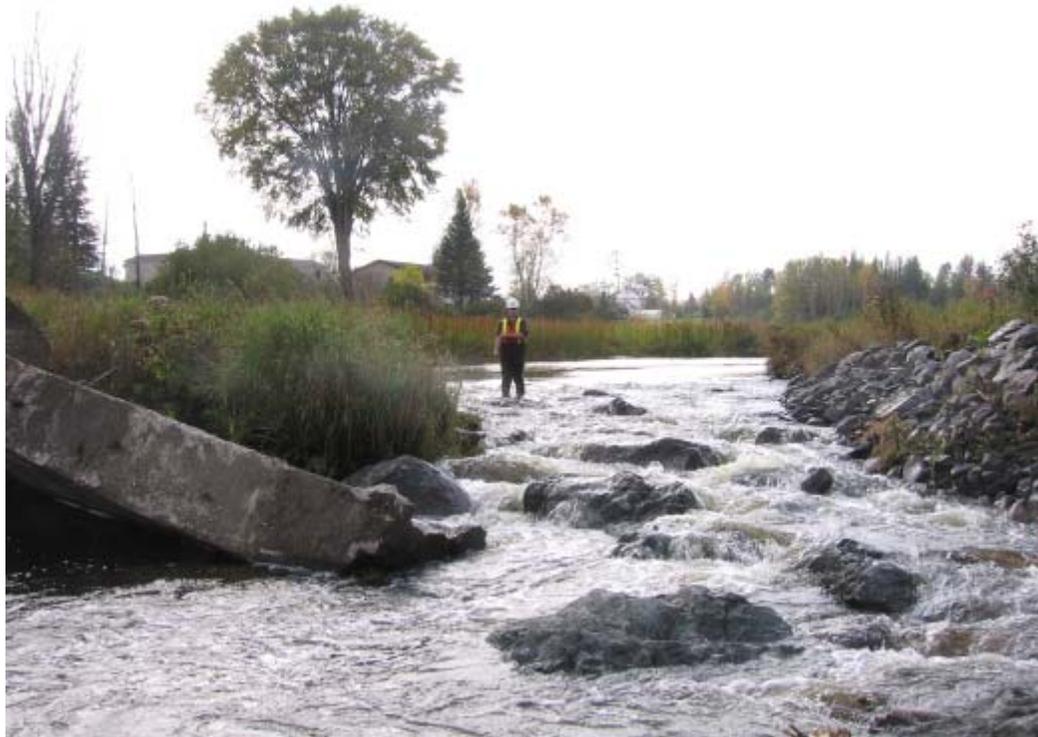
After Compensation Work Completed

Little Presque Isle - Fish passage restoration work was conducted at the derelict former sawmill dam, located on the Little Presque Isle Stream at Waterville, which had collapsed since operations of the sawmill were terminated in the mid 1960's. The concrete remaining from the former structure had trapped woody debris, and resulted in a partial to complete impediment to fish passage at this location. Concrete debris was removed from

the stream channel and placed on the bank for stabilization during high water flows, and a turbine was removed and placed off site. The low flow channel was excavated and boulders were placed to break-up the current and create eddies. Rip rap excavated from the channel was placed in the portions of the channel that were not being excavated. Refer to Figure 4.3a for photos of this project site before and after compensation work was completed.

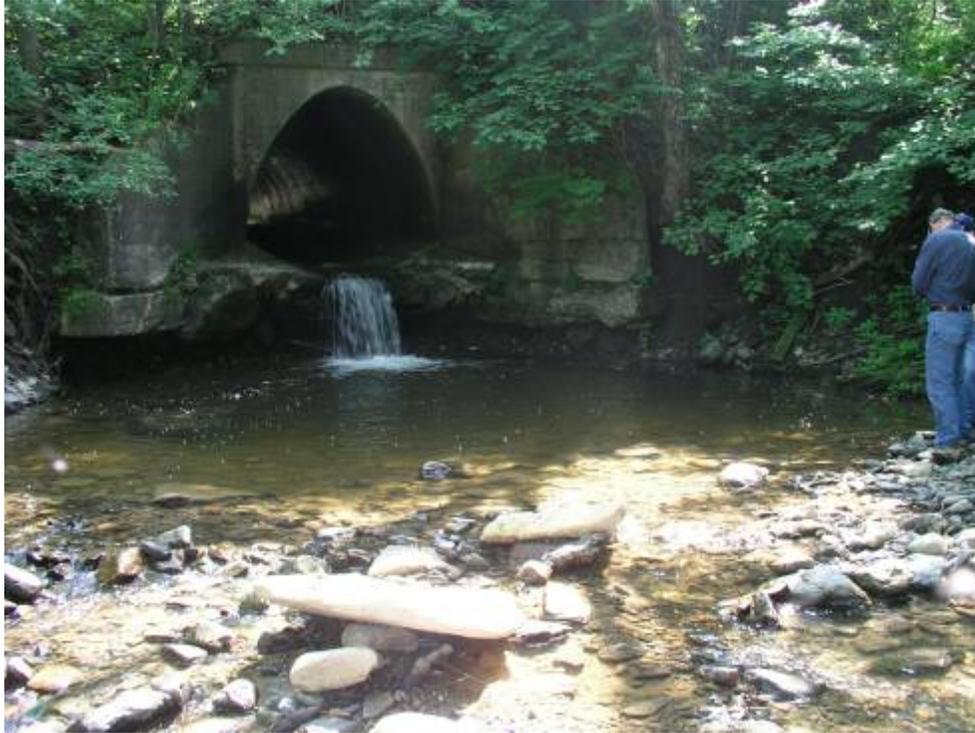
**Figure 4.3b
Hales Brook Compensation Site**

Prior to Rehabilitation Work by DOT

Hales – This site was located on Route 105 near Upper Brighton in Carleton County. The existing concrete arch was installed in 1909 and had a hanging outlet that prevented fish passage. A fish ladder and fish baffles were added to the existing culvert to restore passage. Refer to Figure 4.3b for photos of this project site before and after compensation work was completed.

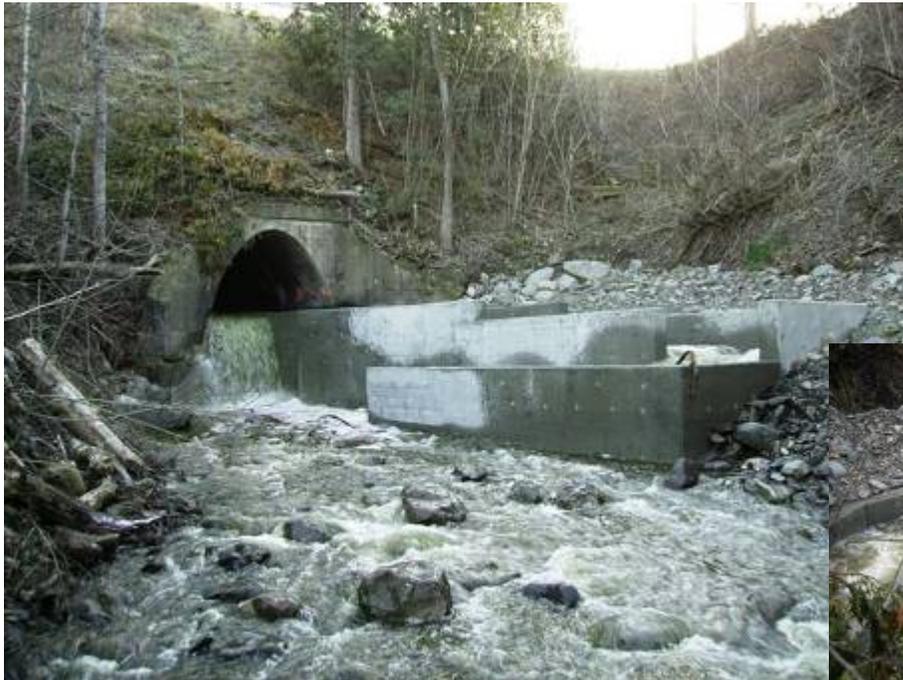
After Compensation Work Completed

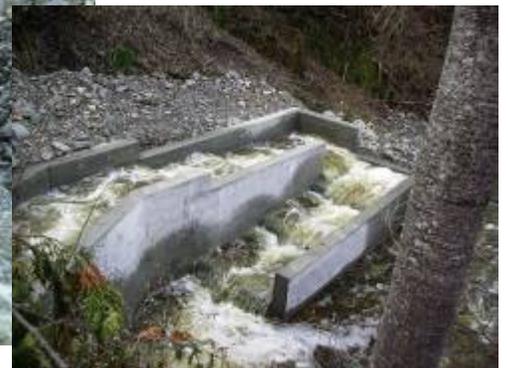
Figure 6.0
Example of Effects of New Construction on Fish Habitat
(River-de-Chute Bridge)

Natural stream condition with significant vegetative cover prior to construction

Stream condition after construction – natural vegetation along stream channel and slopes removed along with installation of a permanent stream diversion.

Figure 6.0 demonstrates an example of the effects of new bridge construction on an existing TCHP watercourse where most of the natural vegetative cover was removed within the project right-of-way. It will take several years to re-establish vegetation in these areas. This site also includes a permanent stream diversion that bypasses the original stream and the associated fish habitat therein.

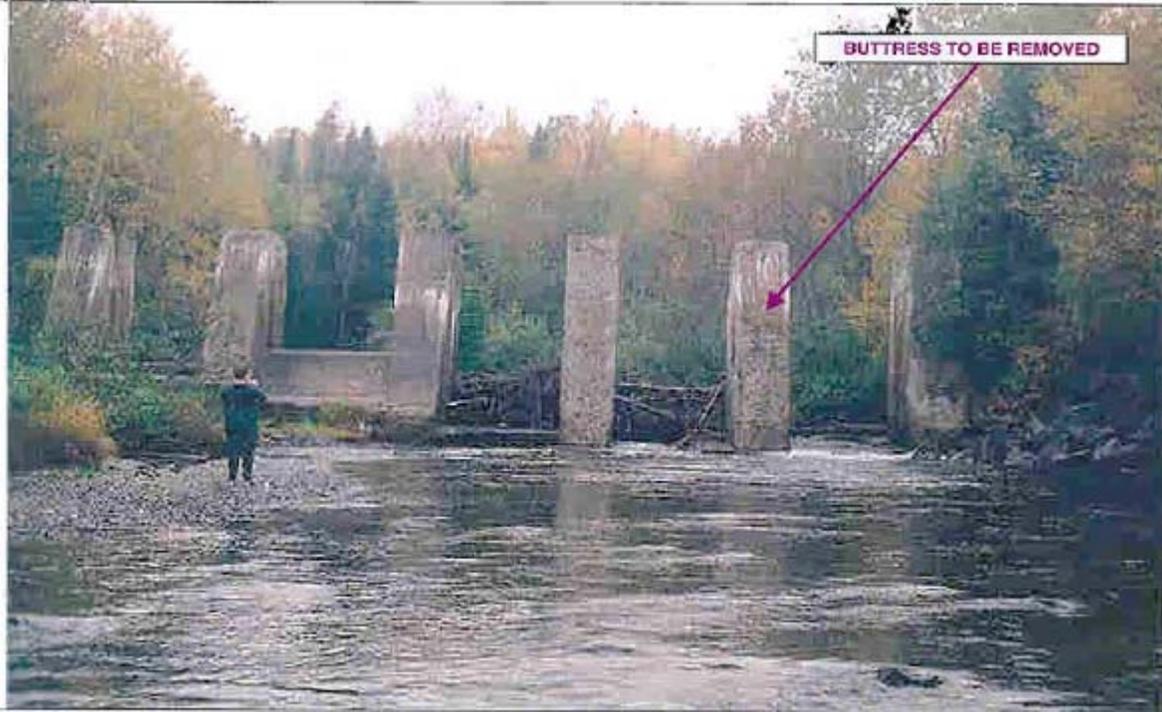
Figure 6.1
Quisibis River Compensation Site

Prior to Rehabilitation Work by Brun-Way

Site #6 Quisibis River – This site was located near Montagne-de-la-Croix in Madawaska County. The remains of the Quisibis River Dam were a partial obstruction to fish passage mainly during low flow conditions and also the remaining dam buttresses often accumulated logs and other debris which affected fish passage. Brun-Way removed the accumulation of debris and also removed one concrete buttress to provide improved fish passage. This project was by far Brun-Way largest compensation site (refer to Figure 6.1 for photos of the site prior to and after the rehabilitation work).

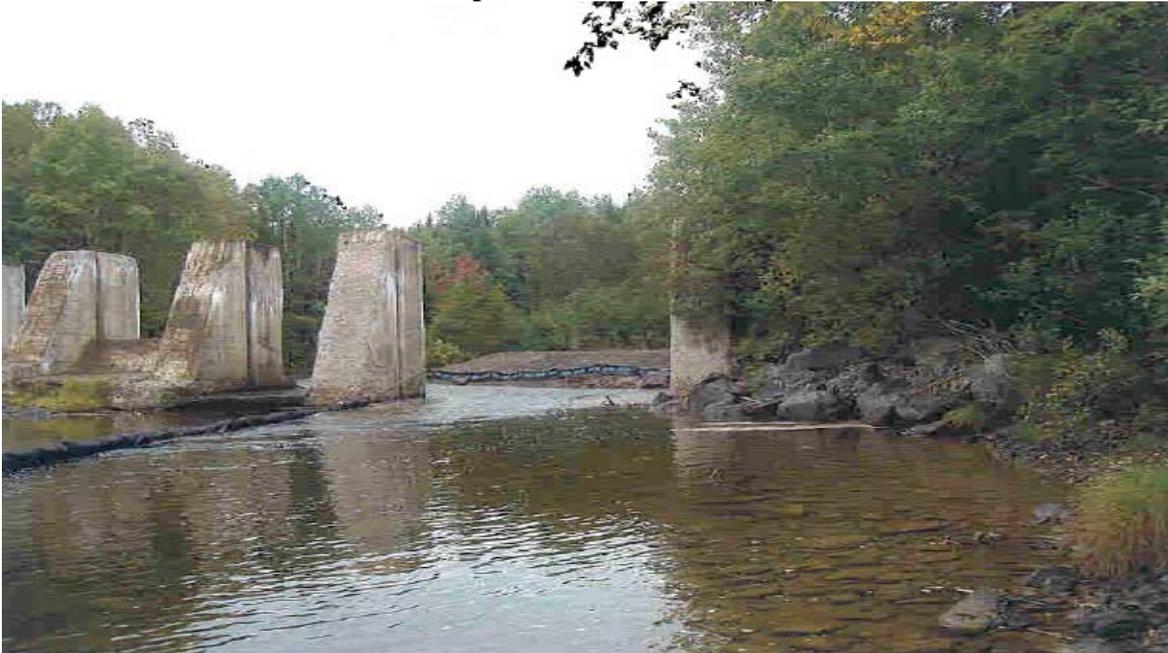
After Compensation Work Completed
