# Highway 2 Bridge over Peace River at Dunvegan, AB An Integrated Work Zone and Road Condition Solution

**Transportation Association of Canada**  
2008 Annual Conference  
September 21-24  
Toronto, ON

**Author:** Mark F. Pinet, P. Eng.  
Manager, Intelligent Transportation Systems  
Totten Sims Hubicki Associates (TSH)  
302-1150 Morrison Drive, Ottawa, ON K2H 8S9  
Tel: 613-820-8282, e-mail: [mpinet@tsh.ca](mailto:mpinet@tsh.ca)

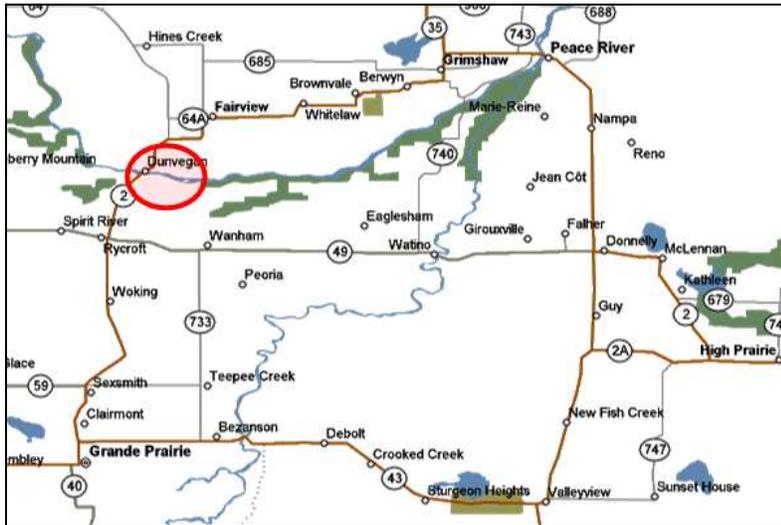
Figure 2 - Site Location

The Dunvegan Bridge is situated 500 km northwest of Edmonton, 90 km north of Grande Prairie, and approximately 120 km southwest of Peace River on Highway 2 as shown in **Figure 2**. The land adjacent to the crossing is undeveloped with the exception of the Dunvegan Provincial Park and Historic Site which sits on the north bank of the Peace River straddling the highway.

The bridge crossing is located in a deep portion of the river valley where the difference in elevation from the water surface to the top of the adjacent plateaus is approximately 600 metres. Highway 2 traverses the valley walls over a distance of approximately 4000 metres resulting in steep average gradients of 7-8%. The topography around the bridge creates a microclimate resulting in local weather events, more concentrated and directional wind patterns, and higher humidity levels than the adjacent plateaus.

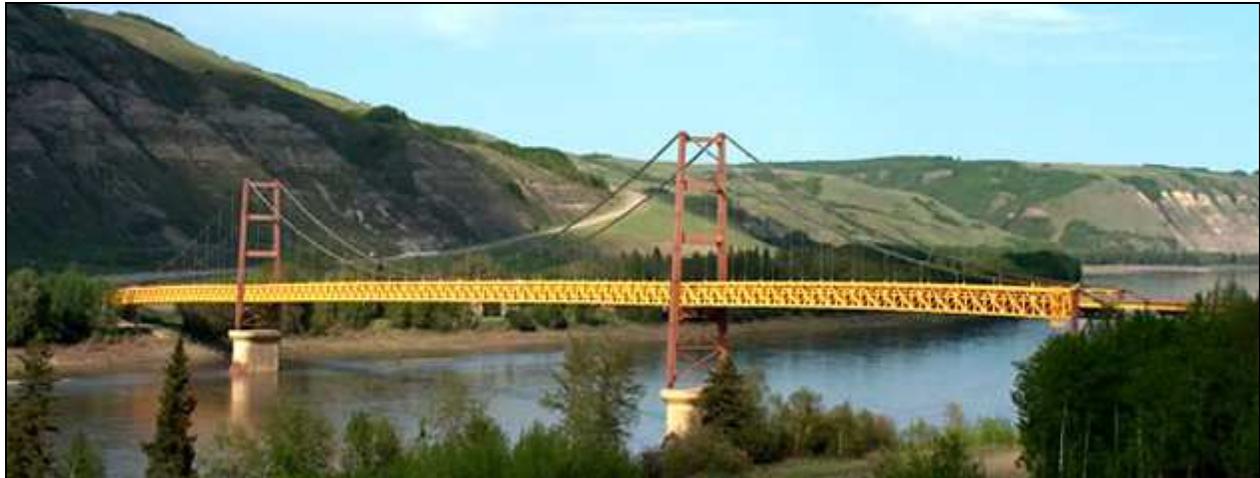
Figure 3 - Dunvegan Bridge Looking Northeast from the South Bank

The structure was originally built in 1960 to replace a ferry crossing. The deck was upgraded in 1978. Under the current contract with AE, the deck replacement design was to be completed in 2007 with construction undertaken in 2008 and 2009. The life of the replaced deck is projected to be in excess of 50 years.
