Using SUE to reduce Delays and Disruptions on City of Toronto's Yonge Street Project

Paper prepared for presentation at the
Innovative Construction/Maintenance Practices and Techniques to
Minimize Costs and Traffic Disruptions Session of the 2008 Annual
Conference of the Transportation Association of Canada
Toronto, Ontario

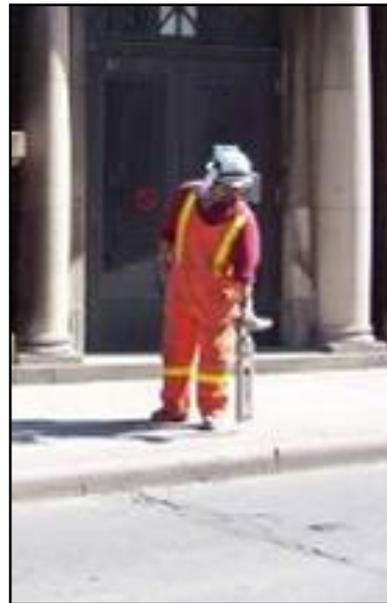
Figure 3 - Field Technician using Cable Locate Equipment

For the Yonge Street project, due to the congestion of utilities within the investigation area, a number of different instruments and techniques were used. The equipment used was a Metrotech 810 (single frequency) and a Subsite 950 (multi-frequency). The measurements from the instruments were used to determine where to place paint on the ground. The paint was then surveyed and used to create the drawing.

Single and multi-frequency electromagnetic cable locate equipment is used extensively for mapping underground utilities. The basic principle behind the use of this equipment is that when current is passed through a conductor it will create an electromagnetic field that can then be detected and measured. With cable locate equipment there are two components: a transmitter and a receiver. The transmitter emits a signal onto the conductor via either directly connecting to the conductor or by inducing signal onto the conductor. The receiver is then used to measure the magnetic field created and determine the horizontal location of the utility that is creating the field.

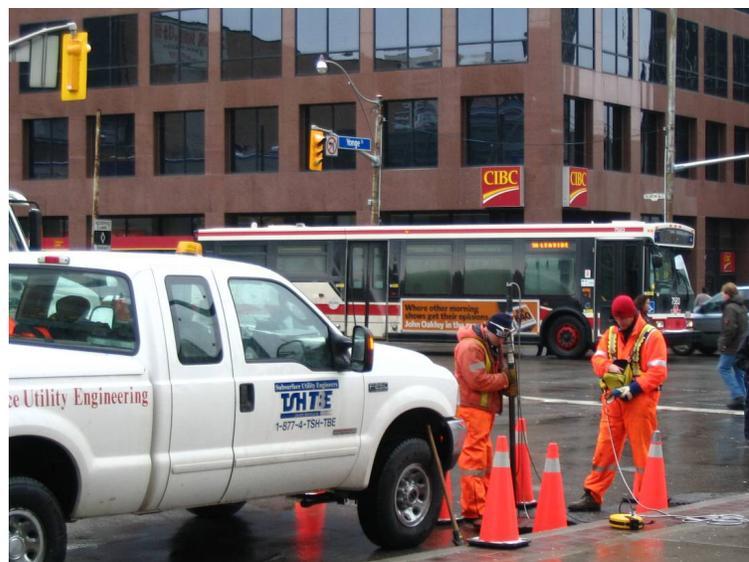
Figure 4 - Field Technicians operating Zoom Camera

The zoom camera was mounted to a rod that could be lowered and positioned in order to take photos of manholes and pipes. The camera is capable of taking video and still shots. The camera has a powerful zoom lens (216:1 for the camera used in this investigation), allowing it to take photos up the sewer lines, while physically remaining in the manhole. It uses High Intensity Discharge Lamps to provide a bright narrow beam of illumination, allowing it to focus effectively on objects several hundred feet away.

When operating the camera, one technician was responsible for holding and manipulating the camera on the pole while the second technician was responsible for viewing the image from the camera and taking still photos or video footage as required.

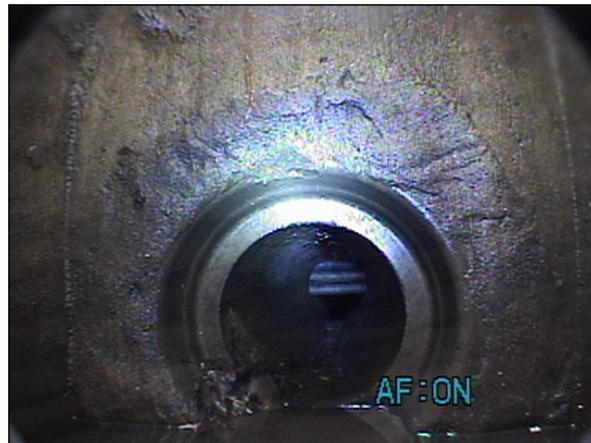
Figure 6 - Zoom Camera photo showing conduits directionally drilled through Storm Sewer

For the Yonge Street investigation the use of zoom cameras provided the City with an opportunity to collect data more safely and more quickly than traditional techniques. This minimized impacts to traffic during the investigation. It also provided additional data that may not have been identified. One such example is the location where the camera identified conduits that had been directionally drilled through a sewer. Identifying this upfront allowed the City the opportunity to rectify the issue prior to construction, so that there would be no delays to their contractor.
