Design and Construction of a Pervious Concrete Pavement

Chris Raymond, Ontario Ministry of Transportation Becca Lane, Ontario Ministry of Transportation Maria Bianchin, Ontario Ministry of Transportation Stephen Senior, Ontario Ministry of Transportation Melissa Titherington, Ontario Ministry of Transportation

of the 2008 Annual Conference of the Transportation Association of Canada Toronto, Ontario

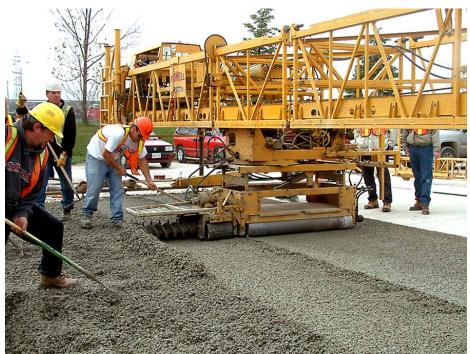
Figure 2. Finishing Equipment

The trial slab was constructed on October 10, 2007 at the concrete supplier's Ready Mix Concrete Plant located in Burlington, Ontario. The contractor opted to use a Bid-Well bridge deck finishing machine as shown in Figure 2, instead of equipment typically used for placement of pervious concrete pavement. The finishing machine was a self-propelled unit with a power screw auger, a vibratory roller, and a rotating cylinder screed. The equipment did not meet the requirements of the contract, which specified that the equipment used for placing, consolidating and finishing the pervious concrete pavement be a vibratory steel screed or steel cylinder screed with integral internal vibration including automatic shut-off, operating on fixed forms. Another requirement was that following strike-off, the concrete be roller-compacted to the form level using a steel pipe roller spanning the width of the section placed, exerting a vertical pressure of 65 kPa to 205 kPa on the concrete, or alternatively, a hydraulically actuated rotating tube screed. Instead, the contractor proposed to place the pervious concrete slightly higher than the forms and compact it using a steel pipe roller to achieve compaction. However, this was not carried out during construction.

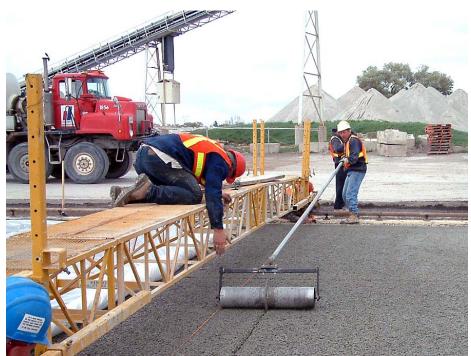
Figure 3. Transverse Joint Rolling (Trial Slab)

Longitudinal and transverse joints were constructed using a steel roller with a bevelled fin as shown in Figure 3. During the jointing process, it was observed that this equipment could not produce clean vertical cuts. Coarse aggregate was plucked up during the operation making it difficult to roll the equipment and to produce clean vertical lines. Also the contractor's decision to place the pervious concrete in 10 metre wide strips with a single longitudinal joint resulted in a wide slab, which created challenges for maneuvering the roller. Another observation from rolling the joints in the plastic concrete was that the process inhibited the timely placement of the plastic moisture barrier for curing.

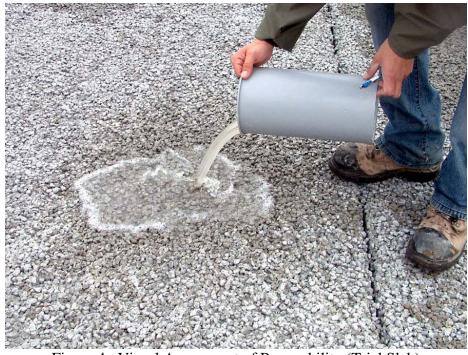
Figure 4. Visual Assessment of Permeability (Trial Slab)

A visual assessment of the trial slab was carried out 7 days after the concrete placement. The surface of the pervious concrete appeared to be in excellent condition with the exception of the joints, which exhibited slight ravelling. A visual assessment of permeability based on water drainage was performed in a number of areas by pouring water on the pavement as shown in Figure 4, with all areas draining freely except for one location where water ponded. The area of water ponding corresponded to the location where a visually wet load of concrete was placed.

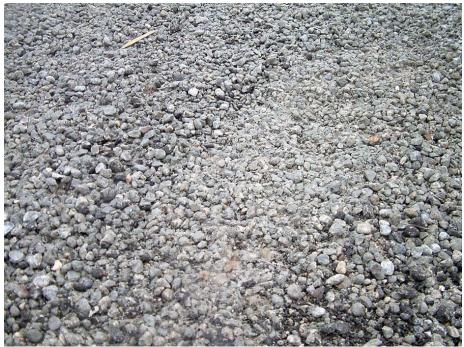
Figure 8. Areas of Severe Raveling

A post construction inspection of the commuter parking lot was carried out on January 4, 2008. The pervious concrete in Sections 1, 2, and 3 was exhibiting raveling throughout with the most severe raveling occurring in Section 2. The northern part of the parking lot in each of the three sections had a few loose aggregates on the surface. Progressing southerly towards the entrance area, the amount of loose aggregate increased. The most severe areas were located in the traveled portions of the parking lot especially where vehicles are turning into the parking spots as shown in Figure 8. In the most severely raveled areas, joints are difficult to identify. Section 4, which was constructed using a Razorback, did not exhibit any raveling. The surface appeared to be consistent throughout, with some areas not meeting the surface tolerance. Contamination was evident in some areas of the parking lot; mainly from sawdust, granular, asphalt and oil spills.
