## BISHOPVILLE ROAD ARCH, NOVA SCOTIA REDUCTION OF EXCAVATION FOR SOIL FOUNDATION IMPROVEMENT

Paul Proctor, P.Eng. (Presenter) Reinforced Earth Company Ltd. Antigonish, Nova Scotia, Canada

2008 Annual Conference of the Transportation Association of Canada Toronto, Ontario

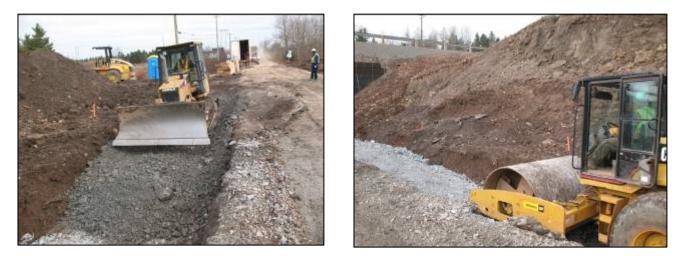
Figure 14a & 14b - Placement and Compaction of Foundation Improvement Material - Stage Two

As a part of the revised foundation improvement design, the contractor utilized the services and experience of Maritime Testing Ltd. onsite full time, until stage two foundation improvement was complete. A MTL geotechnical technician inspected the exposed layer of excavation to evaluate soft pockets or areas of concern that required removal. The trench was proof rolled prior to the rockfill and Type 2 placement (see Figures 14a & 14b).

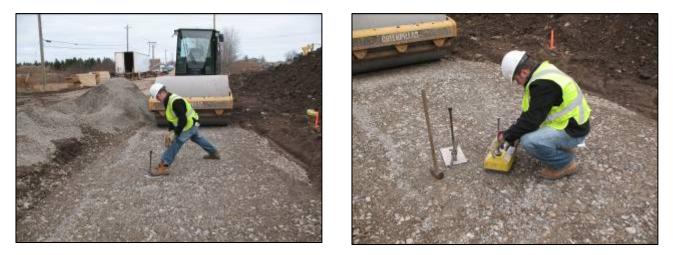
Figure 15a & 15b - Compaction Testing Foundation Improvement - Stage Two

The contractor requested compaction testing throughout the foundation improvement process, with particular attention to the compaction of the reduced foot print in stage two. The contractor wanted to ensure the backfill material was placed and compacted in strict accordance of the geotechnical design (see Figures 15a & 15b).
