# **Thompson River Retaining Wall Rehabilitation**

Carlo Elholm, P.Eng.  
Technical Director – Structural Engineering,  
WorleyParsons Westmar

Paper prepared for presentation  
at the Bridges in a Climate of Change (B) Session

of the 2009 Annual Conference of the  
Transportation Association of Canada  
Vancouver, British Columbia

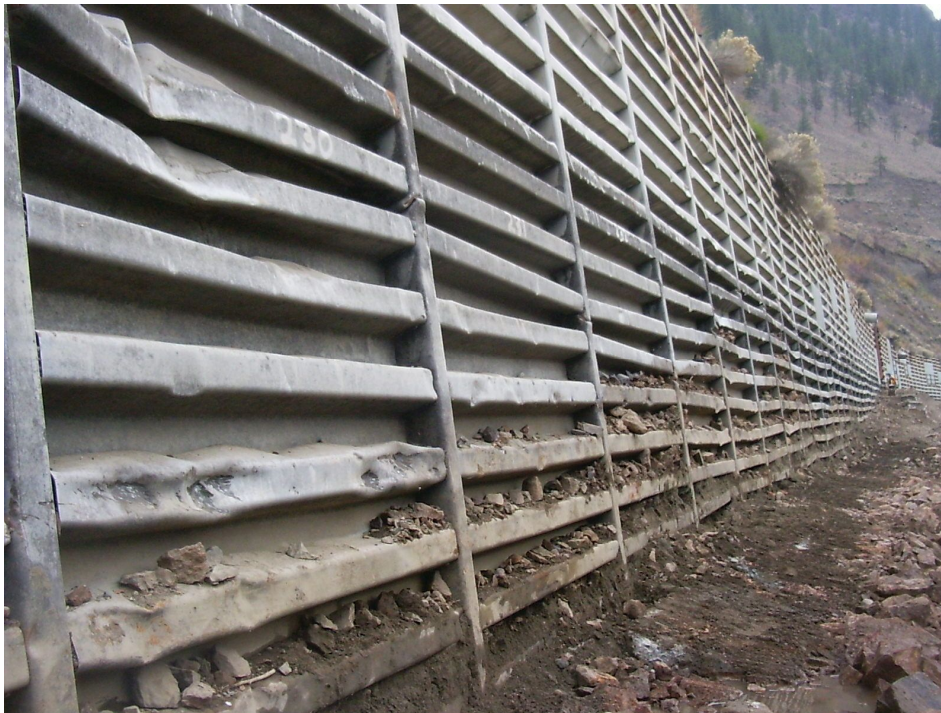
The field investigation also showed evidence of physical distress and significant deformation. Undermining of the soil at some locations would have caused substantial gravity loads on those sections of wall founded on firm materials. Some of these sections showed evidence of compression buckling of the vertical connectors. There were also sections of the wall that had responded to the loss of support by settlement and outward rotation. Maintenance of the riprap between the bin wall and the river had been accomplished by end dumping material at the edge of the roadway. In some locations, the falling riprap had impacted the horizontal stringers and caused severe mechanical damage. In other locations, the corroded horizontal stringers were in a state of bending failure and were bulging approximately 100 mm over their 3050 mm span.

Photo 1: Typical Condition of the Bin Wall

A detailed inspection of the wall was carried out in 1999 to assess the feasibility of repair and replacement options. The primary conclusion was that extensive areas of the front face were severely corroded. In general, the corrosion had been from the inside out and the wall was in fact more corroded than was apparent from a casual visual inspection. At many locations, the bin wall appeared entirely serviceable from the exterior front face. The external coating had performed so well that frequently the steel was completely corroded with no visual evidence of distress or corrosion. Modest blows of a hammer or even finger pressure were sufficient force to penetrate the coating and create a new perforation at a location that otherwise had no visual evidence of impending failure.

The condition inspection included excavation of a representative sample of the bins. The back and side walls of the bins typically exhibited some corrosion and section loss, but the deterioration was much less than on the inside surface of the front wall. It was estimated that the back wall and side walls could have 25 years further service life. There was no obvious explanation for the significant difference in durability between the front wall and the other three

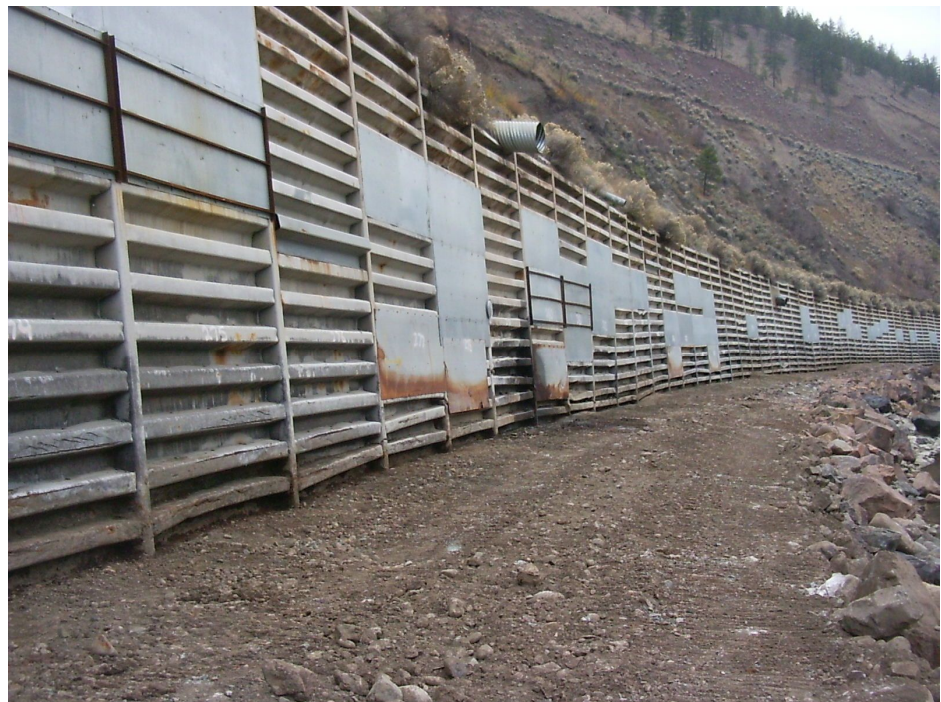
An inspection in the fall of 2000 showed that some of the panels had been torn loose by the spring river currents. Additional perforations in the bins were observed at new locations. A follow-up program of additional sheet installation was completed prior to the 2001 freshet and again prior to the 2002 freshet.

Photo 2: Typical Temporary Repairs to the Face of the Bin Wall

A repair program was implemented in the winter of 2000 to help the wall continue to function during the spring freshet. A series of test pieces were installed to determine the most effective fasteners. Toggle bolts, powder-actuated fasteners and self-tapping screws were tried and the self-tapping screws were found to be most practical. Drawings were prepared to show the locations of the 183 required panels. The local highway maintenance contractor completed the work in a timely fashion and repairs were ready for the 2000 freshet.

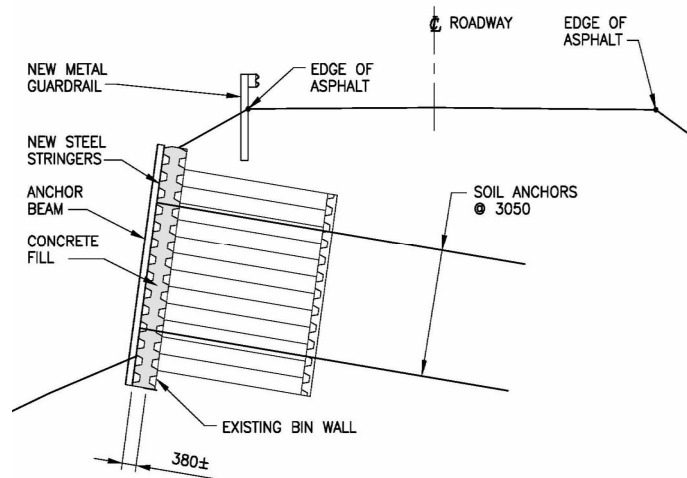
Option 1 was construction of a new steel face in front of the existing wall. The structure would have similarities to a traditional sheet pile wall. Cold-formed steel stringers similar to the existing bin wall stringers would span horizontally. Vertical strongbacks made with a pair of structural steel channels would be spaced at 3 m on centre. Soil anchors would be installed into the existing fill and would be in the gap between the two channels. Option 1 was not advanced for detailed design because its estimated cost exceeded the cost estimate of other options and because the service life of sheet steel had been shown to be limited.

Figure 1: Steel Stringers

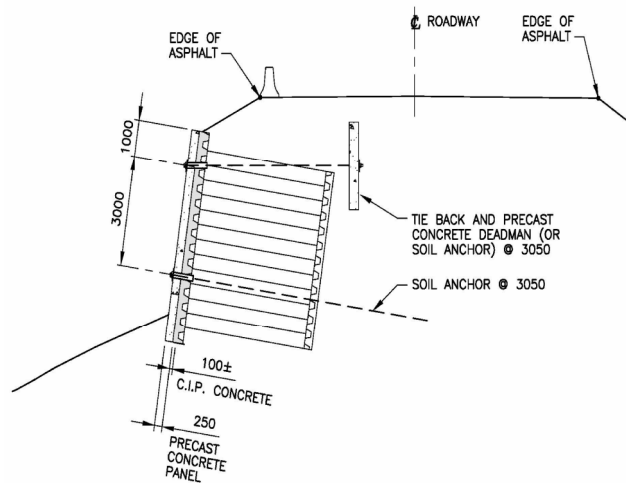
Option 2 was installation of new precast panels in front of the existing bin wall and anchored with soil anchors. The precast panels could be restrained by either or both soil anchors and concrete deadman anchors. During preliminary design, the panels covered the existing bin wall but did not cantilever up to provide additional roadway width. This option was selected for the detailed design phase and ultimately for construction. Option 2 will be described in further detail below.

Figure 2: Precast Concrete Panels

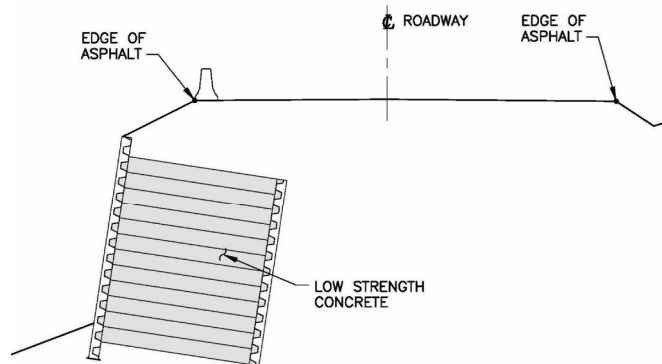
Option 4 was the simple concept of filling the existing bins with low strength unreinforced concrete to create a gravity retaining wall. The existing bin wall would act as a form and the bins would be sequentially excavated and filled with concrete made with local aggregates at a site batch plant. The existing front face would eventually corrode away which would have been unsightly but not detrimental to structural performance. This option was not developed further because of the practical challenges of the required depth of excavation, and cost of the large volumes of excavation and concrete.

Figure 4: Concrete-filled Bins

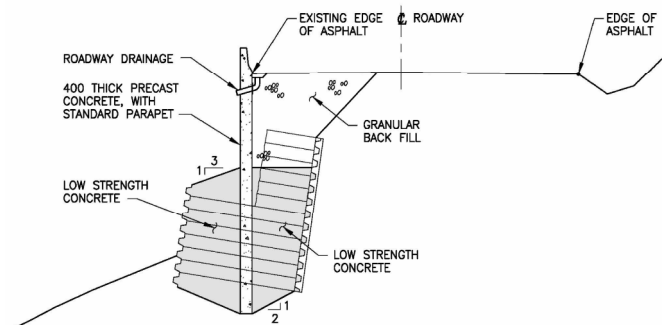
Option 5 was a hybrid of Options 2 and 4. The existing bins would be excavated and partially filled with low strength concrete which would act as mass footing for a cantilever retaining wall. The wall would be reinforced precast concrete panels positioned prior to placement of the concrete fill. This option was not advanced because it was not cost effective. This option did influence the final design as it introduced the concept of projecting a new concrete wall above the existing bin wall and this idea was incorporated into the final design to increase the roadway width.

Figure 5: Precast Wall and Concrete-filled Bins

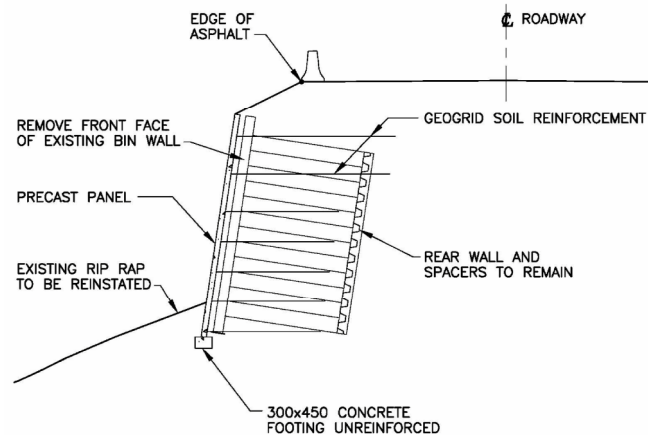
Option 7 was a mechanically stabilized earth (MSE) wall. The existing bins would function as the temporary shoring scheme and would be excavated one at a time. Concrete facing panels would be held in place with geogrid soil reinforcement. This option was not advanced because it was deemed impractical to excavate the full depth of the bins while maintaining traffic flow. The shoring requirements to safely work in the excavated bin were also of concern. The common cost efficiencies of MSE walls were not available because work would have to take place in small 3 m sections. This option required removal of the face of the existing bins which would add a significant disposal cost due to the asbestos within the coating.

Figure 7: Mechanically Stabilized Earth Wall

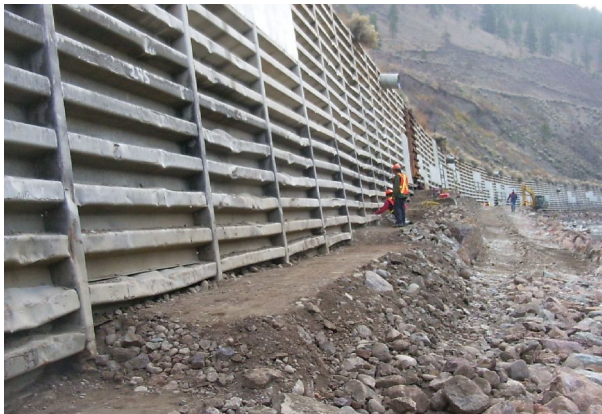
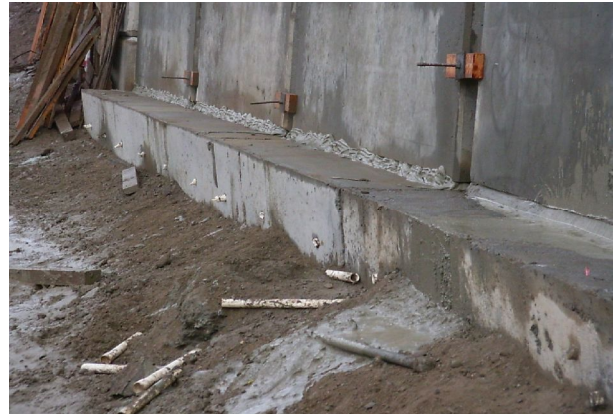
A small concrete strip footing was cast along the base of the existing wall to provide a surface on which to set the wall panels and to resist the nominal gravity loads of the panels. In elevation, the footings are level with discrete steps at panel joints. In section, the top of the footing is sloped back at a slope of one vertical to six horizontal to provide uniform grout thickness between the underside of the wall panel and the top of the footing. Footings were cast-in-place during winter low water periods as they are submerged during much of the year.

The strip footing was not designed as part of the load system to support the earth pressures because there is no connection between the panels and the footing to transfer either moment or shear. In addition, the footing may not be reliable for resisting soils loading if there is future scour that is not reinstated in a timely manner.

Photos 3 and 4: Ground Preparation and Footing Construction

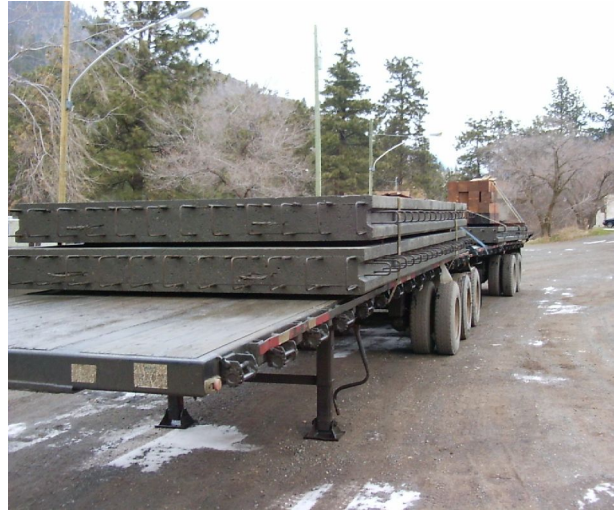
The panels are 300 mm thick, a depth that was governed by the structural requirement to resist concrete punching shear at the anchors.

Panel widths were determined by the spacing of existing bin wall vertical connectors as the design intent was to place one panel per bin so that anchors would be drilled through the center of the bins without hitting the bin side walls. In addition, the selected panel sizes would enable transportation on public highways without special overwidth permitting. The panel width is typically 2850 mm with a few exceptions at locations where the existing bin was only 2890 mm wide instead of the typical 3050 mm width. At locations with an expansion joint instead of a shear key, the panel is 2950 mm wide.

Photo 5: Concrete Wall Panels

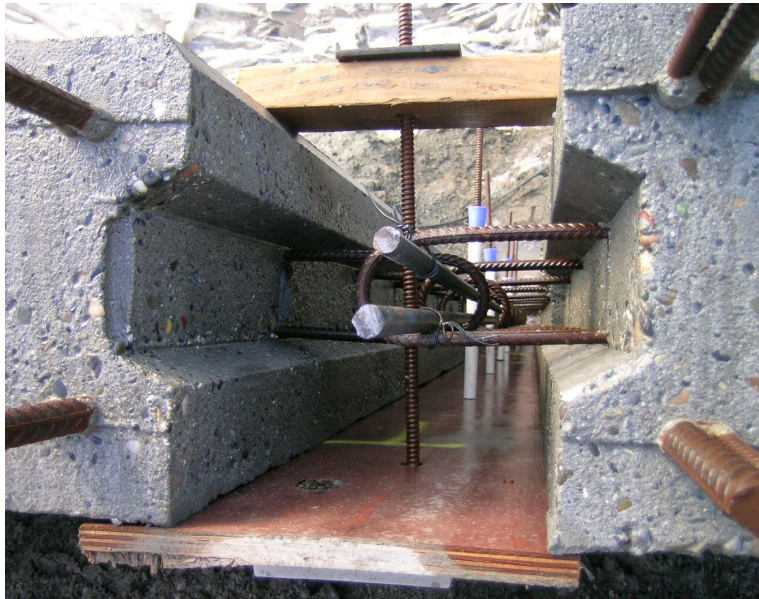
Closure strips act as shear connectors between different panels to share vertical or lateral loads and thus provide redundancy to the wall assembly. The closure pours also reduced tolerance concerns for accurately fitting panels together. The closure pours are approximately 200 mm wide. Hairpin dowels project from the edges of each precast panel into the closure pour and two vertical rebars were field installed. The edge of the wall panels included a formed shear key and the edge was sand-blasted to roughen the surface for improved bond. A self-consolidating concrete was installed in the space to create a monolithic joint.

Photo 6: Top View of Shear Key

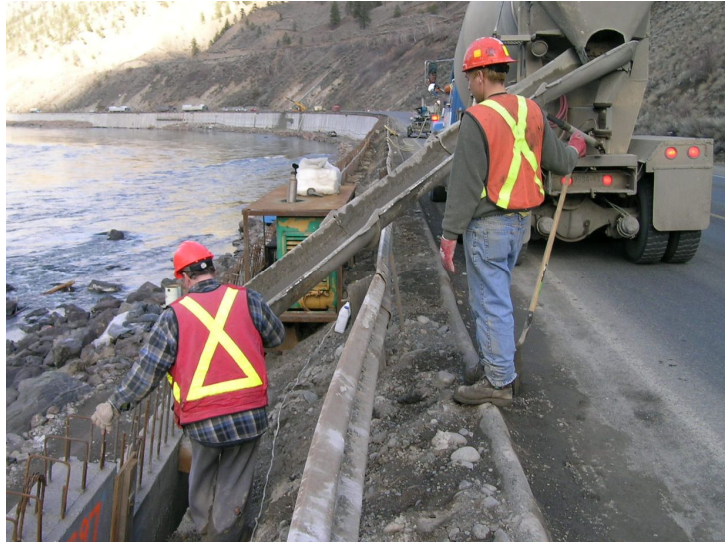
A controlled density fill was placed in the void between the precast panels and the existing metal wall as an alternative value engineering concept to the specified pea gravel. After experimentation, a workable fill made with cement and a locally available gravel mix was developed which produced an economical material in a flowable state. Care was required and

staged pours were necessary so that the concrete pressures did not overload the wall or anchors since the pressure of wet concrete exceeds the pressure of granular fill used for design of the wall.

Photo 7: Placing Controlled Density Fill

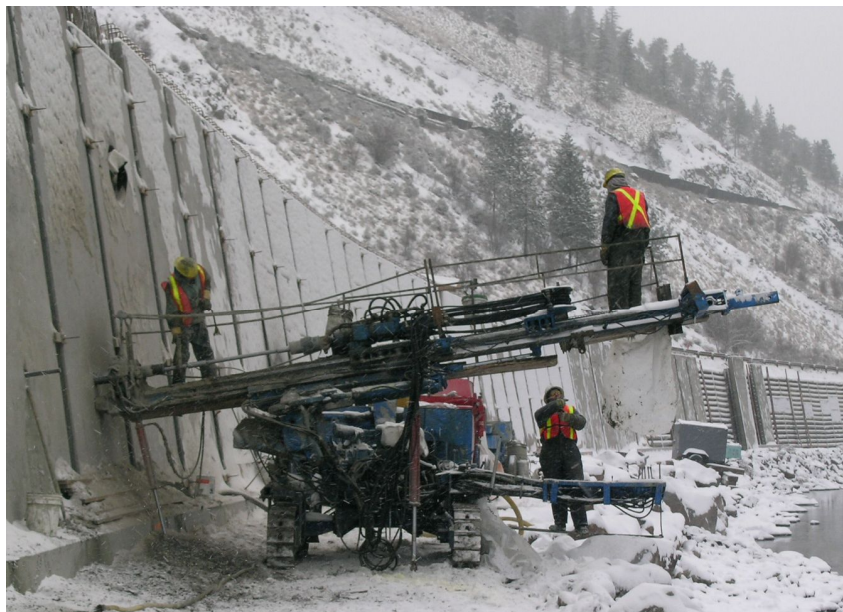
The anchors are grouted into the granular fills under the existing highway. The drilling was performed after panel erection so the panel functioned as the template for anchor placement.

The anchors are 44 mm diameter threadbars with a bonded length of 6800 mm and an unbonded length of 3000 mm with a design service load of 400 kN. At locations where bedrock was encountered, the bond length was reduced to 4000 mm.

Photo 8: Drilling Anchors through the Wall

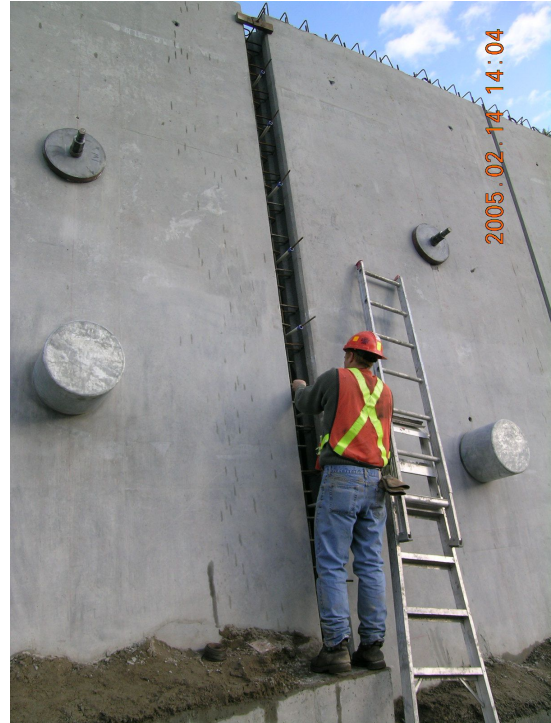
The most common method of covering anchors is to use a plastic cover filled with grease, but this cap material was deemed unsuitable for this project. Concrete bolsters were considered but they were not cost effective. The solution developed for this project was a galvanized steel cap. The anchor bearing plate was cut in a circular shape and threaded on the outside. A pipe section was fitted with a welded cover plate on one end and provided with an internal thread on the other end.

At the completion of anchor installation, the cap was screwed onto the bearing plate and the cavity was grouted through a hole in the pipe.

Photo 9: Anchor Bearing Plates and Caps

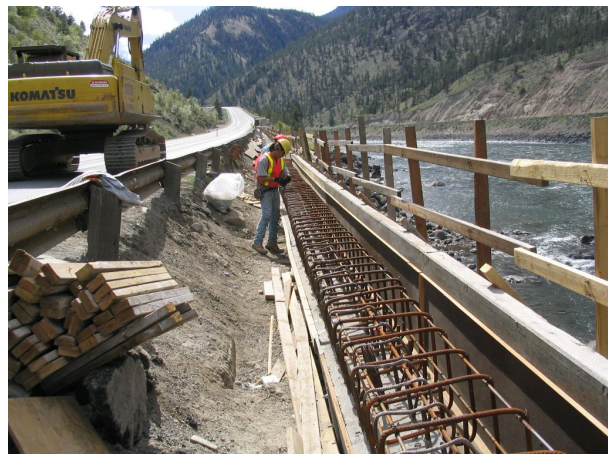
A cast-in-place concrete cope beam was installed for the full length of the wall. The cope beam serves as a structural tie to prevent differential movement of the precast panels. It also performs an aesthetic function by smoothing out the tops of the panels to avoid the castellated appearance caused by the rectangular panels trying to follow the roadway profile and obscuring construction and survey tolerances for the panels. The cope beam also provides a secure anchorage for the handrail base connection. The cope beam is fastened to the walls with projecting hairpin dowels.

Photo 10: Cope Beam Formwork and Reinforcing

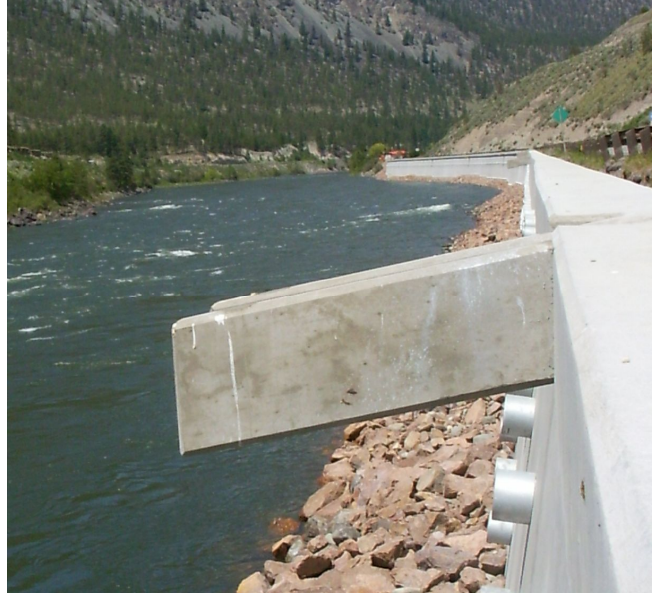
A system of downspouts was not used because it was expected that they would be damaged by river debris and because they can become plugged. Instead, an open channel scupper system that used precast concrete was chosen. In order to use standard precast wall sections and to accommodate field tolerances, the scupper walls were precast 800 mm shorter than normal with projecting vertical dowels.

On site, scuppers were attached to the wall with simple bent dowels to a short height of cast-in-place concrete. The scuppers are 1400 mm long and promote the flow of drainwater clear of the wall. The slope is one vertical to six horizontal to assure self cleaning. On the roadway side, the asphalt is locally depressed to function as a drainage swale.

Photo 11: Precast Concrete Drainage Trough

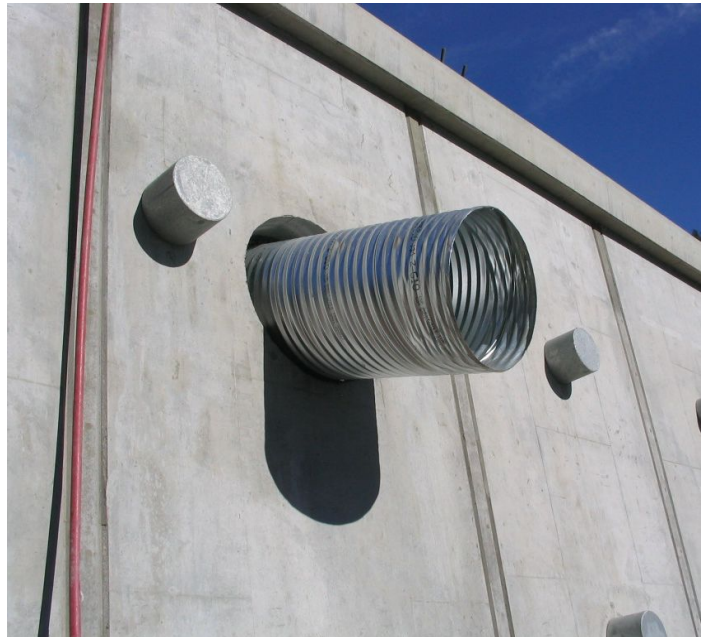
The contractor measured the position of the existing culverts and used the information for wall panel fabrication. Openings were cast into the wall panels with additional reinforcing steel placed around the openings. The top centered anchor was replaced with two anchors adjacent to the culvert opening.

Photo 12: Corrugated Steel Pipe Drainage

Since the openings in the wall were only 150 mm to 200 mm larger in diameter than the culverts, care was required in measurement and fabrication to meet the small tolerance on opening locations. The panels were placed over the protruding culverts, and all eight culverts fit without needing field modifications.

After the wall construction was complete, the roadway works were implemented. During this stage, the culverts were excavated and replaced with new sections that projected through the same wall openings. The culvert cantilever dimension was also increased to 1000 mm to direct runoff clear of the base of the wall for increased wall durability.

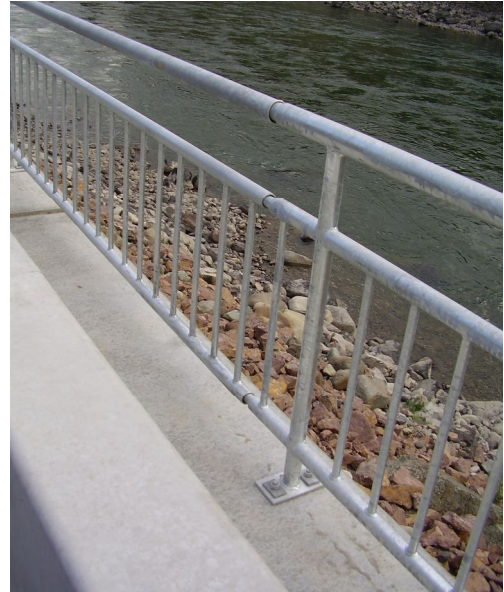
Photo 13: Handrail Details

The contractor was given the option of coring holes and embedding the posts in grout or using epoxy-grouted anchors to secure the base plate of the posts. The contractor chose the latter, and base plates were made with slotted holes and nuts were supplied with plate washers for installation tolerance.

The design of the handrail included vertical pickets to prevent small children from climbing through a gap of the more common style of handrail constructed with only a mid rail and top rail. The handrail panels were made in sections approximately 6100 mm long for shipping and for installation in the vertical profile and horizontal curve following the top of the wall. Top rail and mid rail splices were made with pipe dowel inserts that provide tolerance and also permit thermal movement. Splice locations were matched with concrete wall expansion joint locations so the handrail would not bridge the expansion joints.

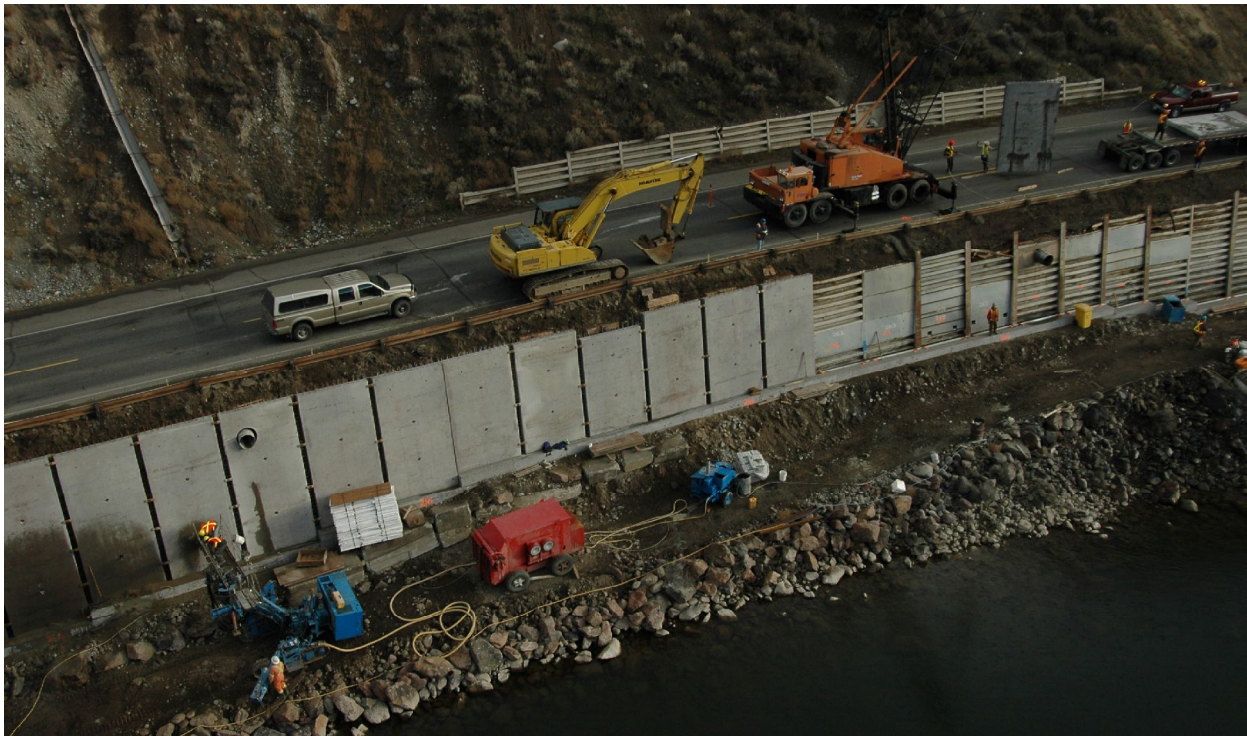
The survey results were combined with computerized three-dimensional solid modeling of the wall to provide erection data that would ensure a smooth uniform curve that is aesthetically pleasing while satisfying structural engineering demands. The care taken in surveying, solid modelling, shop drawing production, panel fabrication and erection contributed to a precast project with a zero failure rate.

Photo 14: Aerial View of the Concrete Panel Installation Operations

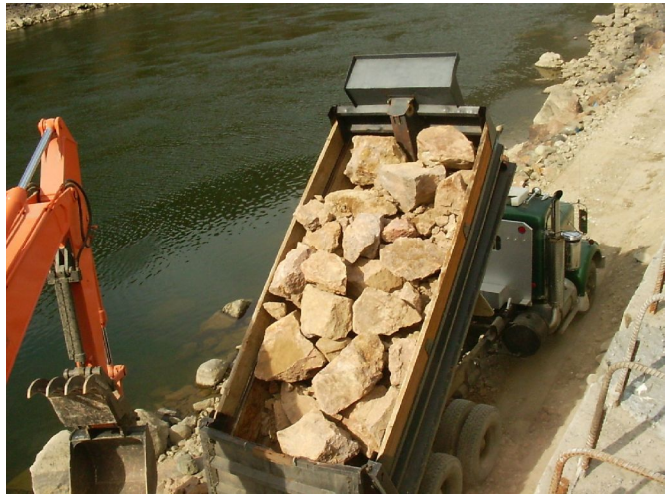
The bend in the river at the project site exacerbates scour and significant past erosion had occurred, requiring a hydraulic analysis and upgrading of the existing riprap scour protection as part of the project scope. Existing material of appropriate size was reused and a nearby pit was quarried for additional material. The hydraulic analysis determined that material meeting the standard 250 kg class gradation was necessary for most of the wall. In the area of the river bend, 750 kg class riprap was installed.

The riprap design also varies with the ground slope. Those areas with steeper slopes have a 7 m width of riprap while the flatter regions have a 5 m width of riprap. The toe of the riprap was keyed into the existing ground line. Due to the potential environmental disturbance, there were areas where the base of the wall could not be excavated because the excavation would take place under water. There were also some areas of bedrock. In these two conditions, the toe of the riprap was made with oversize boulders that were approximately 1500 mm to 2000 mm in dimension.

Photo 15: Riprap Installation in Progress

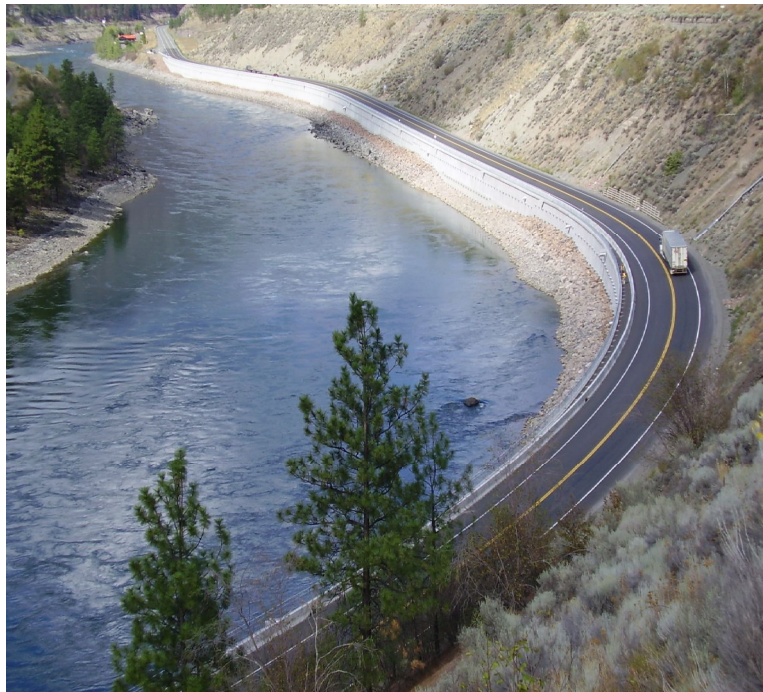
To implement roadway safety improvements, the new retaining wall is higher than the existing bin wall to provide support for additional fills to increase the roadway width. The shoulder width was increased to 2700 mm and standard Jersey-style concrete median barriers were installed.

Photo 16: Completed Roadworks
