Transportation Association of Canada – 2009 Annual Conference

Modifications to Queensborough Bridge, New Westminster, BC

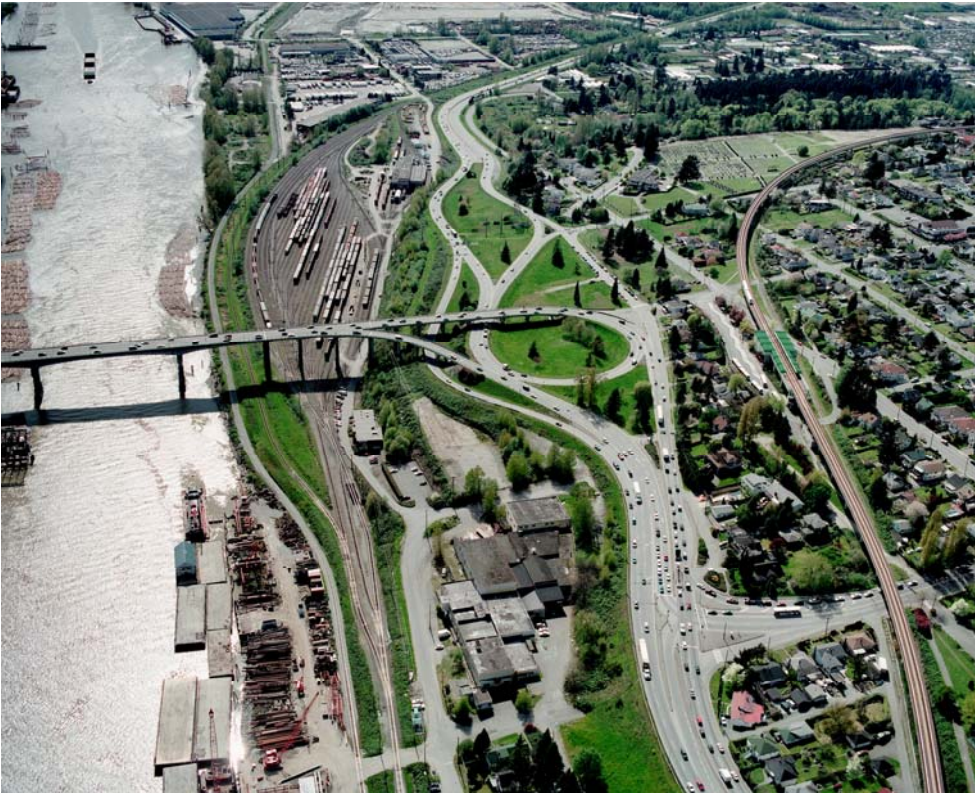
Figure 1 Previous Queensborough Interchange

The Border Infrastructure Program required several significant modifications to address both the functional requirements of the new Queensborough Interchange, and the safety modifications required to meet the program objectives (Figures 1 and 2). The new interchange involved replacing the geometrically sub-standard loop on the east side of the bridge with a new loop on the opposite side. As a result the two northbound spans which curved to the east were no longer required, and were replaced with embankment fill. Also, the 20th Street and 6th Avenue exit for northbound traffic was relocated from the south side to the north side of Marine Way. To accommodate the change in traffic movements, a second northbound lane was added north of the four-span east exit ramp to Stewardson Way. As a result, there are now four traffic lanes across the full length of the main bridge.

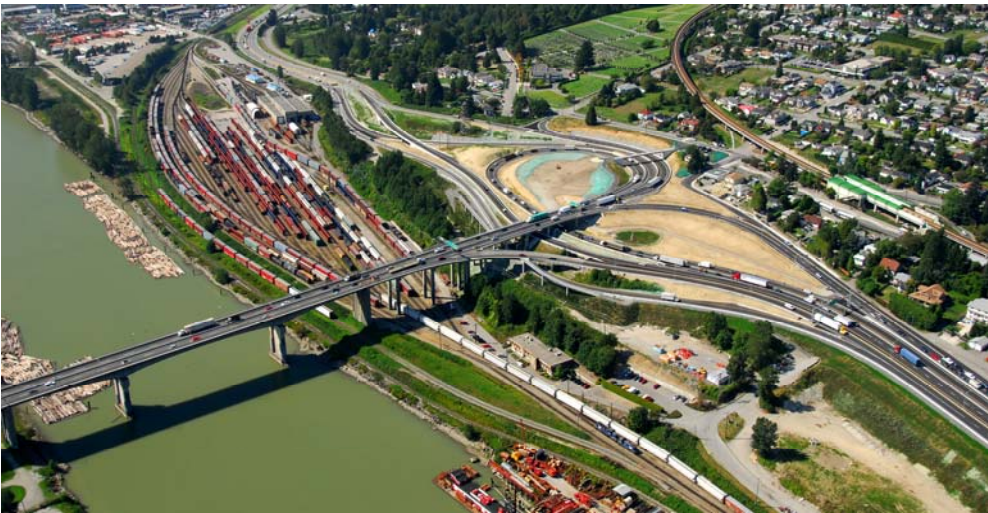
Figure 2 New Queensborough Interchange

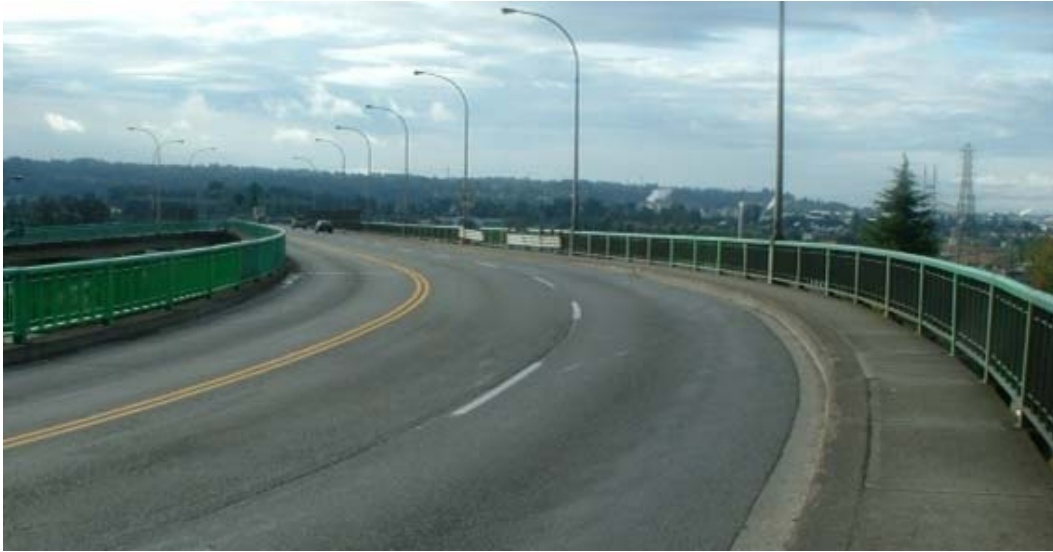
Figure 3 Previous Queensborough Bridge North End and Sidewalk Details

The existing steel railings at the back of the sidewalks (Figure 3) were replaced with new PL-2 type roadside barriers mounted on top of the curbs (Figure 4). This important change separated the vehicular traffic from the sidewalk users and added significantly to the safety and reliability of the Queensborough Bridge. On the concrete approach spans, dowels were drilled through the curbs into the fascia girders to resist anchorage forces. As a result, the parapets became vertical extensions of the fascia girders. As the shorter spans were less weight sensitive, the parapets were formed from cast-in-place concrete. On the more weight-sensitive main steel spans, the upper portion of the parapets were lightweight steel fabrications. The steel sections were anchored by drilling through the existing lightweight-concrete curbs and installing anchor bolts, which reacted against washer plates on the underside of deck.

The existing bridge sidewalks consisted of thin precast concrete panels, about 1.2 m wide, spanning 3 m between concrete beams cantilevering from the fascia girders. The panels were very lightweight with only a 38 mm thick deck spanning transversely between three stiffening ribs. Despite their ultra-light construction and low cover to the wire fabric reinforcement, the panels had survived nearly 50 years of exposure and several unintended vehicle loads. However, they were at the end of their serviceable lifespan. The supporting cantilever beams were about 380 mm square in section and had fared much better. Some had suffered accident damage but the beams were considered fit for continued service.

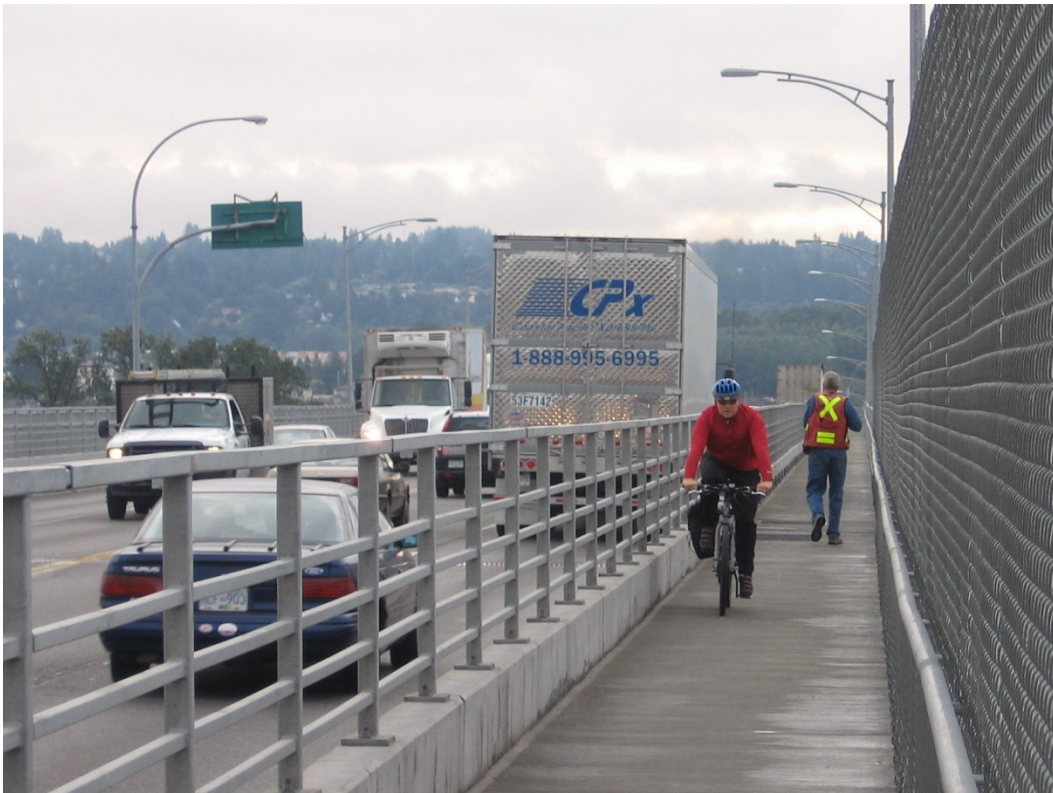
Figure 4 New Queensborough Bridge Sidewalk Details

Steel bicycle fences were installed along the full length of parapets which were located between sidewalk and roadway (Figure 4); other parapets had the standard pedestrian handrail mounted on top. The approach span parapets were used as support structures for the three sign bridges and were locally widened to accommodate the sign-bridge anchorages. To minimize the effect of forces from the sign bridges applied to the fascia girders, custom-designed sign bridges supported by vertical trusses were used with the widened section of parapet acting as a distribution beam.

An extremely light sidewalk replacement design was needed. Steel gratings are not appropriate for this application, and with almost 1.5 km of replacement sidewalk required, steel plate decks were too expensive. To provide the desired concrete surface, a unique design was developed using steel metal decking with a minimum of 25 mm of concrete topping (Figure 4). The metal decking was supported from new galvanized steel framing; an angle bolted to the back of curb, and an HSS fascia beam supported by angles extending from the existing concrete cantilever brackets. Connector plates for the bicycle railing were welded to the HSS fascia beams. Given the minimal thickness of the concrete topping, all embedded reinforcement was hot-dip galvanized, and drain holes were detailed at the low end of troughs to address concerns about moisture entrapment at the interface at the concrete / metal deck interface.

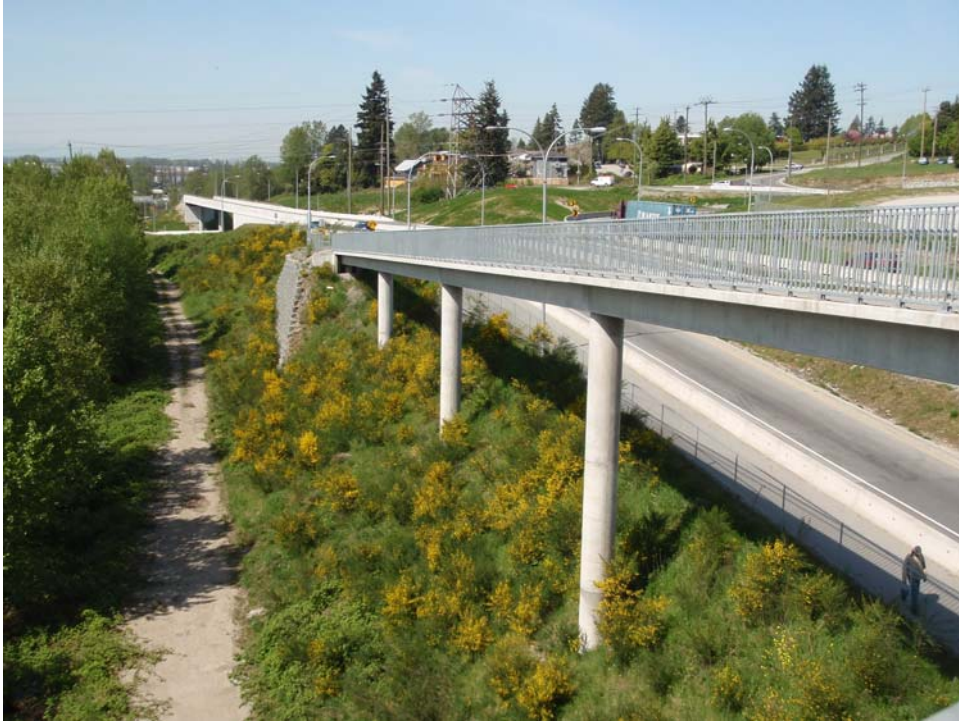
Figure 5 New Queensborough Bridge West Pedestrian Ramp

The Queensborough Bridge was originally constructed with two sidewalks, but in adapting the bridge to accommodate Highway 91A, the Ministry abandoned the east walkway. Key to accommodating sidewalk traffic during replacement was to reactivate the east sidewalk. This was done by installing new elevated ramp connections to the south side of Marine Way, and building new on-grade ramp connections with Boyd Avenue at the south abutment to set up sidewalk diversions. The sidewalks were then closed alternately for reconstruction work. The new elevated ramp connections consist of a three-span 60 m long east ramp, and a four-span 80 m long west ramp (Figure 5), each 2 m wide and placed at 7% grade. The ramps consist of flanged precast box-girders with cast-in-place topping, supported by discrete concrete columns and pilecaps. The pilecaps are each supported by four micro-piles consisting of cased threadbars, drilled in to underlying dense till to provide sufficient bearing and uplift capacity.

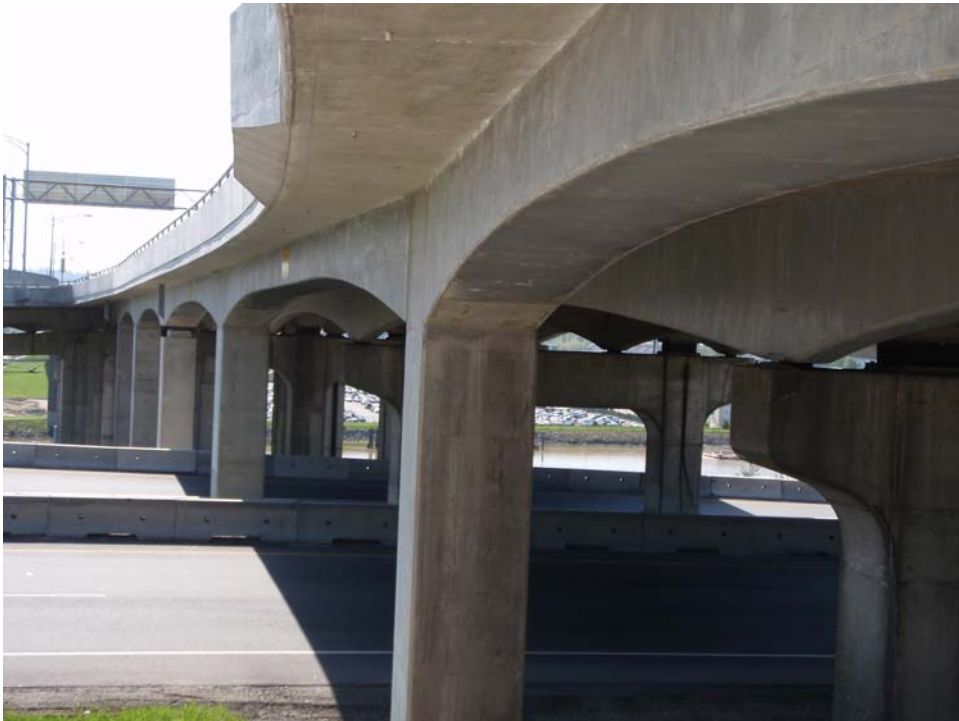
Figure 6 Queensborough Bridge North End Widening

The north end widening is a 6-span structure between the east ramp and the new north abutment. Spans are arranged to match the existing bent locations and are typically 18 m long, with one 24 m span over Marine Way (Figure 6). Near the north end, the deck flares in plan to accommodate the geometry of the new exit ramps. The deck widening is typically 5 m but flares to 8 m locally at the new abutment. The widening was sufficient to accommodate a two-lane detour during removal of the two north-end spans.

The new superstructure design does not replicate but complements the original construction. The additional northbound traffic lane is carried by a single line of precast box beams and cast-in-place concrete deck, supported by a row of discrete cast-in-place concrete columns. Foundations consist of pilecaps, supported by 12 micro-piles drilled in to underlying dense till; or on spread footings where the till was close to grade.

In order to closely replicate the existing girder profile, the precast box girders are parabolically haunched, with a depth of 1.4 m at the supports and 0.7 m near mid-span. The girders are erected as simple spans, but act compositely with a 250 mm thick deck slab to resist imposed loading as two three-span continuous units. The two three-span units are connected above a common pier by a link deck which was then extended across the deck of the original bridge, replacing an expansion joint. The inboard edge of the new deck slab was supported from the former fascia girder after the original cantilevered portion of deck had been removed. Supporting the widened deck slab placed additional loading on the former fascia girder which was strengthened accordingly.

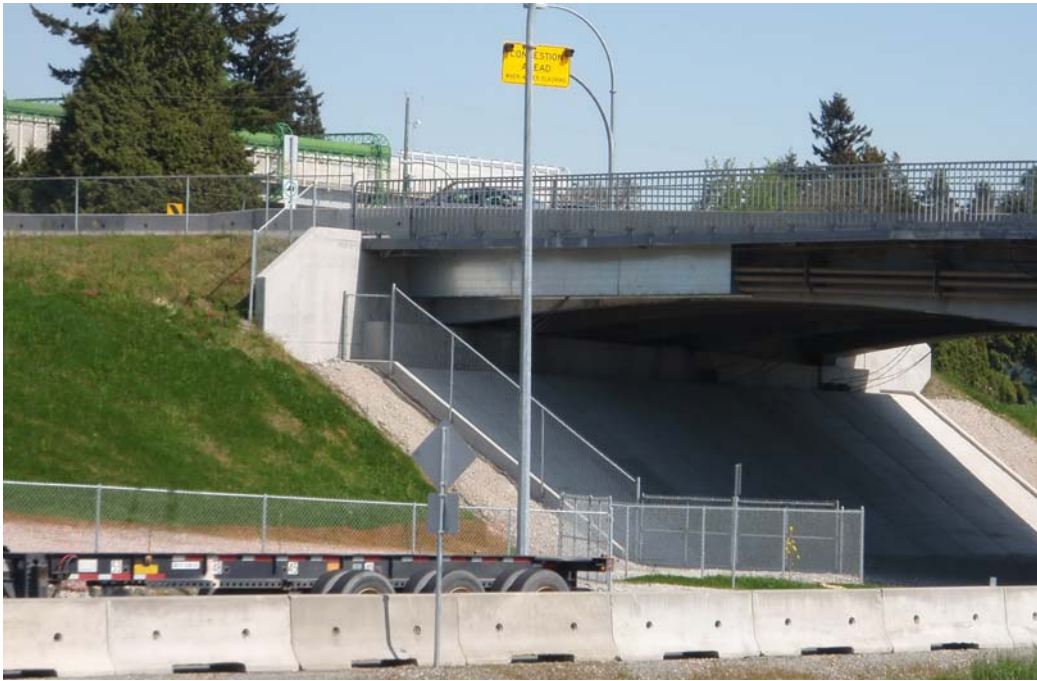
Figure 7 Queensborough Bridge's New North Abutment

The new section of deck was cast to the required profile allowing for a 50 mm thick asphalt wearing surface similar to the existing bridge. However, considerable re-profiling of the asphalt on the existing deck was required near the east exit ramp to accommodate the new northbound lane; and at the new north abutment, where three traffic lanes now curve in a westerly direction instead of east. As the re-profiled asphalt thickness is up to 200 mm at the North Abutment, the original expansion joint was removed. The ballast-retaining wall at the new North Abutment spans between new pinned connections with the deck slab and abutment seat beam (Figure 7).

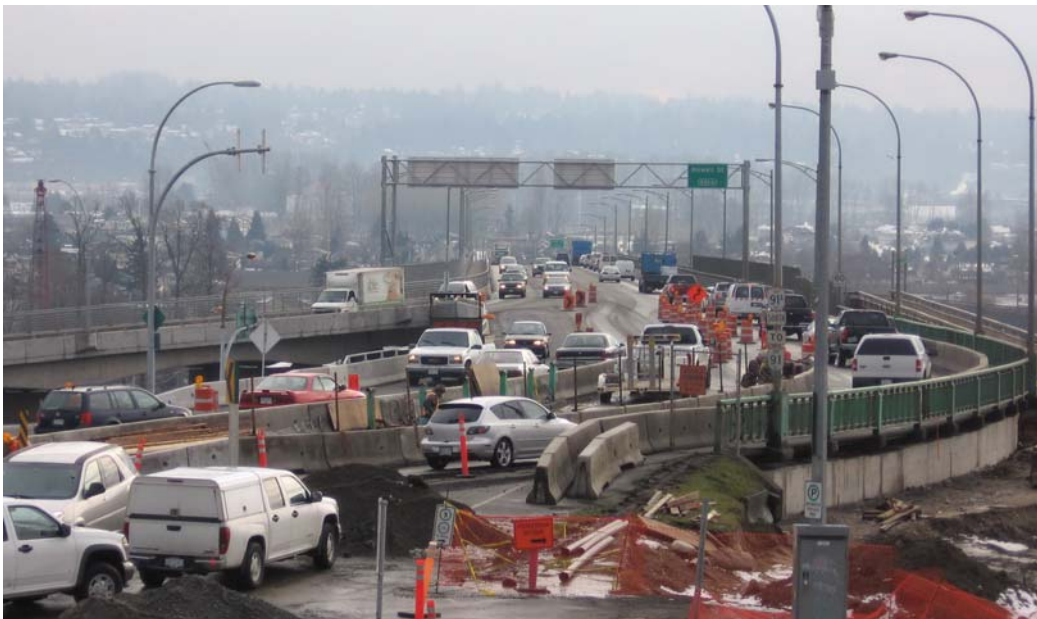
Figure 8 Queensborough Bridge - Traffic Detour for North End Span Removal

To avoid future maintenance issues, the bridge deck of the redundant spans was removed in stages. Two traffic lanes were detoured over the north end deck widening onto the east section of the new approach fill, while the remaining southbound lane continued in operation on the west side of the spans (Figure 8). The east half of the deck was then removed and the approach grade completed. Next, all three lanes were detoured to the east side and the remainder of the deck was demolished. The traffic staging was developed as an integral part of the design to ensure that traffic could be maintained throughout construction with the minimum of interruption to operations. Except on exit ramps, lane detours were designed to the posted construction zone speed of 50 km/h.

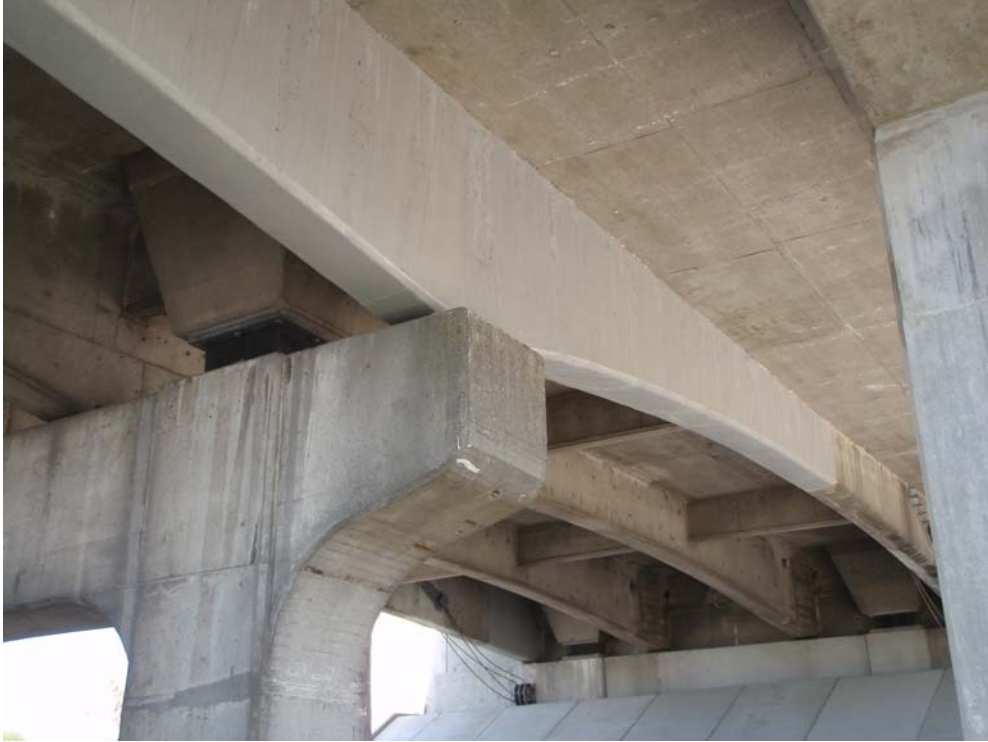
Figure 9 Queensborough Bridge - Fascia Girder Strengthening

The fascia girders were assessed as being deficient in both shear and flexural capacity in the positive-moment zones. This deficiency was rectified by applying bonded advanced composite materials while the bridge continued in operation. The west fascia girder only experiences minor additional forces from the widened sidewalk, and so the strengthening design used bonded glass fibre external reinforcement. The east fascia girder, which receives additional live loading from the additional traffic laning at the north end of the bridge, required more significant strengthening. Accordingly, the strengthening design used much stronger carbon fibre external reinforcement (Figure 9).

The design philosophy was to provide shear strengthening to ensure a flexural failure mode. Flexural strengthening was carried out only in the positive-moment regions, which would force initial yielding to occur in the negative-moment regions where ductility is available. The original ductility in the positive moment regions is available for secondary yielding following rupture of the external reinforcement.

Application of the bonded advanced composite materials was carried out using a combination of suspended scaffolding and overhead lifting equipment, which ensured minimal interference with traffic operations beneath the bridge. The work took place in the spring and summer of 2005 which ensured that temperatures were well above the minimum for curing of the epoxy adhesive bonding layer.

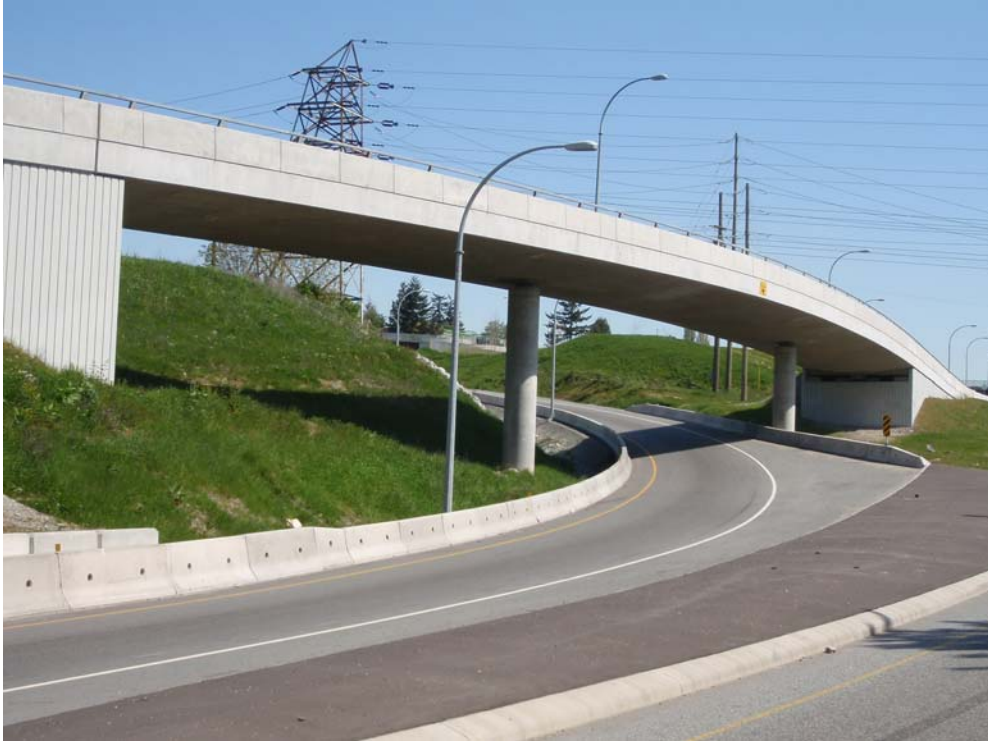
Figure 10 Completed Marine Way Flyover

Firm ground support for foundations was available, but the main challenges for a flyover were the extreme skew angle of the crossing, and the limited structure depth available. The eastbound ramp was climbing at maximum grade towards the north end of the Queensborough Bridge, while the westbound ramp was crossing beneath 230 kV overhead power lines with minimum clearance. Only 1200 mm of structure depth was available near the westbound ramp centerline and 800 mm on the north edge. By using an 80 m long three-span continuous structure with a main span of 32 m, single-column intermediate supports could be placed outside of the roadside barriers and the abutments could be placed normal to the control line. The solid cast-in-place reinforced concrete superstructure is 8 m wide and tapered from 800 mm deep on both edges to 1200 mm near the longitudinal centerline, utilizing all the depth available for the structure. The columns support the superstructure via fixed bearings, and torsional loads are resisted at the abutments by pairs of laminated elastomeric pads (Figure 10). The abutments are large gravel-filled concrete box structures which resist seismic forces. The superstructure is restrained by a link deck at the west abutment and a shear key at the east abutment where the expansion joint is located. The estimated cost for the flyover was similar to the tunnel solution, and was adopted because of its open appearance. Its excellent aesthetic qualities were enhanced by detailing vertically grooved finish to the external faces of the abutments and wingwalls.

Construction was in a green field location adjacent to Marine Way westbound traffic. To form the heavy superstructure after casting the substructure elements, the contractor used fill falsework. The fill was later excavated in controlled fashion from beneath the span.

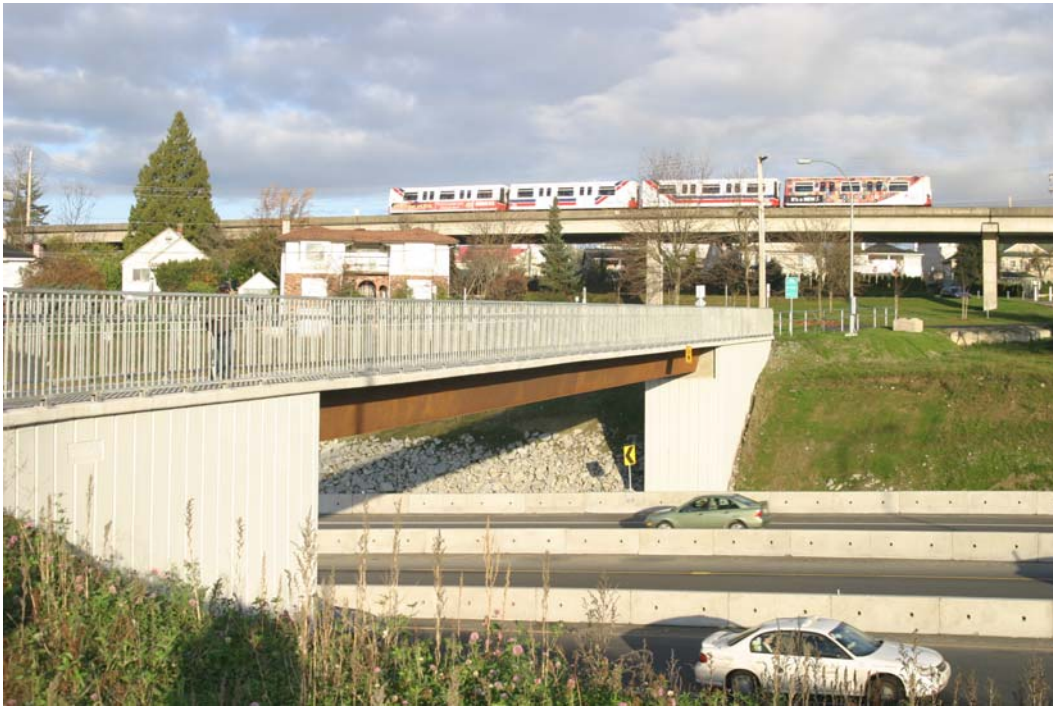
Figure 11 22nd Street Pedestrian Overpass

A span of 32 m with headroom of 5.5 m was adopted (Figure 11). As the superstructure needed to be placed above an operating roadway, prefabrication was essential. A steel trapezoidal-box spine beam 1.1 m deep was used, with precast stay-in-place full-width deck panels, and a cast-in-place concrete overlay. Weathering steel is used for the girder and deck reinforcement is galvanized for durability. The girder was supported from hollow box-abutments and was cast in to the end diaphragms to eliminate bearings and expansion joints. Simply supported for dead loads, imposed loading is resisted by the composite girder acting as part of a portal frame structure.

Aesthetic qualities are emphasized by the simple, elegant form of the overpass. The exposed concrete areas of the abutments and wingwalls are provided with a vertically grooved finish.

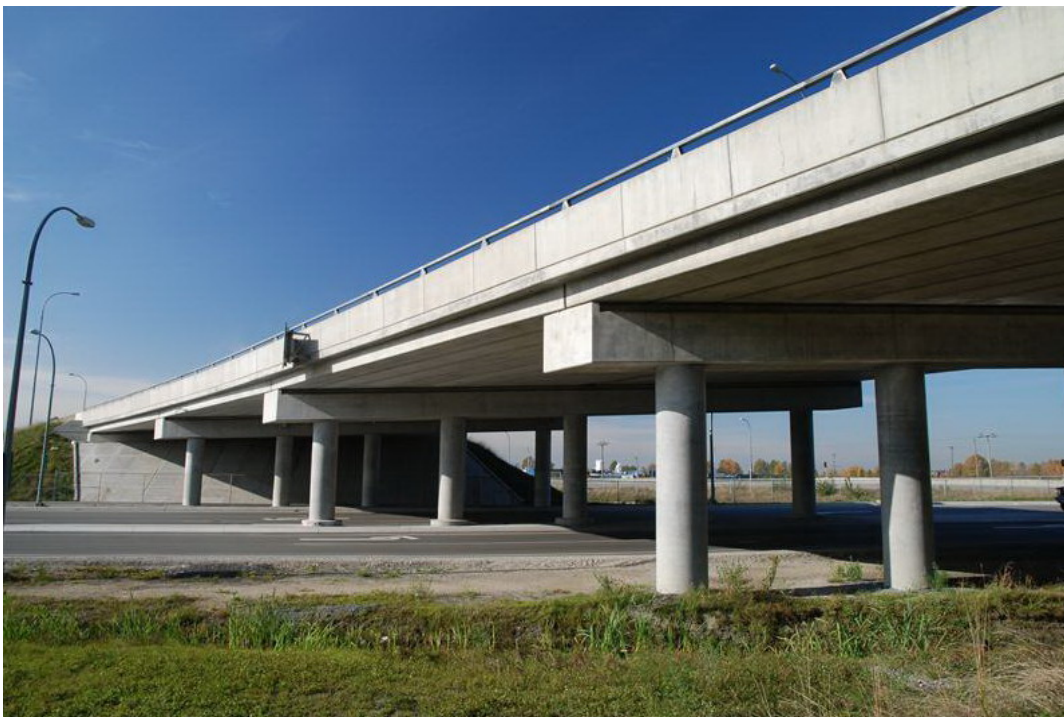
Figure 12 Completed Howes Overpass

The optimum solution was obtained by using the thinnest possible superstructure depth for the underpass which minimized the thickness, width and length of expensive expanded polystyrene fill required for the approach embankments. In addition, retaining walls are difficult and expensive to construct on very soft ground and were avoided. Accordingly, the selected overpass configuration was a 22 m wide, 76 m long, four-span structure; all supports being multi-column bents (Figure 12). The configuration accommodated four lanes on Howes Street and turning lanes in the centre two spans, while the end spans accommodated sidewalks and the embankment end slopes. The 1100 mm diameter columns in the support bents were above-grade extension of the 1200 mm diameter steel pipe piles, which were driven closed-ended into the sand layer. Pile capacity was verified using a 5.2 MN test load. The use of "extended pile" bents avoided the need for pile caps and the resulting ground "hang up" associated with subgrade settlement. To minimize "down drag" the piles were sleeved through the denser surficial deposits. Seismic forces on the support bents were high as a result of the heavy superstructure, soft subsoils, and lack of abutments or approach fills to "anchor" the superstructure. The box girders were dowelled to each pier cap using 50 mm diameter high-strength steel bars.

The four 19 m long spans consisted of multiple box beams of BC-standard 1200 mm width. A special ultra-thin design, using 550 mm deep single-cell boxes which act compositely with a 200 mm thick deck slab, was used for the spans. The deck provided the necessary shear connection between boxes which avoided the requirement for shear keys, and also provided a robust diaphragm to resist seismic loading. To maintain diaphragm continuity over the piers and eliminate maintenance-prone expansion joints, link decks were provided above intermediate supports. The lack of shear keys allowed variations in the box girder spacing which accommodated the plan curvature of the highway. The fascia girders were carefully placed to minimize the variation in width of the short deck-edge cantilevers.

At \$3.5 million the overpass was both economical and constructible, and has simple elegant lines. The elimination of expansion joints will minimize maintenance requirements and the careful detailing will ensure that the settlements that are inevitable in the soft subgrade will not affect the structure of the overpass.
