Slope Redesign and Slope Remediation during
Design/Build Construction at
Kicking Horse Canyon– Phase 2

By Richard Humphries, P.Eng.
Don Lister; P.Eng.
and
Paul Schlotfeldt, P.Eng.
Golder Associates Ltd., BC

Paper prepared for presentation

of the 2009 Annual Conference of the
Transportation Association of Canada
Vancouver, British Columbia

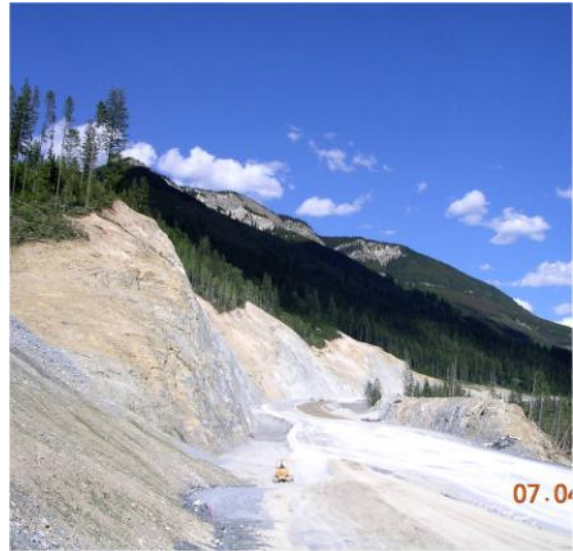
Photograph 1 – East End Road Cuts

ditch, as shown in Figure 1 and Photograph 1. The limited thickness overburden was laid back at 1.5:1. The wide-catch-ditch design was selected so that slope rock support could be minimized and so that rockfalls from the cut slopes will be caught in the ditch. Construction proceeded according to this design and few problems were encountered.

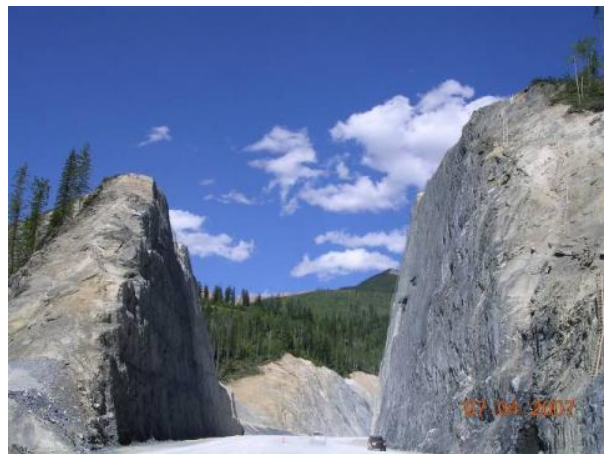
Photograph 2: 70m high through cut East of Bridge

At the east end of the bridge, in the central third of the project, the new highway alignment cuts through a high, steep rock dome of limestone of the McKay Group Unit 6. The bedding exposed in the double sided cuts varies from near vertical to about 60° and strikes across the highway alignment. The rock mass is relatively strong, so selected slope design for the 70m high rock cuts for the bid was for near vertical (1/6:1), cuts with pattern rock bolt support and 8m to 10m wide rockfall catch ditches, as shown in Figure 2 and Photograph 2. As with the far east end of the project, very few problems were encountered during construction and the rock turned out to be of better quality than expected from surface exposures, so the required rock bolting was minimal.

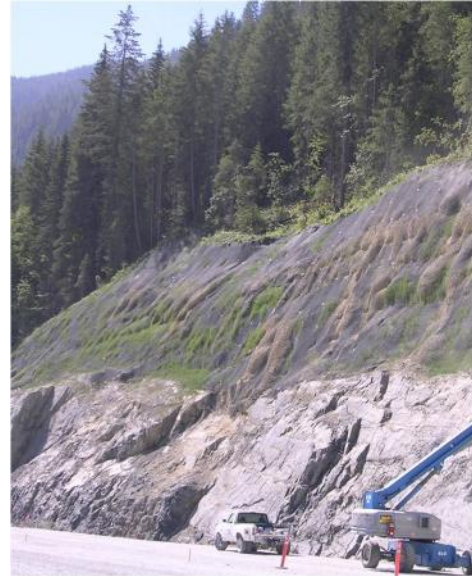
Photograph 3: West End Cuts in Quartzite with Tecco Mesh

- 670m of ½:1 rock cuts in quartzite with a 3m to 6m wide avalanche/rockfall ditch at the toe of the slope and Tecco mesh and anchors to stabilize the overburden at ½:1, as shown in Figure 3 and Photograph 3. The Tecco mesh is a proprietary high tensile galvanized steel wire mesh that was supported and anchored by 25mm galvanized thread bar anchors installed into the overburden on a 3m by 2m triangular grid spacing. The rock cuts are up to 30m high and the overburden thickness varies from about 2m to 8m. The initial excavations of the rock indicated that the dip of the major rock structure (bedding and cleavage) in the quartzite was about 65° so the cut slopes were designed to be just flatter than 65° i.e. at ½:1. As it turned out the dip varied significantly and, in some sections, the dip was flatter than the cut slope angle which resulted in local rock slope failures, which undermined Tecco mesh anchors. Slope remediation, in the form of installing rock bolts in the lower rock slopes and replacing the Tecco mesh and associated anchors, together with shotcreting, was required in these areas;

The Tecco mesh and associated anchors were designed to support the overburden at slopes of ½:1, as shown in Photograph 3. The overburden was initially assumed to be dense glacial till but some areas turned out to have a 2m to 3m thick layer of colluvium overlying the till. The anchors were designed to provide overall stability while the Tecco mesh was designed to support the face of the overburden. During construction, the till had sufficient cohesion to be stable at ½:1 in the cuts between excavation lifts while the colluvium sloughed to a flatter angle. Since construction, the Tecco mesh system has generally behaved adequately, though experience has shown that it is not practical to construct a smooth overburden face with neat “dells” at the heads of the anchors in difficult, steep terrain, so the mesh cannot be adequately tensioned against the face of the overburden. Consequently, the mesh does not provide a uniform, positive support pressure so local sloughing has developed behind the mesh in some areas.

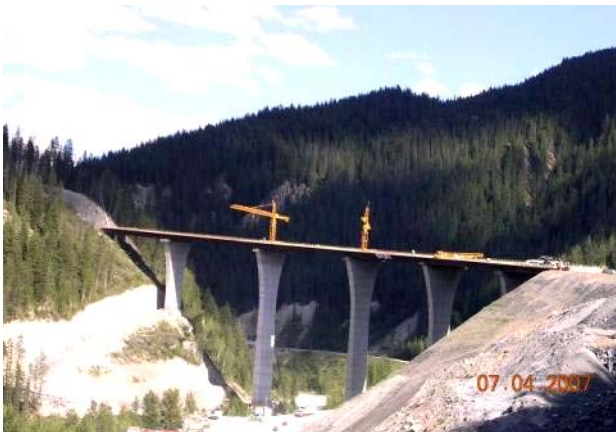
Photograph 4: New Park Bridge

The 400m long curved, steel girder New Park Bridge spans the previous highway alignment, the Kicking Horse River and CP Rail tracks. The five piers vary in height from 50m to 100m high and were labeled sequentially from the west end of the bridge to the east end of the bridge. All piers are supported on 900mm diameter piles which are socketted into rock – typically between 9m and 12m long into rock. A profile of the bridge is shown in Figure 4 and Photograph 4 and the bridge girders being launched is shown in Photograph 5.

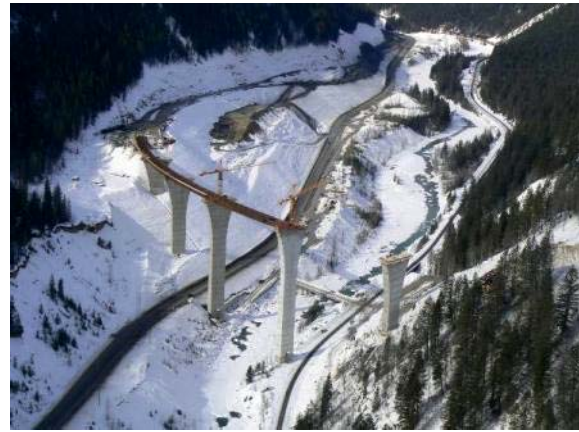
Photograph 5: Launching Bridge Beams
