Infrastructure Risk Assessment of Coastal Roads in Nova Scotia

Andrew McGillis, W.F. Baird & Associates Coastal Engineers Ltd.

Paper prepared for presentation

of the 2010 Annual Conference of the
Transportation Association of Canada

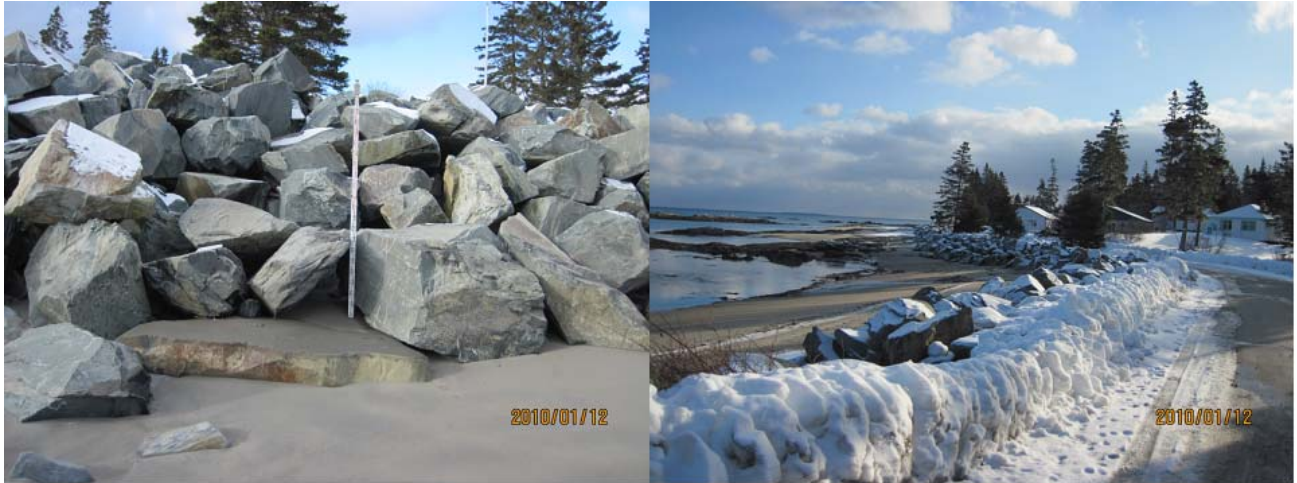
Figure 2 Ad hoc revetment at Green Bay, from beach and from road

The roadway is protected by a revetment with the characteristics provided in Table 1. Two profiles were measured at Green Bay (Figure 3). Shoaling bedrock in some locations of the site's nearshore provide some degree of natural protection, since wave energy will dissipate as it propagates over the shoals. Revetments such as this one are classified as ad-hoc dumped stone and typically have a useful life in the range of 10-15 years.

The existing roadway at Green Bay is in reasonable condition with a relatively new ad hoc armour stone revetment. The ad hoc revetment will likely provide serviceable erosion protection over the short term. When the structure fails, the existing armour stone may be re-used in a newer structure. It would be advisable and more cost-effective to implement an engineered revetment at the time of the next repair. A cross section similar to the one illustrated in Figure 9 is likely to be selected. For protection against flooding, adequate backshore drainage would provide additional benefits to assist in protection against flooding.

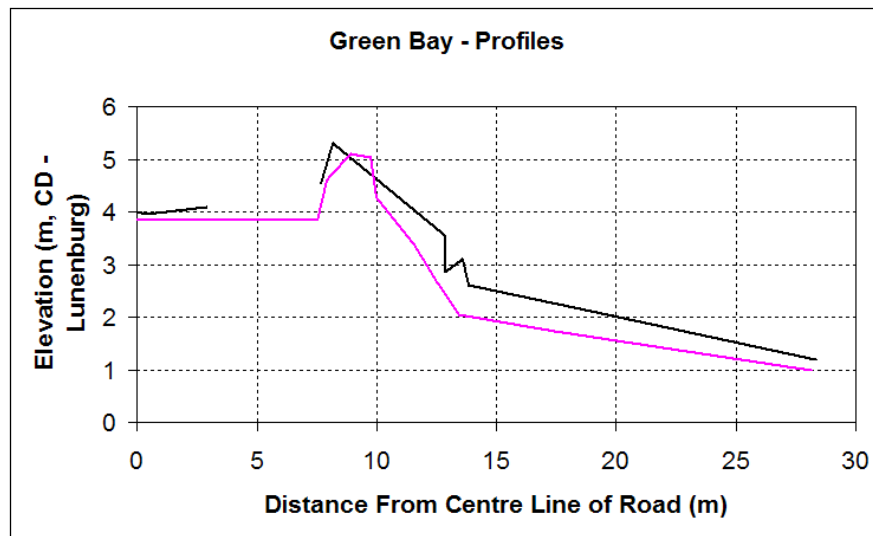
Figure 3 Profiles at Green Bay

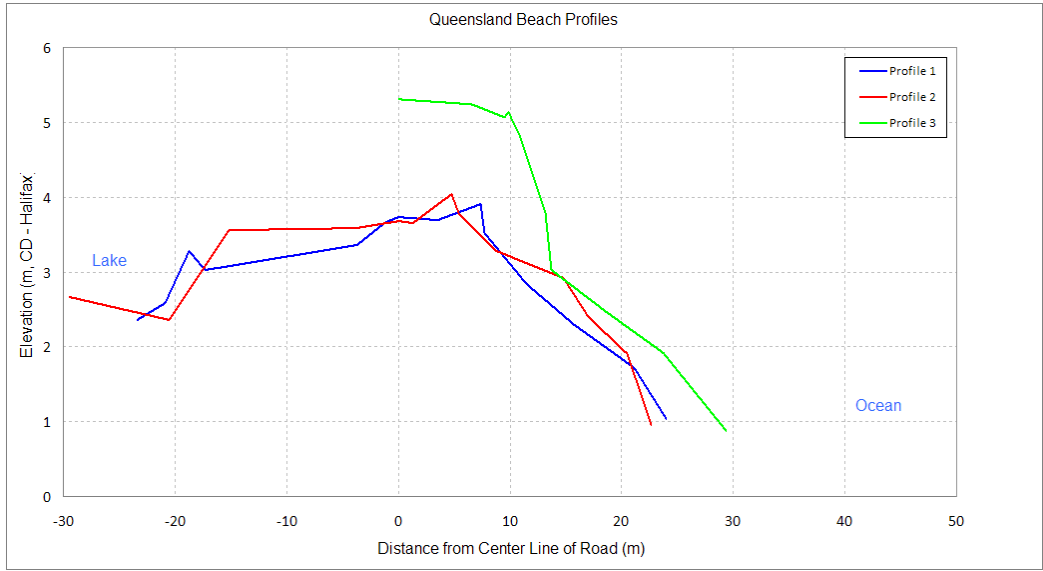
Figure 5. Profiles at Queensland Beach

Three profiles were surveyed at the site, with the results plotted in Figure 5, and physical characteristics summarized in Table 2. The east end of the site (near Profile 3) consists of much larger stone, placed to a greater elevation than the central or west end of the barrier beach, illustrated in Figure 4.

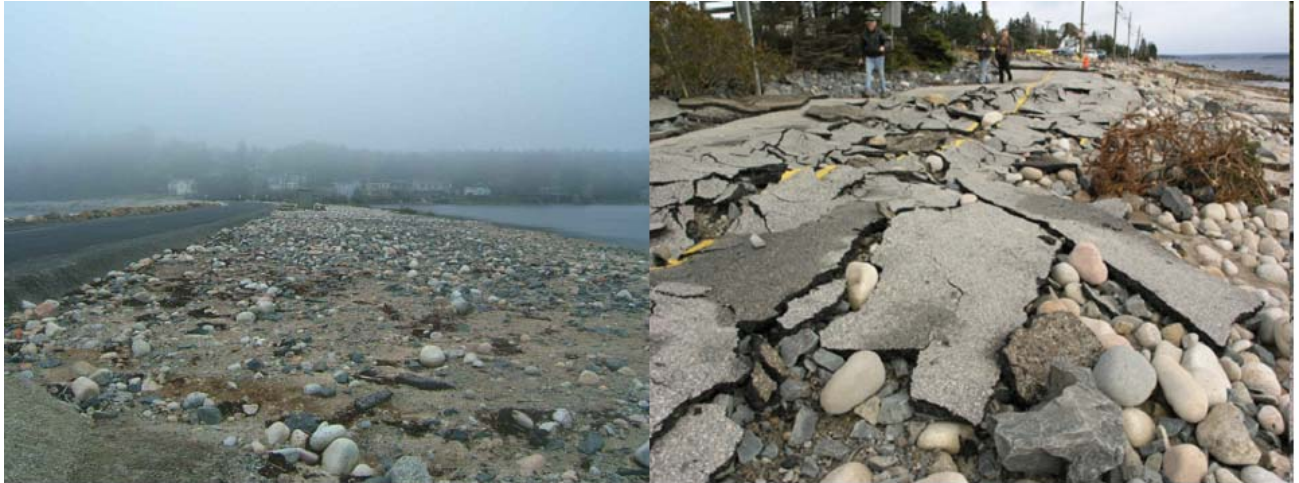
Figure 6. Damages to Queensland Beach roadway (Images courtesy NRCan 2007, NS Department of Fisheries and Aquaculture)

At present the roadway crossing Queensland Beach is at a low elevation and is subject to severe inundation and overtopping damages. The following is a list of the hazards that the roadway, parking lot, and pedestrian access structures are exposed to: *wave impacts*- the existing armour stone revetment in the low areas consists of stones that are generally undersized; increased stone size with better placement would provide for better protection and would last longer; *overtopping and flooding*- the roadway is too low, is subject to severe flooding and overtopping damages, and it is likely that this road will be damaged in the future due to an overtopping event; and, *barrier migration*- the beach exhibits many signs of a migrating barrier beach, with historic breaches and overtopping events, and this process is likely to continue.

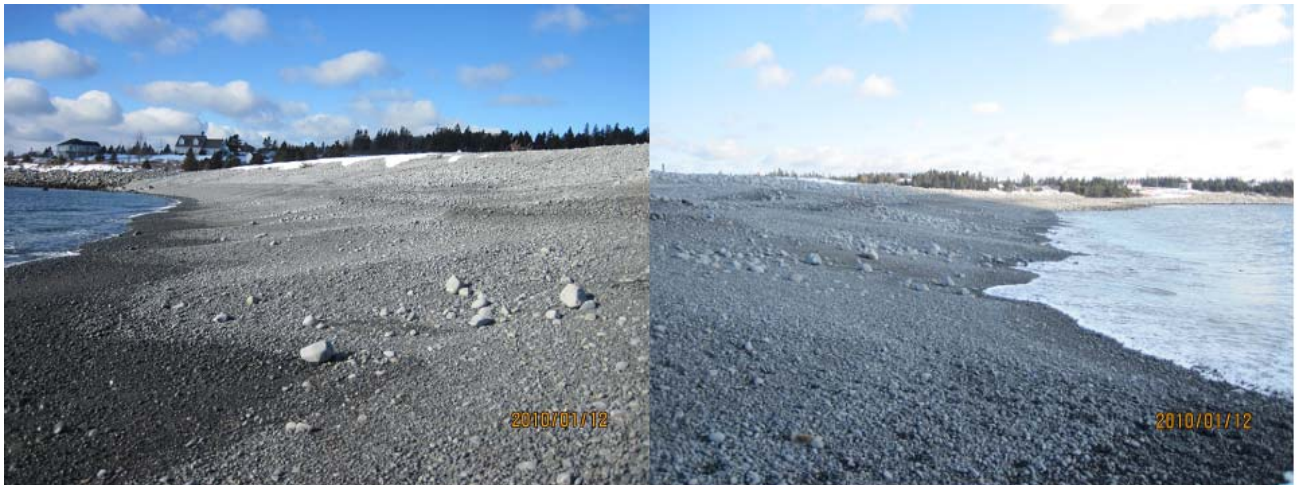
Figure 7. Sand and cobble beach at Western Head (looking west - left, and looking east - right)

The Western Head roadway crosses a sand and cobble barrier beach, as depicted in Figure 1 and Figure 7. The roadway is near the landward side of the barrier beach and is lower than the natural crest of the beach. Two profiles were measured at Western Head (see Figure 8). Profile 1 was measured in an area where the roadway has not been threatened by prior events and Profile 2 was measured in an area where a recent breach occurred and caused significant damage. During the field survey, repairs were underway to reinstate the roadway as well as protect the roadway from future storm events. The crest of Profile 1 was found to be at the same elevation as the crest of the newly installed protection measures.

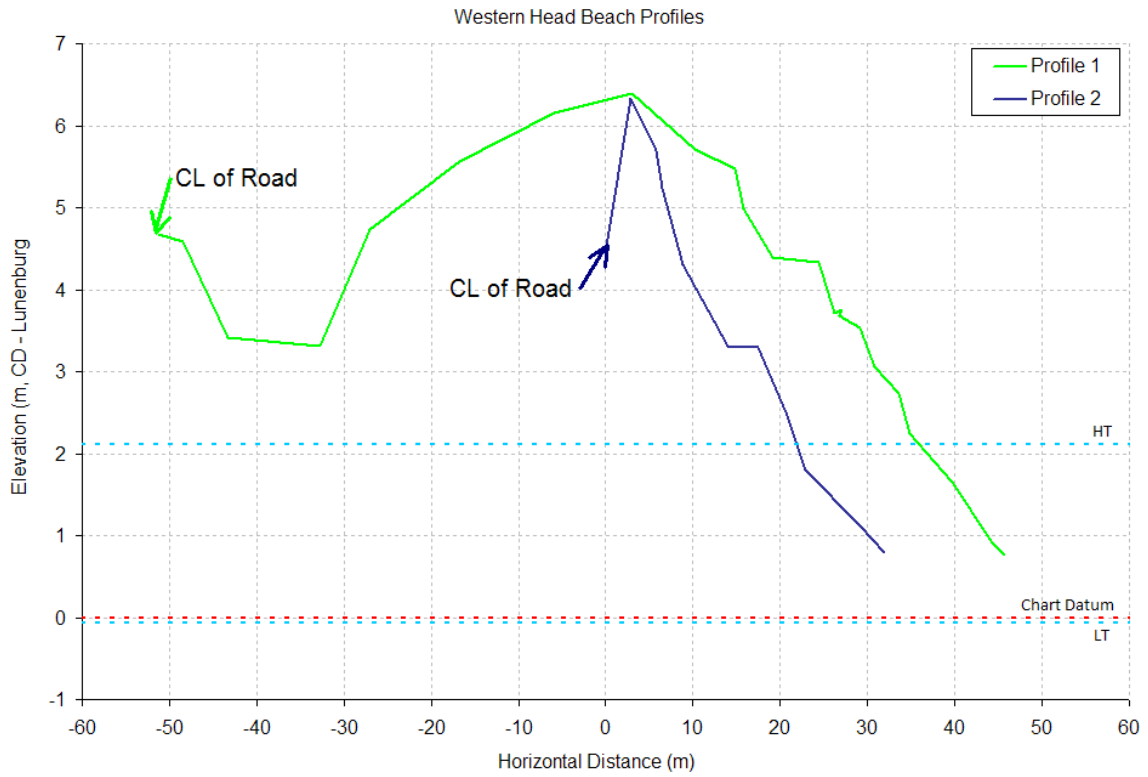
Figure 8. Profiles at Western Head

Upon review of the profiles, it was noticed that a full barrier dune is seaward of the roadway in the Profile 1 location, and that the roadway at the Profile 2 location is in the approximate location where a dynamic beach dune crest would be, if it were present at this location. The profile shape observed at the western end is closer to what would be expected with a natural barrier beach. These facts are indicative of a situation where part of the roadway infrastructure exists within the dynamic beach zone (area near Profile 2) and other portions of the roadway infrastructure exist landward of the dynamic beach zone.

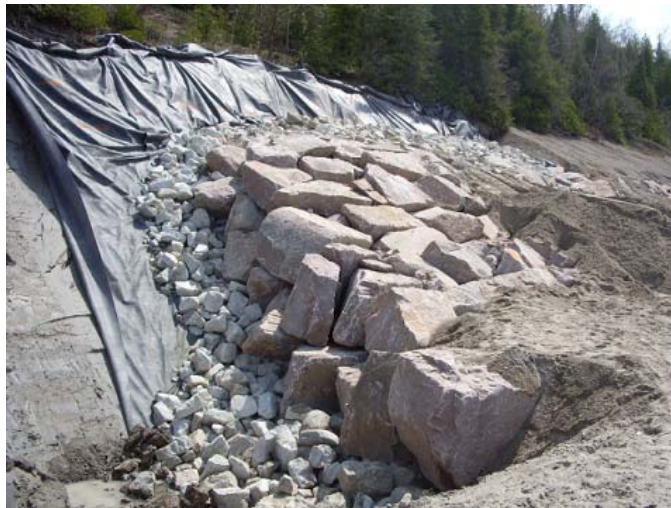
Figure 9. Example of an engineered two-layer revetment under construction
