**Evaluation of Recycled Pavement Test Sections with Alternative Surfacing Systems at the
University of Saskatchewan**

Paper prepared for presentation
at the Development of New Technologies for Classification of Materials Session
of the 2010 Annual Conference of the
Transportation Association of Canada
Halifax, Nova Scotia

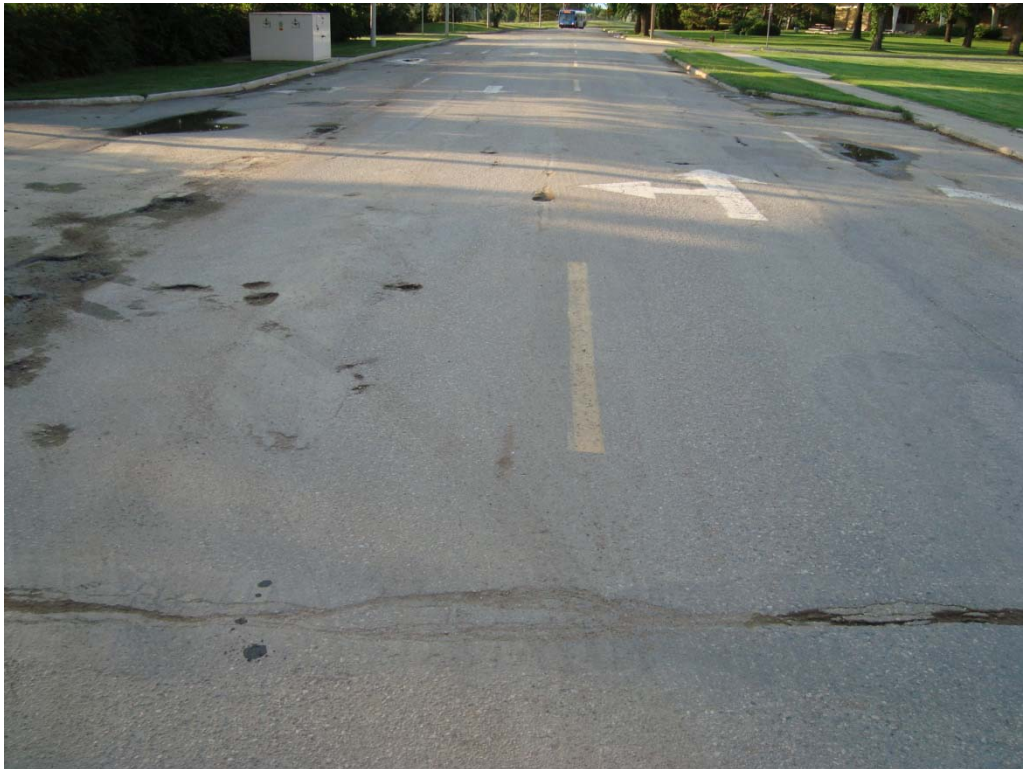
Figure 3 Typical surface distresses and structural failures of North Road – km 0.225

Prior to construction, North Road was comprised of a conventional HMAC surface on a granular base structure. As part of the pre construction survey, a digital photo log was collected to evaluate the visual condition of North Road. Figure 3 illustrates the typical surface condition of North Road. As seen in the visual condition survey, North Road surface was experiencing severe rutting, potholes, fatigue cracking, and longitudinal and transverse cracking. In addition, several locations were exhibiting full depth structural failures. It is expected that the distresses observed along North Road were due to a combination of substructure as well as surface moisture problems combined with heavy traffic loadings, specifically bus traffic.

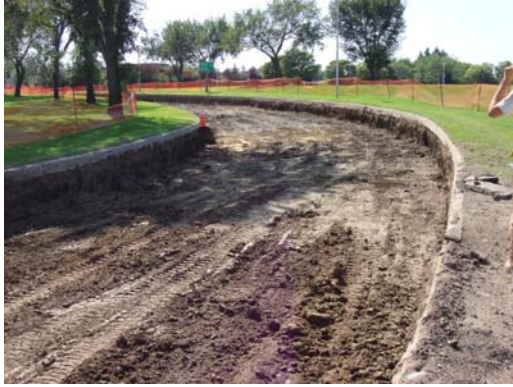
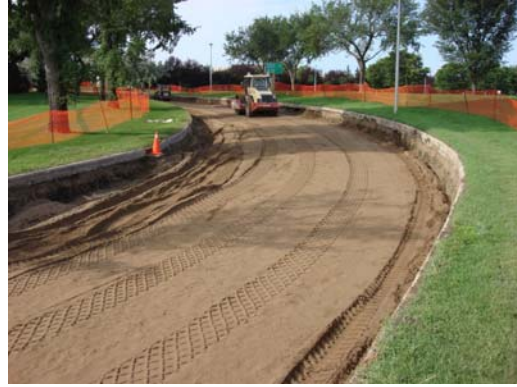
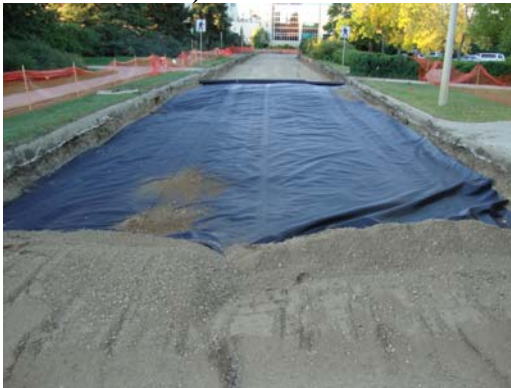
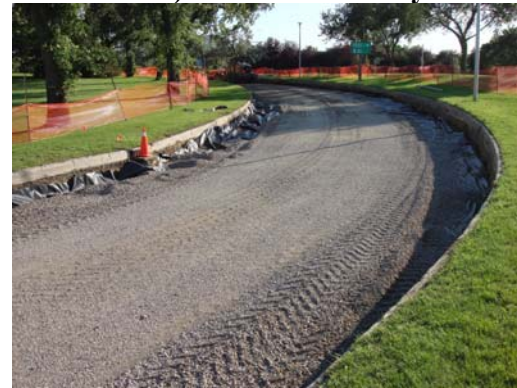
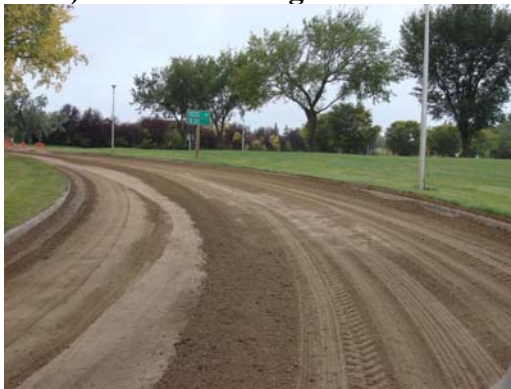
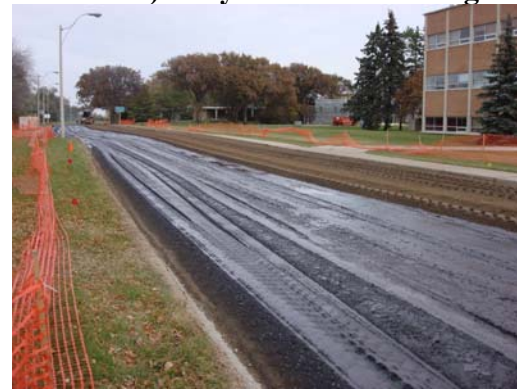
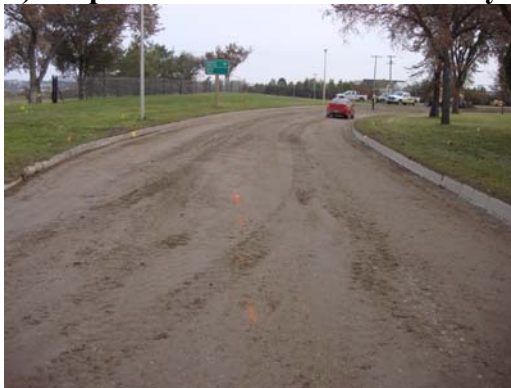
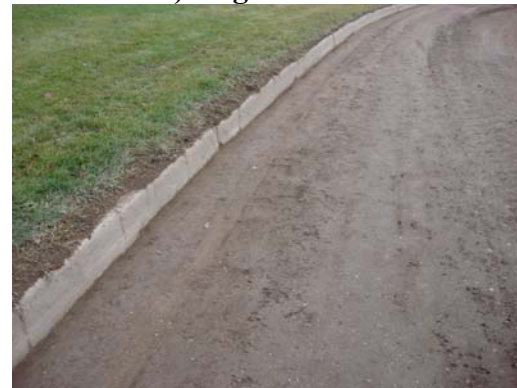
Figure 4 North Road Construction Process

A photo log documenting the North Road construction process for Section 1, Section 2, and Section 3 is presented in Figure 4. Figure 4 a) shows the excavation of the subgrade and b) shows the placement of the drainage sand subbase layer. Figure 4 c) and d) show the step-by-step installation of the geotextile fabric, weeping tile, and the PCC drainage layer. As seen in Figure 4 e) and f), the reclaimed base layer was stabilized, graded, compacted, and prepared for surfacing. Figure 4 g) and h) show the base layer prepared for surfacing and the curbing for North Road. Each surfacing system is pictured in Figure 5.

a) Excavation

b) Sand subbase layer

c) Installation of geotextile fabric

d) Recycled PCC drainage layer

e) Preparation of reclaimed base layer

f) Engineered cold mix added

g) Base layer prepared for surfacing

h) Curbing

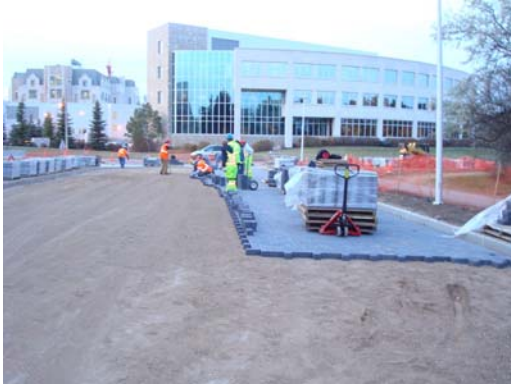
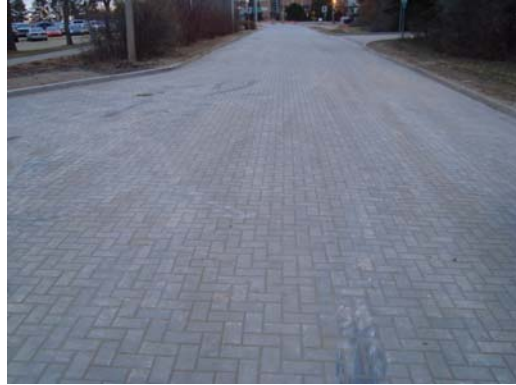
As seen in Figure 5 a), Section 1 (km 0.000 to km 0.153) was constructed with a surfacing structure of 80 mm of interlocking concrete paving stones, a 25 mm sand bedding layer, and 125 mm recycled and stabilized reclaimed asphalt concrete base shear dissipation layer. Section 2

a) Section 1 sand bedding layer (left) and final paving stone surfacing (right)

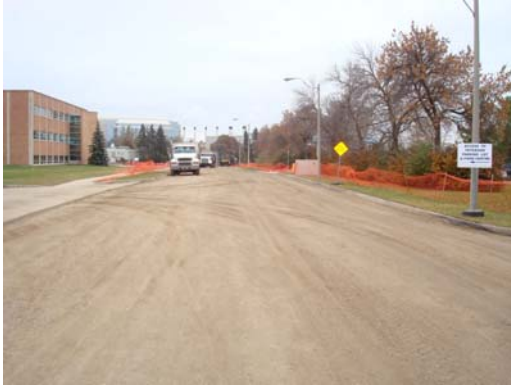
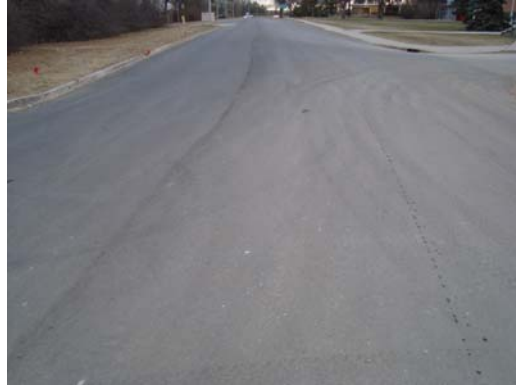
was constructed with 50 mm HMAC over 40 mm engineered cement-emulsion cold mix (Figure 5 b). Section 3 was constructed with 80 mm HMAC over the remixed and stabilized base layer (Figure 5 c).

b) Section 2 engineered cold mix layer (left) and final HMAC surfacing (right)

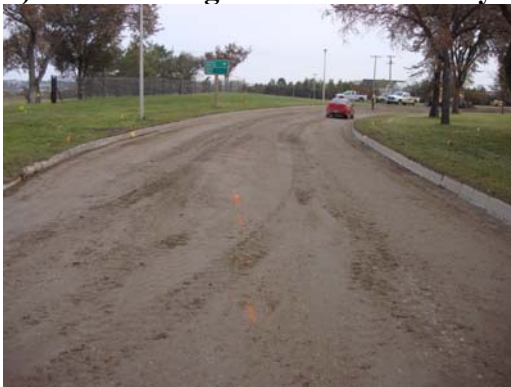
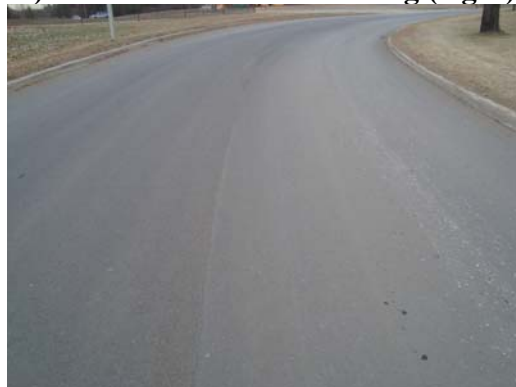
c) Section 3 stabilized reclaimed base layer (left) and HMAC surfacing (right)

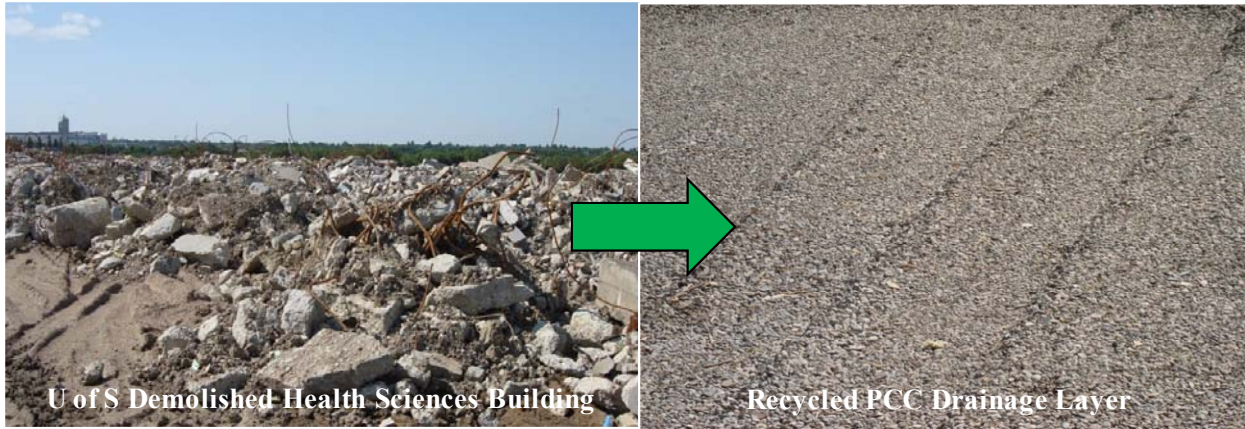
Figure 6 Rubble PCC Generated from U of S Demolished Buildings

Laboratory characterization was conducted during the reconstruction of North Road. Materials characterized during construction included the HMAC surfacing, the engineered cold mix, the *in situ* RAP used in the black base layer, the reclaimed and crushed PCC, the sand subbase, and the subgrade. All samples were retrieved during construction. The crushed PCC material was generated from on-campus buildings such as the Health Science Building and was impact crushed by PSI Technologies and used in the PCC drainage layer, as seen in Figure 6. The *in situ* RAP is a typical representative sample of the in-place HMAC and base material rotomixed and reused in the black base layer as in the engineered cold mix, as seen in Figure 7.

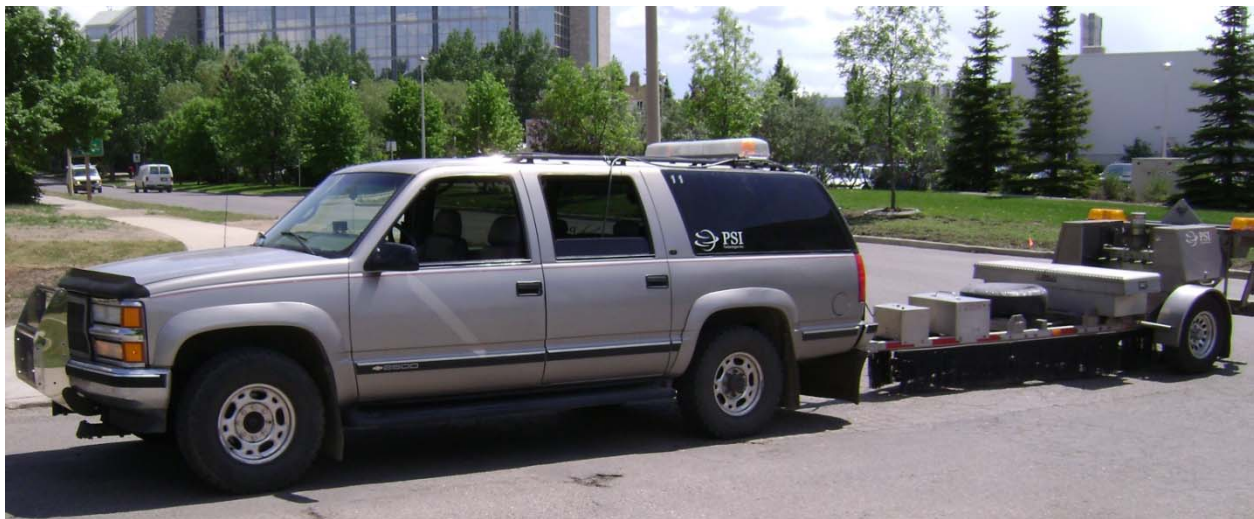
Figure 9 PSI Technologies Heavy Weight Deflectometer on North Road

Dynamic surface deflection measurements were obtained by heavy weight deflection testing, as seen in Figure 9. To characterize the structural asset condition of North Road, HWD testing was conducted under the spectra of typical commercial truck loadings ranging from secondary legal load limits to primary legal load limits plus 50 percent. Peak surface deflection and PSIPave structural index profiles were calculated based on the collected primary deflection profiles and are presented herein. Contour profiles are presented for primary weights plus 25 percent as this represents the weight of a typical, fully loaded, City of Saskatoon transit bus, of which North Road is routinely subjected.

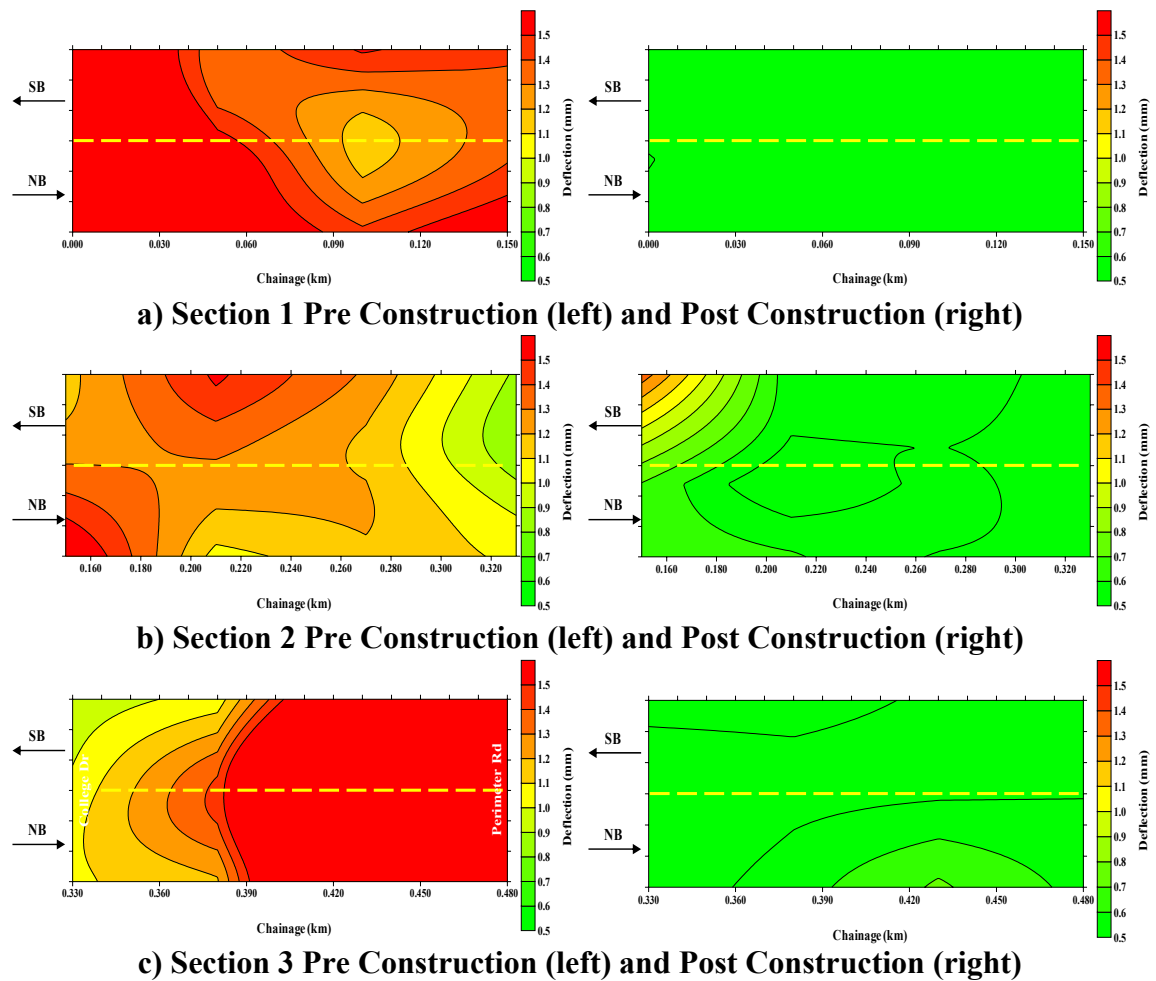
Figure 10 Peak Surface Deflection Contour Profiles at Primary + 25% Weight Limits

Figure 10 illustrates the peak surface deflection contour profiles at primary plus 25 percent weight limits of North Road both pre and post construction for Section 1, Section 2, and Section 3. Figure 11 summarizes the peak deflection results across all weight limits. Pre construction, all test sections rated fair to poor across all weight limits with significant variability across the road structure. Section 3 was especially weak pre construction towards the last end of the test section. Post construction, the peak surface deflection improved significantly and rated good across all weight limits. In addition, there was a reduction in variability across all test sections. At the beginning of Section 2, a minimal amount of variability in deflection measurements were observed at primary plus 25 percent weight limits, as seen in Figure 10. This is due to the connecting parking lot entrance at this location.

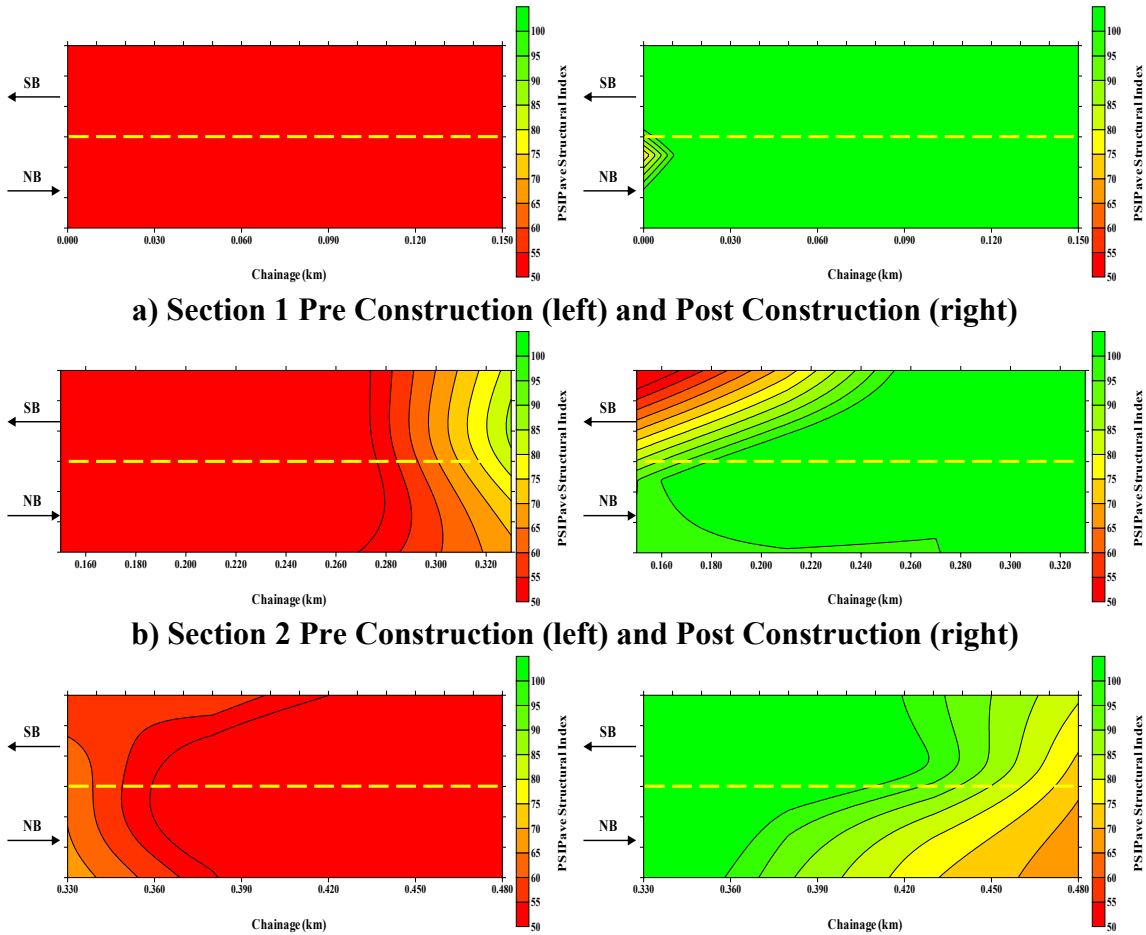
Figure 12 PSIPave Structural Index Contour Profiles

Figure 12 illustrates and Figure 13 summarizes the PSIPave structural index results of North Road both pre and post construction of all test sections. The PSIPave is a measurement of the structural integrity of the road. Pre construction, the entire length of North Road, across all test sections, exhibited poor structural condition. Post construction, the PSIPave structural indices improved significantly and rated good, as seen in Figure 12 and Figure 13. The contour profiles, as seen in Figure 12, show the same variability in Section 2 as previously noted. The PSIPave structural index exhibited some variability post construction in the northern most part of Section 3. This is most likely due to the significantly poor structural condition pre construction and the seam to the existing North Road.

a) Section 1 Pre Construction (left) and Post Construction (right)

b) Section 2 Pre Construction (left) and Post Construction (right)

c) Section 3 Pre Construction (left) and Post Construction (right)
