Pavement Assessment and Design Methodologies Used for the Rehabilitation of Urban Pavements in The City of Calgary, Alberta

Nader Nabhani, M.Sc., M.Eng., P.Eng.
Pavement Engineer, Engineering Practice
EBA Engineering Consultants Ltd.
Calgary, Alberta

Joe Chyc-Cies, P.Eng.
Materials & Research Engineer
City of Calgary, Roads
Calgary, Alberta

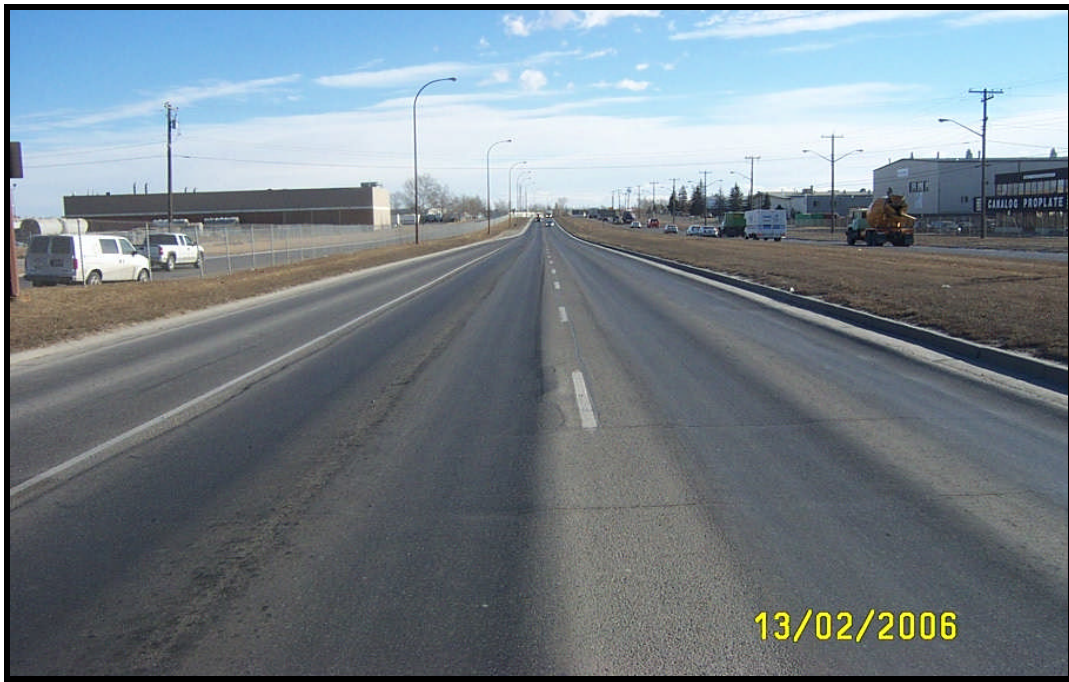
Figure 2. Barlow Trail, northbound lanes, between 61 Avenue and 50 Avenue, high severity wheel-path rutting.

- Segment A (km 0.0 to km 1.65), northbound lanes, from 61 Avenue to 50 Avenue: Medium to high severity wheel-path rutting (more severe at intersections), edge cracking, and moderate severity ravelling at 61 Avenue and 50 Avenue intersections.

Figures 2 and 3 represent some of the typical distresses for the subject section of Barlow Trail.

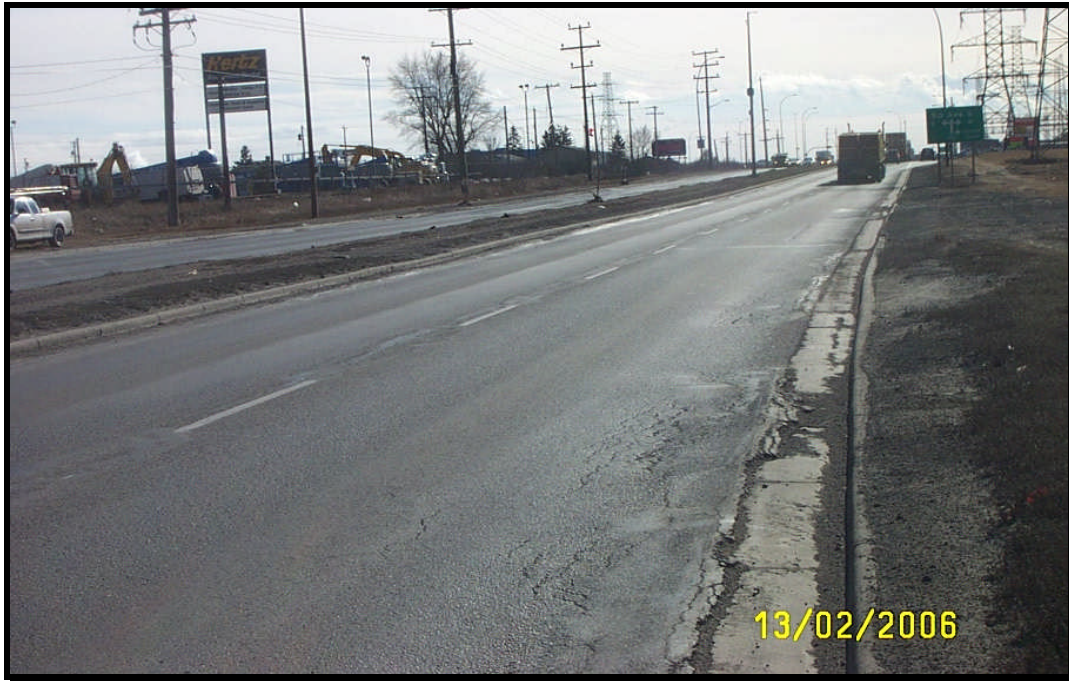
Figure 3. Barlow Trail, southbound lanes, between 50 Avenue and Peigan Trail, fatigue cracking in the outer wheel-path along curb lines, medium severity wheel-path rutting

- Segment E (km 1.65 to km 2.40), southbound lanes, from 50 Avenue to Peigan Trail: Fatigue (alligator) cracking primarily in the outer wheel-path along curb lines with patching and shoving, medium severity wheel-path rutting (low severity where milled), frequent high severity transverse and medium severity longitudinal cracking, edge cracking.

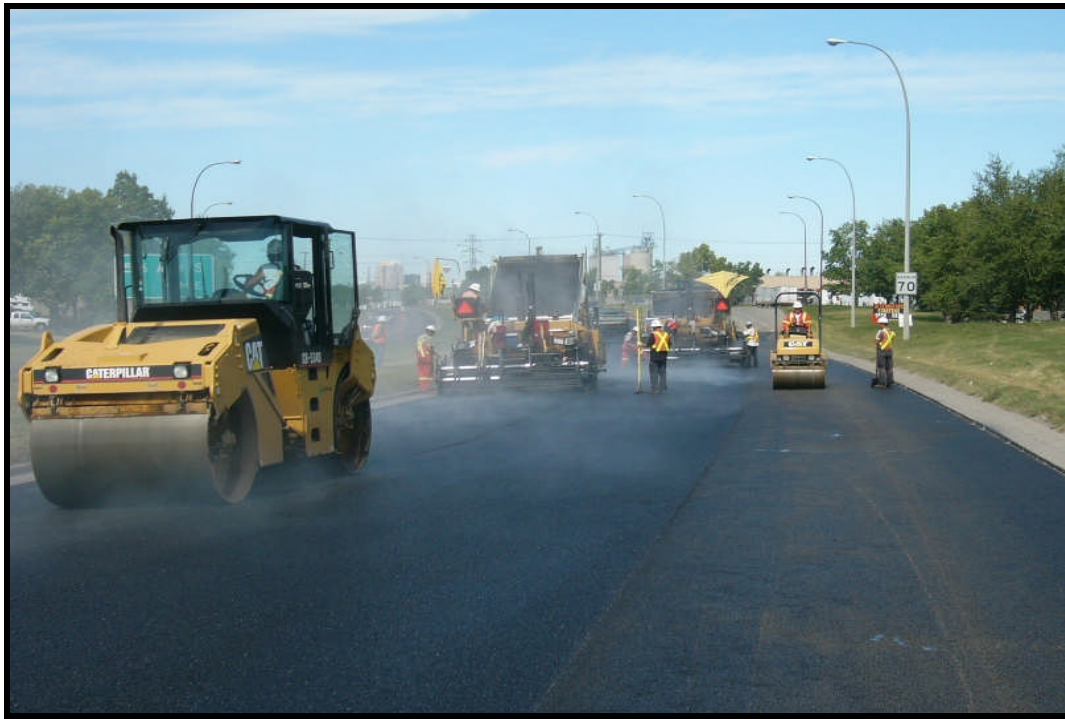
Figure 4. Barlow Trail Paving, northbound lanes, south of 61 Avenue.

The 50 Avenue to 61 Avenue section of Barlow Trail paving was undertaken on August 26 and 27 on the northbound lanes and September 2, 2006, and September 3, 2006, on the southbound lanes (Figure 4). The paving was undertaken during two weekends to minimize traffic disruption. The rehabilitation included milling of the existing pavement to a typical depth of 60 mm in the southbound lanes and 100 mm in the northbound lanes. In the southbound lanes, the milling and replacement depth was increased to 100 mm within intersection areas. Based on the monitoring, the level of organization, dedication to quality and workmanship associated with the SMA installation exceeded industry standards. This resulted in to date high performance of the rehabilitation for this section. The 50 Avenue to Peigan Trail section was reconstructed in 2008/2009 in conjunction with an AT upgrading of the Barlow/Peigan/Deerfoot Trail (Highway 2) Interchange. The construction was in accordance with the recommendations provided to The City, including Superpave specified mixes with an SMA surfacing. To date, the early performance of this section is very good (Figure 5).

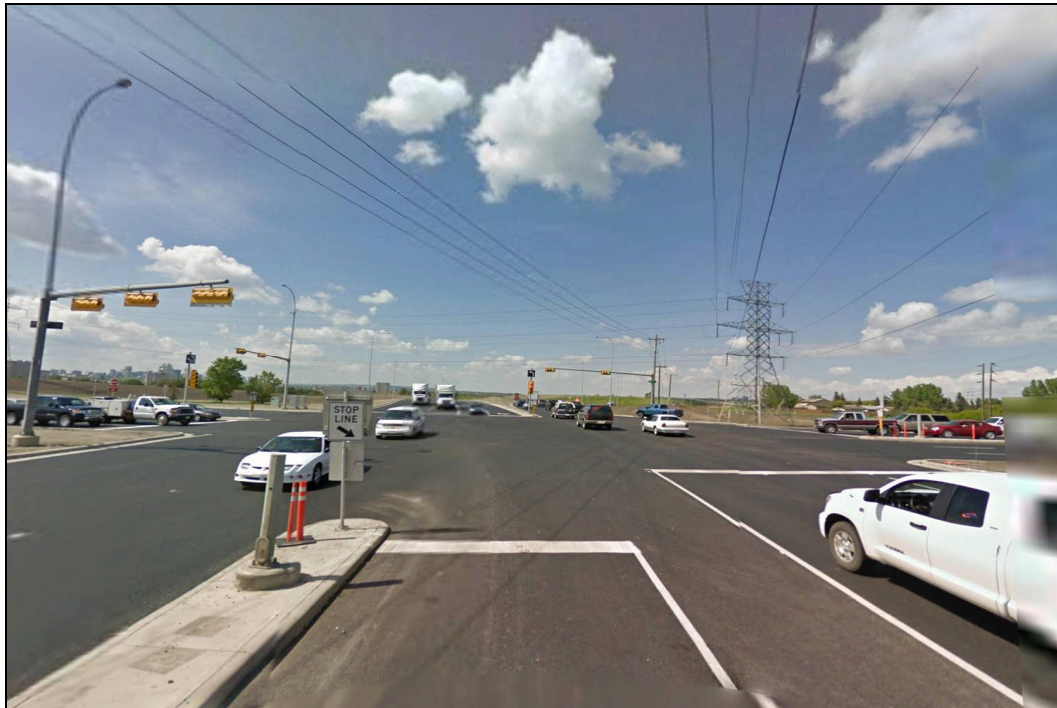
Figure 5. Barlow Trail Reconstruction (2009), between 50 Avenue and Peigan Trail.

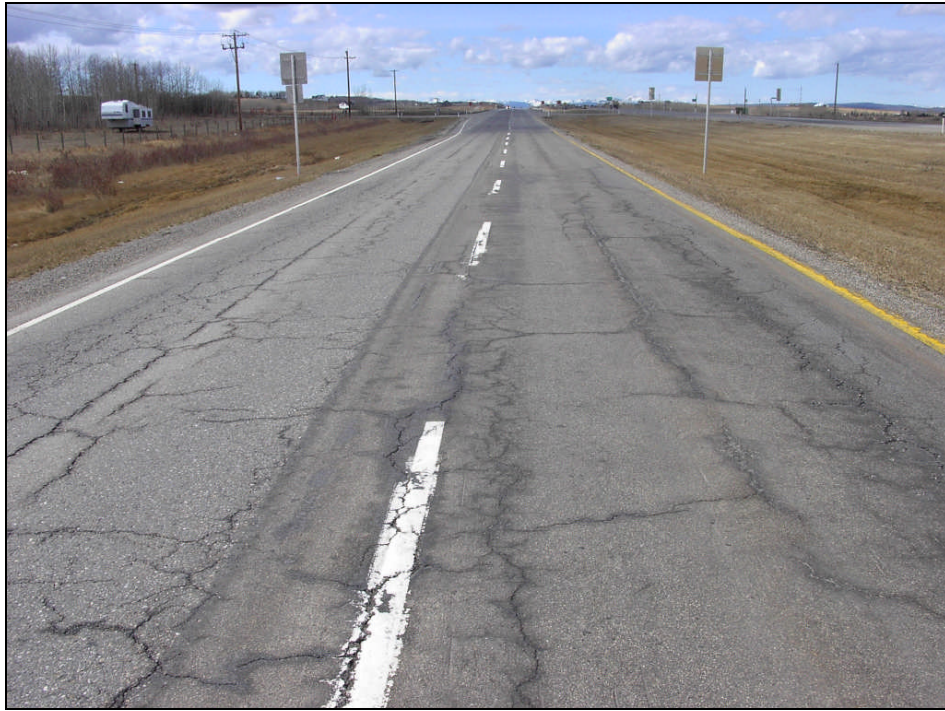
Figure 6. Typical Pavement Condition, Spruce Meadows Boulevard Eastbound.

A detailed visual condition survey was undertaken for both lanes in each direction of travel. Based on the visual condition survey, the primary distresses in the eastbound lanes were longitudinal and transverse cracking, which were medium to high severity and extensive (50% density and higher). Other less extensive distresses were high severity alligator cracking and low to medium severity rutting.

Photographs illustrating the condition of the eastbound and westbound lanes are provided in Figures 6 and 7, respectively.

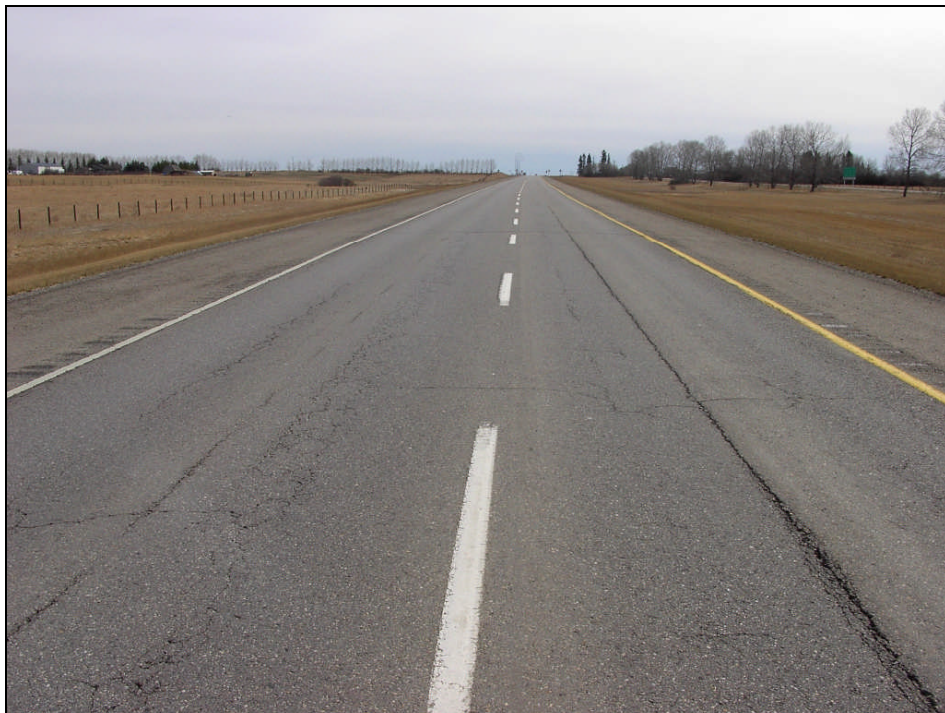
Figure 7. Typical Pavement Condition, Spruce Meadows Boulevard Westbound.

The most predominant distresses in westbound lanes were medium severity longitudinal cracking and low severity rutting throughout the section. Transverse cracking of varying severity effected about 7% of the section.

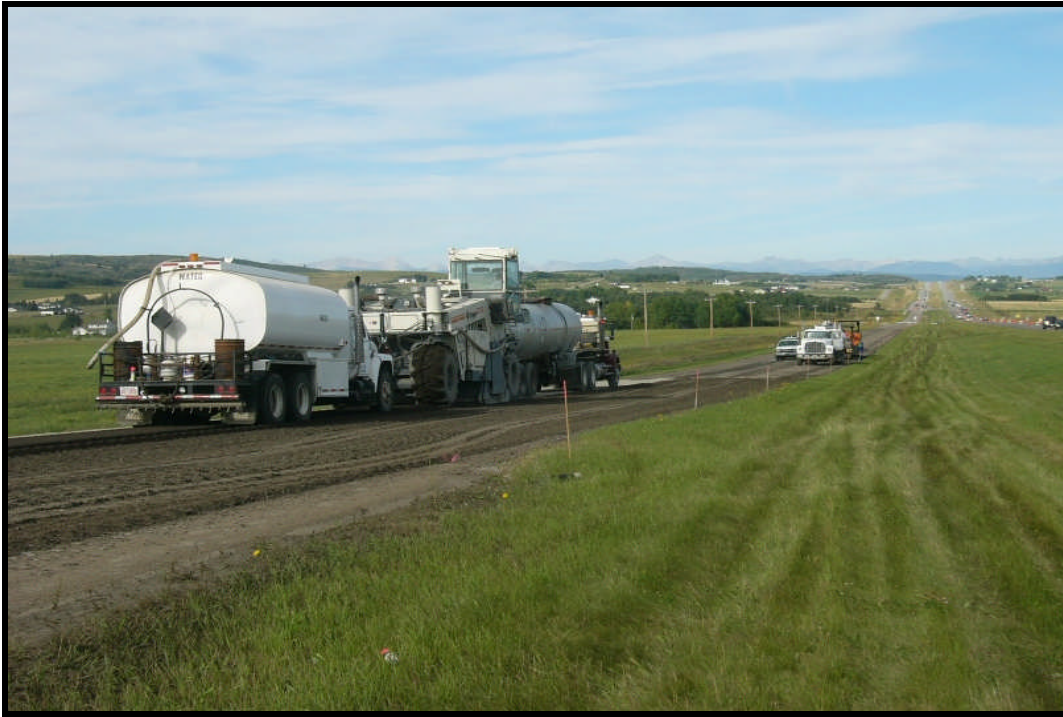
Figure 8. Spruce Meadows Boulevard Eastbound Lanes – FDR Construction

Due to the requirement to increase pavement width and recognizing the poor pavement condition, a FDR Design Alternative was selected for the eastbound lanes, with the following design structure:

Construction was undertaken in 2006 for both the eastbound and westbound lanes. Figure 8 shows the FDR construction in the eastbound lanes.
