## **Innovative Culvert Asset Management and Relining**

Paper prepared for presentation  
at the Managing the Risk of Aging Infrastructure in the  
Face of Climate Change and Budgets Session  
of the 2010 Annual Conference of the  
Transportation Association of Canada  
Halifax, Nova Scotia

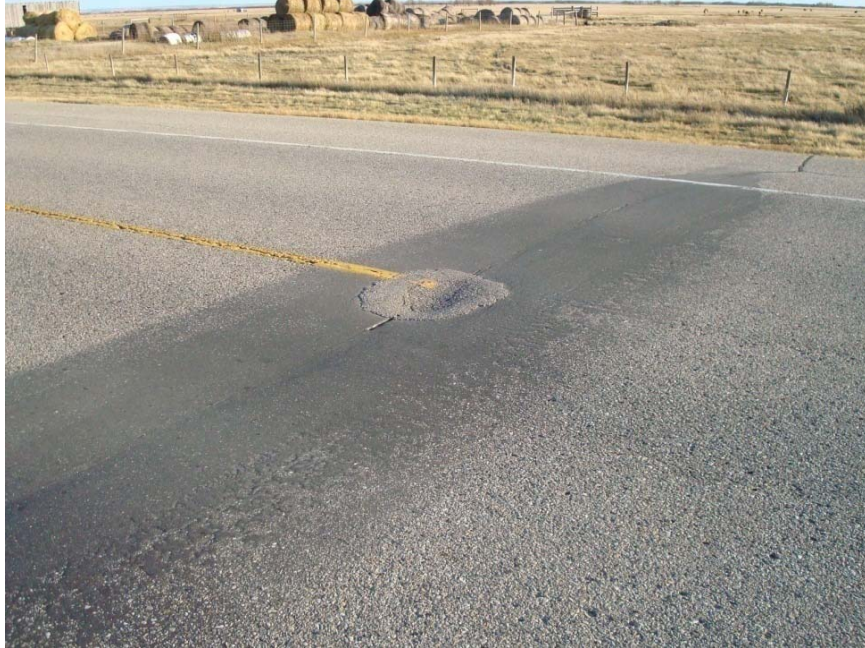
Figure 1 shows a typical road minor top cavitation as a result of a culvert joint separation failure and the corresponding crown material loss and settlement. Culvert failure can occur in conjunction with conditions that overwhelm the existing capacity and/or structural integrity of the culvert. The Saskatchewan Ministry of Highways and Infrastructure has surveillance protocol in place to monitor and mitigate any potential safety concerns with regards to culverts.

**Figure 1** Surface cavitation as a result of culvert joint failure

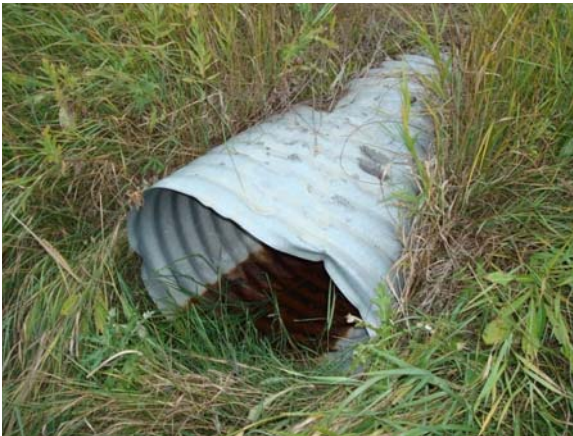
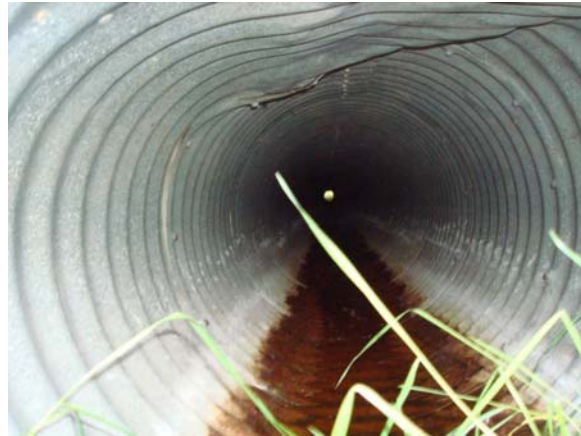
Three CSP culverts in need of rehabilitation were selected as candidates for relining in October 2009. The solution involved rehabilitating existing culverts with grout in-place HDPE pipe, specifically designed for the purpose of relining culverts. The three culverts were rehabilitated in with an HDPE culvert liner and were located in Saskatchewan on Control Section (C.S.) 16-16 at km 1.400, km 10.950, and km 11.400. Figure 2 through Figure 4 illustrates photos of the existing culverts taken during a culvert inspection in October 2009, as detailed below. Figure 2 shows the CSP culvert at km 1.400 (diameter of 600 mm). Figure 3 shows the CSP culvert at km 10.950 (diameter of 600 mm). Figure 4 shows the CSP culvert at km 11.970 (diameter of 600 mm).

**a) Culvert end (km 1.400)**

**b) Culvert interior (km 1.400)**

**Figure 2** CSP culvert at km 1.400 (diameter of 600 mm)

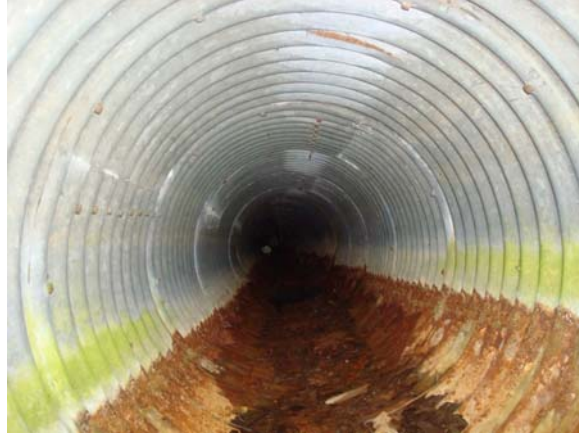
**Figure 3** CSP culvert at km 10.950 (diameter of 600 mm)

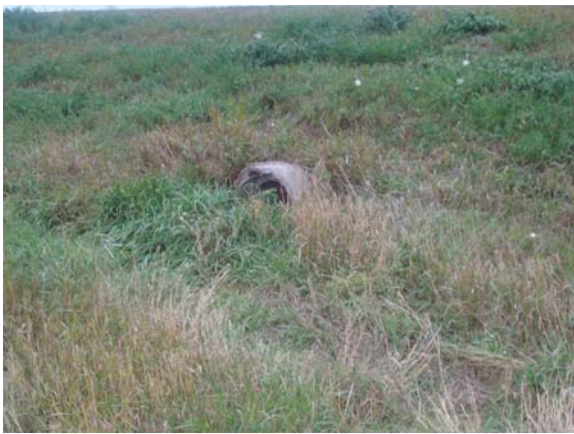
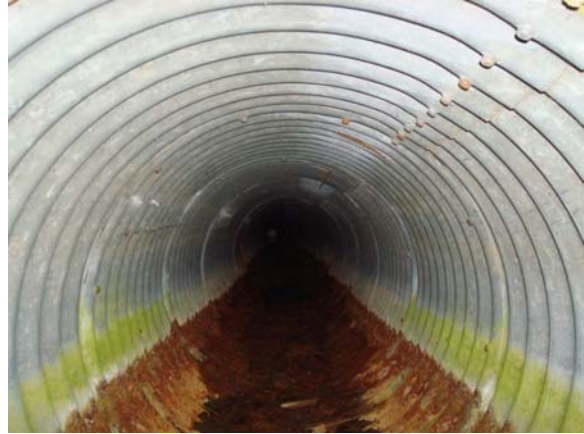
**a) Culvert end (km 11.970)**

**b) Culvert interior (km 11.970)**

**Figure 4** CSP culvert at km 11.970 (diameter of 600 mm)

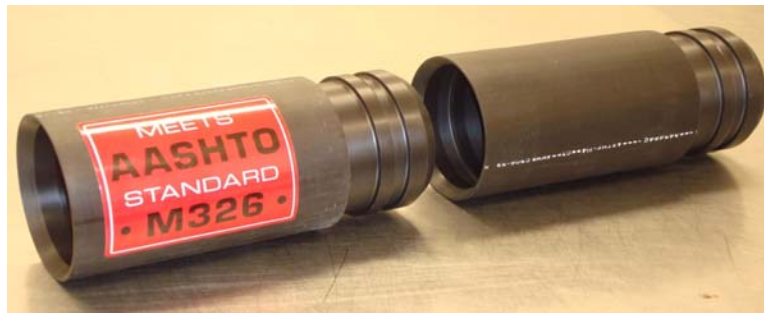
Snap-Tite® HDPE pipes are engineered to reline culverts. Snap-Tite® is a culvert relining product that can significantly improve the cost effectiveness of culvert remediation and/or replacement. Snap-Tite® is a product that has been specifically engineered for use as a culvert relining material. Figure 5 presents a photo of the unique Snap-Tite® joint design. Snap-Tite® technology has the following benefits (1, 2, 3):

**Figure 5** Snap-Tite® joint design

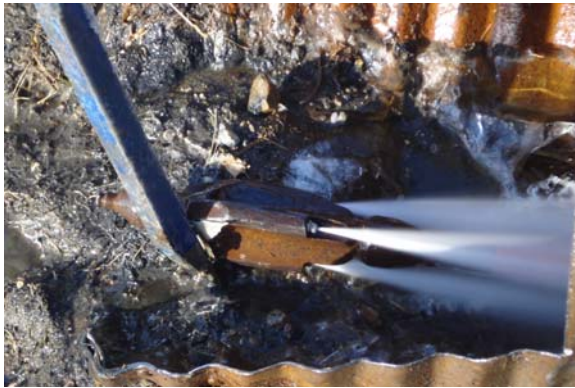
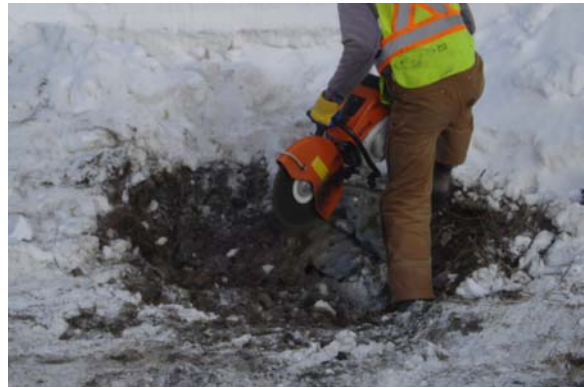
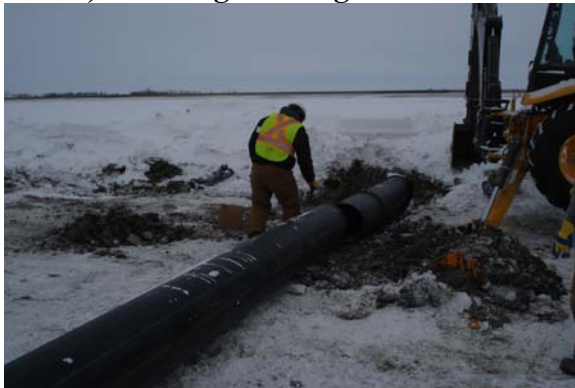
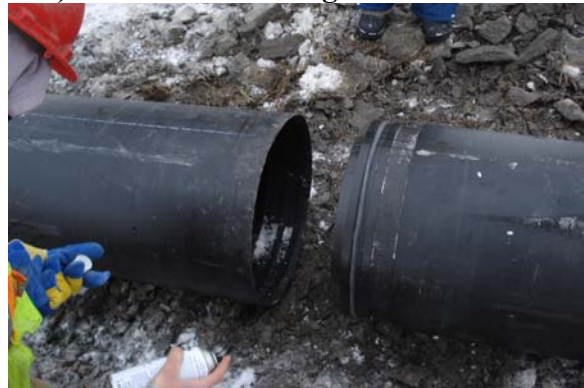
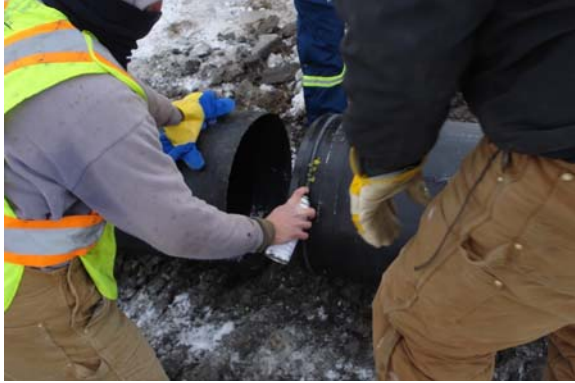
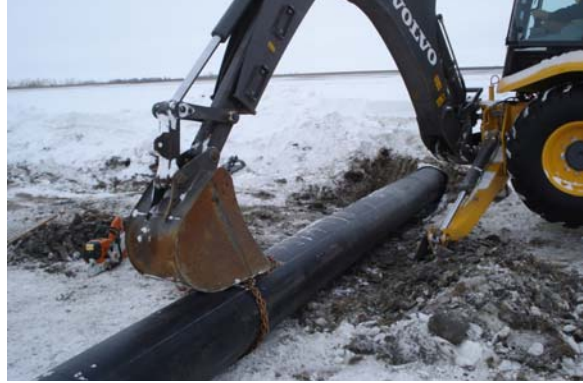
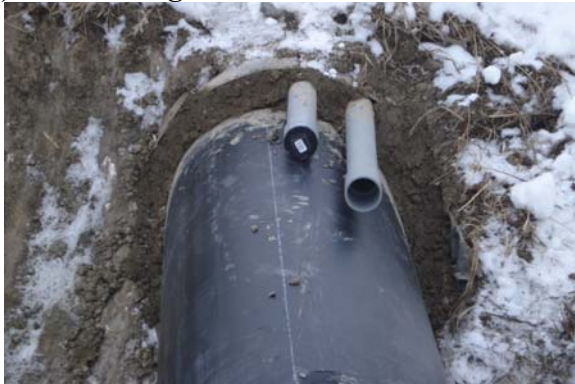
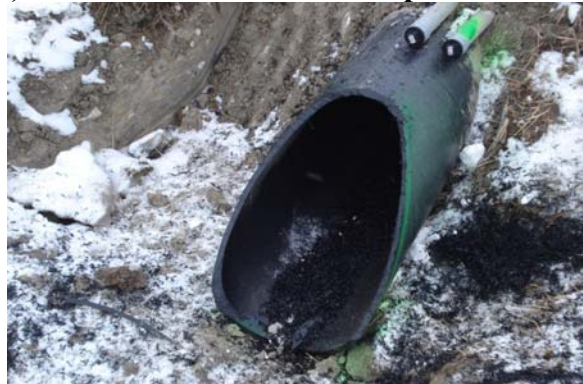
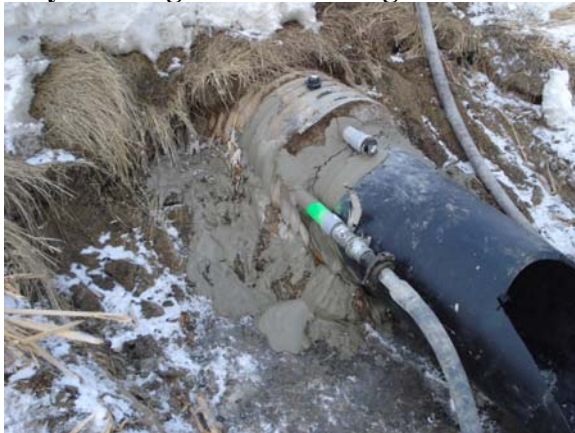
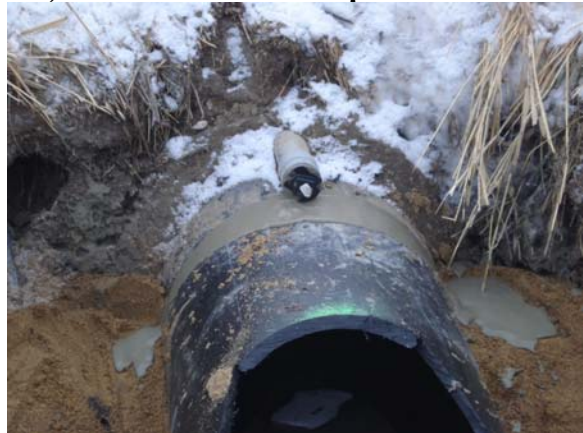
**Figure 7 Installation Process of Snap-Tite® culvert liners (continued next page)**

**Installation Process of Snap-Tite® culvert liners**

Initially, each existing CSP culvert was inspected for obstructions, debris, and dirt. As pictured in Figure 7 a), dirt and debris was removed as necessary from the existing CSP culvert using a hydro-vac machine. If the existing CSP culvert was already clean, hydro-vac cleaning was not required. As pictured in Figure 7 b), the damaged ends of the existing CSP culvert were removed to allow for the Snap-Tite® culvert liner to be inserted.

Figure 7 c) shows one of the HDPE culvert liners inserted into the CSP culvert with the second Snap-Tite® culvert liner positioned against the first liner. Figure 7 d) shows the Snap-Tite® culvert liners aligned and Figure 7 e) shows the lubrication of the end of the Snap-Tite® culvert liner.

Figure 7 f) shows the Snap-Tite® culvert liner being inserted into the existing CSP culvert. The liner was pushed into the CSP culvert until it was completely lined. When the culvert was completely lined, the ends of the culvert were sealed using a cement grout and pipes were inserted to drain water, vent air, and allow for the installation of grout, as pictured in Figure 7 g). The ends of the Snap-Tite® culvert liner were trimmed as seen in Figure 7 h). The annular space between the CSP culvert and the Snap-Tite® culvert liner was then grouted, as pictured in Figure 7 i). Figure 7 j) shows the Snap-Tite® lined culvert with grouting in place.

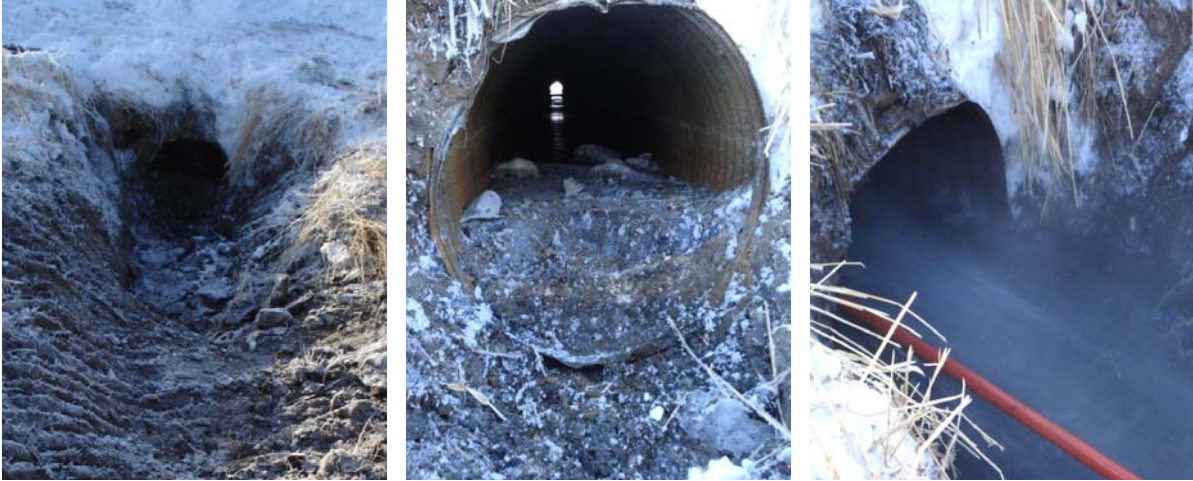
The existing CSP culvert located on C.S. 16-16 at km 1.400 had an average diameter of 600 mm. It was approximately 34 m in length. The existing CSP culvert was significantly plugged with mud and debris and its end was partially submerged, as pictured in Figure 8 a) and b). Before relining with the Snap-Tite® culvert liner, the CSP culvert was cleaned out using the hydro-vac machine, as pictured in Figure 8 c). It was found that the hydro-vac machine cleaned the culvert out sufficiently and effectively. The Snap-Tite® culvert liner used in the rehabilitation was 500 mm in diameter. Based on the area of the annular space between the CSP culvert and the Snap-Tite® liner as well as the length of the culvert, the estimated volume of grout required was  $3.6\text{ m}^3$ . However, the volume of grout used in the field to fill the annular space was  $4.8\text{ m}^3$ . Therefore, it is approximated that  $1.2\text{ m}^3$  of grout was expelled into the void spaces in the backfill of this culvert.

a) Culvert end submerged      b) Culvert plugged with debris      c) Cleaning culvert  
**Figure 8      CSP Culvert at km 1.400**

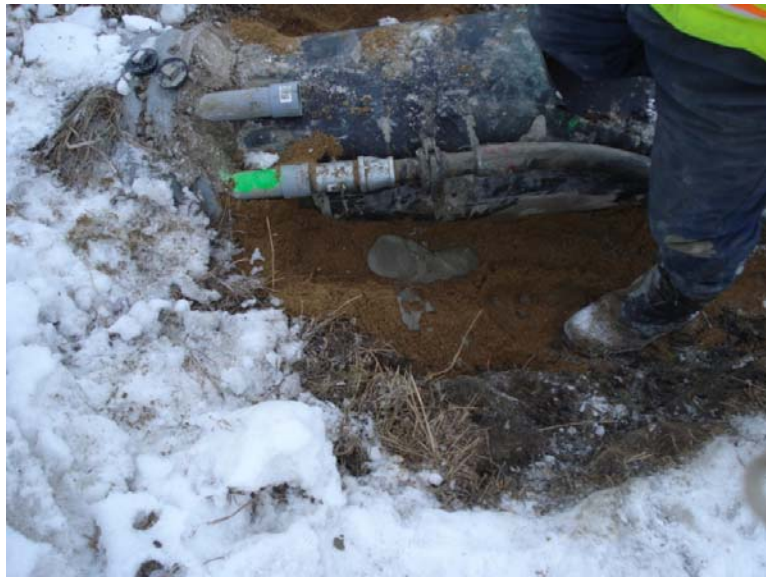
During the grouting process on C.S. 16-16, it was found that more grout was used for each of the three culverts than initially calculated expected. This was particularly the case for the CSP culvert at km 10.950 where the grout expelled from the backfill surrounding the CSP culvert; twice as much grout was used than anticipated. The existing CSP culvert at km 10.950 had been very corroded and had localized voids, similar to the schematic illustrated in Figure 6. In this case, there were voids within the backfill and the grout filled these voids. The timely rehabilitation of culverts improved the structure surrounding the culvert and mitigates the risk of a severe structural failure in the foreseeable future (2).

**Figure 9      Grout Expelled Out of the Backfill at km 10.950**

The existing CSP culvert located on C.S. 16-16 at km 10.950 had an average diameter of 600 mm. It was approximately 34 m in length. The Snap-Tite® culvert liner used in the rehabilitation was 500 mm in diameter. Based on the area of the annular space between the CSP culvert and the Snap-Tite® liner as well as the length of the culvert, the estimated volume of grout required was  $3.6\text{ m}^3$ . However, upon initial grouting it was visible that grout was expelling out backfill around the CSP culvert, as seen in Figure 9. An initial volume of  $3.1\text{ m}^3$  of grout was left to set. Upon allowing time for partial setting, an additional  $2.3\text{ m}^3$  of grout was pumped into the annular space and backfill voids.

The total volume of grout required for the culvert rehabilitation at km 10.950 was 5.4 m<sup>3</sup>. Therefore, it is approximated that 1.8 m<sup>3</sup> of grout was expelled into the void spaces in the backfill of this culvert (based on an estimated 3.6 m<sup>3</sup> required).

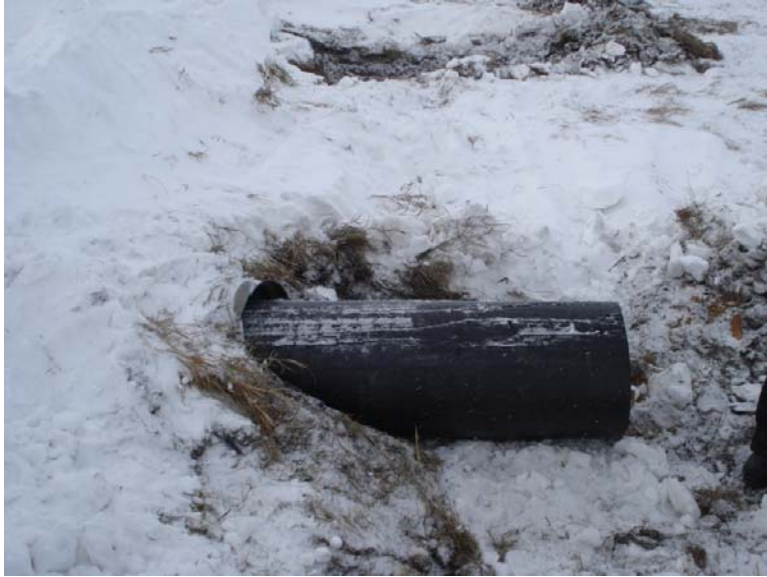
The existing CSP culvert located on C.S. 16-16 at km 11.970 had an average diameter of 600 mm. It was 34 m in length. Figure 10 shows the installation of the Snap-Tite® line at this location. The Snap-Tite® culvert liner used in the rehabilitation was 500 mm in diameter. Based on the area of the annular space between the CSP culvert and the Snap-Tite® liner as well as the length of the culvert, the estimated volume of grout required was 3.6 m<sup>3</sup>. However, the volume of grout used in the field to fill the annular space was 4.7 m<sup>3</sup>. Therefore, it is approximated that 1.1 m<sup>3</sup> of grout was expelled into the void spaces in the backfill of this culvert.

**Figure 10**      **Installation of Snap-Tite® Liner at km 11.970**
