Pervious Concrete Pavement Performance in Field Applications and Laboratory Testing

Session: Permeable Pavement Design and Technology

May 2010

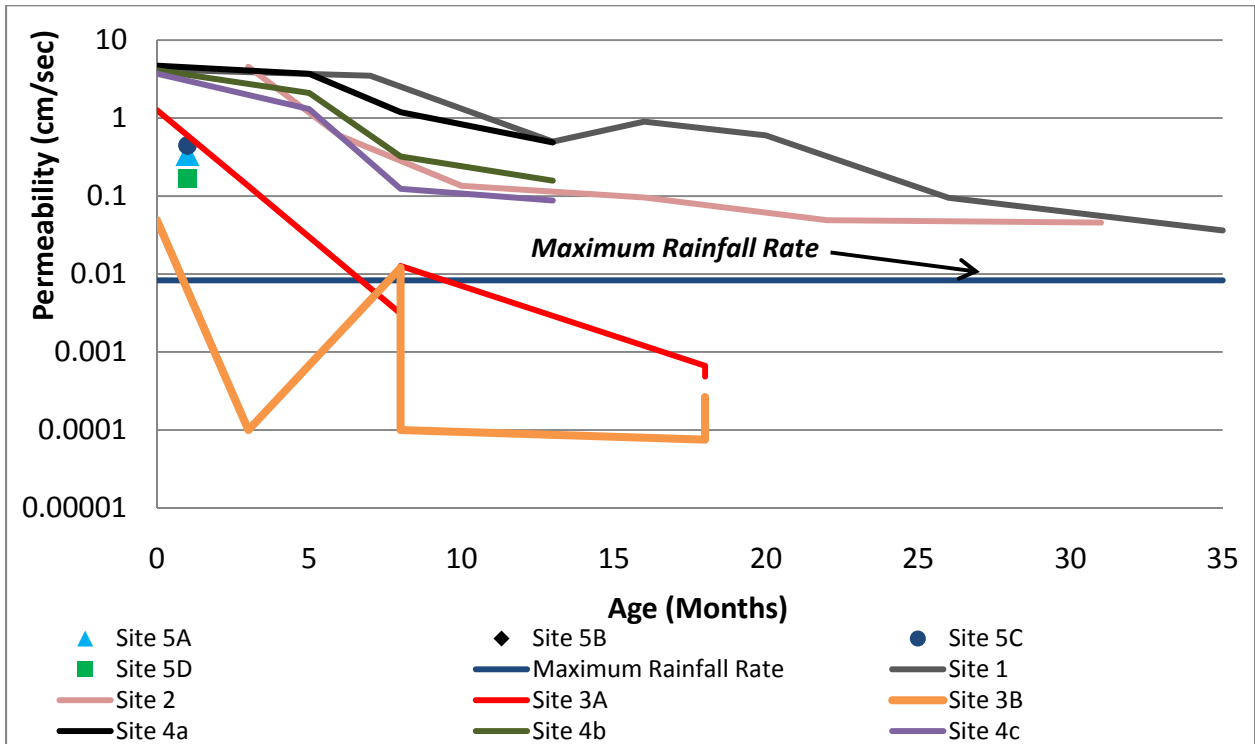
Figure 2: Site Permeability

Permeability testing is carried out at all sites multiple times each year. Testing is done using a permeameter which allows the user to record the amount of time required to drain a specific quantity of water from the surface. The permeameter is sealed to the surface using putty to ensure that water moves into the pavement structure and does not seep horizontally on the surface. Testing is carried out three times on at least 25 points that are distributed across the site during each testing session. Figure 2 shows the permeability of each site section since construction. The maximum rainfall rate that is experienced at any of the sites is noted on Figure 2 and is 0.0083cm/sec.

As Figure 2 shows most of the sites are well above the maximum rainfall rate and continue to perform adequately with no maintenance. Site 3 started with a lower permeability rate than some of the other sites and efforts have been made to renew the permeability. As is shown in Figure 3, the permeability has been increased slightly and this was done with sweeping and vacuuming of the surface. The use of a power washer was evaluated however proved to decrease the permeability of the surface rather than increase it [Henderson, 2010]. Other rehabilitation maintenance has been trialed at various sites for research purposes. The other four sites have not required rehabilitation maintenance to date. The results of this research can be found in Henderson et al, 2010. Further rehabilitation maintenance is planned for 2010 as portions of Sites 1 and 2 are now performing below the required rate.

The three mixes at Site 4 are all showing similar decreases in permeability however at different rates. Mix 4A continues to maintain the highest permeability and contains the smallest aggregate. Mix 4B has the next highest permeability and only one type of aggregate, 20mm gravel. The third mix is more than adequate but has the lowest permeability of the three and has two types of 20mm aggregate, gravel and crushed limestone. While these trends may be solely related to the mix type it is also important to note two other features. The mixes were placed in the following

order, 4A, 4B, 4C. As construction progressed it became more efficient, perhaps producing a denser material with less voids. In addition, Mix 4C is adjacent to the yard at the concrete plant and therefore has the most sand materials being tracked on to it from vehicles and snow removal equipment.

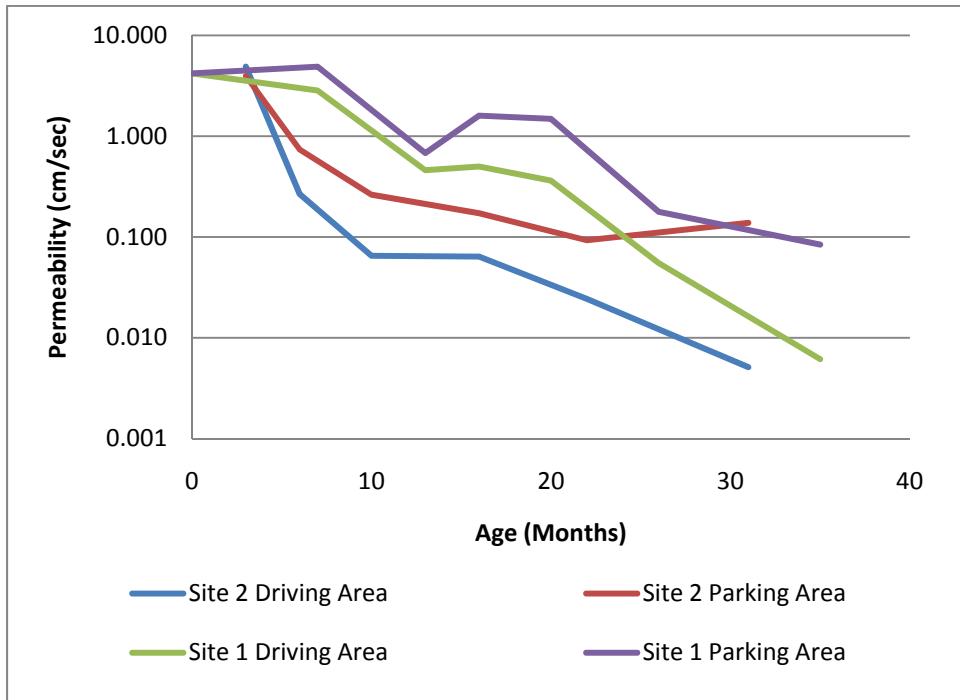
Figure 3: Comparison of Driving and Parking Areas of Sites 1 and 2

A common trend has developed at Sites 1 and 2 and that is more significant decreases in permeability in areas that are used primarily for driving. The areas that are used generally as parking spots have remained more permeable over time. Figure 3 shows the permeability of the driving and parking areas of Sites 1 and 2 since construction.

Figure 3 shows the driving areas of both Sites 1 and 2 decreasing at similar rates since construction. The parking areas at both sites are not exhibiting the same deterioration rates but both continue to remain well above the level of the driving areas. The fluctuations in permeability, where it increases at both sites is due to natural causes as maintenance has not been performed. The increases at both sites occurred during the summer and fall seasons and may be attributed to intense rain events.

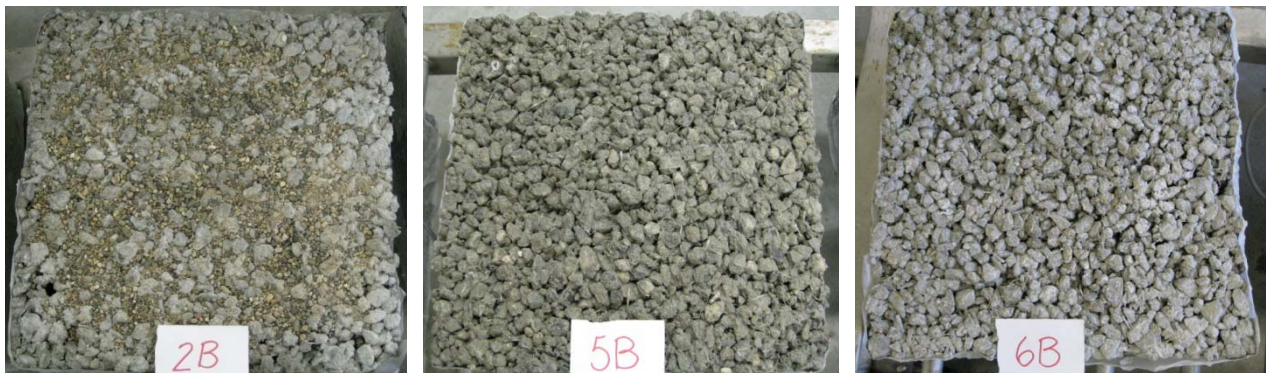
Figure 6: Slab condition during cycling

Figure 6 shows the various conditions of the slab surfaces during the replication of one year of freeze-thaw cycling and loading. The slab group 5 is the only one that is loaded with a salt solution. Figure 6 shows slabs 2B, 5B and 6B and group 5 slabs are darker in colour than the rest of the slabs during all points of the freeze-thaw cycle.

The slab 5 group is the only one loaded with a salt solution and is showing different distresses than the other mixes. The salt solution seems to be wearing away the paste in the pervious concrete to the point where many of the aggregates on the surface of the slab are no longer covered in paste. The loss of paste has not yet lead to raveling however this could be the future condition.
