# **Concrete Pavement Rehabilitation Techniques and Canadian Based Case Studies**

Rico Fung, P.Eng., LEED®AP, Director, Markets & Technical Affairs  
Tim Smith, P.Eng., Director, Transportation & Public Works  
Cement Association of Canada

of the 2010 Annual Conference of the  
Transportation Association of Canada  
Halifax, Nova Scotia

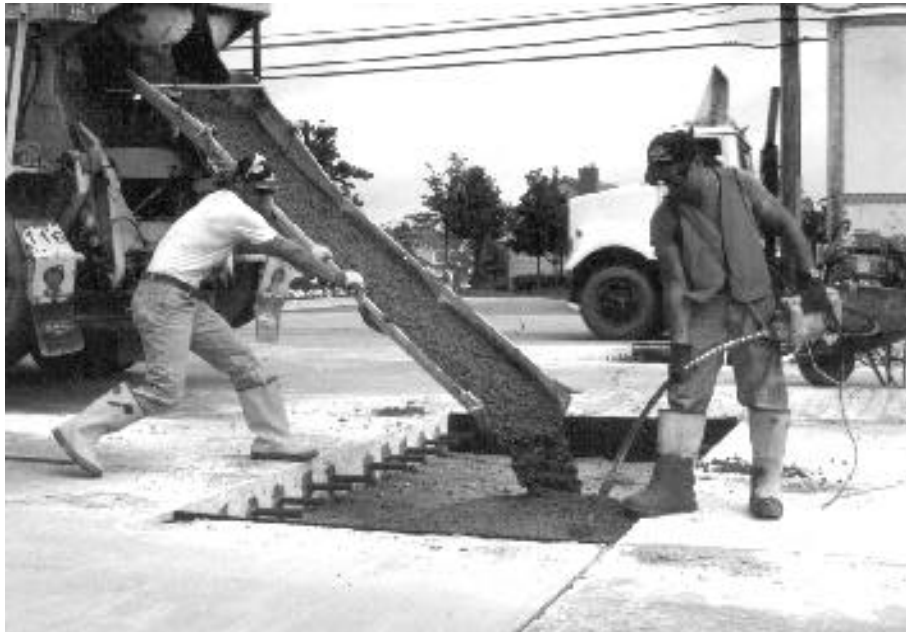
*Figure 2: Placing concrete in full-depth repair [ACPA-TB020P]*

- Full-Depth Repairs — full-depth repairs (FDRs) fix cracked slabs and joint deterioration by replacing a portion of or the entire existing slab with new concrete. This will maintain the structural integrity of the existing slab and pavement structure. This technique also repairs shattered slabs, corner breaks, punchouts in CRCP, and some low-severity durability problems. Figure 2 shows the placement of a full depth new concrete slab. It involves marking the distressed concrete, saw cutting around the perimeter, removing the old concrete, providing load transfer bars, and placing new concrete. Each repair must be large enough to replace all significant distress and resist rocking under the traffic.

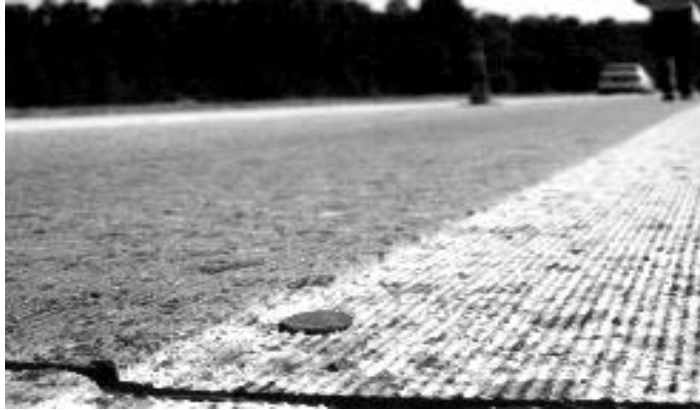
*Figure 3: Diamond Ground Surface [ACPA-TB020P]*

- Diamond Grinding and Grooving — diamond grinding (DG) improves the pavement's ride quality by creating a smooth, uniform, corduroy-like longitudinal grooved profile and removing faulting, slab warping, studded tire wear, and patching unevenness (Figure 3). DG reduces the impact loadings, resulting with less cracking and pumping potentials, leading to longer pavement service life. DG also decreases the undesirable tire/pavement noise, improves skid resistance, corrects poor drainage caused by inadequate cross slope, and thus reduces hydroplaning potential.

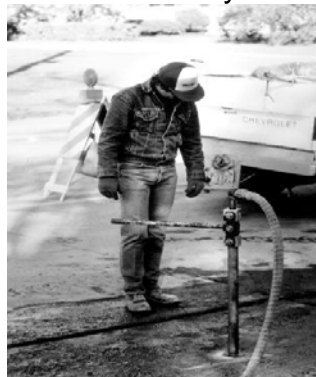
Figure 6 Slab Stabilization/Jacking [ACPA-TB020P]

- Slab Stabilization/Jacking — Slab stabilization/jacking restores base/subgrade support to the concrete pavement slabs by filling small voids with foam/grout that develop underneath the concrete slab at joints, cracks, or the pavement edge (Figure 6). The voids are caused by pumping or consolidation of the subgrade from high corner deflections. Without proper support, the pavement will develop faulting, corner breaks, and extensive cracking, reducing the structural capacity and service life. This CPR Technique is sensitive to the construction practices and care should be taken by the crew when injecting foam or grout, so as not to cause other problems such as accidentally sealing the transverse joints.

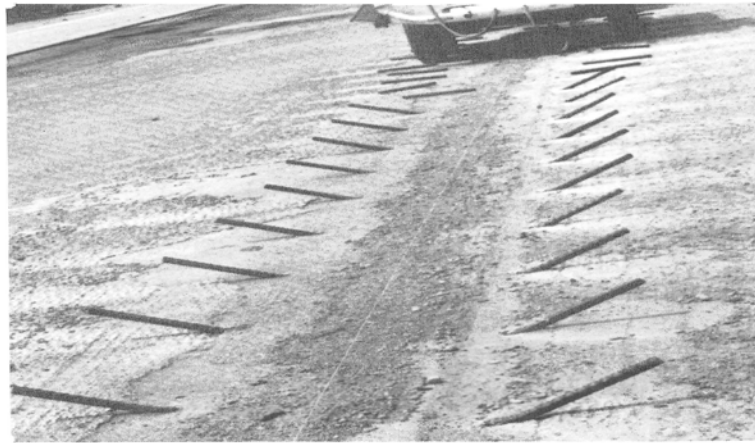
*Figure 7: Cross-Stitching [ACPA-TB012P]*

- Cross-stitching — cross-stitching repairs longitudinal cracks not joints that are in fair (low-severity) condition. It increases load transfer across the crack by adding steel reinforcement to hold the crack together tightly (Figure 7). This limits the crack’s horizontal and vertical movement and prevents it from widening. Cross-stitching will not repair severely deteriorated cracks that are functioning as a moving joint. At severely deteriorated cracks, there is too much deterioration to re-establish effective load transfer; other CPR techniques such as partial or full depth repair may be warranted. Cross-stitching transverse joints/cracks may restrain the pavement slab movement in the direction of traffic and will cause a new transverse crack to form not too far away. In these cases, dowel-bar retrofit is the proper CPR technique to address the distresses.

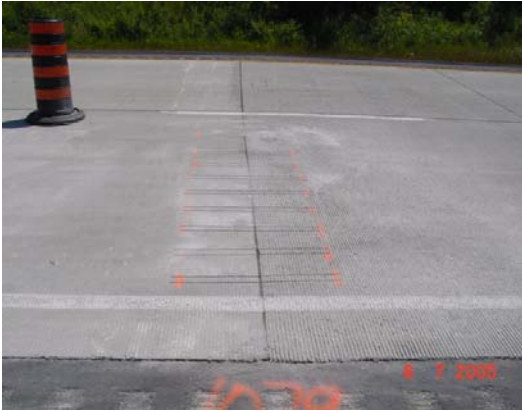
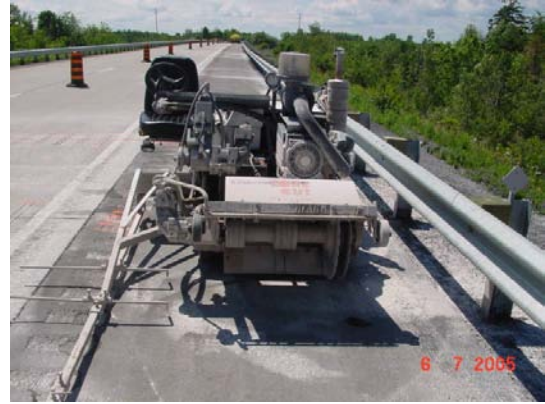
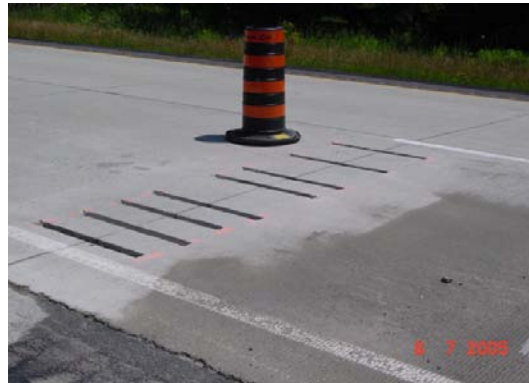
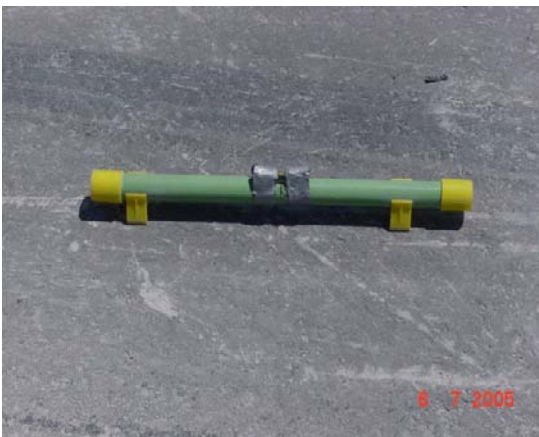
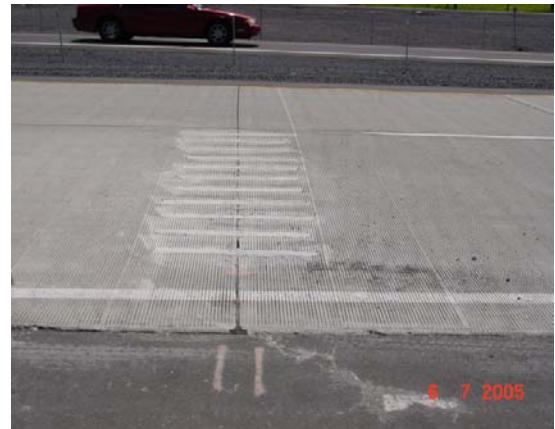
*Figure 9 Highway 417 Westbound Dowel-Bar retrofit*

First MIT (Magnetic Imaging Tools) scan was deployed to identify misaligned dowel bar locations, then these bars were cut and adjacent slots were cut for new dowel bars. In some transverse joints, only a few bars were replaced but there were instances where the dowel bars were replaced for the entire joint. Figure 9 shows pictures depicting the installation process. As of today, the retrofit appears to work with minimal problems.

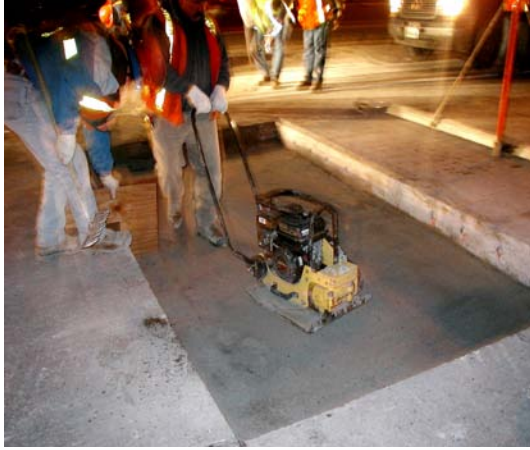
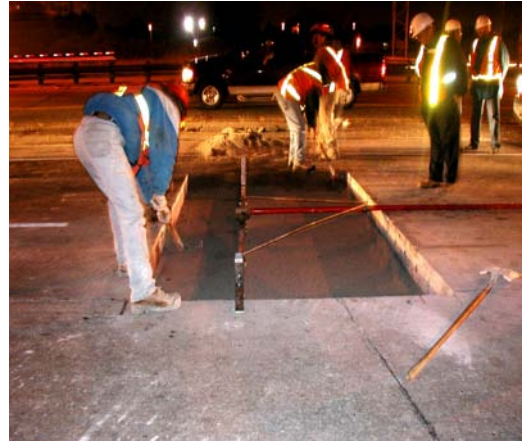
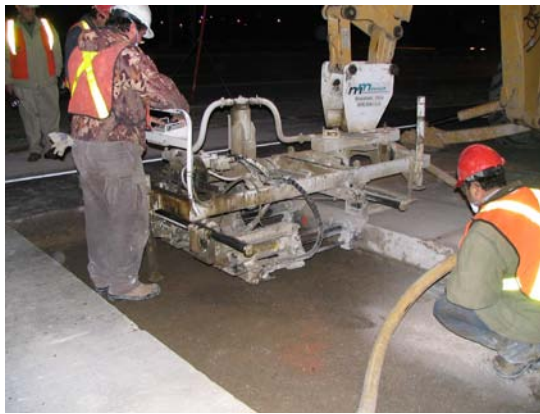
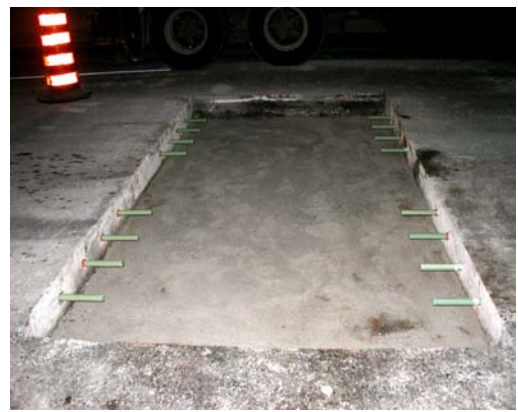
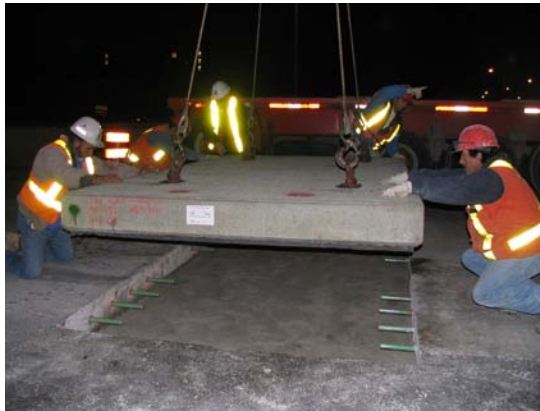
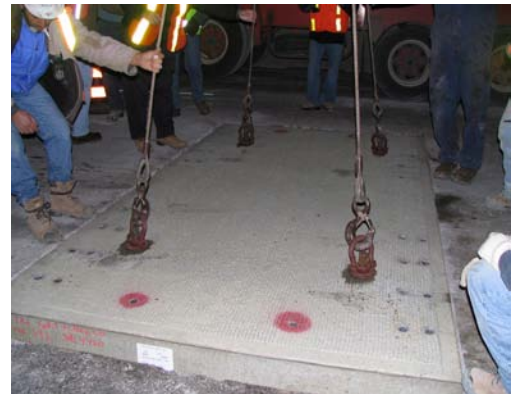
*Figure 10 Highway 427 Full Depth Repair-Precast Concrete*

Each section was saw cut the night before and the removal of old concrete and precast slab placement were done the following overnight. Michigan Method involved dowel bar retrofit technique to tie the new to existing concrete pavement. For the “Super-Slab™” sections, the dowel/tie bars were drilled and grouted into the existing to tie the two together.

The sections are still in service today and MTO continues to monitor the performance. Another precast concrete pavement project was tendered in 2007 for Highway 427 involving over 100 plus precast slabs for both north and southbound lanes. Below are pictures depicting the 2004 trials (Figure 10).

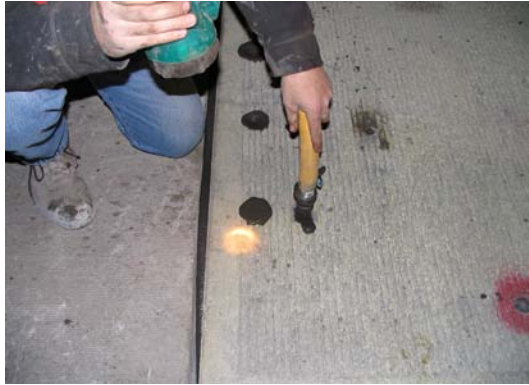
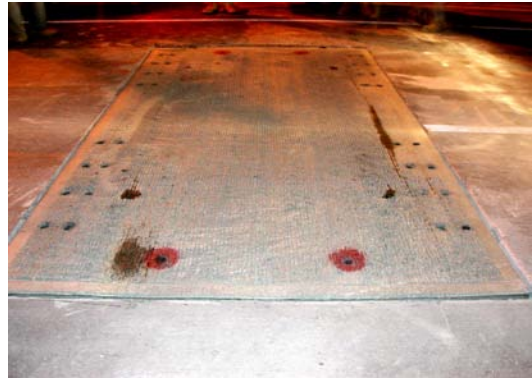
*Figure 10 (cont'd): Highway 427 Full Depth Repair-Precast Concrete*

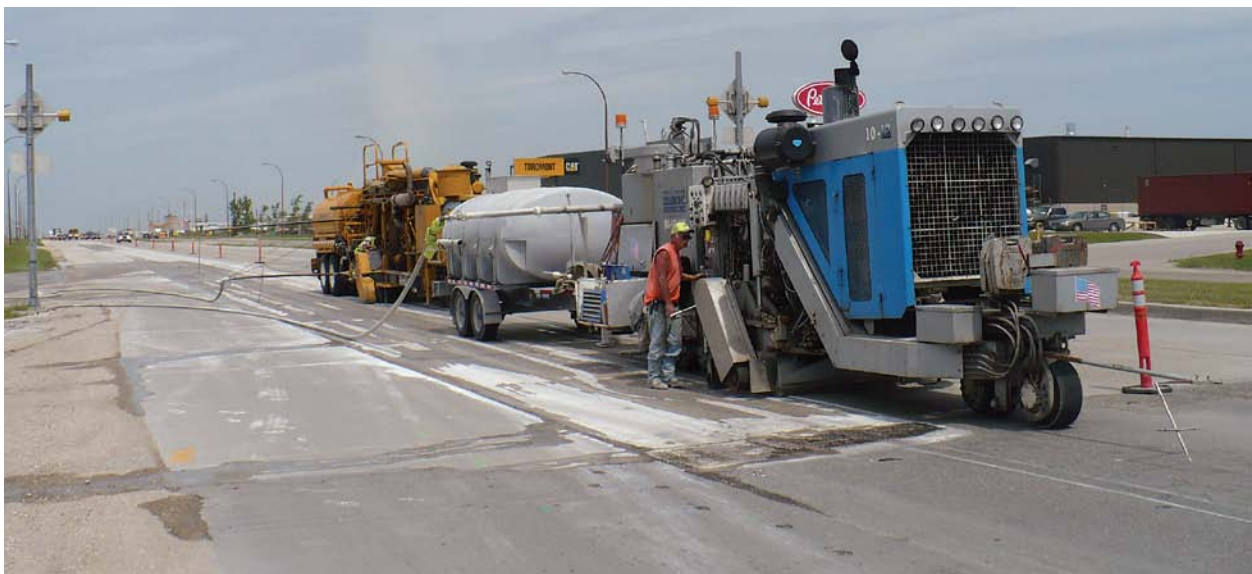
*Figure 11: Diamond Grinding Test and Trial Project in Winnipeg, Manitoba*  
*[IGGA January 2010]*

The total cost of the diamond grinding sections was \$566,250 and was completed in 22 working days. It is anticipated the pavement service life will be extended by at least 15 years. See Figure 11 below for picture of the diamond grinding operation. Ken Boyd, Support Services Engineer for the Winnipeg Public Works Department, stated the following on the diamond grinding projects:

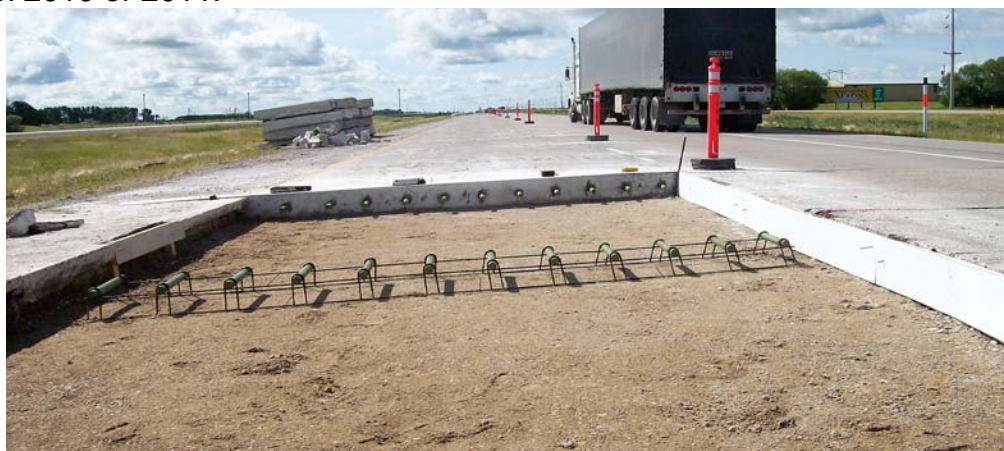
*Figure 12: Highway 75 Full Depth Repair Winnipeg, Manitoba [IGGA March 2010]*

Figure 12 below shows a full depth repair being done on the roadway. Upon completion of the restoration work, Gary Dyck, Maintenance Superintendent for the area, noted that “Highway 75 is finally smooth and the difference for the snow plows and their operators is unbelievable. The smooth pavement should dramatically reduce wear and tear on the equipment for years to come.” [IGGA March 2010]
