Characterizing Field and Laboratory Performance of Cementitious Partial Depth Repair Materials

Paper prepared for presentation at

the "Successes and Innovations in Maintenance Methods and Practices" Session

of the 2011 Annual Conference of the Transportation Association of Canada Edmonton, Alberta.

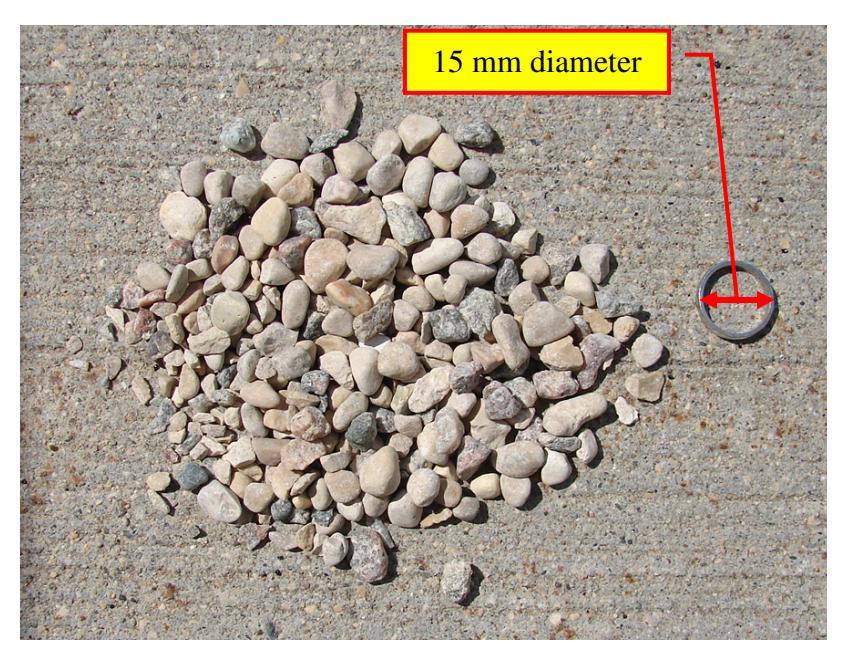
Figure 3: Sample of Aggregate Extender

Six cementitious repair materials were used in this field evaluation. Three repair materials were placed along test section 1 and the other three materials were placed along test section 2. Table 3 shows the technical data of the six repair materials. Out of the six repair materials, aggregate extender was added to 4 repair materials as shown in Table 3. The aggregate extender consisted of well graded rounded gravel with low angularity as shown in Figure 3. Repair materials were mixed according to the manufacture's specifications and recommendations. Repair materials were poured into the repair area, made flush with the existing concrete surface with a shovel or trowel and then internally vibrated using a 25 mm head vibrator. The repair patch was finished using a trowel and a curing compound was applied.

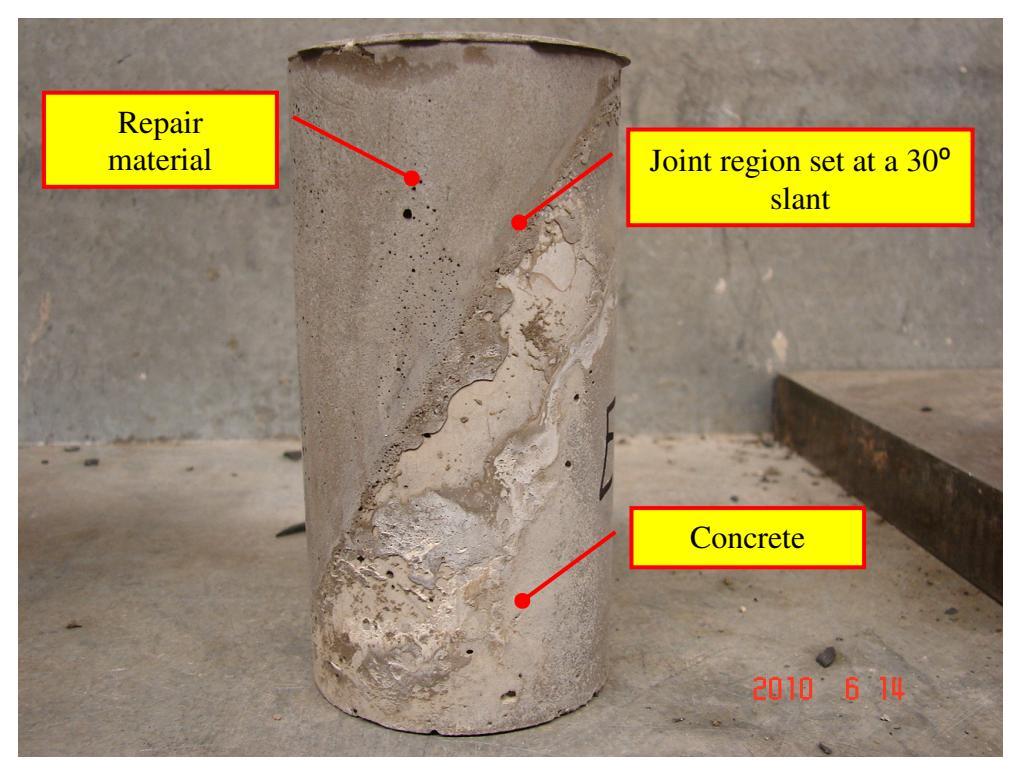
Figure 8: 3×6 Inches Composite Cylinder for Bond Strength Test

The bond strength between repair material and concrete is tested under compression failure adapted from ASTM C 882: Standard Test Method for Bond Strength of Epoxy-Resin Systems Used with Concrete by Slant Shear [6]. Bond strength tests are conducted on composite samples. A composite sample consist of repair material and concrete which are cast in a  $3\times6$  inches cylinder with a joint region situated along a cylindrical section set at a slant of 30 degrees, as shown in Figure 8.
