**Performance of Precast Concrete Pavement Repairs
on an Urban Freeway in Toronto**

Paper prepared for presentation

of the 2011 Annual Conference of the
Transportation Association of Canada
Edmonton, Alberta

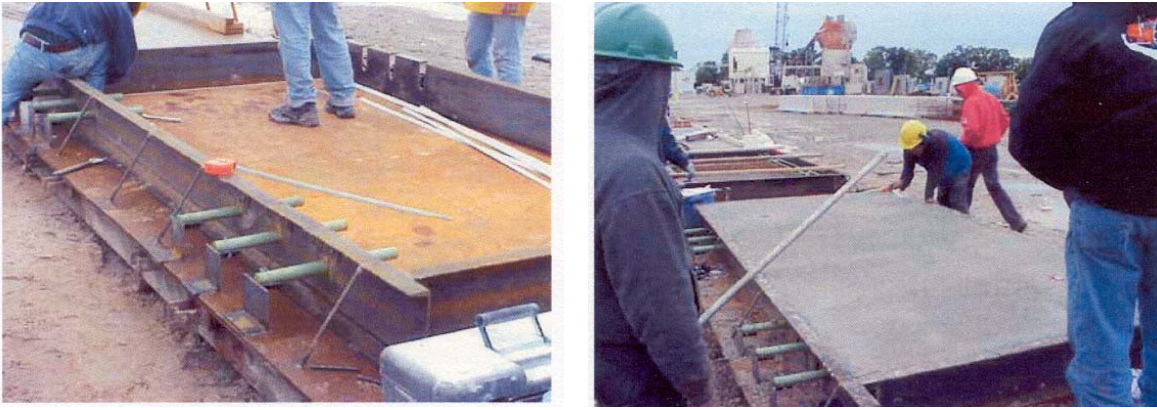
Figure 1. Precasting Michigan Method slabs, 3 dowel bars per wheel path

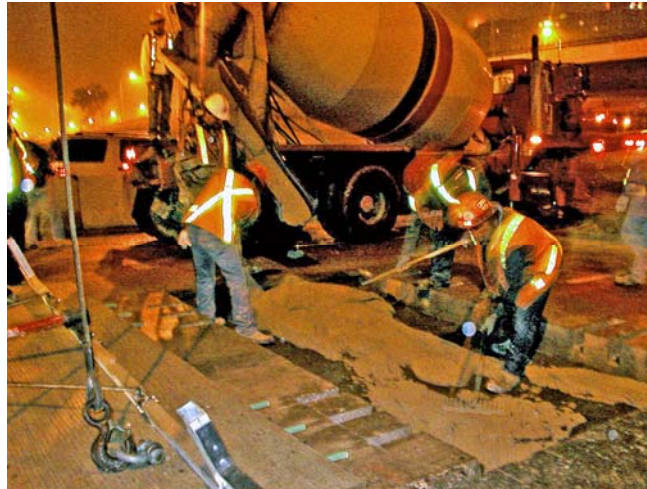
Figure 4. Use of flowable fill as a levelling material.

The Michigan slabs were lowered by crane onto the flowable fill with the 12 cast-in dowel bars fitting into the sawcut slots. The first slab was placed slightly high. The contractor attempted to drive heavy equipment over the slab to settle it deeper in the flowable fill, but the slab was set. All three Michigan Method slabs were placed between 10:00 pm and 3:00 am. The second slab was the best of the three slabs, being flush with the existing concrete pavement. The other two slabs sat slightly higher than the existing concrete. These slabs should have been diamond ground to meet surface tolerances.

- The base preparation method used a manual screed, which was not accurate enough to place the slabs to meet surface tolerances. Precision grading is recommended.

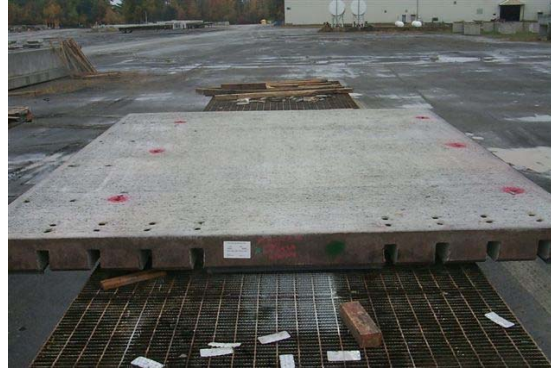
Figure 6. Four block-outs per wheel path are cast into the Fort Miller intermittent slabs.

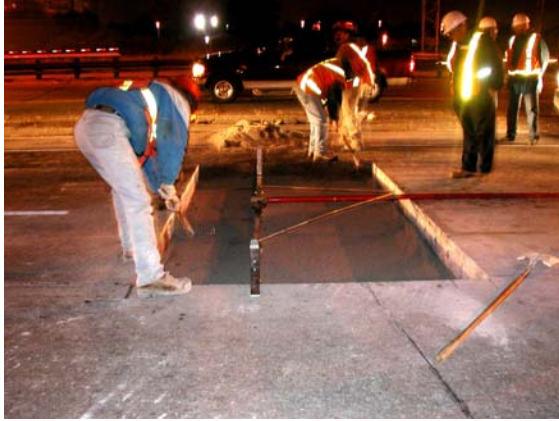
The Fort Miller Method uses crusher screenings for leveling material beneath the precast slabs. The crusher screenings were placed, then screeded with the Contractor's full lane width leveling screed (Figure 7a). A plate-packer was used to compact the fine aggregate base (Figure 7b).

Figure 7. Construction sequence for Fort Miller Intermittent precast slab installation: a) using full lane width leveling screed to fine grade crusher screenings, b) compacting crusher screenings using plate packer, c) dowel bars installed, ready to place precast slab, d) lowering precast slab.

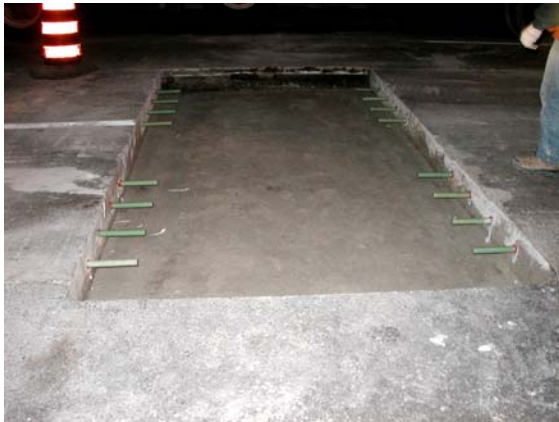
c)

In the Fort Miller Intermittent Method, dowel bars are drilled into the existing concrete. The precast slabs have block-outs to allow the slabs to be placed over the protruding dowel bars. A gang-drill consisting of four independently powered pneumatic drills was used to drill four dowel bars per wheel path. The location of the dowel bars was accurately marked with a template. The dowel bar slots were blown out and epoxy adhesive was used to secure the bars (Figure 7c).

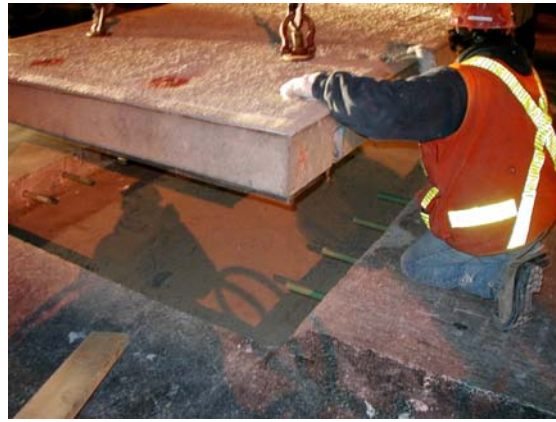
d)

A crane was used to lower the precast slabs in place (Figure 7d). The first two slabs matched flush with the existing concrete pavement. The third precast slab was placed low. The slab was lifted out and screenings added, however because the dowel bars were installed, the leveling float and plate packer could not be used. The third slab was eventually levelled and met flush.

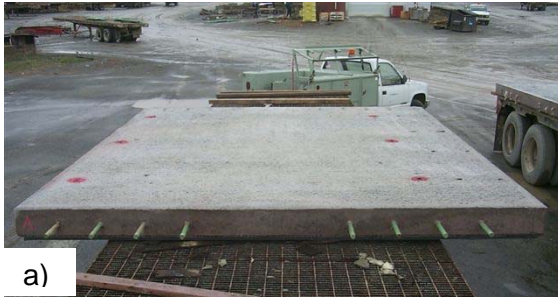
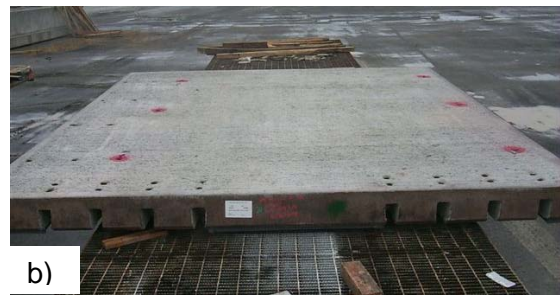
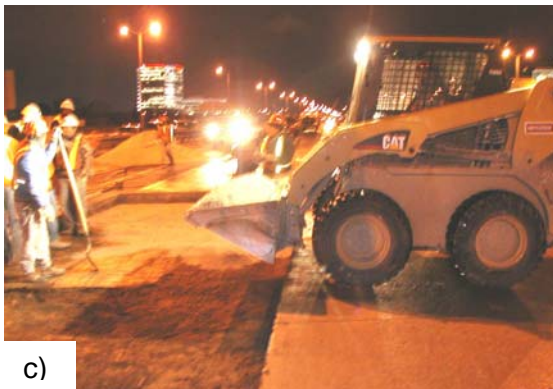
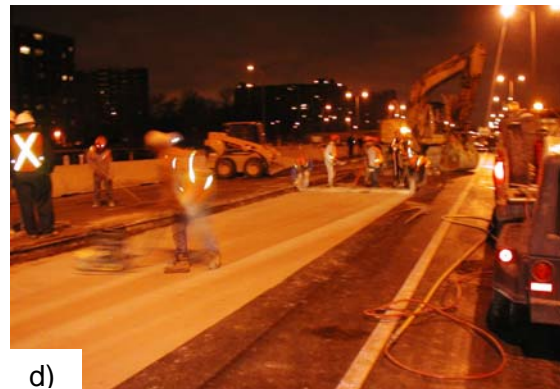
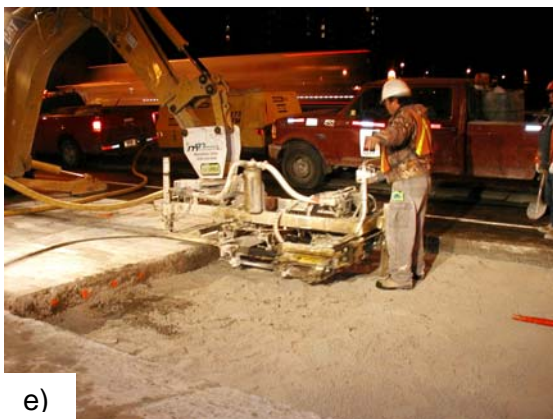
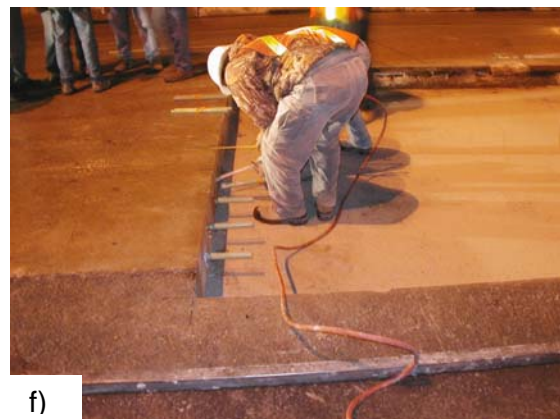
In the Fort Miller Continuous Method, dowel bars and block-outs were cast alternately into a set of six 4 m long by approximately 3.65 m (lane width) concrete slabs, which fit together like puzzle pieces (Figure 8 a & b). Following sawcut and removal of a continuous 25 m long section of deteriorated concrete pavement, the underlying CTB was partially excavated with a backhoe, then crusher screenings were placed on the existing base, precision graded and compacted (Figure 8 c & d). The first slab and last slab placed were dowelled into the existing pavement at each end of the excavation (Figure 8 e & f). All slabs in the continuous repair were tied into the adjacent lane with drilled and epoxied tie bars. Once the slabs were set, the dowel bars and tie bars were grouted through ports in the precast concrete slabs using an automatic grout pump, to connect the slabs to the existing pavement and to each other (Figure 8 g). Finally, bedding grout was injected through interconnected ports and channels in the bottom of the slabs to fill voids beneath the concrete (Figure 8h).

Figure 8. Construction sequence for Fort Miller Continuous precast slab installation.

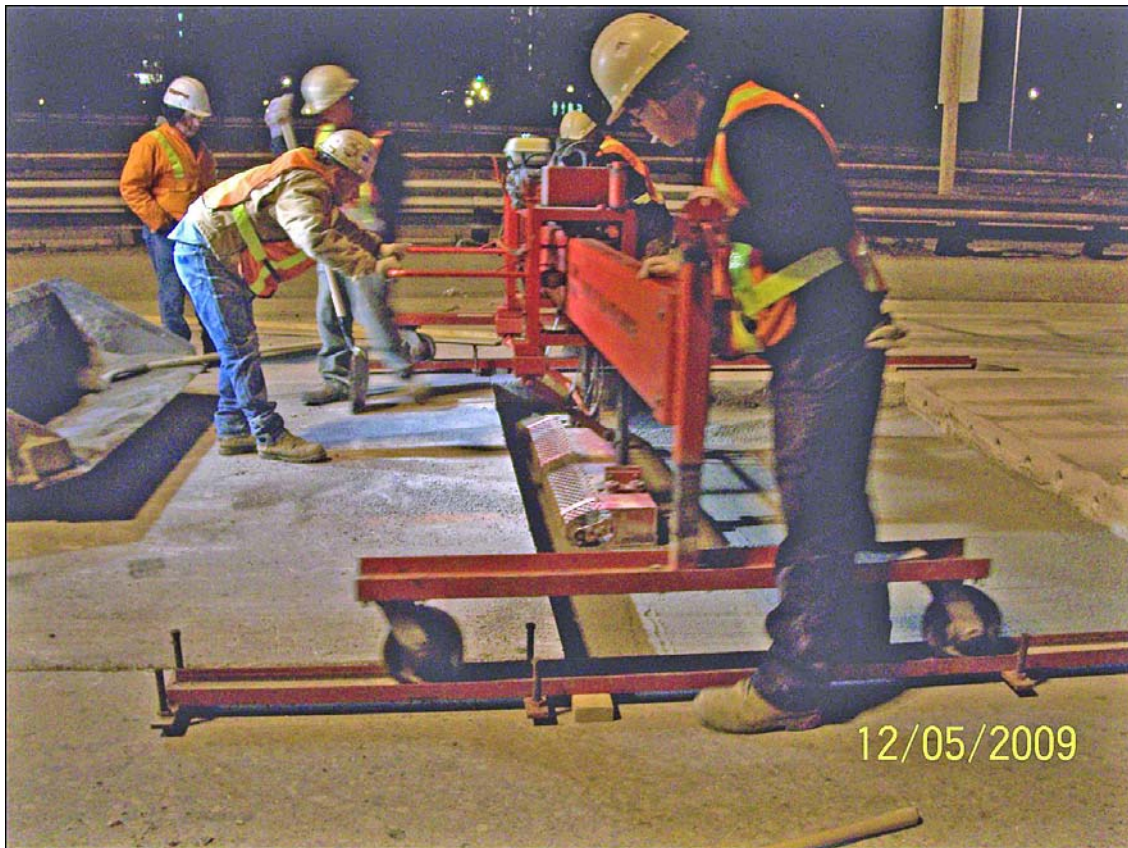
These contracts elected to use the Fort Miller Intermittent and Fort Miller Continuous methods. The most significant change to construction practice was introduction of precision grading equipment rather than using a manual screed to grade the crushed screenings prior to setting the slabs (Figure 16).

Figure 16. Precision grading equipment implemented on two contracts in 2009.
