BCT Pilot Project for Culvert Integrity Analysis in the City of Toronto

Brian Anderson, OGRA
Contact: brian@ogra.org

John Bowles, M.Sc.E. P.Eng, Inversa Systems
Contact: john.bowles@inversasystems.com

During the summer of 2011, OGRA supported an integrity analysis pilot project on selected roadway culverts using recently-developed inspection equipment capable of quantifying undermining. This new modality, Backscatter Computed Tomography (BCT), is a practical *in-situ* form of Computed Tomography also known as a CAT Scan. The purpose of the pilot was to evaluate the technology’s potential to measure undermining, thereby facilitating the planning of major roadway culvert replacements or rehabilitation. Three culverts in the City of Toronto were inspected to determine the culverts’ structural condition using BCT equipment provided by Inversa Systems Ltd.

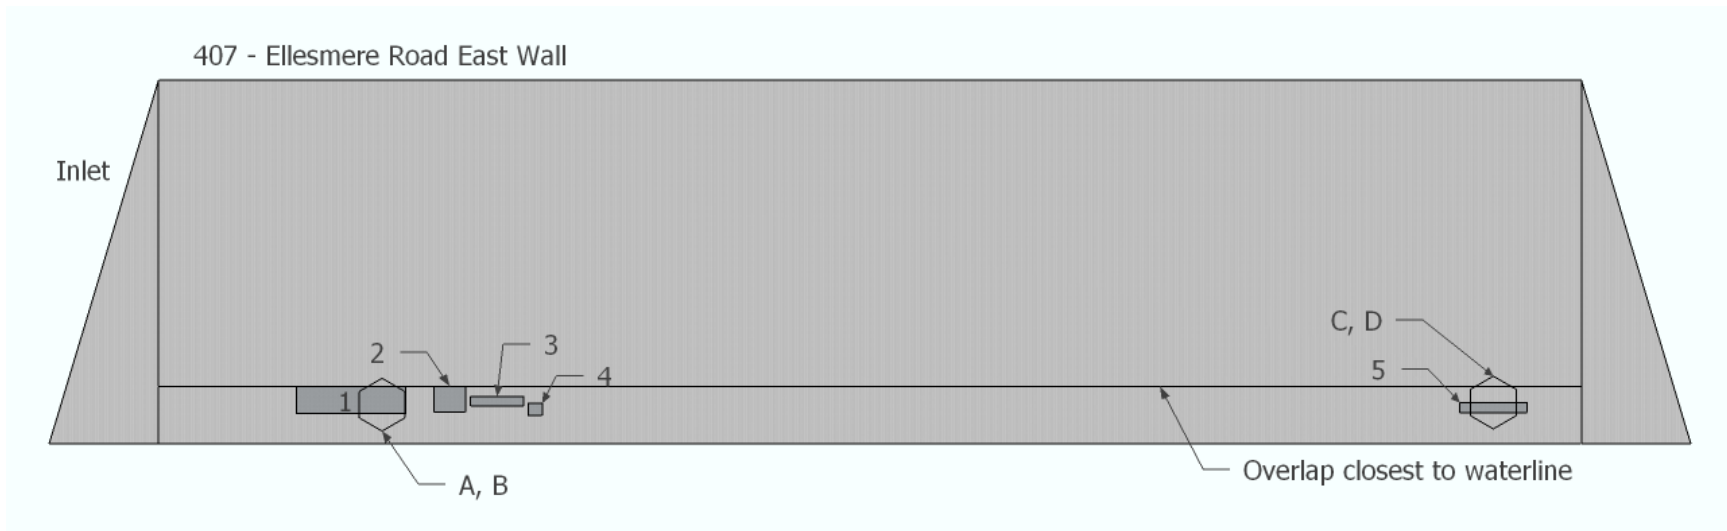
Acoustic Inspection Maps – 407 Ellesmere Road East Wall

The results of the inspection of culvert 407 – Ellesmere Road follow.
