## **Investigation and Repair of the Diefenbaker Bridge Fracture**

Paper prepared for presentation  
at the \_\_\_\_\_ Session  
of the 2013 Conference of the  
Transportation Association of Canada  
Winnipeg, Manitoba

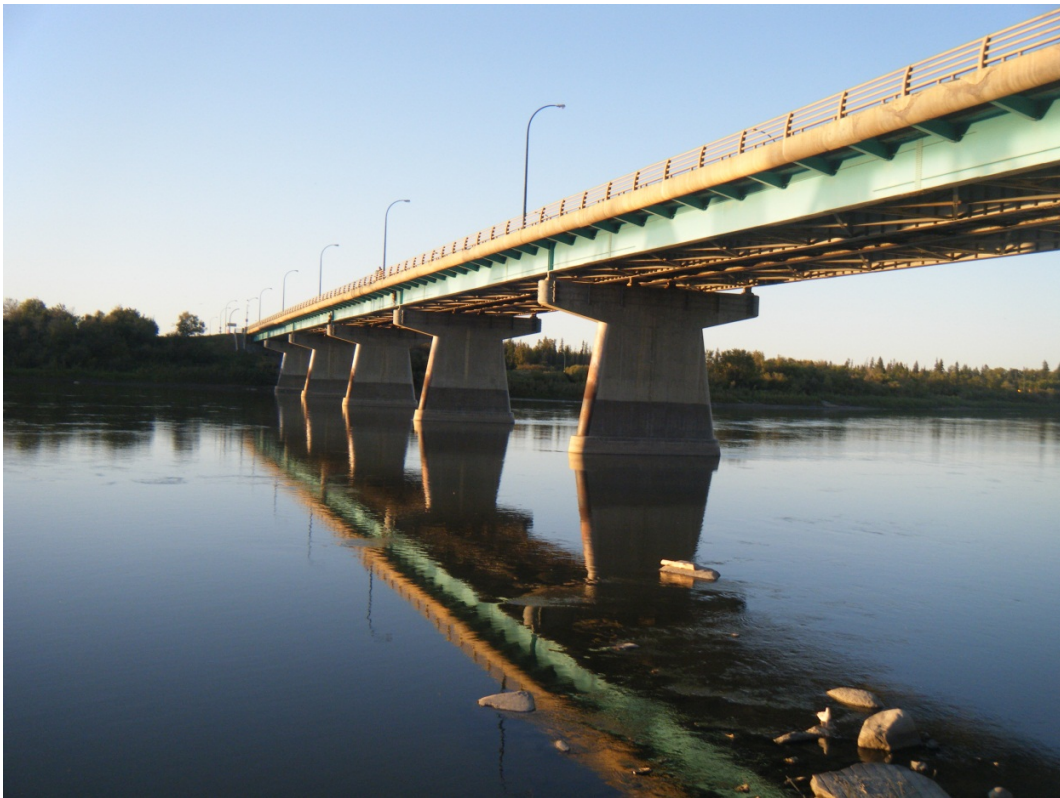
The Diefenbaker Bridge is a 7-span, 304m (1000 ft) long, fracture critical steel structure crossing the North Saskatchewan River in Prince Albert, Saskatchewan, Canada (Figure 1). The bridge is an important regional crossing and was constructed in 1959. On August 29<sup>th</sup>, 2011 a major fracture was found in one of the two steel girders of the southbound bridge.

**Figure 1 Diefenbaker Bridge, Prince Albert, Saskatchewan**

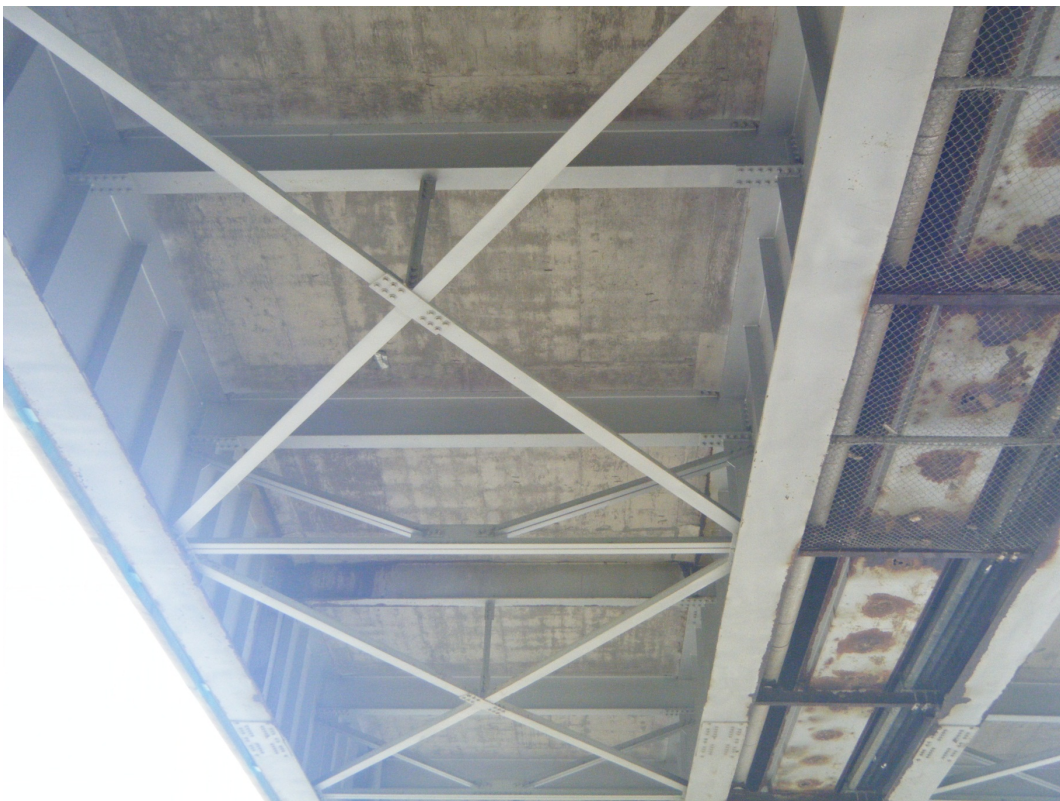
The 2 lane northbound and southbound structures are classified as fracture critical structures comprised of two continuous welded plate girders per structure. The superstructures share a common substructure. Horizontal plan cross bracing was provided throughout the structure, floor beams were spaced at 11'-9" (3.581m) and vertical bracing diaphragms were spaced at 23'-6" (7.162m). Girders, stiffeners and gussets were of welded construction, while the rolled shapes in bracing and floor beams used bolted connections. (Figure 2).

**Figure 2 Girders, horizontal cross bracing, floor beams and k-brace diaphragms**
