Pavement Evaluation to Detect Potential Voids Under the Surface After the Historic Flood of June 2013 in the City of Calgary

Paper prepared for presentation at the
“Emergency Repair and Reconstruction of Transportation Infrastructure Damaged by Catastrophic
Environmental Events” Session of the
2014 Annual Conference of the
Transportation Association of Canada
Montreal, Quebec

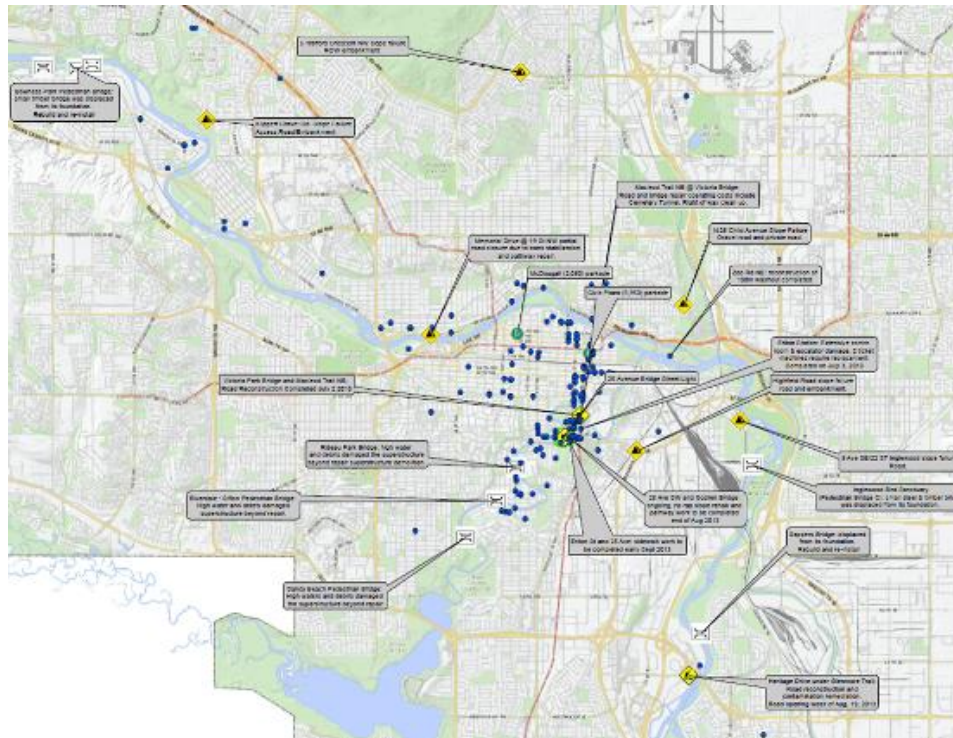
Figure 4: Majority of the Sinkhole Locations Developed During the 2013 Flood in the City of Calgary

A review of the sinkhole location map shown in Figure 4 indicates that although the sinkholes developed throughout the City's road network, they were concentrated within the road segments identified for detailed investigations.

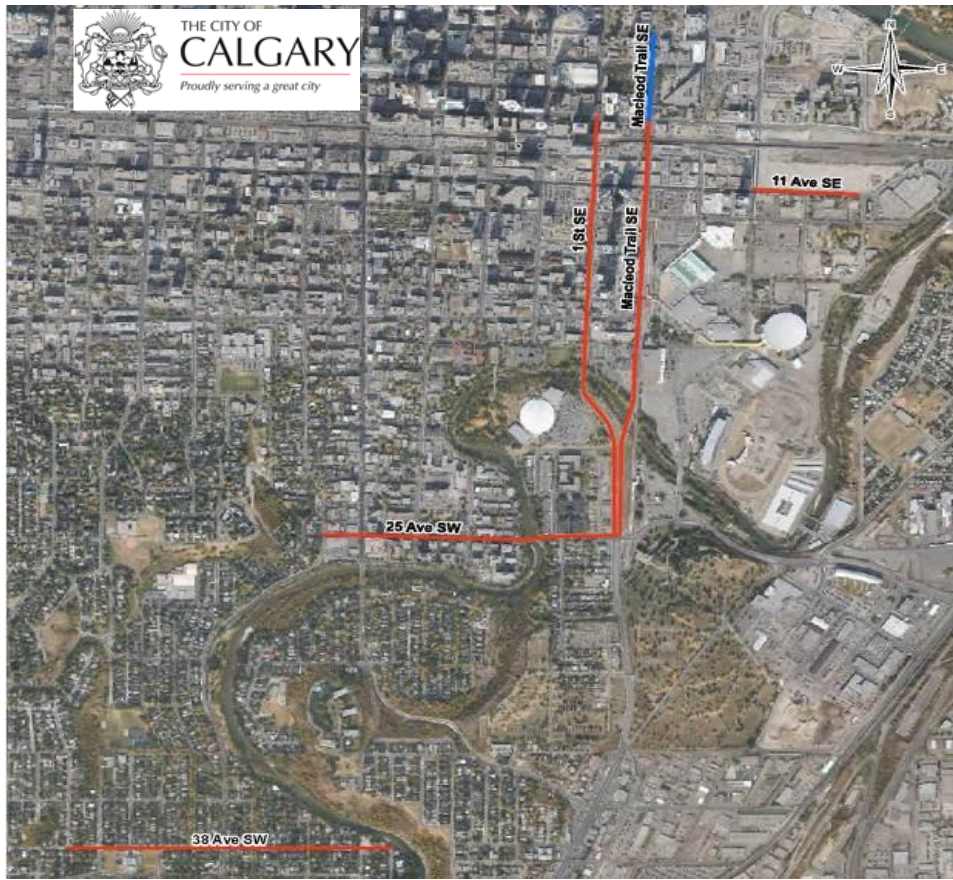
Figure 5: Roadway Segments Included in the Evaluation

- Macleod Trail SE (Northbound) – 25 Avenue SE to 9 Avenue SE;
- 1 Street SE (Southbound) – 9 Avenue SE to 25 Avenue SE;
- 11 Avenue SE – 4 Street SE to 6 Street SE;
- 25 Avenue SW – Macleod Trail S to 5 Street SW; and
- 38 Avenue SW – 8A Street to Edison Crescent.

These roadway segments are shown in Figure 5.

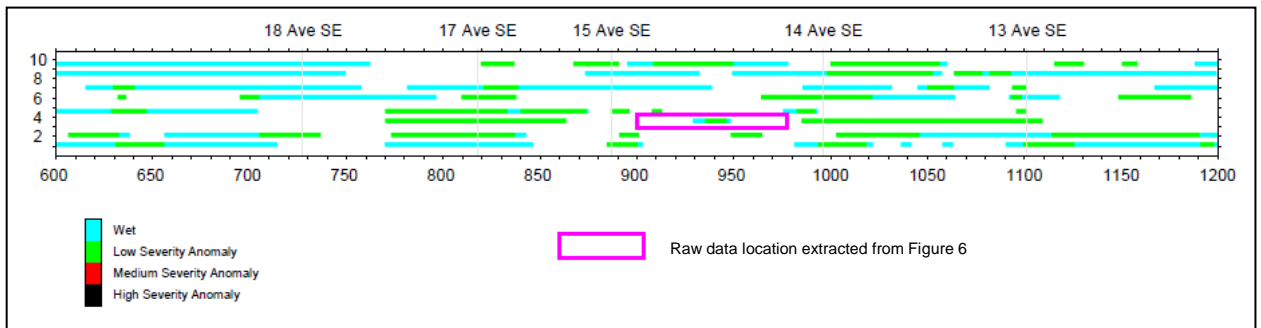
Figure 7: Plan Map View of Macleod Trail SE with Highlighted Section from Figure 6 Identified

Figure 6 shows, for a localized area of Macleod Trail SE, wet areas identified in light blue, and a low severity anomaly approximately at 945 m in light green. Figure 7 identifies the same section of data in the anomaly plan map. Anomaly Plan Maps for all five roadway segments surveyed were prepared.
