Bow River Bridge near Gleichen, AB, after the flood

Laurie McCarron, P.Eng., Bridge Engineer, Stantec Consulting Ltd.

Paper prepared for presentation

Transportation Association of Canada

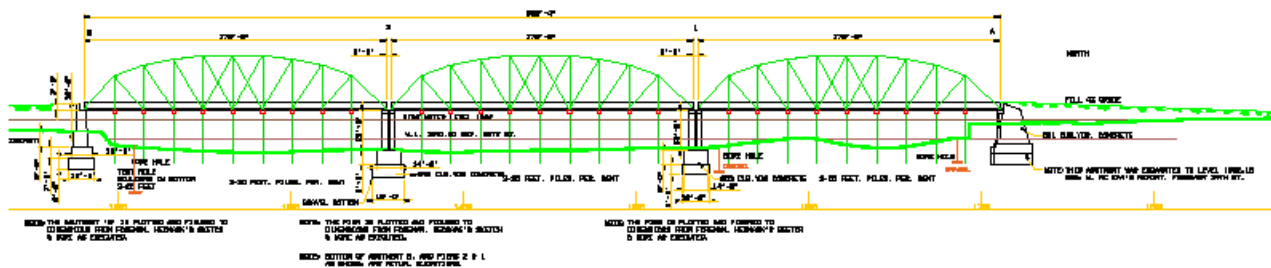
Figure 1: BF 01293 General Layout (Alberta Transportation)

BF1293 is located on Highway 547:04, within the Siksika First Nation and south of the Town of Gleichen, Alberta (approximately 1 hour East of Calgary). This three span bridge was constructed in 1908 with a length of 159.9m, a clear roadway width of 5.1m, a deck height of 8.5m, and detour route of over 70 km. The through trusses are on concrete abutment and pier spread footings in the active channel. The general layout is shown in Figure 1.
