CHALLENGES AND INNOVATIVE SOLUTIONS FOR BRIDGE FOUNDATION REPAIRS

Drew Monnier¹, P.Eng. (Presenting)
Kimberly Yathon², B.Sc. CE (Presenting)
Ruth Eden¹, M.Sc., P.Eng.
Randy Fingas¹, P.Eng.
Emile Shehata², Ph.D, P.Eng.

¹Manitoba Infrastructure and Transportation
²Tetra Tech WEI Inc.

Paper prepared for presentation
at the "Structures" Session
of the 2015 Conference of the
Transportation Association of Canada
Charlottetown, PEI

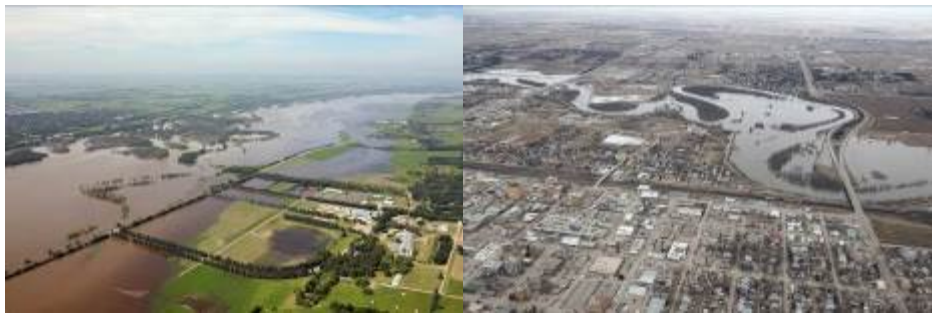
Figure 1 – 2011 Manitoba Flood Along Assiniboine River in Brandon, MB (left) and Souris River in Souris, MB (right)

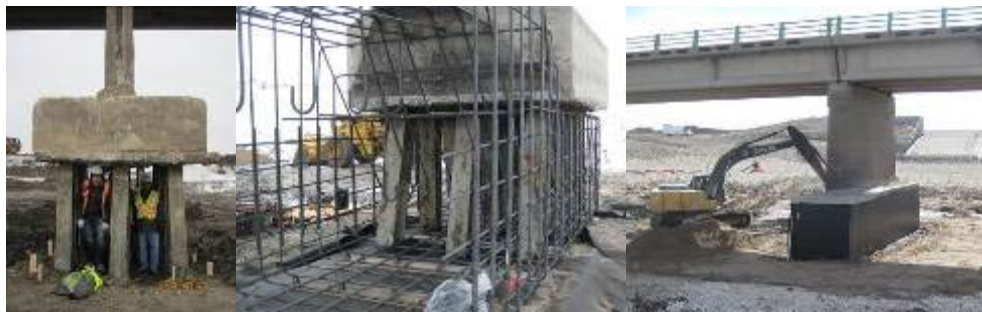
Figure 4 – Excavation Complete Beneath Pier (left), Reinforcing Steel for New Pier Footings (centre), Completed Pier Footing (right)

The design consisted of new 3.0 m deep reinforced cast-in-place concrete pier footings, which would encase and join together the two existing 900 mm deep pier footing components to provide overall structural continuity. Detailed design was fast-tracked and all design elements considered an extremely tight construction schedule, with consideration made for an early spring melt. Connectivity between new and existing concrete was provided by means of dowels to fully and effectively transfer loads to the new foundations. Stability of the existing channel slopes was evaluated between the drop structure and around the bridge. A monitoring program was developed, along with a construction staging plan to not only maintain stability of the existing channel banks, but to also maintain integrity of the bridge itself during construction and exposure to live loads. Staging consisted of offloading of the upper channel embankments and providing toe stability, sequencing the construction of pier footings, moving from the centre of the channel outward, and phasing construction of the pier footings to maintain vehicular access at all times. Erosion protection around the bridge was coordinated with other work at the drop structure that was concurrently being undertaken by MIT. This consisted of placing Class 600 and 900 stone rip-rap. Design was completed in only 45 days. Figure 3 illustrates the proposed pier footing modification.

Construction began in late February 2012. Tetra Tech supported with CA services during construction, which served well for making timely design decisions in order to accommodate site variations and accelerate the construction schedule. Coordination and partnering efforts were undertaken by the client, designer, and contractor in order to complete construction within a tight timeline. One major modification which served as a means for accelerating the construction schedule was to completely eliminate phasing of the pier footings, to allow each footing to be excavated, reinforced, and cast together as one complete unit. A monitoring program consisted of slope inclinometers on embankments to monitor channel movement and a combination of prisms on piers and abutments to ensure that no movement was observed on the structure during construction. Daily monitoring confirmed that no movement occurred as the pier foundations were constructed. The pier modifications and channel erosion protection was successfully completed by the end of March 2012. The Portage Diversion was opened two days after completion of construction to divert flow from the Assiniboine River. Figure 4 shows the progression of construction.

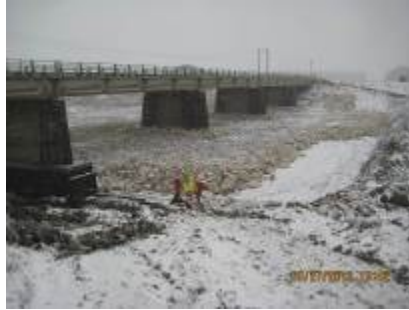
Figure 5 – Completed Bridge Scour Repair Works

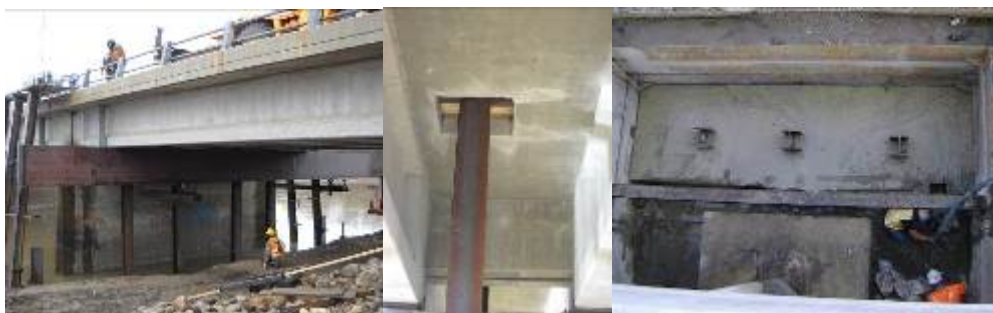
Figure 7 – Steel Support for Driving of New Piles (left), New Piles Driven Through Existing Deck (centre), Partial Concrete Tremie Plug for New Foundation (right)

The design consisted of a new 3.0 m deep reinforced cast-in-place concrete pier footing, which enveloped the existing pier footing. The pier footing was supported on steel H-piles driven into shale, with anticipated lengths of 35.0 to 40.0 m. Eighteen additional steel piles were located around the perimeter of the existing pier footing to satisfy design loads for the foundation, eight of which were to be driven through the bridge deck. The use of a custom segmental steel cofferdam was required to isolate flow and enable construction of the new pier footing. A tremie concrete cofferdam plug would be necessary to isolate river flow within the cofferdam and support construction of the new pier footing. Steel reinforcing dowels were utilized to effectively transfer loads to the new foundation.

Construction took place between March and August 2012. MIT provided full time construction inspection and Tetra Tech provided ASDC and on site construction inspection for elements of work that impacted the overall foundation design. All work took place under flood conditions, which varied from all other bridge sites due to the urgency of the work. Piling work was completed effectively, operating from the existing deck surface and using subsurface data to develop an appropriate foundation design that could be constructed prior to the end of March. However, cofferdam operations and the tremie concrete cofferdam plug were interrupted and delayed due to high spring flows and difficulties isolating and dewatering the cofferdam. Divers were used to identify the areas of the breach, but dewatering operations proved to be unsuccessful. The cofferdam was inundated with water in April, with operations halted until water levels receded to accommodate foundation construction. Figure 7 shows the extent progress of foundation construction.

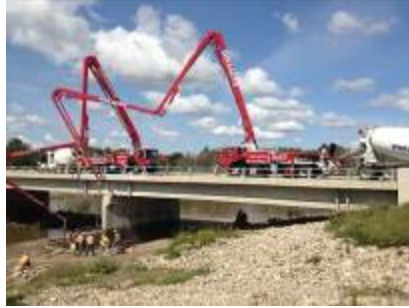
Figure 8– Final Concrete Pour for New SU.5 Pier Footing

Construction resumed in July, at which time the Contractor worked to dewater and isolate the flow within the cofferdam and successfully placed the new pier footing by means of structural tremie concrete. Construction was completed in August and the bridge was reopened to traffic.

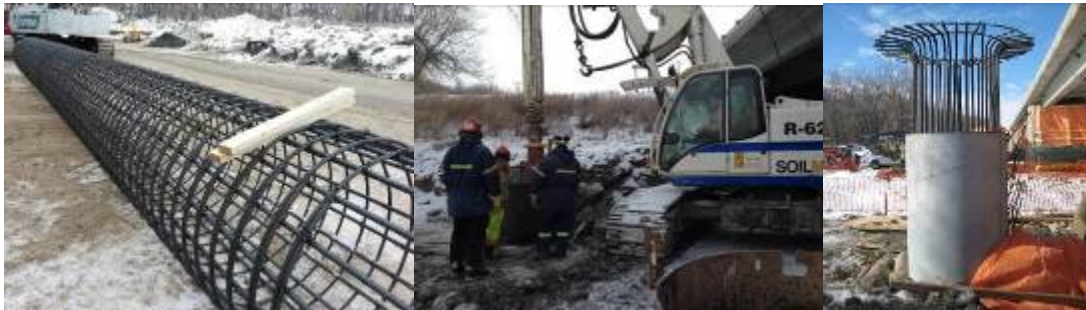
Figure 11 – Reinforcing Steel for Drilled Shaft Caisson (left), Drilling of Caisson, Metalized Steel Jacked Caisson and Reinforcing Steel (right)

The deep foundation system consisted of two reinforced concrete cast-in-place drilled shaft caissons. Each shaft consisted of two different diameters; the lower 5.0 m was 1,380 mm diameter supported against earth, while the upper 16.0 m was 1,530 mm diameter supported by a metalized steel jacketed sleeve. Drilled shaft caissons were reinforced using 35M black steel reinforcing for the full length of the shaft and developed into a reinforced cast-in-place concrete pier cap. Drilled and grouted steel dowels

MIT provided full time construction inspection while Tetra Tech provided ASDC, full time inspection for all drilling and installation of caissons, and monitoring of piers for movement or instability. Installation of the temporary shaft sleeves was inspected and installed successfully to isolate seepage flows and minimize the occurrence of softening of shale layers. A monitoring program, using a combination of survey prisms installed on several locations of each pier, was implemented specifically to inspect for the occurrence of movement in the piers, and was monitored three times every week. Survey data was analyzed and plotted within 24 hours of survey. No significant movement was recorded during the course of construction. Minor design changes to the caissons were completed to accommodate an elevated concrete plug to allow construction of concrete infill walls above the water level. Additional thickness of stone rip-rap was in turn placed around piers. Erosion protection consisted of Class 450 and 900 stone rip-rap on the channel banks and around piers. Construction was successfully completed between January and March 2014. Figure 11 shows the progression of foundation construction and Figure 12, the completed structure.

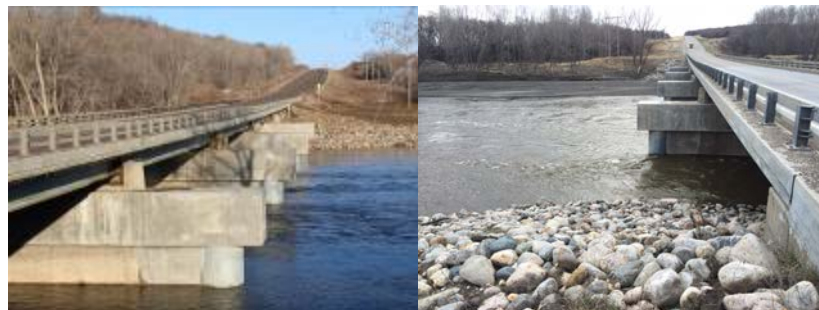
Figure 12 – Completed Pier Modifications and Channel Erosion Protection

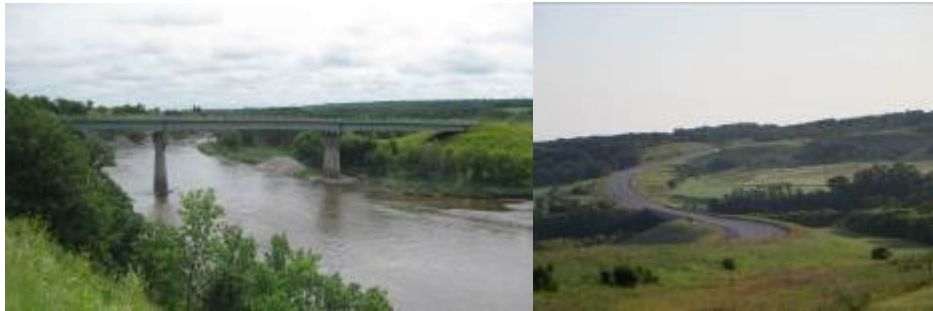
The bridge on PTH 10 over the Souris River was constructed in 1979 as a two lane, 137.5 m long, three-span, continuous bridge, situated in a deep valley north of Minto. The substructure consists of two cast-in-place concrete abutments founded on driven steel H-piles, and two cast-in-place concrete piers supported on shallow spread footings founded on shale. During the 2011 Flood, scouring of the river bottom led to concerns for the potential of undermining of river piers. Armouring of piers took place prior to and following the flood, but additional scour was observed again in the spring of 2013. Due to the height of the existing piers (approximately 12.0 m high), MIT was concerned with risks associated with the stability of the structure if any undermining were to occur, especially since the spread footings were supported on a layer of shale.

Figure 13 – Existing Bridge on PTH 10 over Souris River

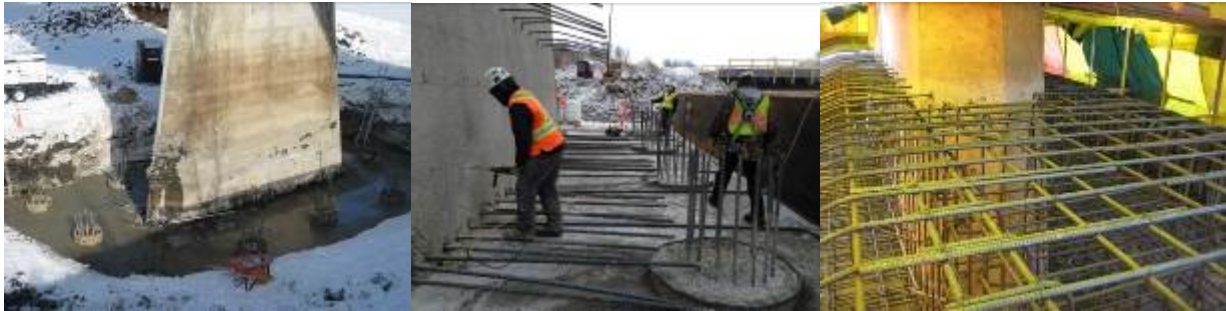
Figure 15 – Drilled Shaft Caissons for Footing (left), Anchoring Reinforcing Into Existing Pier (centre), Pier Footing Reinforcing (right)

coordination. In order to move forward with construction, the elevation of the underside of pier footing was increased above the existing ice elevation, thickening the pier footing by 200 mm. The length of piles were also increased by 3.0 m to maintain specified design capacities, which required the use of an additional temporary casing to prevent collapse of the shaft extension. Additional stone rip-rap was needed to provide scour protection for the pier footing.

Due to concern of disturbing bridge foundations, limitations were imposed for excavation around piers and regular monitoring of piers, abutments, and slopes took place. No significant movement was recorded during the course of construction. The pier modifications and channel erosion protection works were successfully completed between January and late March 2014. Figure 15 demonstrates the progression of pier modification works during construction. Figure 16 shows the completed pier substructure.

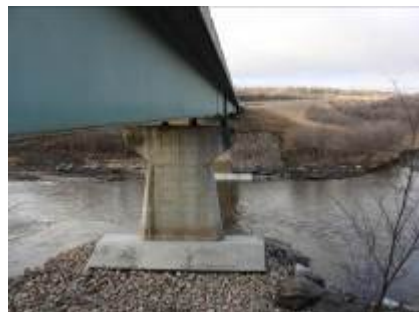
Figure 16 – Completed Pier Foundations

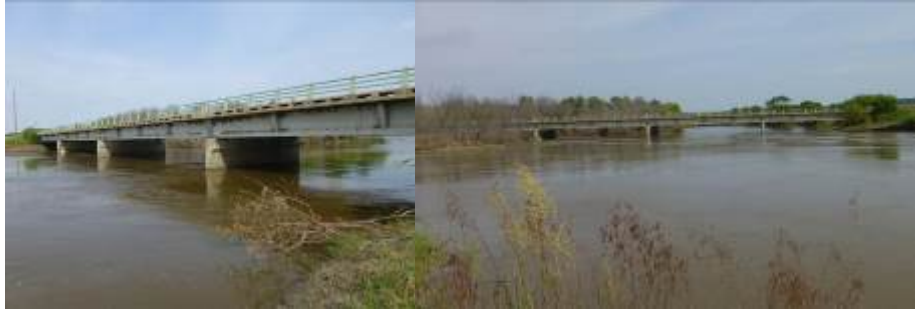
The bridge on PTH 41 over the Assiniboine River, constructed in 1969, is a two lane, 102.4 m long, four-span, continuous bridge, situated approximately one kilometre west of St. Lazare, Manitoba. The substructure consists of two cast-in-place concrete abutments founded on driven steel H-piles, and two cast-in-place concrete piers supported driven steel H-piles founded on shale. During the 2014 Heavy Rain Event, severe scouring of the outer bend of the Assiniboine River occurred, which produced a large scour hole downstream of the bridge and significant scouring of the easterly-most pier (Pier SU.4). An emergency inspection and evaluation of the existing piers took place following the heavy rain event, which led to a recommendation that immediate pier repairs be undertaken and that traffic be limited to a single lane with maximum gross vehicle weight of 39,500 kg. Based on the analysis, it was determined that the axial capacity of the driven steel H-piles had been reduced due to scour beneath the footing, the east embankment headslopes were marginally stable, and that changes in river levels would lead to instability of the channel slopes.

Figure 17 – Existing Bridge on PTH 41 over Assiniboine River

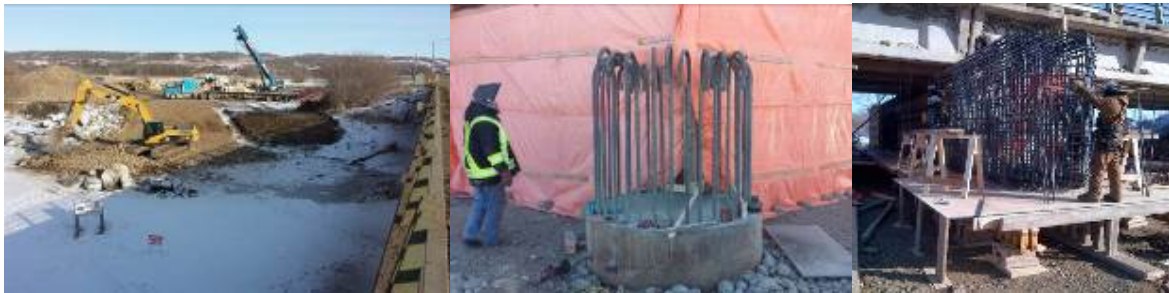
Figure 21 – Work Bridge Construction (left), Completed Caisson (centre), Pier Shaft Reinforcing (right)

During construction, overhead and underground utilities were moved to allow for the permanent caisson installation and overhead crane and drilling equipment clearances. During placing of the north steel jacket, the contractor encountered several subsurface obstacles that prevented placement of the jacket in accordance with the original design. The caissons were shifted an additional 0.45 m away from the centerline of the bridge. This meant that modifications would be required to the pier cap, increasing the length of the pier cap to accommodate the shifted caissons, but also an increase in the cap depth of 0.3m.

Finally, modifications were made to the rock rip-rap placed on site, to suit material available locally and the expedited supply of rock for the project. A total of 24,885 tonnes of rip-rap was used to construct the permanent stabilizing berm, the work bridge, and the permanent erosion protection. Class 900 rip-rap was placed around SU.4, downstream of the bridge, and other key locations. Temporary materials 150 mm in diameter were placed during construction of the work bridge. The pier modification, bank stabilization, and channel erosion protection works were successfully completed between January and late March 2015. Figures 21 and 22 show the progression of the pier modifications and bank stabilization works.

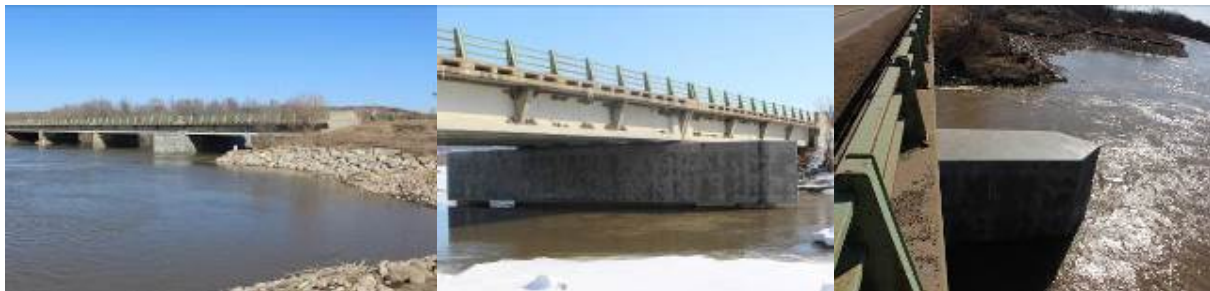
Figure 22 – Completed Pier Foundation
