ROADSIDE SAFETY STUDY: INVENTORY AND CONDITION AND RISK ASSESSMENT

Prepared for Presentation at the Transportation Safety and Security Session

*2015 Conference of the Transportation Association of Canada
Charlottetown, Prince Edward Island*

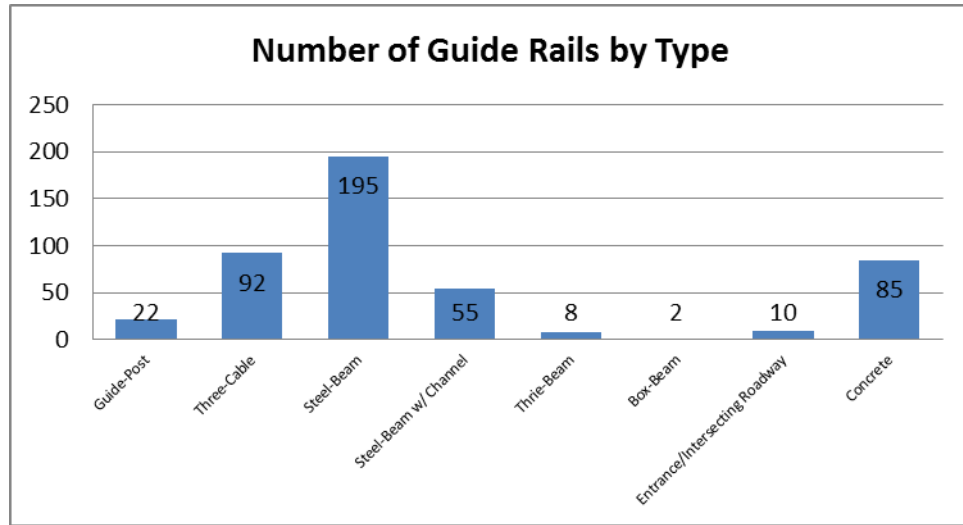
Figure 1
Number of Guide Rails by Type

The various types and corresponding instances of the roadside safety systems inventoried are presented in **Figure 1**. As illustrated, a majority of the systems inventoried along the municipal roadways were steel-beam guide rails (195) accounting for approximately 42 percent of the network.

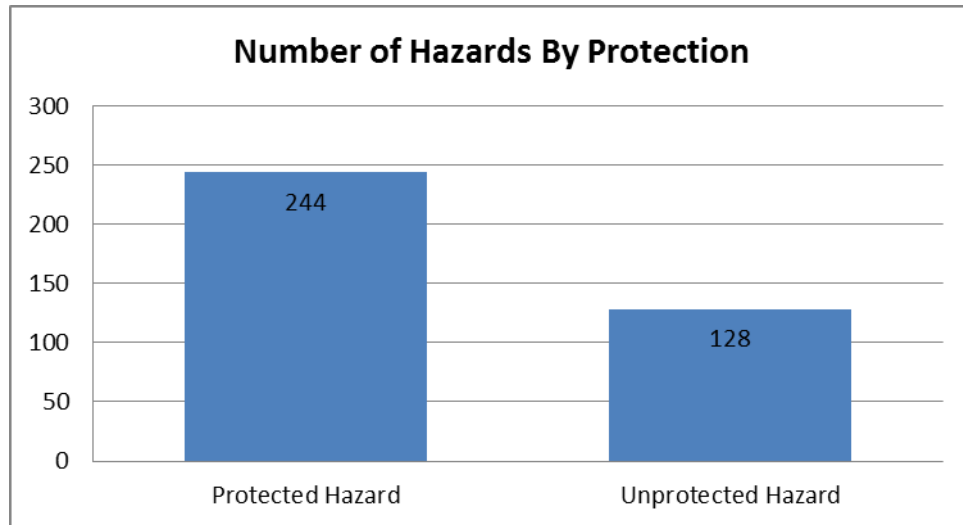
Figure 2
Number of Hazards by Protection

A total of 372 roadside hazards were identified; a majority were situated behind some form of roadside protection while a lesser number (128) remained completely unprotected as illustrated in **Figure 2**. Of these 372 hazards, the most frequently observed type of hazard were box-culverts, of which 150 were identified, followed by watercourses and embankments at 103 and 99 instances, respectively.

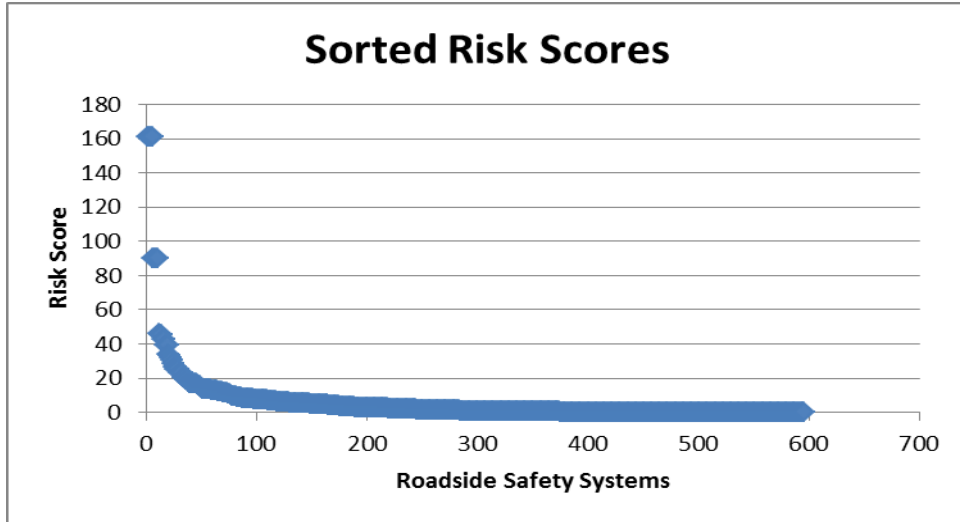
Figure 7
Sorted Risk Scores

Based on the methodology discussed in **Section 3**, the roadside safety systems and unprotected roadside hazards inventoried were assigned a risk score. **Table 5** and **Table 6** present the top ten roadside safety systems and unprotected roadside hazards with the highest ranked risk scores; these risk scores may be attributed to a number of factors including the roadway's AADT, the length of the system or hazard, and specifically in the case of a roadside safety system, the condition of the system and its ability to provide protection from the corresponding roadside hazard. It is noted that the top system or hazard is relatively higher than the others and is due a combination of high traffic volumes, poor condition or lack of a functional system, and a close proximity of the hazard to the adjacent roadway. The risk score may be used as a means of prioritizing remediation amongst the different roadside safety systems and/or unprotected roadside hazards. From the analysis, the risk scores range between 0.0 and 160.9 with a distribution presented in **Figure 7** whereby 0.0 represents a situation with a very low risk due to the presence of an adequate system fully protecting from the hazard in a location with low traffic volumes situated near the edge of the clear zone.
