Redwood Bridge – Rehabilitative Maintenance and Related Works

Paper prepared for presentation

of the 2007 Annual Conference of the
Transportation Association of Canada
Saskatoon, Saskatchewan

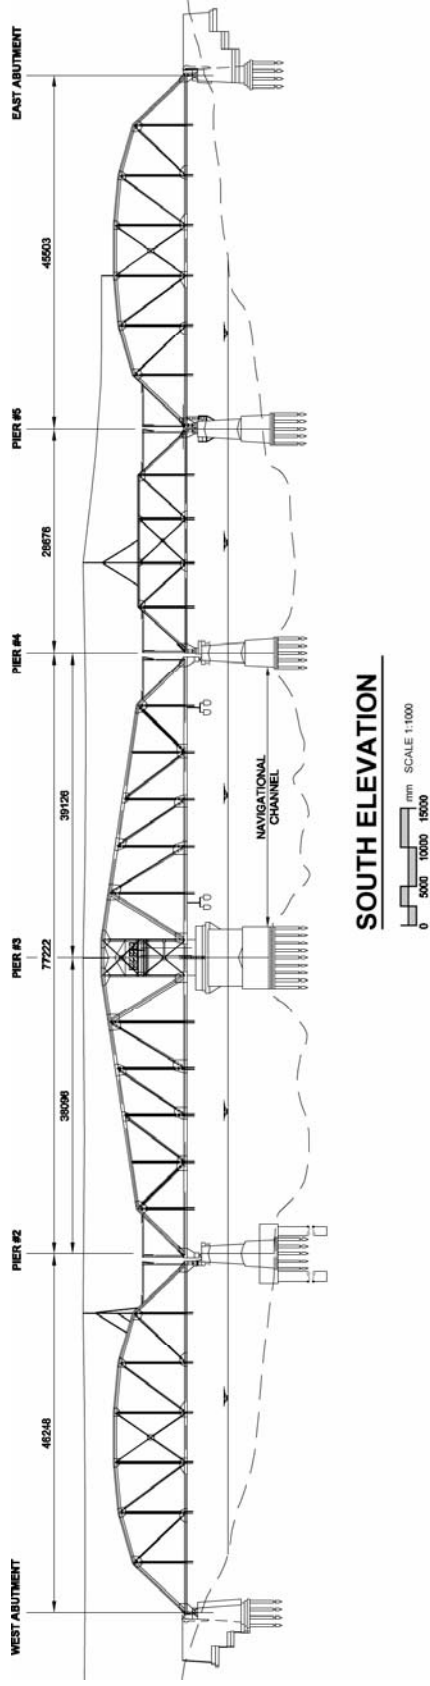
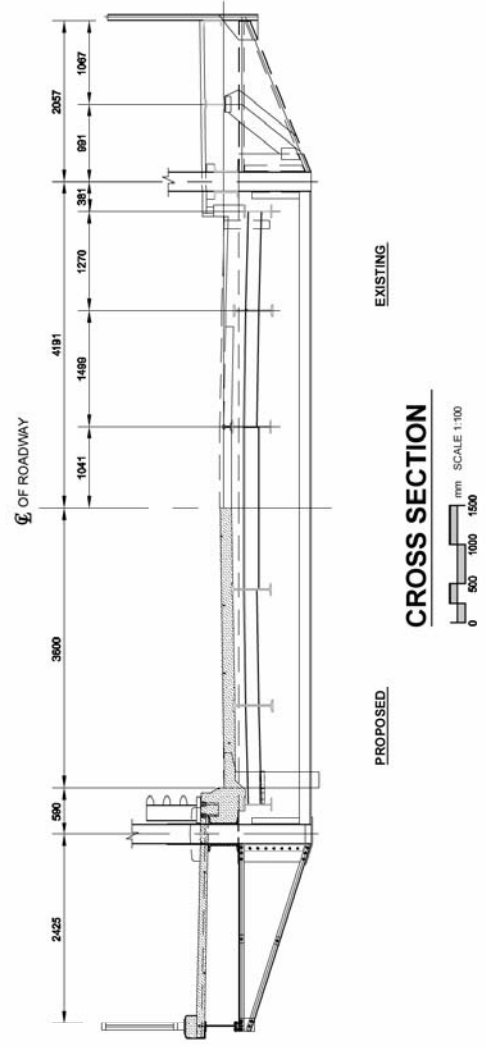
Figure 1: Redwood Bridge - South Elevation & Cross Section

The original Redwood Bridge was a two-lane, five-span bridge which consisted of a 45.7-m simple span steel through truss at each end, a 77.6-m swing span steel through truss, and a 29.1-m long simple span steel through truss, with a total length of 198.1 m. It had a clear roadway width of 7200 mm and a 1900 mm wide sidewalk on each side of the bridge. Figure 1 shows the elevation and section of the bridge. The foundation consisted of four reinforced concrete piers and two reinforced concrete abutments supported on timber piles. As expected for a structure that is nearly 100 years old, the bridge was showing its age. The bridge's foundations had shifted and the steel beams and trusses that carried the loads had deteriorated, partly due to corrosion from the road salt necessary for safe winter driving. Rehabilitating the bridge at this time will prevent further deterioration and avoid much more costly work and lengthy unscheduled closures in the future.

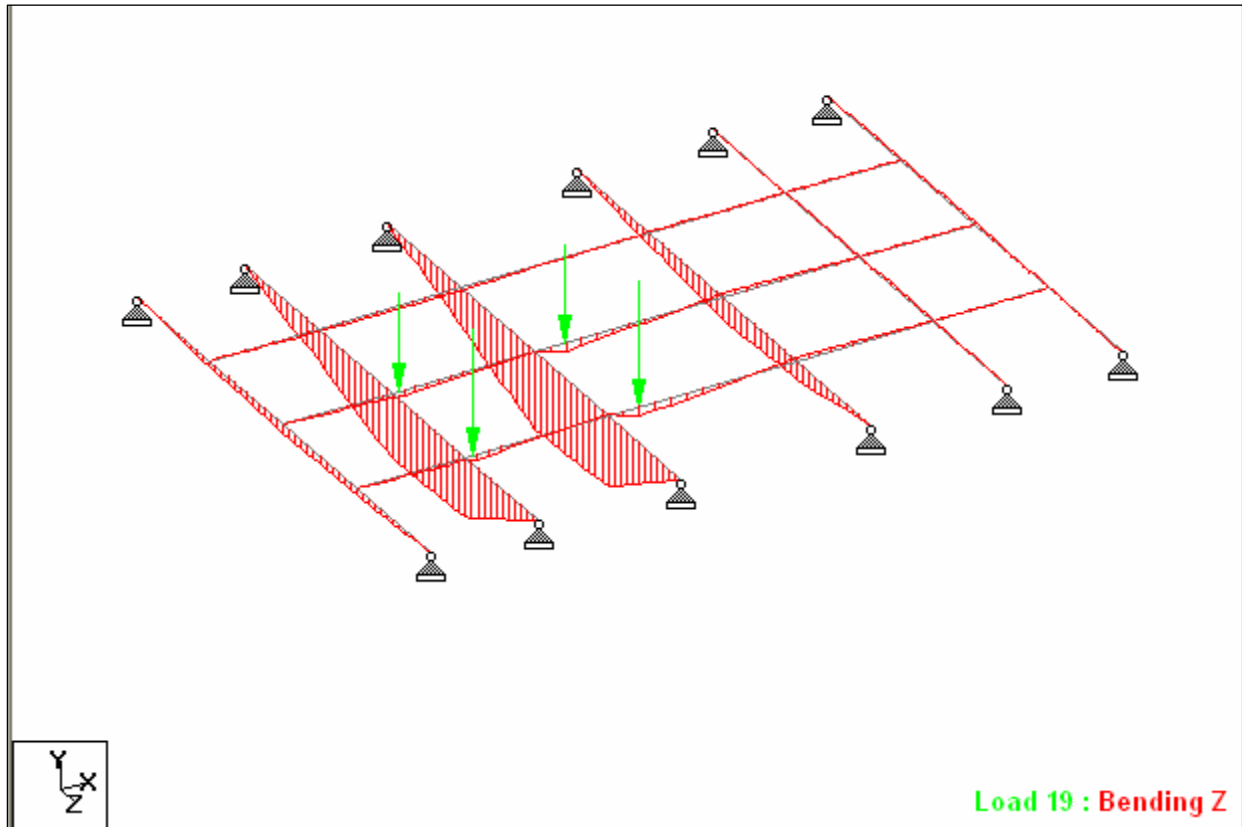
Figure 5. Grillage analogy model

Previous to rehabilitation, the posted maximum allowable truck loading on the bridge was 36.5 tonnes. To maintain the same level or to increase the truck loading on the bridge, the bottom floor beams, stringers and struts of the trusses were modeled by grillage analogy method, as shown in Figure 5. STAAD/Pro STructural Analysis And Design Software was used to determine the maximum bending and shear forces on the members with an assumed bridge deck slab thickness and truck loading. The optimum bridge deck slab thickness was determined to be 150 mm thick and the bridge deck was reinforced with galvanized reinforced bars.

The existing bridge deck consisted of reinforced concrete encasing streetcar rails and timber ties. The concrete deck was in poor condition and heavy efflorescence was present on the underside of the bridge deck. The existing deck was completely removed and replaced by a 150 mm thick reinforced concrete deck.
