# **DEVELOPMENT OF CONCRETE LINK SLABS TO ELIMINATE BRIDGE EXPANSION JOINTS OVER PIERS**

Paper prepared for presentation

of the 2008 Annual Conference of the  
Transportation Association of Canada  
Toronto, Ontario

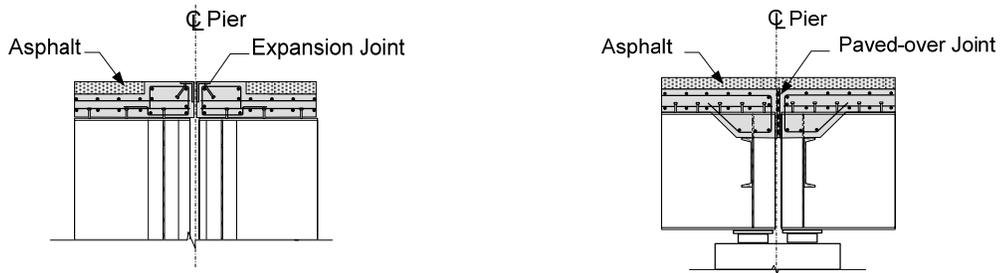
Figure 1: Deck Joints in Structures with Multiple Simple Spans

It was common practice before the 1970's to design multiple-span bridges as single-span structures, which were simply-supported on piers and then connected by expansion joints or paved-over joints at the pier locations (Figure 1). While this system provided a simple and effective structural solution, it brought along a range of maintenance issues that have compromised the durability of many of these structures. Historically, bridge expansion joints have never performed up to design expectations. Their recurring inability to provide reliable and effective long-term leakproof performance has led to early leakage of chloride-contaminated water through those joints, thereby causing premature corrosion at girder ends and supporting substructures below. Typically, the damage is exemplified by cracking, spalling and disintegration of the concrete deck slab in the area adjacent to the joints as well as spalling and delamination of the concrete around the bearing seat and pier cap below (Figure 2).

(a) Expansion Joint between Spans                      (b) Paved-over Joint between Spans

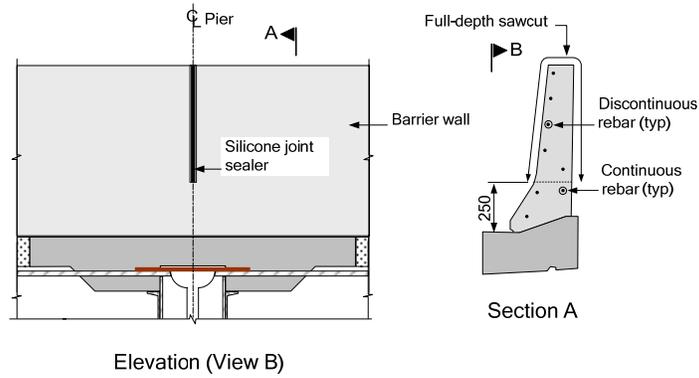
Figure 7: Barrier Wall Details over Link Slab at Hwy 427 SBL/Dixon Road Overpass

Rehabilitation Details: The existing deck was rehabilitated in 1997 as follows: (a) the deck was widened by approximately 6.0 m with the addition of a new 225 mm thick slab, and (b) the existing deck joints at the pier supports were replaced with a continuous 2.0 m wide link slab element that bridged the gap between adjacent girders, which remained discontinuous at the piers. The link slab system (Figure 6) was generally similar to the design used in the first trial application at the Kent County Road No. 10/Hwy 401 Underpass. The main differences were due to the implementation of the recommendations of the new design guidelines, which included revised reinforcement in the link slab and new barrier wall details over the link slab (Figure 7). Note that the shear ties were still used in this structure but they were dropped in later projects.

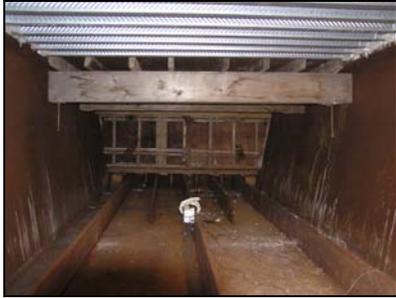
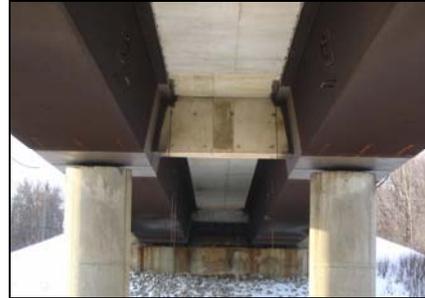
Figure 9: Construction of Concrete Diaphragm Linking Simple Spans

Figure 8 shows the main structural details used to convert the initial simply-supported box girder system into a semi-continuous system for live load. It can be seen that the modifications are extensive with major retrofitting of the steel box girders required to resist the negative moment at the pier support. As a result, the costs of this rehabilitative scheme became expensive. Figure 9 shows the construction work inside the box girder and the completed concrete diaphragm between the box girders.

(a) Formwork inside Box Girder

(b) Completed Concrete Diaphragm

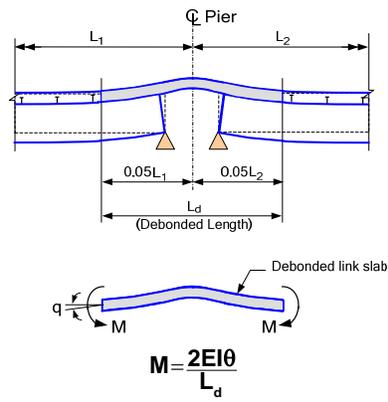
Figure 10: Design Moment for Debonded Link Slab

- (3) Determine end rotations of the girders under serviceability limit state (SLS) loads assuming beams are simply-supported and impose end rotations to ends of link slab.
- (4) Determine bending moment in link slab due to imposed end rotations, assuming cracked section properties for the link slab (Figure 10).
- (5) Design reinforcement for link slab to meet crack control criteria of the Canadian Highway Bridge Design Code (CSA S6-06) [6].

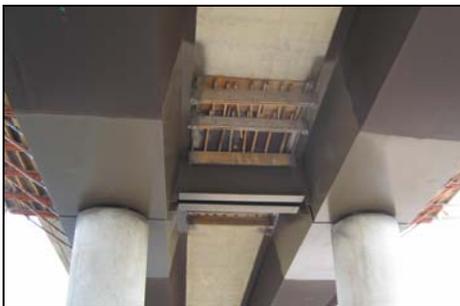
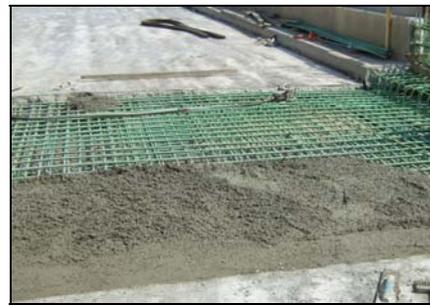
Figure 15: Construction of Debonded Link Slab at Camlachie Road/Hwy 402 Underpass

Construction of the link slab consisted of: (i) removal of a 6.0 m wide strip of existing deck symmetrical about the pier centreline including all existing shear studs in the middle 4.0 m wide strip, (ii) replacement with a new cast-in-place link slab of matching thickness to existing deck slab, which was cast on top of the exposed girders but debonded from the top flanges over the middle 4.0 m wide segment, and (iii) repaving the whole deck with a 90-mm thick asphalt and waterproofing layer. Figure 15 shows some photographs of the link slab construction.

(a) Formwork at Soffit of Link Slab

(b) Concrete Pour for Link Slab
