Case Study of an Innovative Forensic Investigation of a Dramatic Pavement Failure, 14 Street NW, Calgary, Alberta.

Art Johnston, C.E.T.
Principal, Transportation Practice
EBA Engineering Consultants Ltd.

Joe Chyc-Cies, P.Eng.
Materials & Research Engineer
City of Calgary, Roads

Paper prepared for presentation
at the Introducing Innovation into
Pavement Design and Engineering Session
of the 2009 Annual Conference of the
Transportation Association of Canada
Vancouver, British Columbia

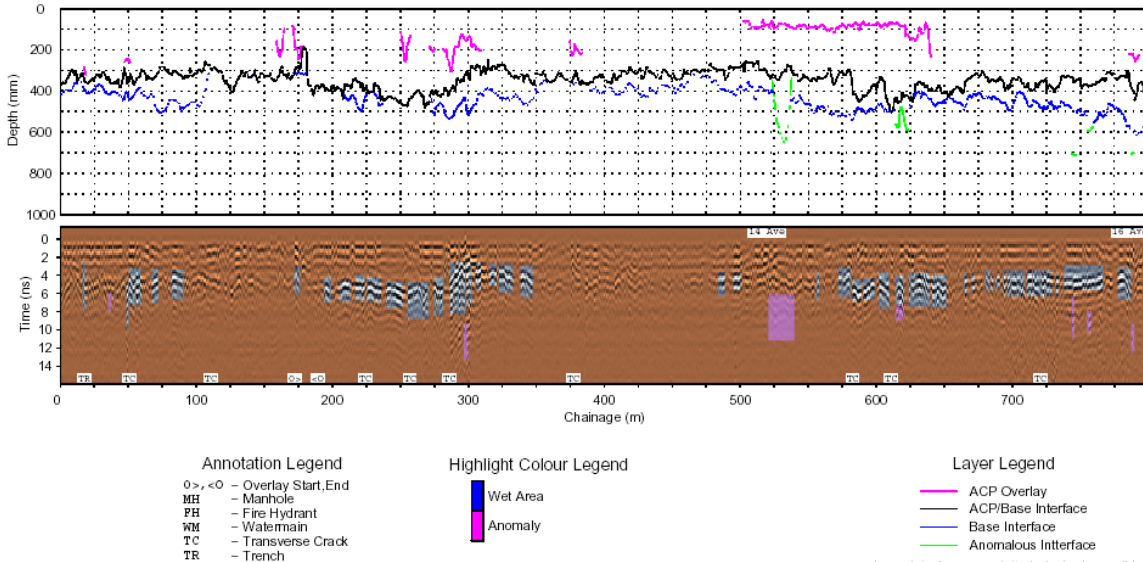
An example of the detailed continuous profile radar survey results for the surveys is provided as Figure 9.

Figure 9: Typical ROAD RADAR™ Profile Presentation

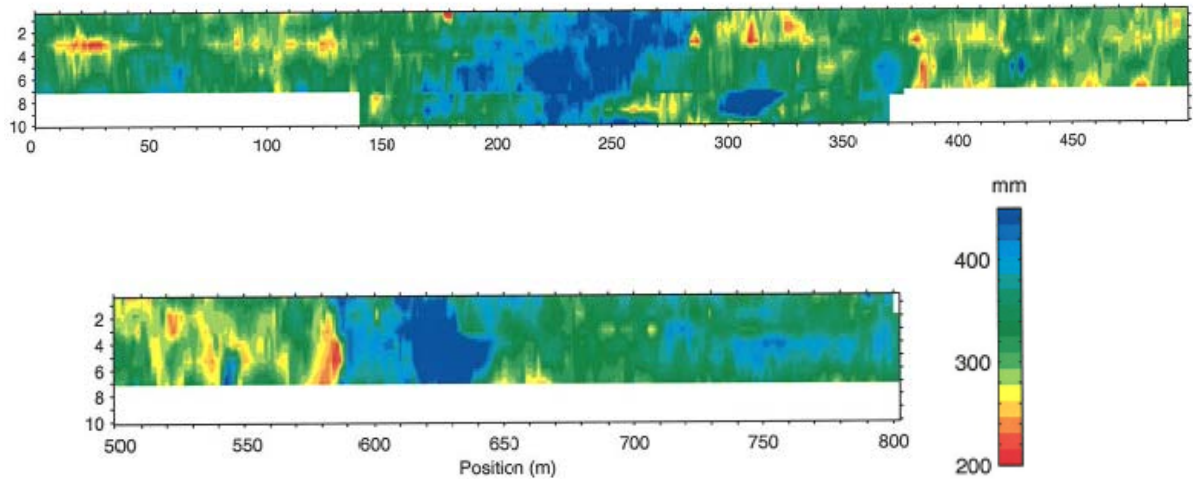
Asphalt Concrete Thickness Plan Map (Figure 10)

This plan map shows the measured asphalt concrete thickness. This measurement is reported from the roadway surface to the top of the first detected base layer. The worst case measurement accuracy for this parameter is 6 mm or 5%, whichever is greater. A legend is provided which relates each color to a thickness range and identifies the percentage of the total area corresponding to that thickness range.

Figure 10: Asphalt Concrete Thickness Plan Map

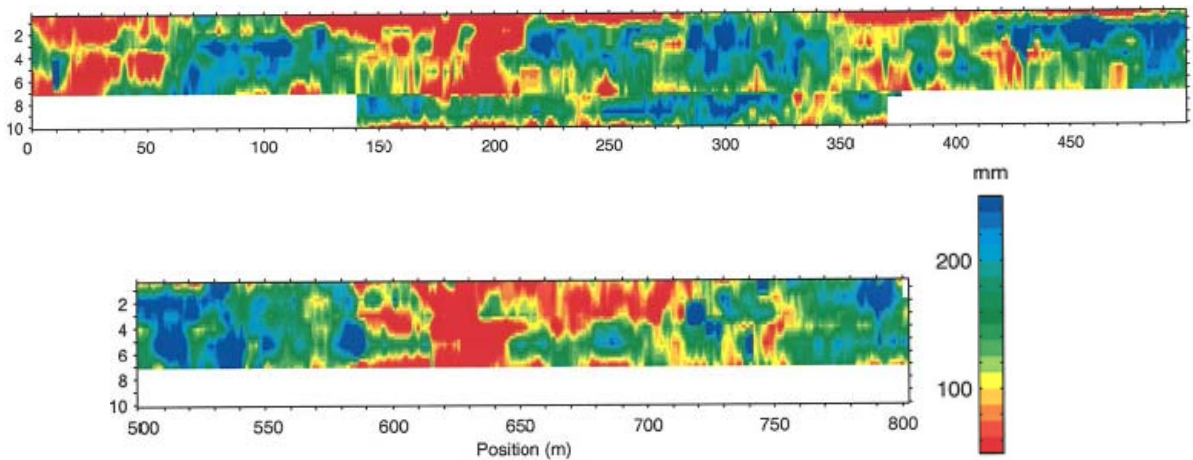
Granular Base Thickness Plan Map (Figure 11)

This plan map displays the thickness of the total base below the ACP, with a worst case measurement accuracy of 12 mm or 10%, whichever is greater. A legend is provided as for the Granular Base Thickness Plan Map.

Figure 11: Granular Base Thickness Plan Map
