**Long Term Performance and Acoustic Properties of an
Aging Open Graded Friction Course Asphalt Pavement Surface**

Paper prepared for presentation at the
Introducing Innovation into Pavement Design and Engineering Session of the
2009 Annual Conference of the Transportation Association of Canada
Vancouver, British Columbia

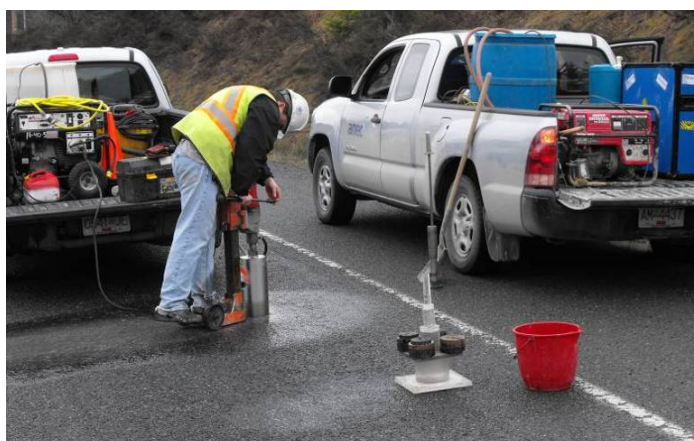
Photo 14: Coring and Permeability Testing

The permeability testing showed relatively low permeability in each location. The results for the shoulders ranged from 2.2×10^{-4} to 3.8×10^{-4} cm/s. The results for the wheelpaths ranged from 1.0×10^{-4} to 5.9×10^{-6} .
