Alternative Condition Assessment for Concrete Bridge Decks – A Case Study

The City of Calgary commissioned EBA Engineering Consultants Ltd. (EBA) to undertake a condition survey in 2008 of the 16 Avenue Bridge (TransCanada Highway Bridge [TransCanada Bridge]) over University Drive NW. The bridge was constructed in 1959 and was rehabilitated in 2001. At the time of rehabilitation, the deck underwent hydrodemolition to a depth of 90 mm and to a depth of 105 mm at the pier strips. The new deck reinforcing was reportedly galvanized steel, and the concrete deck was covered with a HD concrete overlay with steel fibres. Due to the presence of steel fibres in the overlay and galvanized reinforcing steel, copper-copper sulphate half-cell potential testing was not conducted. Instead, a comprehensive concrete deck coring program was proposed to determine the concrete condition and to determine chloride profiles for life cycle modelling. The program was accepted by The City of Calgary, and the visual condition survey and core extraction from the bridge deck commenced in the summer of 2008. During that time, EBA's Calgary Materials & Pavement Group had been awarded EBA's internal Applied Techn

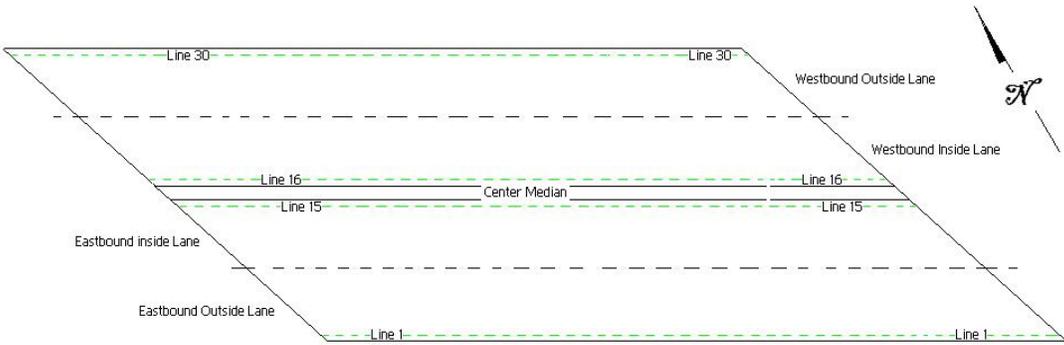
Figure 1: Survey line layout (not to scale).

Due to the heavy traffic volumes along the TransCanada Highway, the bridge deck survey was confined to off-peak hours between 10 p.m. and 5 a.m. The total survey time was approximately 12 hours and was conducted with lane closures. The complete coverage survey was accomplished by closing off a single lane of traffic at a time. The survey line layout is presented in Figure 1.

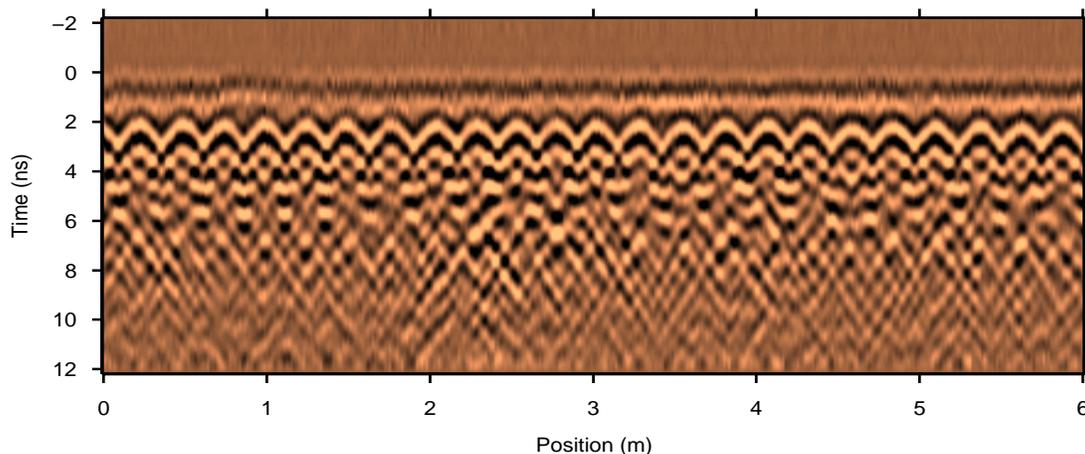
Figure 2: Typical section of bridge deck data without distresses.

Deck Anomaly Plan Map (interfered parameter) presents a measure of the location and areal extent (as well as total affected area and percentage of the total surveyed area) of subsurface anomalies as detected by radar at or above the top mat of rebar boundary. Figure 2 shows a section of ROAD RADAR™ data with no subsurface anomalies. For this figure, the black line near 0.0 nS (vertical time axis) represents the surface of the structure, and the apex of each inverted hyperbola represents the location of each transverse rebar in the top mat of reinforcing steel.
