Development of a Rural Municipal Road Conditions Assessment Method and Associated Quality Assurance Process

**Paper prepared for presentation at the:
Transportation Innovations and Opportunities in Small Municipalities Session
of the
2012 Conference of the Transportation Association of Canada,
Fredericton, New Brunswick**

This paper discusses the issues confronted during a multi-year project involving the development of a conditions assessment method and a quality assurance process for surfaced rural roads in Parkland County, Alberta, Canada.

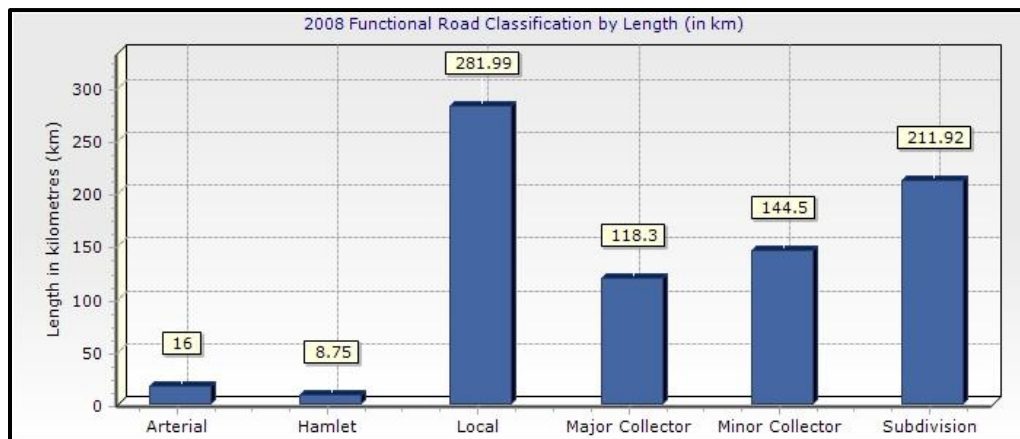
In 2008, the total length of Parkland County's surfaced road network was 782 kilometres. This network was divided into 611 segments. A segment is a relatively homogenous part of the road network and is typically 1.6 km (1 mile) in length or shorter. The surfaced roads are divided into the following functional road classifications: Arterial; Major Collector; Minor Collector; Local; Subdivision and Hamlet Roads, Figure 3.

Figure 3 – Distribution of ALL of Parkland County's surfaced roads by, road classification.

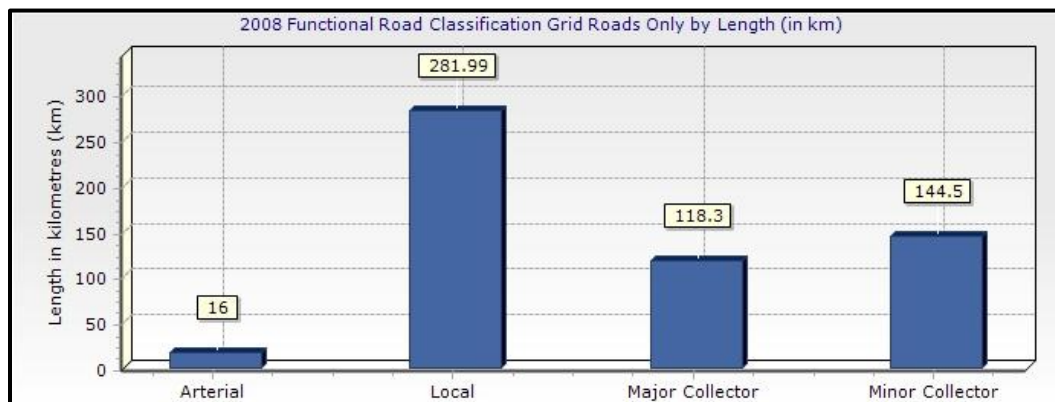
To date Parkland County has only analyzed surfaced grid roads and therefore this paper only addresses the grid road network. With the subdivision and hamlet roads removed, 424 segments with a total length of 560 kilometres remain, Figure 4.

Figure 4 – Distribution of Parkland County's surfaced GRID roads only, by road classification.

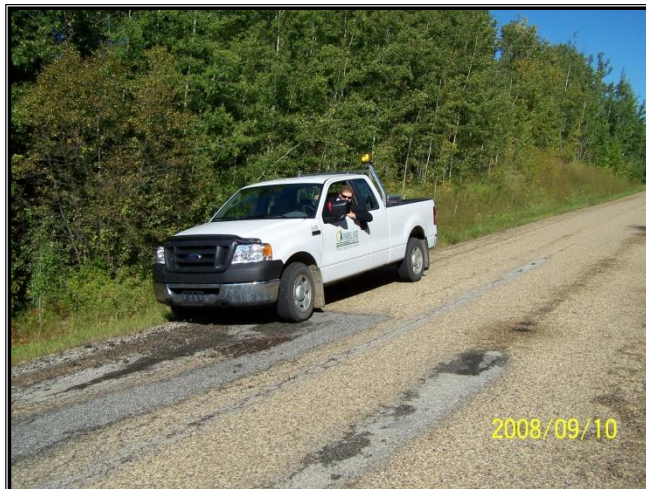
The driving portion of the rating procedure is called the “In Vehicle” rating, Figure 6. During the In Vehicle rating, the following distresses are observed:

- The General Surface Condition (new, good, fair, poor).
- Patch Frequency (none, small less than 30% of area, isolated large less than 30% of area, extensive).
- Patch Condition (zero patches, new patches, good, fair, poor).
- Any hazardous surfacing failures are also recorded during the in vehicle rating.

To observe these distresses, the rater first drives the full length of the segment at the posted speed limit to determine the General Surface Condition of the road. The rater then drives the full length of the road segment a second time at a speed of 10 to 15 km/hr and observes the Patch Frequency and Patch Condition distresses.

Figure 6 – “In Vehicle” surface rating inspection.

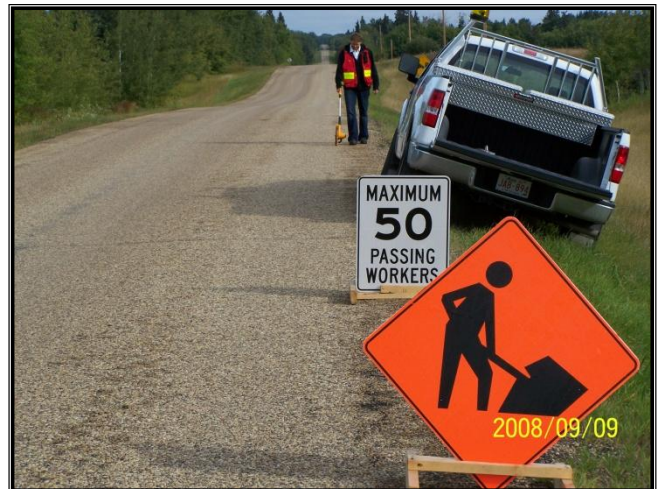
The walking portion of the rating procedure is called the “Exit Vehicle” rating, Figure 7. During the Exit Vehicle rating, the following distresses are physically measured; Alligator Cracking, Block Cracking, Ravelling or loss of surface material and Rutting.

For the Exit Vehicle rating, the rater chooses a 50 m long section of road, called the gauging area, to physically measure the distresses. The 50 m section of road is chosen so that it is a representative sample that reflects the general surface condition of the entire road segment.

Figure 7 – “Exit Vehicle” surface rating inspection.

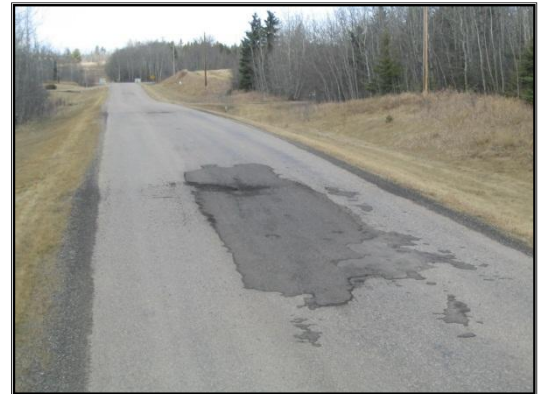
Patching, Figure 10, is rated as a distress because patches are placed on the road to correct a surface failure such as cracking or potholes. Raters measure the amount of patching that is present on the entire segment. The patch frequency is then given a rating score of 0, 1, 2 or 3 as outlined in the Table 1 below:

Figure 10 – Typical skin patch in Parkland County.

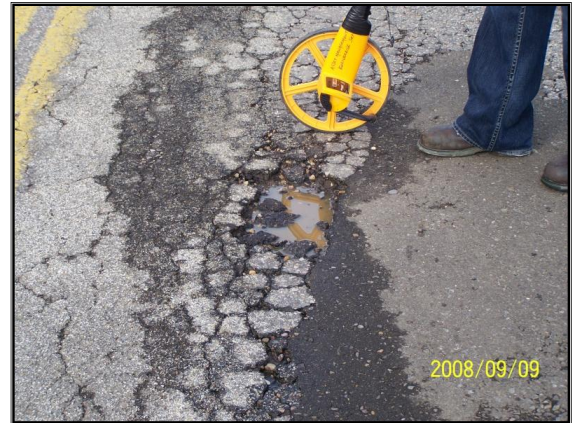
Alligator Cracking is formed when a high density of linear cracks become interconnected to form polygons that are less than 150 mm by 150 mm across. Figures 11 and 12 show samples of alligator cracking.

The appearance of these interconnecting cracks is similar to an alligator's skin. Raters measure the area of Alligator Cracking that exists in the gauging area and assigns a severity to the Alligator Cracking as defined in Table 3.

Figure 11 – Extreme Alligator Cracking.

The presence of Alligator Cracking indicates the subgrade of the road is failing.

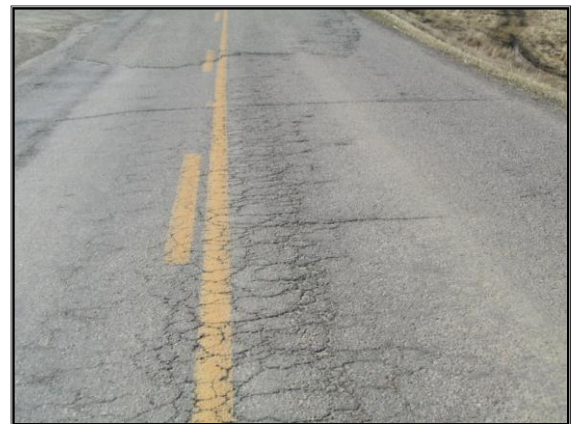
Figure 12 – Moderate Alligator Cracking.

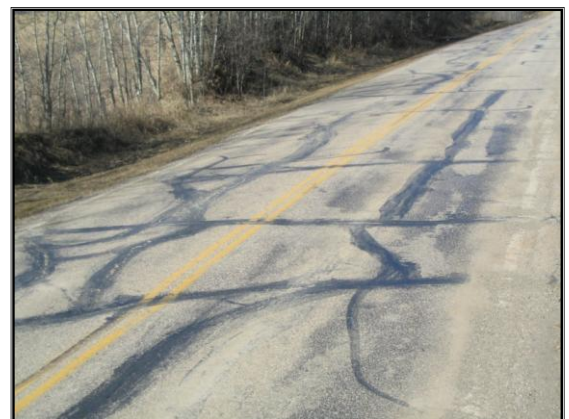
Block Cracking, Figure 13, is formed when linear cracks are joined to form blocks that are less than 2 m by 2 m and greater than 150 mm by 150 mm square. Block Cracking is recorded when 3 or more blocks are interconnecting within the gauging area.

Block Cracking that exists in the gauging area is assigned a severity as defined in Table 4.

Figure 13 – Block Cracking.

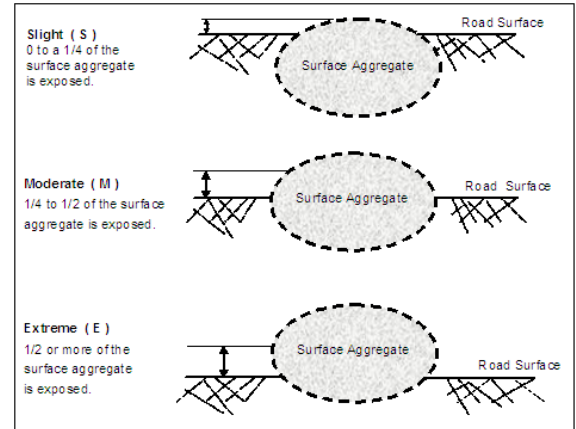
Loss of Surface Material or Ravelling is created through the progressive loss of surface materials, aggregate particles and bitumen binder, from the surface downward, leaving a rough surface which is then vulnerable to deterioration due to weather.

The rater assigns a Ravelling Severity Score of None, Slight, Moderate or Extreme (N,S,M,X) based on the amount of binder that has been lost, or how much of the surface aggregate is exposed, Figure 14.

A percentage of area each Ravelling Surface Score that exists in the gauging is also recorded by the raters. This percentage is the extent measure for this distress.

Figure 14 – Ravelling surface score.

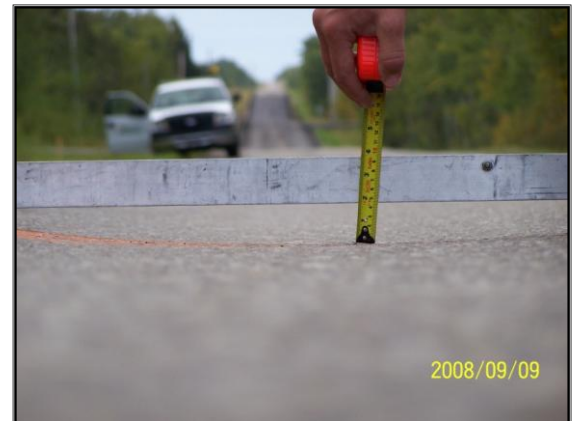
Raters measure rutting in millimetres by placing a straight edge perpendicular to the rut and measuring the deepest depression of the rut, Figure 15. Six rut measurements (three in each lane direction) are taken and recorded for the gauging area being rated.

Figure 15 – Measuring Rutting on a Parkland County Road.

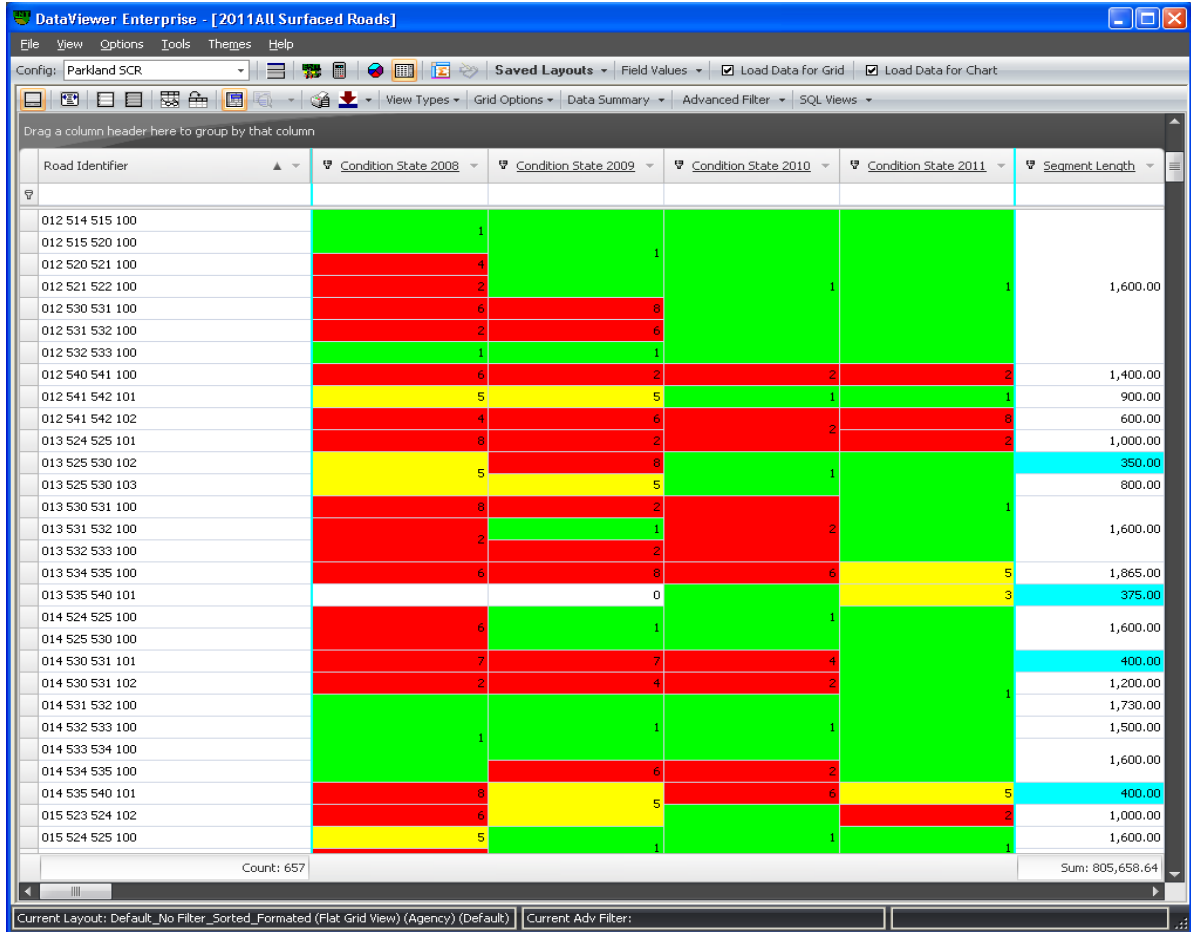
It was decided since 2008 most of the surfaced road network was segmented and condition ratings had been obtained for the roads, that 2008 would be the base year to be compared to. At the end of the 2010 rating season, the County now had three years of condition data that could be used to assess the performance of the surfaced road network. A multi-year data view was developed, Figure 17, with which one could quickly view a Road Identifier's condition state over the years.

Figure 17 – Multi-year data view used to compare each Road Identifier’s performance from year to year.

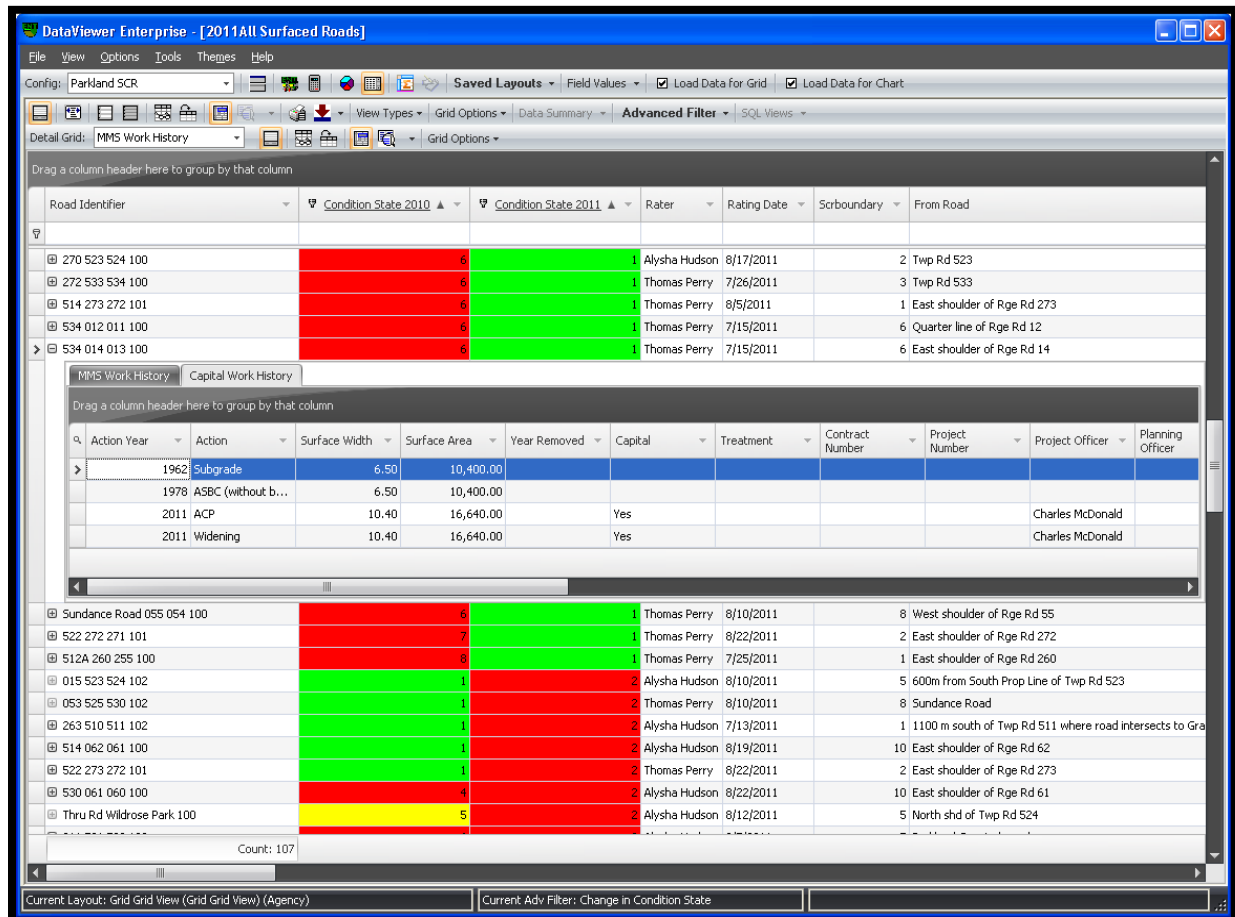
In Figure 18, it is shown Road Identifier 534 014 013 100 was a Condition State of 8 in 2010 and improved to a Condition State of 1 in 2011. Through expanding the Capital Work History Grid in the database, one can see that in 2011 this road was part of the capital program where it was ACP surfaced and widened from 6.5 m to 10.4 m which therefore confirms the reason for the Condition State 1 status of this Road Identifier in 2011.

It should be noted here that although an overlay is the preferred treatment for a Condition State 6, an ACP widening capital project also achieves the same goal.

Figure 18 – Multi-year data view with the Capital Work History Grid displayed. Confirms why 534 014 013 100 became a Condition State 1 in 2011 from Condition State 6.

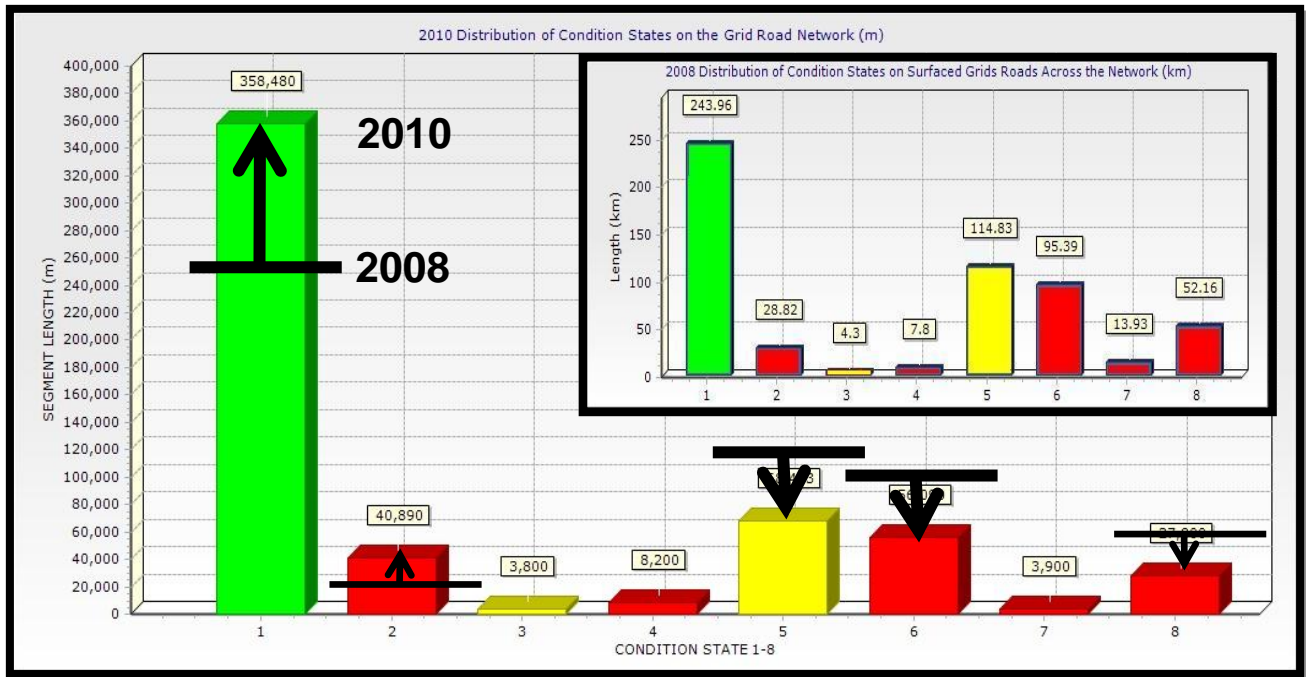
An example of how comparing the condition states of the surfaced road networks between 2008 and 2010 is shown in Figure 20. In Figure 20, it is shown that over these years, the condition of the County’s surfaced road network has improved. The capital and maintenance programs applied over these years has reduced the amount of Condition State 5, 6 and 8 roads and increased the amount of Condition State 1 roads.

Figure 20 – Comparing Total Lengths vs. Condition State of Parkland County's surfaced roads between 2010 and 2008.
