**THE EVOLUTION OF BRIDGE DECK REHABILITATION
STRATEGIES IN ONTARIO**

David Lai, P.Eng.
Head Rehabilitation Engineer
Bridge Office, Highway Standard Branch
Ministry of Transportation Ontario

of the 2008 Annual Conference of the
Transportation Association of Canada
Toronto, Ontario

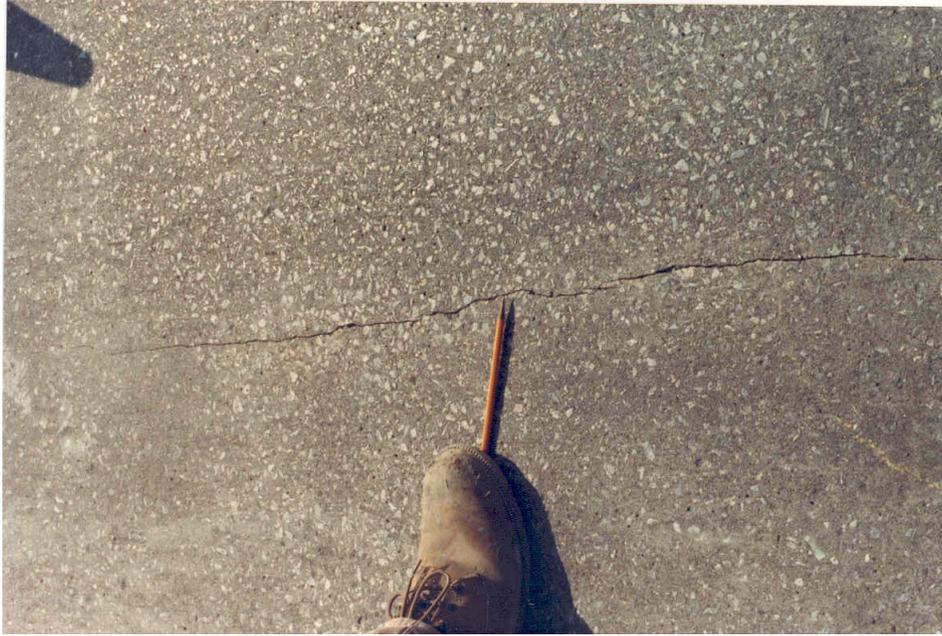
**Figure 1 QEW WB to Highway 427 SB Ramp (Photo taken 1989)
- Typical longitudinal crack in deck over voids**

Most of the post-tensioned decks with circular voids were originally built without transverse post-tensioning. It was soon discovered that longitudinal cracks occurred at every voids due to stress concentration and possible floating up of the void forming ducts during concreting. Figure 1 shows a close-up view of such cracks on the QEW westbound to Highway 427 southbound ramp structure taken in 1989; the deck was constructed in 1968. At the time of condition survey, there was 14.5% of the deck top surface that had delaminated or spalled and the chloride content at rebar level in the delaminated areas was 3 times the threshold. Figure 2 shows a typical delaminated area with rust staining and spalls.

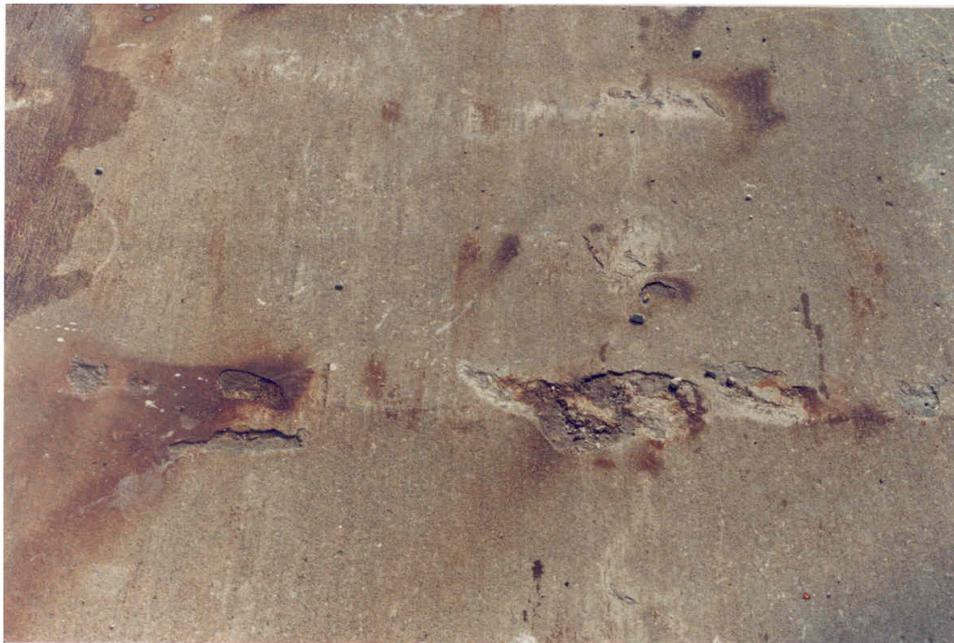
Figure 2 QEW WB to Highway 427 SB Ramp Deck Top Condition (Photo taken 1989)

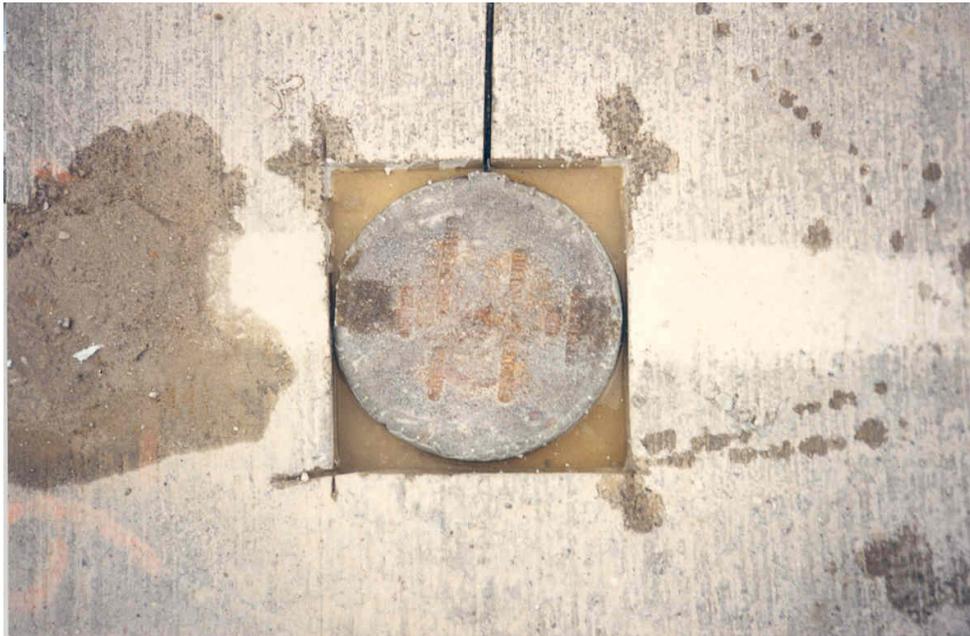
Figure 3 Pancake anode recessed into concrete deck

In 1974, the ministry installed the first conductive asphalt cathodic protection system on bridge decks based on the work by Stratfull [4] in California. It consisted of primary high-silica cast iron anodes recessed in the concrete surface and covered with a 40mm thick layer of electrically conductive cokebreeze asphalt; the conductive asphalt is then covered with a conventional asphalt surface course. This CP system can only be used on properly air-entrained concrete surfaces as the bridge deck cannot be waterproofed. Later on, from around 1990, this system has been used in conjunction with a normal concrete overlay to overcome the problem for decks where the existing concrete was not properly air-entrained. Figure 3 shows a typical pancake anode recessed in the top surface of a deck.

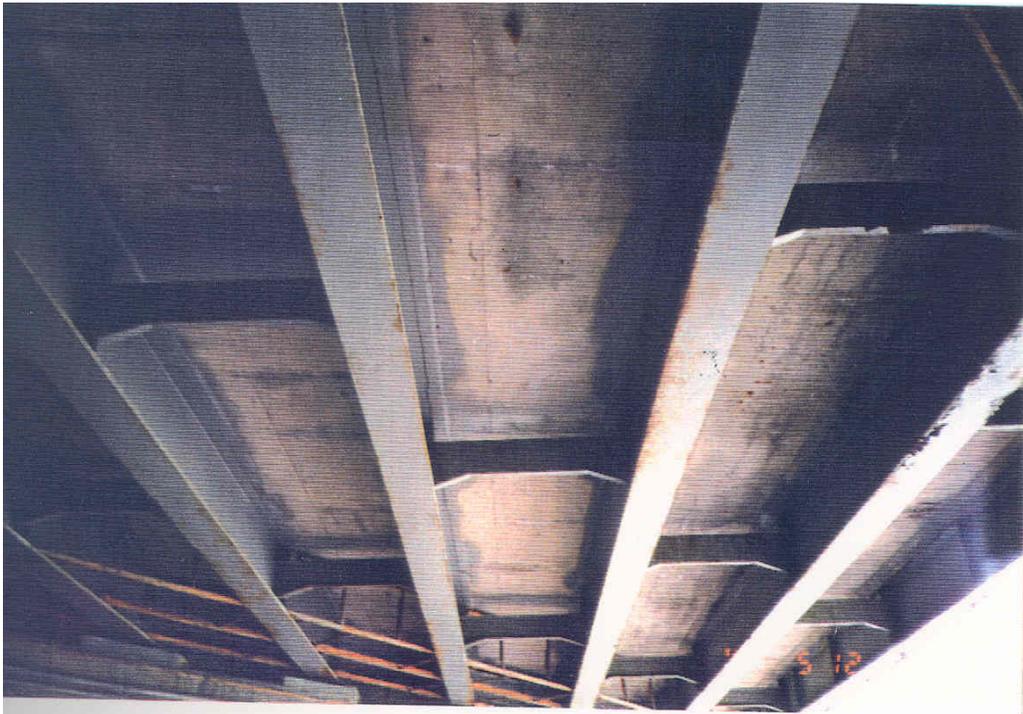
Figure 4 Soffit of Island Park Overpass, Hwy 417, taken in 1993

- (ii) Due to the lack of waterproofing, moisture and chloride would eventually reach the bottom reinforcement and cause corrosion damage at the soffit of a thin deck. Figure 4 and Figure 5 show the progressive soffit deterioration of the Island Park Overpass Highway 417 where the top had been treated with the conductive asphalt CP system in 1983. The same also applies to shear connectors and stirrups of the girders embedded in the concrete.

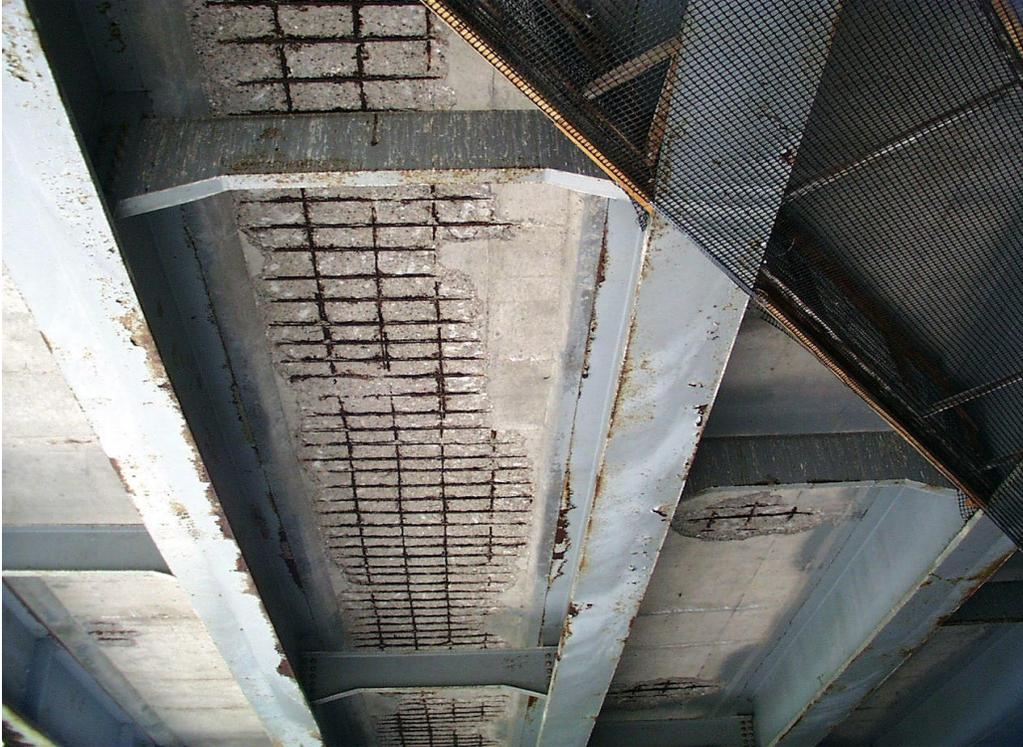
Figure 5 Soffit of Island Park Overpass, Hwy 417, taken in 2000

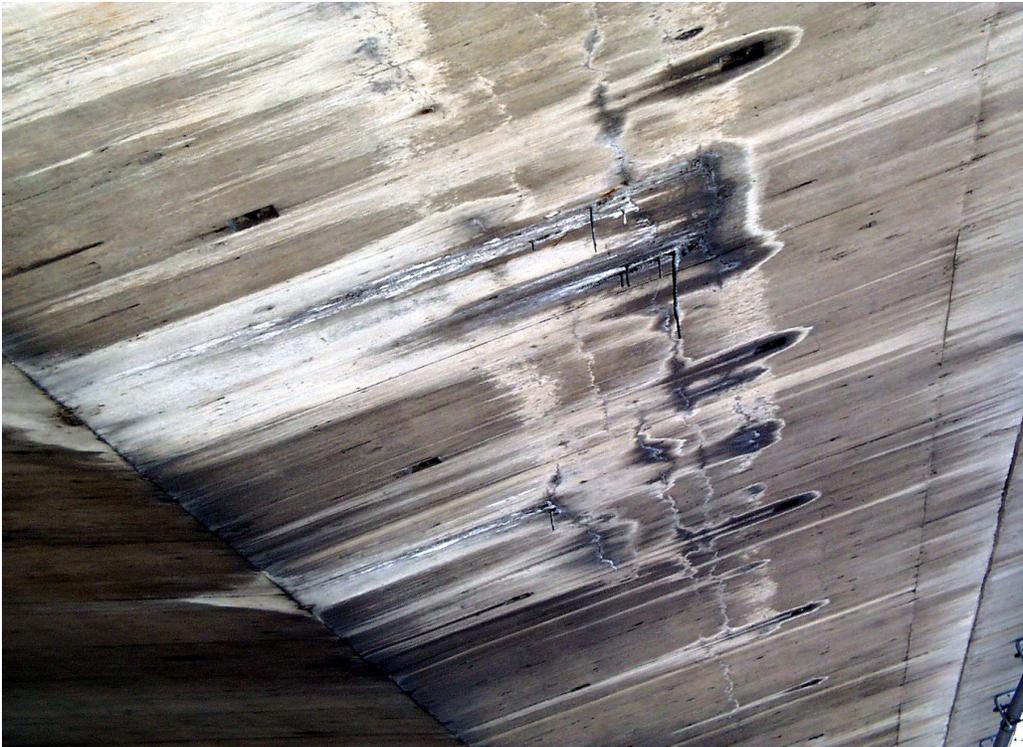
Figure 6 Soffit of Post-Tensioned Deck with leaching cracks

- (iii) The post-tensioning cables are not protected against moisture and chloride ingress due to the lack of waterproofing. This is a serious concern since the grouting of the cables carried out in the 1960's might not have been controlled to a very high standard and could have left behind voids at the high points of the cables. Figure 6 shows leaching cracks at the soffit of a post-tensioned deck with circular voids where the top had been treated with the conductive asphalt CP system.

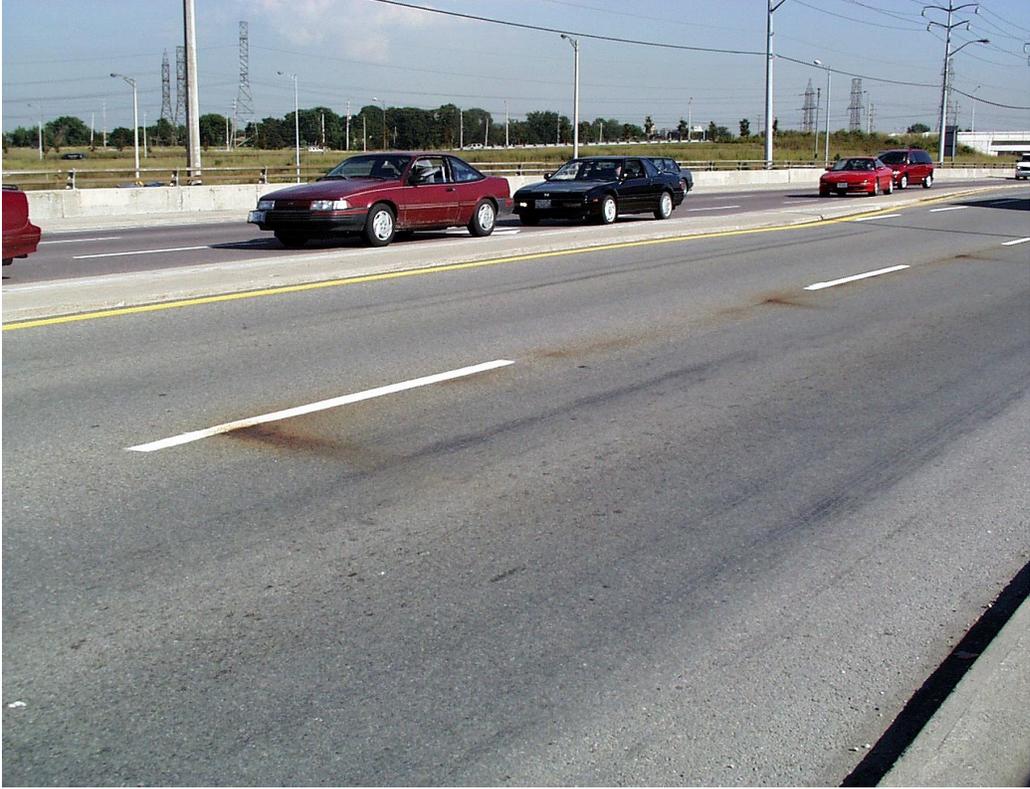
Figure 7 Rust staining at anodes of conductive asphalt CP system

- (iv) The asphalt on top of the anodes would begin to deteriorate in a few years with rust stains bleeding to the surface. Consumption of the coke and acid generation at the anode would soften the asphalt, leading to ravelling and depression of the wearing surface under traffic load (See Figure 7 and Figure 8). The electrical resistance of the system would then increase due to poor current distribution from the anodes and the cable splices could also corrode.

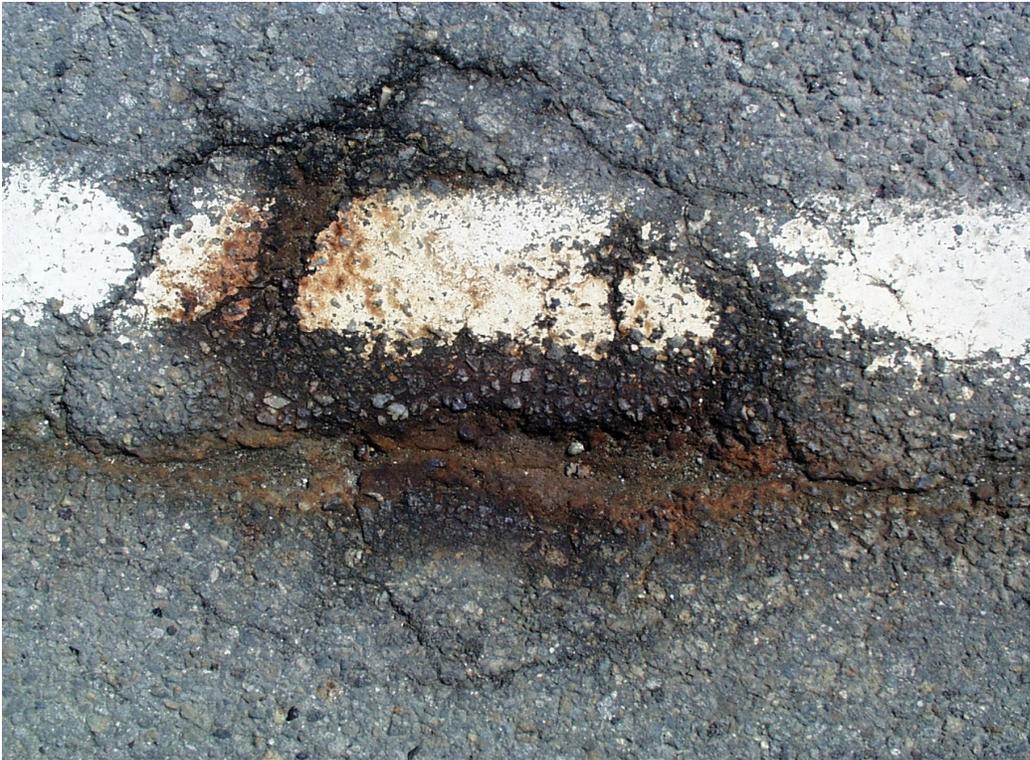
Figure 8 Asphalt deterioration at anode of conductive asphalt CP System

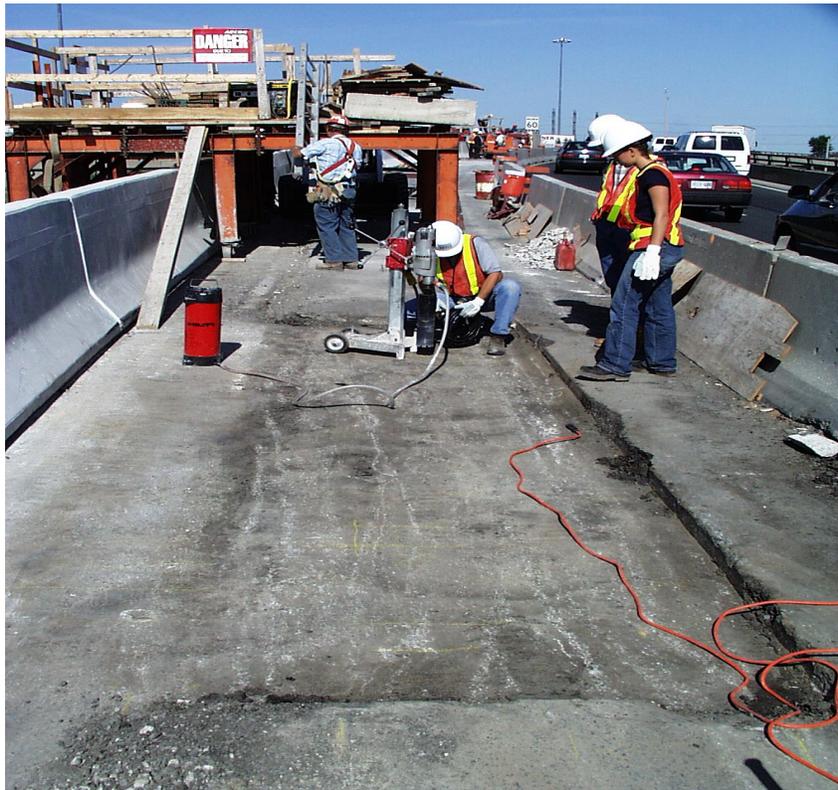
**Figure 9 Condition Survey on Latex Modified Concrete Overlay 2002
(QEW/Hwy 427 Bridge No. 7)**

By the early 1980's, many of the exposed concrete decks that were built in the 1960's were already suffering extensive corrosion damage and condition surveys indicated significant chloride penetration and corrosion potential more negative than $-0.35V$ in large areas. The ministry realised that the service lives of these decks could be extended if further ingress of chloride and moisture could be prevented. Hence, waterproofing was installed during the first cycle of rehabilitation of many of these decks in the early 1980's and since the existing concrete surface was too rough in most cases to receive the waterproofing, most of them also received an overlay. Latex modified overlay was typically used during this period because of its low permeability and good bonding characteristics. Delaminated and unsound concrete were removed but areas with corrosion potential $<-0.35V$ but otherwise sound concrete would have been left in place. The policy also allowed the use of exposed latex modified overlay for secondary highways where the existing structure could not carry the extra load of the overlay, waterproofing and paving. Recent condition surveys conducted on many of these decks in preparation for a second cycle rehabilitation have shown that in general the first rehabilitation treatment has been effective; the corrosion potentials in the previously active areas have shifted into the passive and uncertain range, despite the fact that chloride content at the rebar level has exceeded threshold. The latex overlay is also performing very well with minimal disbondment after 20 years. Figure 9 shows a localized area of removal of the latex modified overlay on a post-tensioned deck during condition survey and Figure 10 shows the core taken from the same area. The

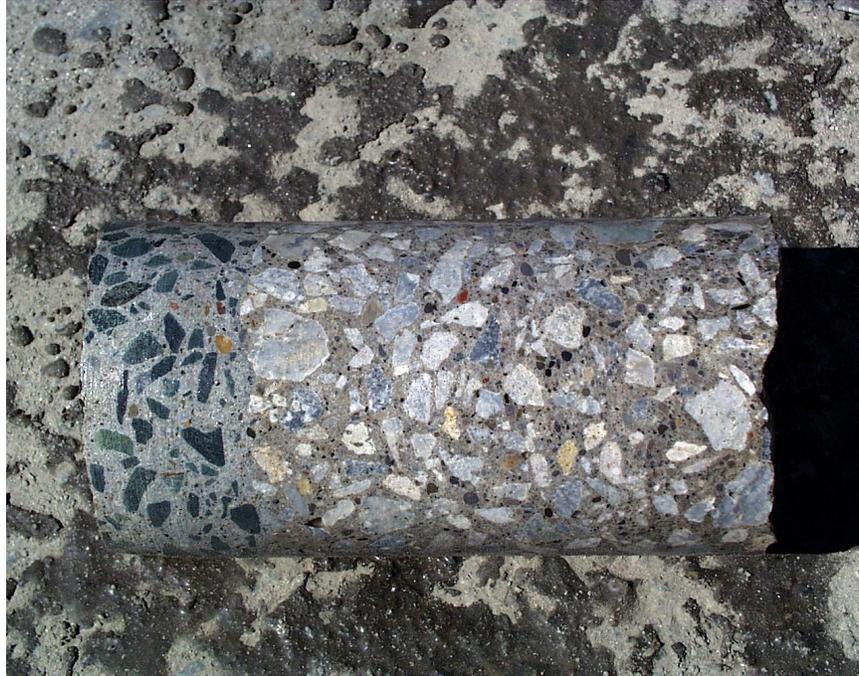
Figure 10 Core taken from deck with latex modified overlay

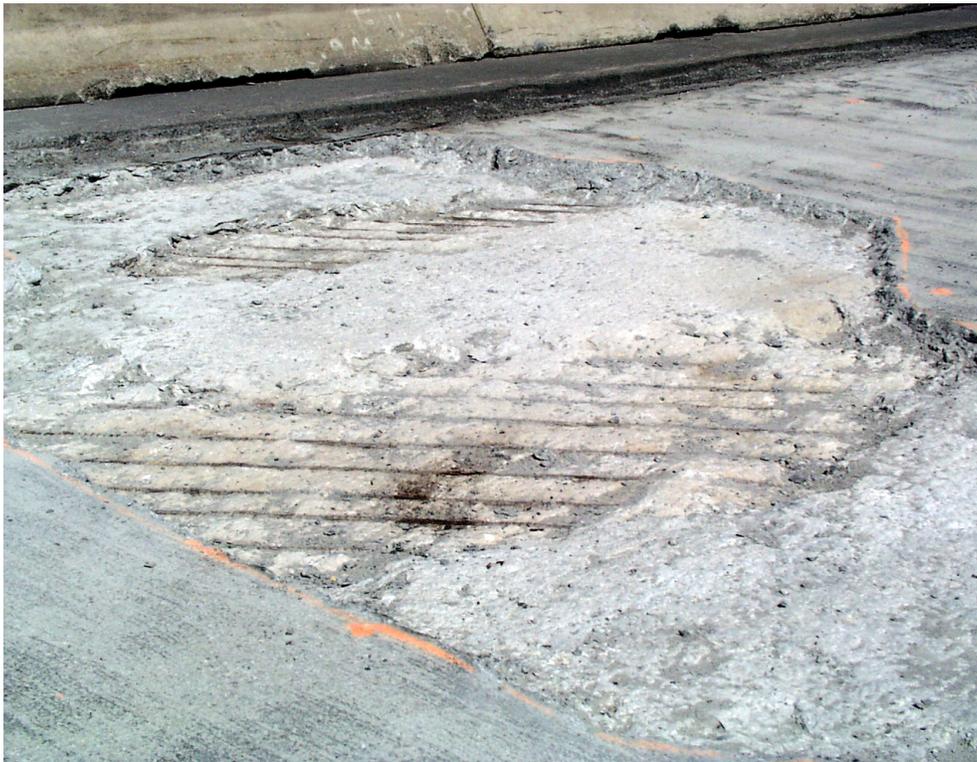
Figure 11 Localized corrosion of rebar over circular voids of PT deck

only area that could perform poorly is localized over the voids where a pre-existing wide crack might have allowed excessive amount of chloride and moisture ingress and the steel would continue to corrode at a significant rate after the rehabilitation. Figure 11 shows the localized corrosion of transverse rebars over the voids.

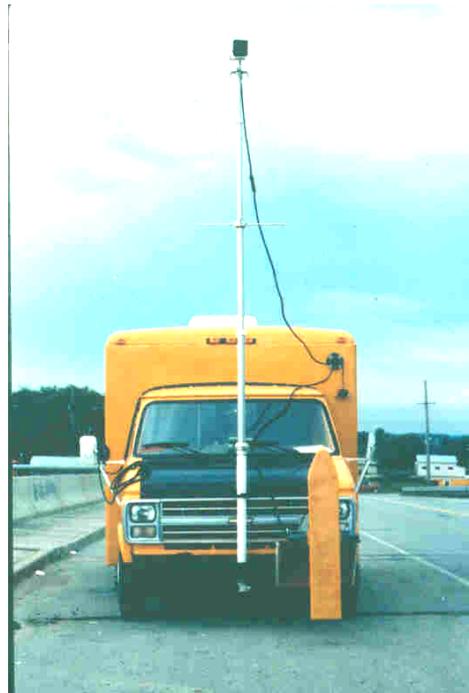
Figure 12 DART survey on decks

It was also recognised that the extent of delamination and severe scaling of an asphalt covered deck could not be assessed accurately by the cores and sawn samples, which only represent a very small percentage of the deck statistically. During this period, the ministry also acquired the deck assessment radar technology (DART) to pre-screen about 50 decks a year. The results of the DART survey (delaminations, severe scaling, cover to rebar) were co-ordinated with the half-cell survey to arrive at the appropriate rehabilitation treatment. Figure 12 shows the DART antenna with an operational frequency of 1 GHz, mounted on an MTO cube van ready to carry out survey of a deck.

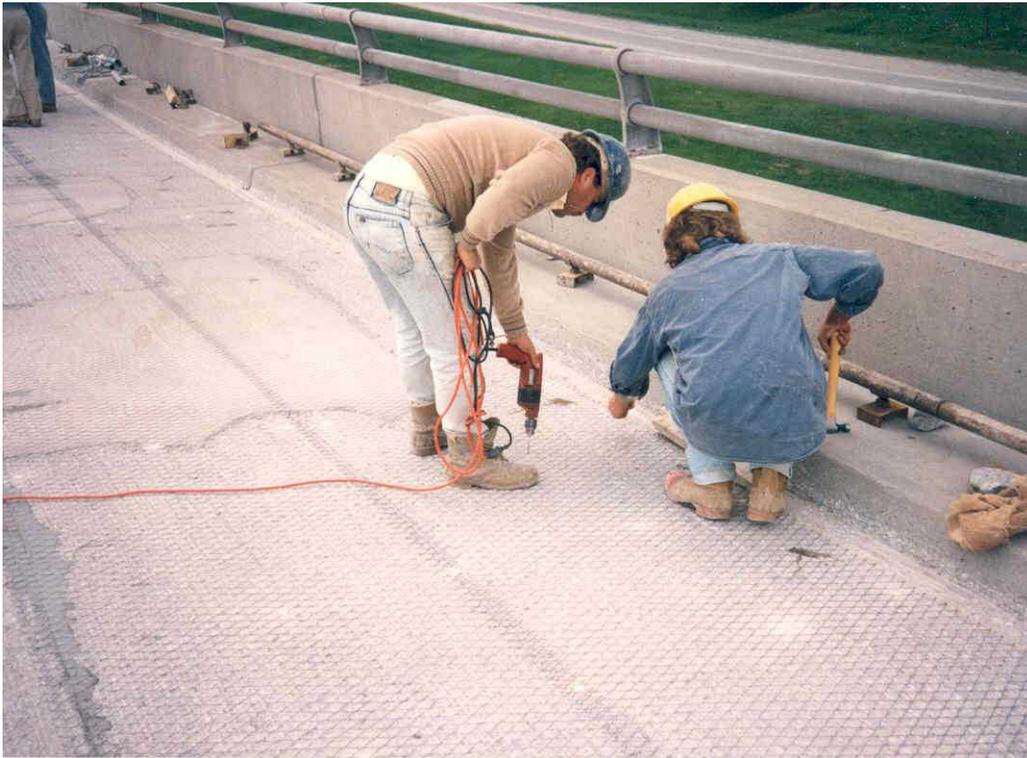
Figure 13 Titanium Mesh Anode Cathodic Protection System

By the early 1990's, it was evident that the conductive asphalt CP system was performing poorly and had fallen well below expectation. However, it did not deter the ministry from exploring other forms of cathodic protection systems. It was recognised that corrosion of steel in concrete is an electrochemical process and can be stopped by electrochemical treatments such as cathodic protection (CP). In 1981, the Federal Highway Administration (FHWA) issued a statement describing CP as the only rehabilitation technique proven to stop corrosion in chloride contaminated structures, regardless of chloride content in the concrete. With the use of cathodic protection, chloride contaminated but otherwise sound concrete does not have to be removed. This is especially advantageous when the structural component has large area of active corrosion (corrosion potential $< -0.35V$) but the delaminated area is relatively small; structural integrity could be preserved since no extensive concrete removal would be required. In 1990, the ministry implemented the second generation CP system consisting of a continuous titanium mesh anode embedded in a normal concrete overlay. The bridge decks were then waterproofed and paved. Presently the ministry has approximately 9 bridges protected with this second generation CP system. Generally, the second generation systems are performing well and a 20-30 year service life is expected. The presence of waterproofing membrane for the second generation system is a big advantage since further ingress of chloride and moisture can be minimized. Figure 13 shows the placing of titanium anode mesh on the existing deck surface prior to placing of normal concrete overlay. Currently, this system would still be considered for new installation whenever the need arises, and if the life-cycle cost is justified. However, the system voltage and current output still needs to be monitored and periodic maintenance and repair of the power supply hardware is required.

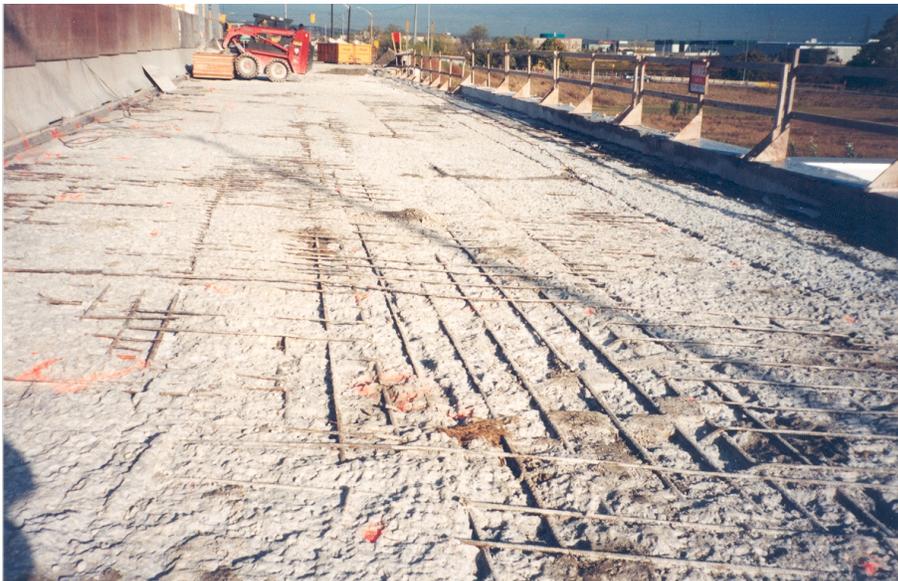
Figure 14 Top surface of deck after hydrodemolition, Hwy 25 over Hwy 401

One of the findings of the overrun study was that the use of jack hammers for partial depth removal of concrete was difficult to control and could often lead to excessive removal, further propagation of cracks and delamination, and damage of the reinforcement. There was therefore a revived interest in hydrodemolition as a systematic approach to concrete removal. The ministry first tried the technology in the late 1980's but it was not very successful due to frequent break down of the equipment. In 1998, the ministry implemented another trial project using hydrodemolition to remove a uniform thickness of concrete over the entire deck top surface. Figure 14 shows the top surface of the deck after hydrodemolition.

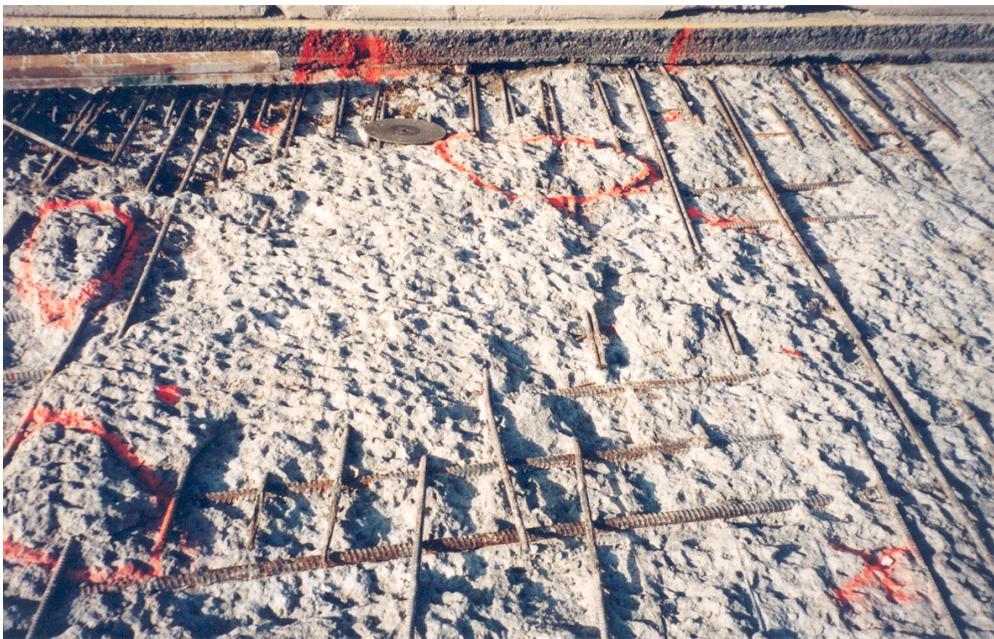
Figure 15 Condition of reinforcing steel after hydrodemolition

From a technical point of view for concrete removal, the trial could be considered a success. The performance of the hydrodemolition equipment was good with little down time and the quality of the resulting concrete surface was good. The only dissatisfaction was that the reinforcement was not as clean as we had expected and that laitance remaining on the steel could harden up if not pressure washed promptly (see Figure 15). However, it was unfortunate that the ministry also wanted to test the capability of the industry to treat the affluent on-site so that it could be discharged back to the environment. This has proven to be quite a hurdle with approval requirements from MOEE and time-consuming testing. The ministry has not used hydrodemolition again since that time due to the apprehension in people's mind regarding the stringent environmental requirements. However, this is a mis-conception, and despite this setback, the ministry still considers hydrodemolition a viable option, particularly for second generation rehabilitation of thick decks that were overlaid previously. In future applications, the contractor would likely be given the option to transport the affluent and dispose of it as liquid industrial waste rather than mandatory on-site treatment.
