VEHICLE CRASH TESTING ON A GFRP-REINFORCED PL-3 CONCRETE BRIDGE BARRIER

Khaled Sennah¹, Benjamin Juette², André Weber³, and Christian Witt⁴

Paper prepared for presentation at the Bridges - Successes: Let's Build on Them Session of the 2011 Annual Conference of the Transportation Association of Canada Edmonton, Alberta

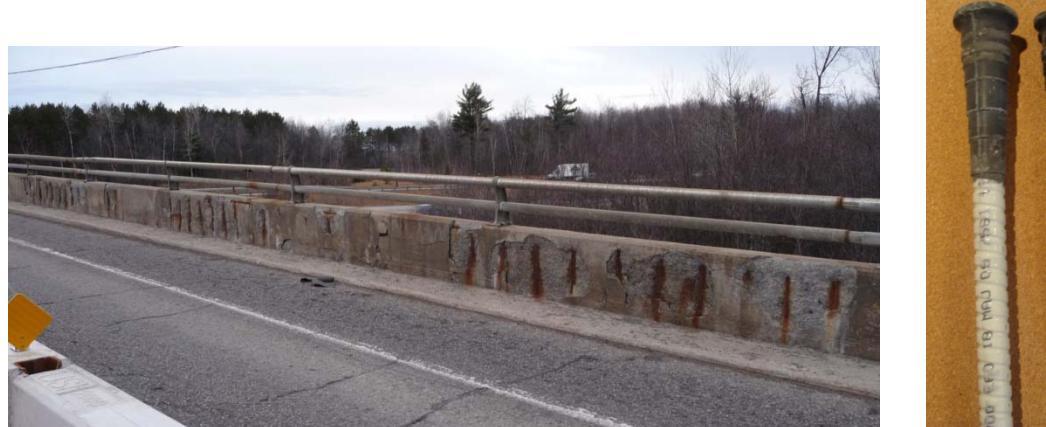
Fig. 1. Corrosion-induced degradation of steel-reinforced bridge barrier wall

Bridges built prior to the 1970's did not use air-entrained concrete and coated reinforcing steel bars to protect from the effects of freeze-thaw cycles and the application of winter de-icing salt. This leads to corrosion-induced degradation in bridge elements as shown in Fig. 1. Accordingly, exposed bridge elements are all likely candidates for expensive replacement on the majority of these older bridges. It is estimated that over 40% of all bridges in Canada are older than 40 years and are in need of rehabilitation or replacement. The backlog of maintenance, rehabilitation and replacement of highway bridges is estimated at \$10 billion. The current traditional bridge rehabilitation/replacement systems in most situations are very time consuming and costly. The prohibitive costs needed to upgrade bridge structures require the development of innovative technologies to accelerate bridge replacement/repair; and (ii) provide sustainable bridge systems that prolong the service life of the structure.

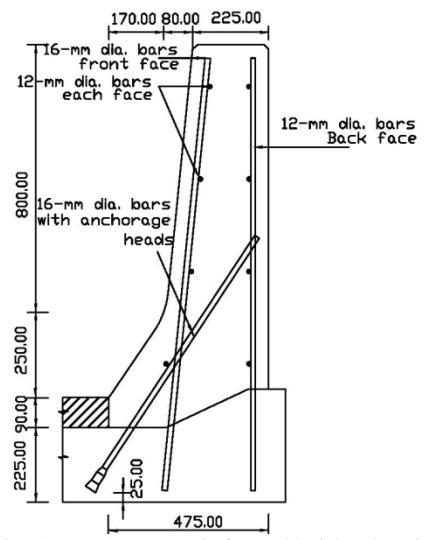
Fig. 3. PL-3 FRP-reinforced bridge barrier

Such design work for the PL-3 bridge barrier proposed the use of 16 mm and 12 mm diameter GFRP bars as vertical reinforcement in the barrier front and back faces, respectively, with 12 mm diameter GFRP bars as horizontal reinforcement in case of PL-3 barrier wall, all at 300 mm spacing. The connection between the deck slab and the barrier wall utilized the GFRP headed end bars for proper anchorage. Figure 3 shows a schematic diagram of the GFRP reinforcement on the designed barrier wall. Two full-scale PL-3 barrier models of 1200 mm length were erected and tested to-collapse to determine their ultimate load carrying capacities and failure models (Sennah et al., 2010). The first barrier was a control one with reinforcing steel bars, while the second barrier model was reinforced with GFRP bars with headed ends. Based on the data generated from the experimental study, it was concluded that GFRP bars with headed anchorage can be safely used in bridge barrier walls to resist the applied vehicle impact load specified in CHBDC at the barrier wall-deck slab anchorage. However, CHBDC Clause 12.4.3.4.4 specifies crash testing for the design of the barrier wall itself (i.e. both vertical and horizontal reinforcement).

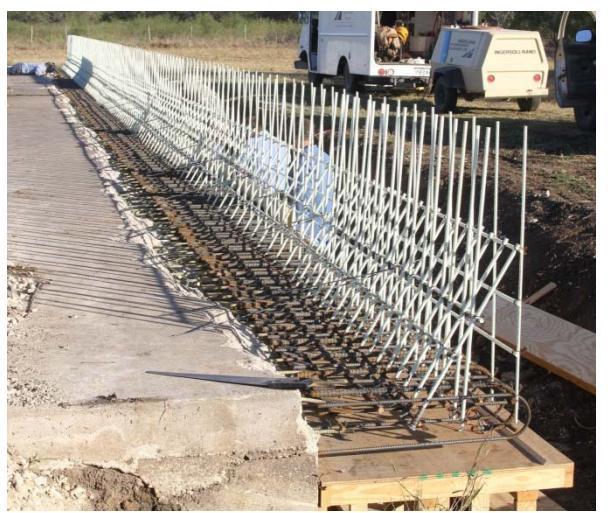
Fig. 4. View of the GFRP reinforcement in the barrier wall

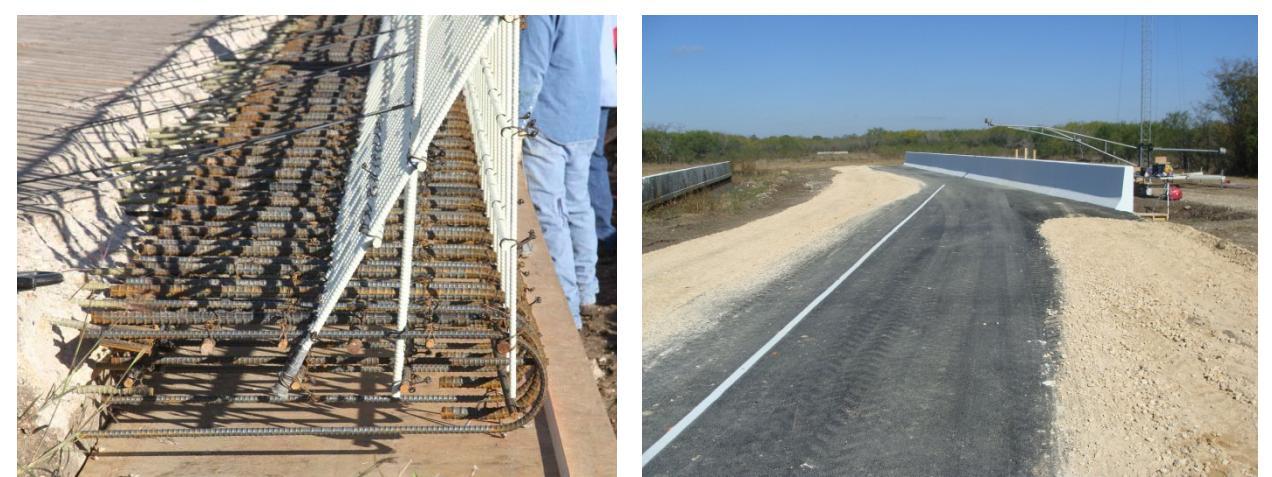
Fig. 5. Close-up view of barrier anchorage to deck slab Fig. 6. View of the barrier wall before crash testing

In November 2010, vehicle crash test was conducted in accordance with Test Level 5 (TL-5) of MASH (MASH, 2009), which involves the 36000V van-type tractor trailer (cab-behind-engine model of 36,000 kg gross weight) impacting the barrier at a nominal speed and angle of 80 km/h and 15° degrees, respectively (MASH, 2009). This test was intended to evaluate the strength of the barrier in containing and redirecting heavy vehicles. Figures 4 and 5 show views of the GFRP reinforcement and deck slab reinforcement before making the timber forms and casting concrete. While Fig. 6 shows view of the built 40-m long barrier before vehicle impact. Figure 7 shows view of the test vehicle, while Fig. 8 shows the test vehicle during a mock test before impacting the barrier at 15° angle.

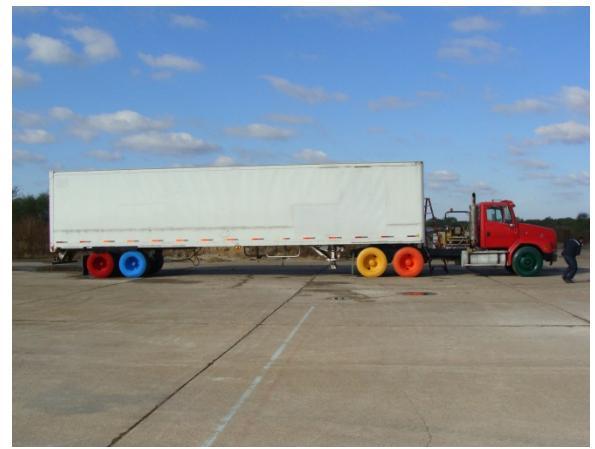
Fig. 7. View of the test vehicle

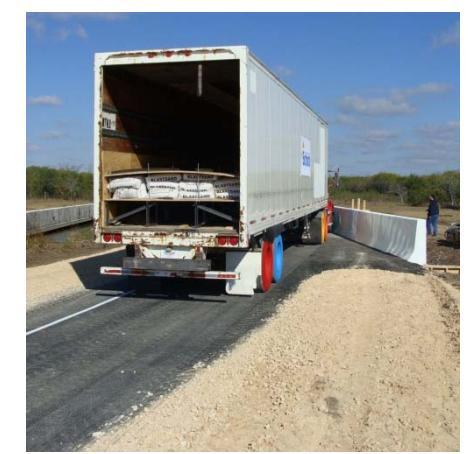
Fig. 8. View of the test vehicle before impacting the barrier

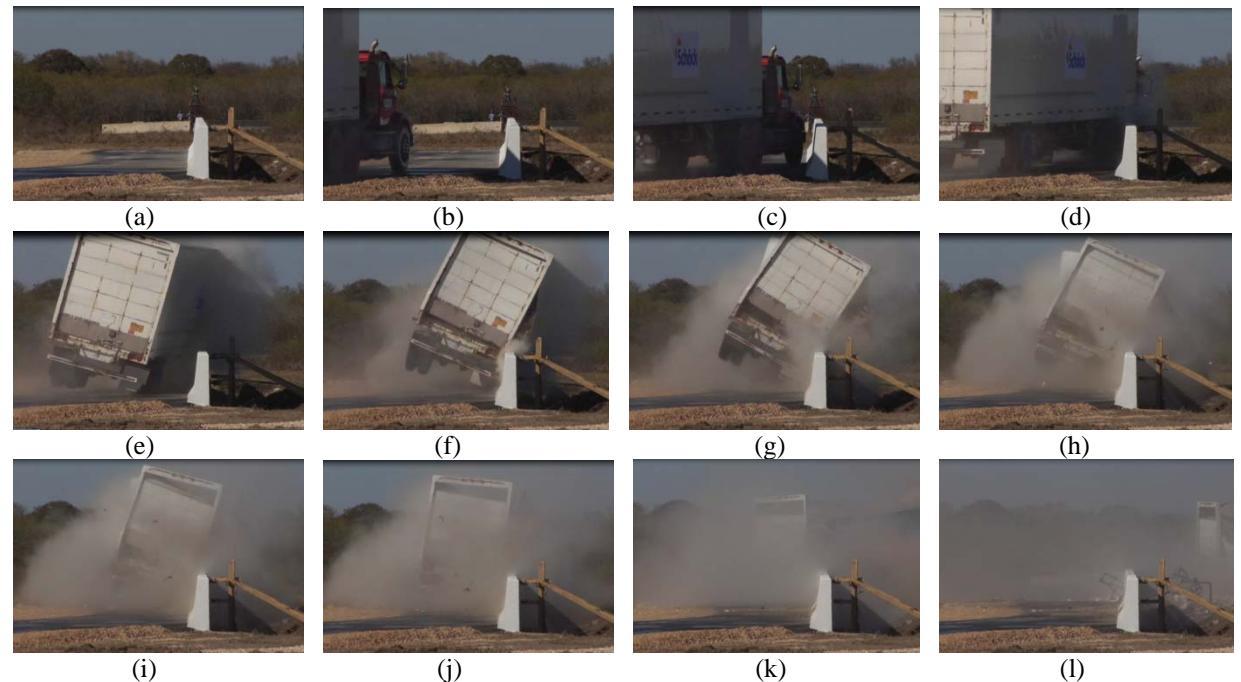
Fig. 9. Sequential photographs for the crash test (frontal views)

the lower right rear corner of the van-trailer contacted near the top of the barrier, and at 0.748 s, the right rear edge of the van-trailer ruptured. As the test vehicle continued along the barrier, it righted itself and rode off the end of the barrier wall. The brakes on the test vehicle were not applied, and the test vehicle subsequently came to rest 35.66 m downstream of the end of the barrier and 2.7 m toward the field side. Sequential photographs for the crash test are presented in Figs. 9 and 10 for frontal and side views, respectively.

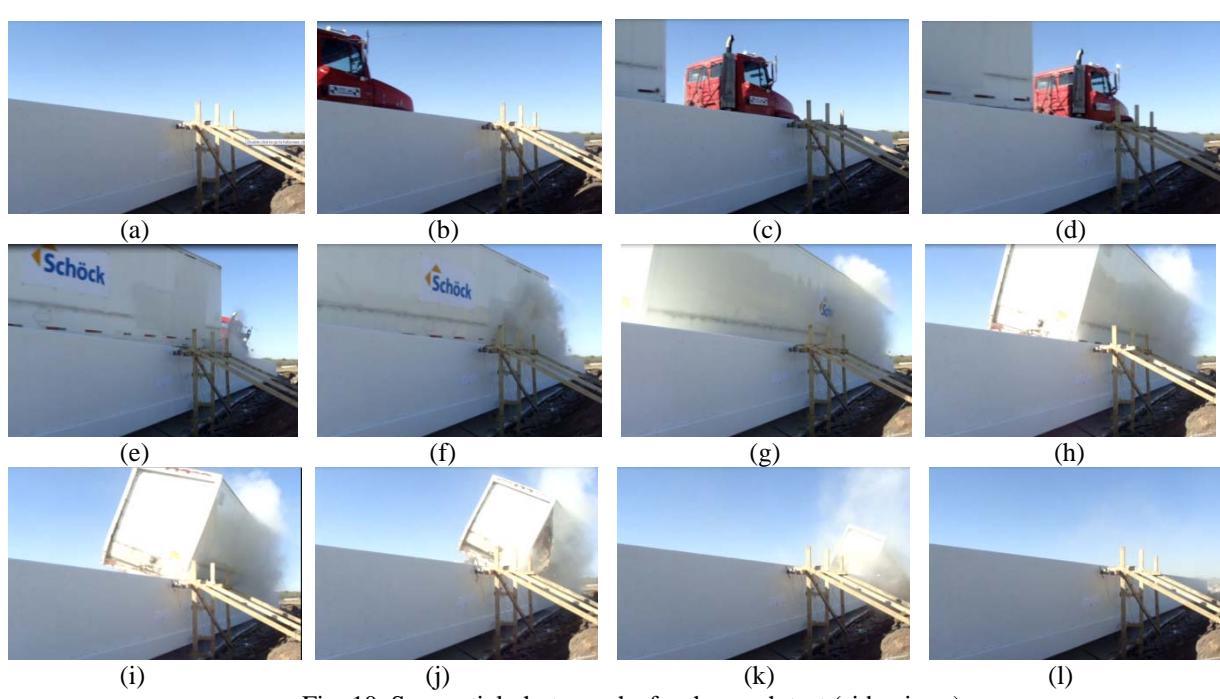
Fig. 10. Sequential photographs for the crash test (side views)

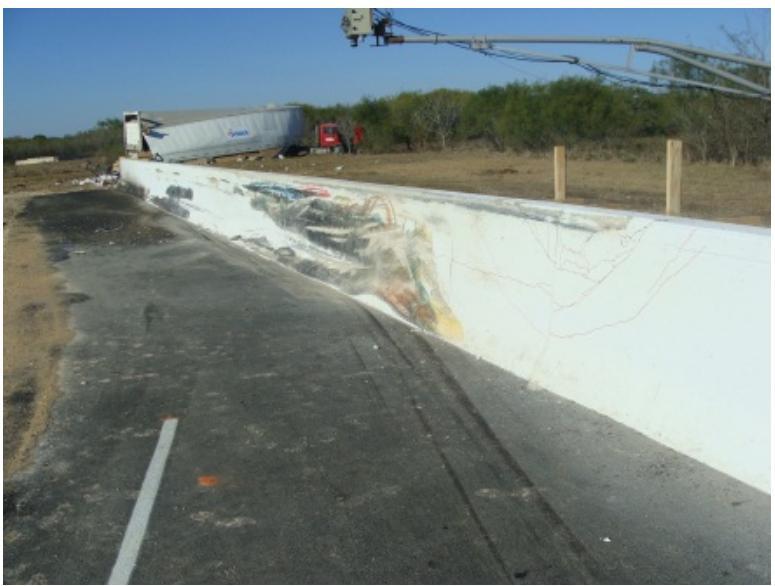
Fig. 11. General view of the barrier wall after vehicle impact

After the crash test, minor cracks in the front and back side of the barrier were observed. However, no complete damage was observed. Figures 11 and 12 show views of the barrier, reflecting this finding. In practice, these minor cracks may need to be repaired to avoid possible crack propagation resulting from other possible vehicle impact. In February 2011, Ryerson University research team conducted static load failure tests on the barrier segments to provide research information that will be used further to evaluate the applicability of AASHTO-LRFD yield-line equations, developed for reinforcing steel bars, to the design of GFRP-reinforced barrier under equivalent static vehicle impact loading. More information about this comprehensive research program can be found elsewhere (Buth and Menges, 2011; Sennah, 2011).

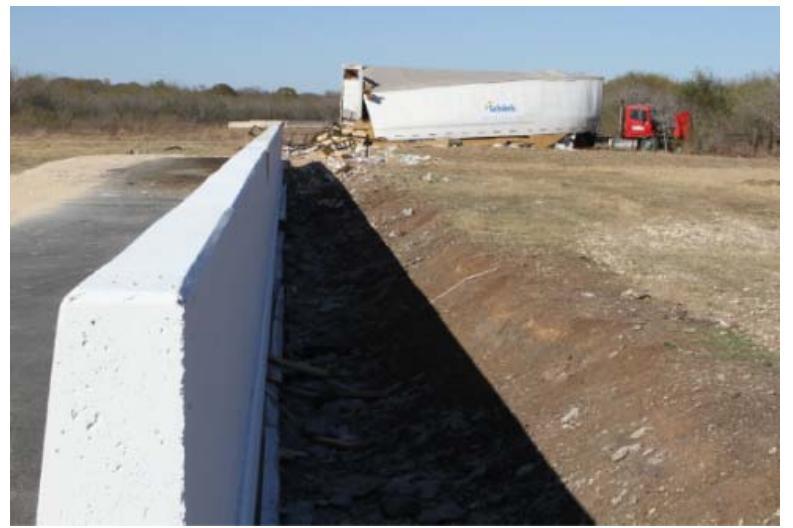
Fig. 12. View of the barrier wall and the test vehicle at rest
