Constructability of the North Saskatchewan River Bridge

By: Mekdam Nima, Ph.D., P.Eng, Paul Bassi, P.Eng. David Middleton, P.Eng., and Matthew Spratlin, P.Eng.,

Paper prepared for presentation at the "Innovations in Bridge Engineering (B)" Session of the 2005 Annual Conference of the Transportation Association of Canada Calgary, Alberta

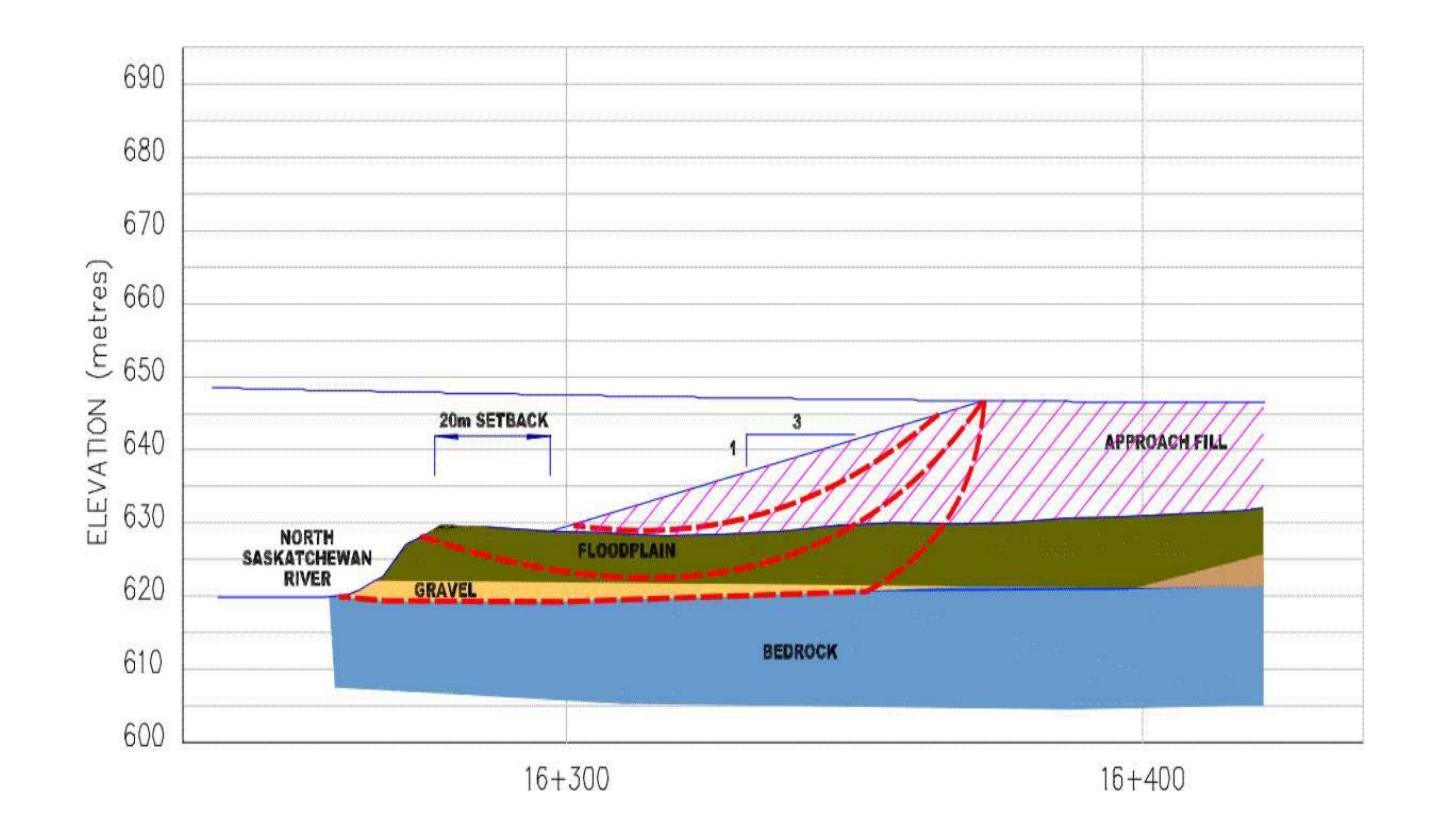
Figure 2: Typical Failure Surfaces at South Approach

Preliminary investigations of the subsurface soil conditions uncovered a slide-prone layer of soil sandwiched between the clay-shale bedrock and the overlying gravel layer. The slip plane was found to slope toward the river beneath both banks, and it was feared that the additional weight of the large approach fills would cause a slide beneath the approaches, as shown in **Figure 2**. To prevent the approaches from sliding, large tangent pile walls, which are shown in **Figure 3**, were constructed beneath the toe of both approach fills, effectively anchoring the overlying clay till and gravel into the bedrock below the slip plane.

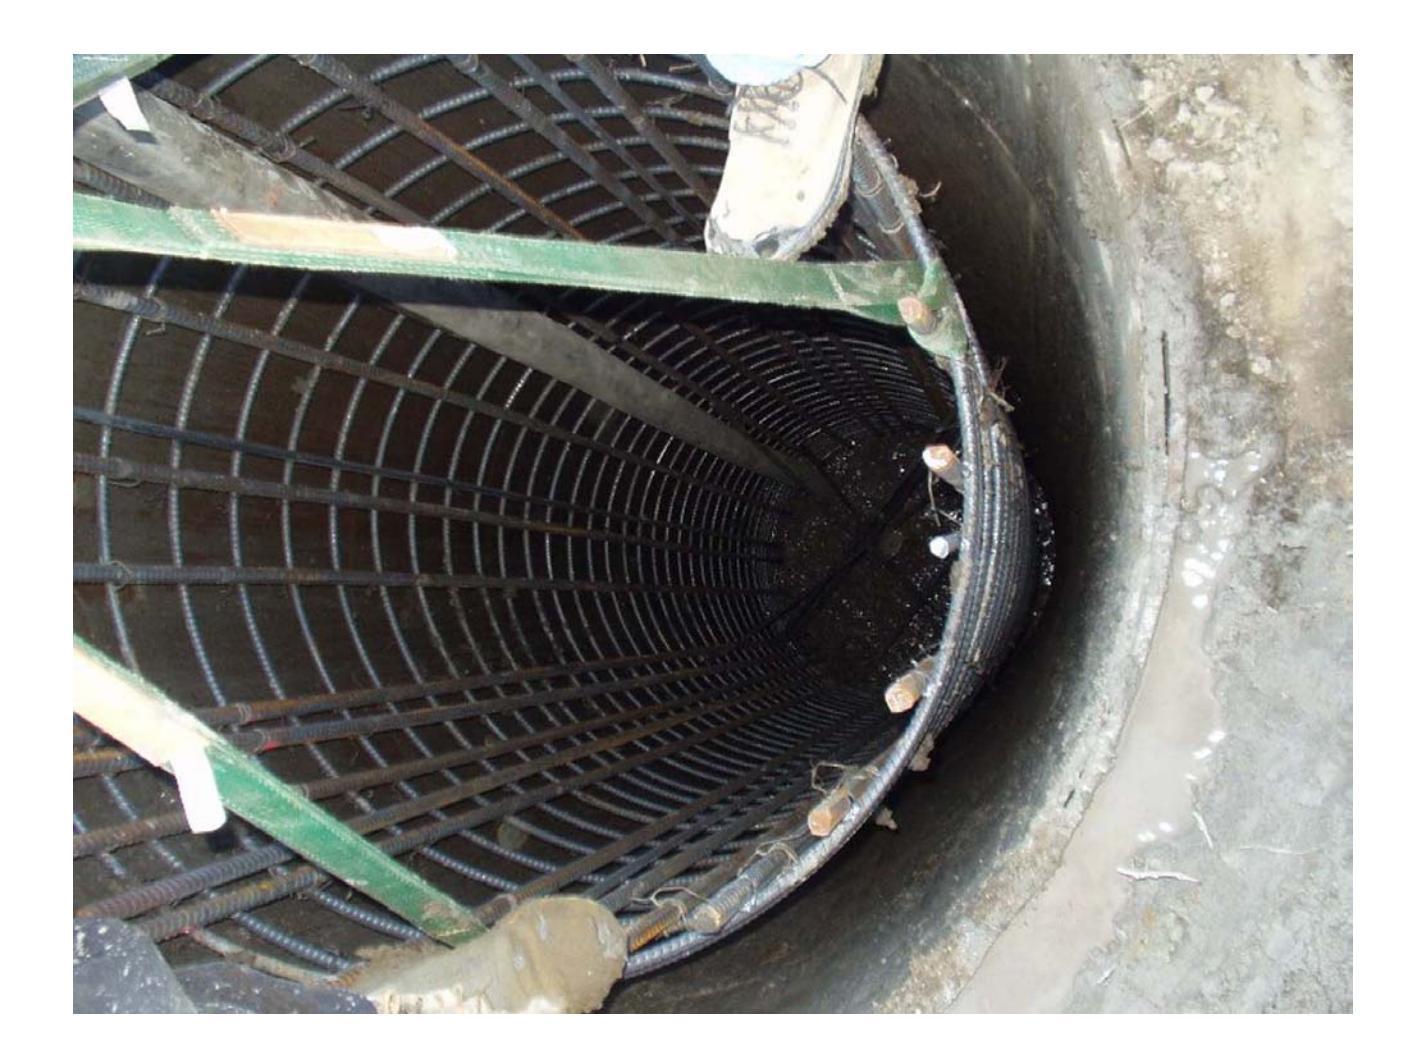
Figure 3: SCC is Being Poured into The Tangent Pile

The concrete could be dumped directly from the truck chute into the hole. A special trunk hose or other means had to be used to guide the concrete so that it fell straight down the middle of the reinforcing cage. To prevent segregation, care had to be taken to ensure that the concrete did not hit any support bars as it was falling to the base of the pile.

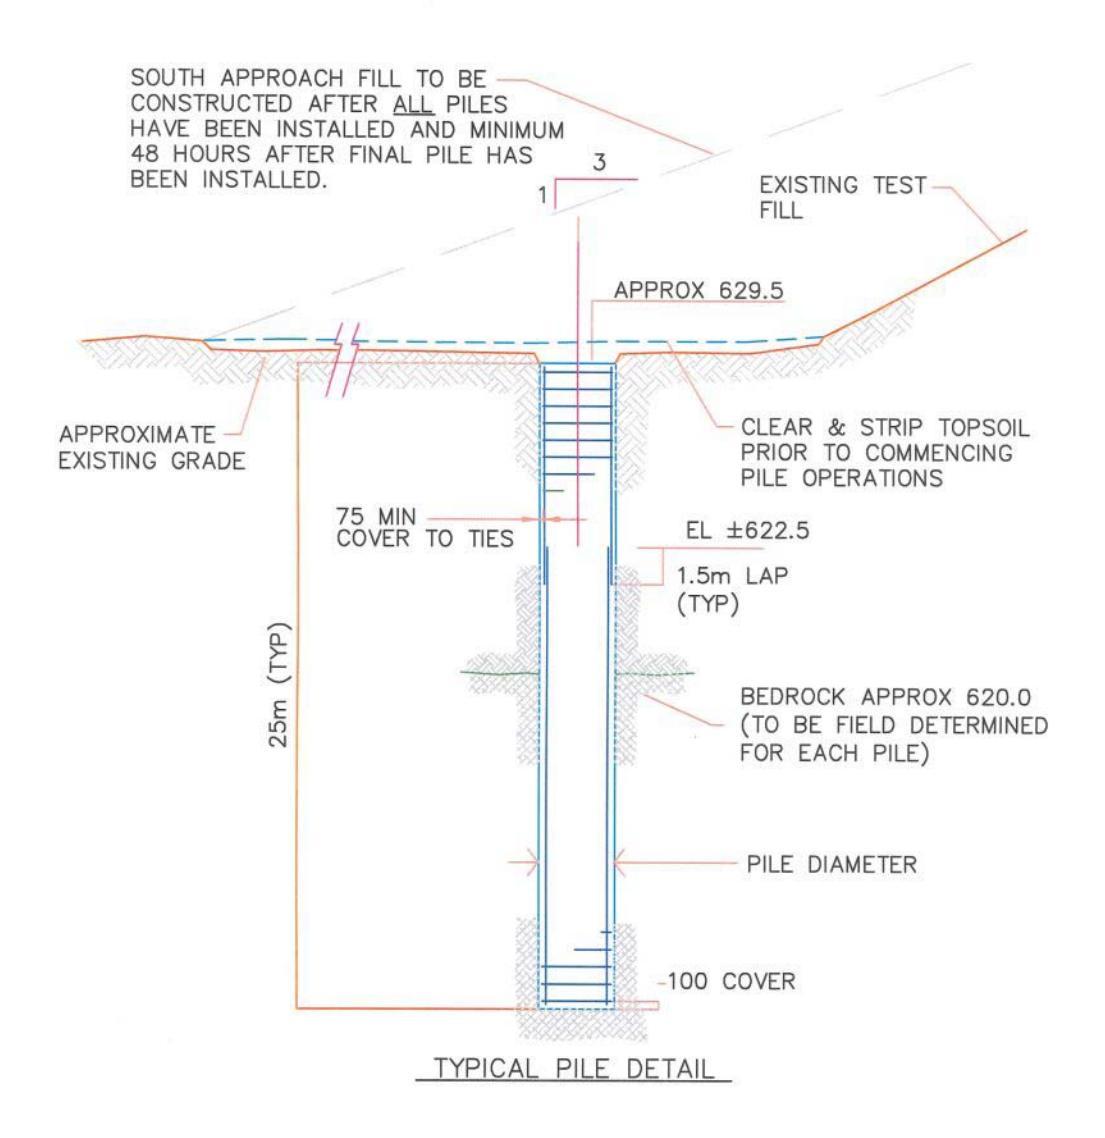
Figure 4: Typical Tangent Pile Detail

The tangent pile walls constructed on the North and South banks of the river consisted of 88 and 49 piles respectively. Each pile was 1.5 m in diameter and between 16 m and 25 m in length. **Figure 4** shows a sketch of a typical tangent pile installation. This project represents one of the few instances in Alberta where large tangent pile walls are used to prevent potential slope instabilities prior to the occurrence of any failure. The tangent pile walls constructed in this project were designed assuming that the full strength of the underlying bedrock would be mobilized during a slide. There was concern that fractures or weakened layers in the bedrock would lead to a reduced residual strength in the bedrock, causing a significant increase in the load applied to the wall. Slope inclinometers for monitoring movement in both the piles and the adjoining slopes were installed to determine if the piles are adequate as constructed. **Figure 5** shows the layout of the instrumentation beneath the South approach, with slope inclinometers labelled SI-2, SI-8A, and SI-6. SI-6 is one of the slope inclinometers that were installed inside one of the piles. If excessive slope movements, or excessive pile stresses are encountered, a contingency plan exists for the addition of another row of tangent piles on either bank.

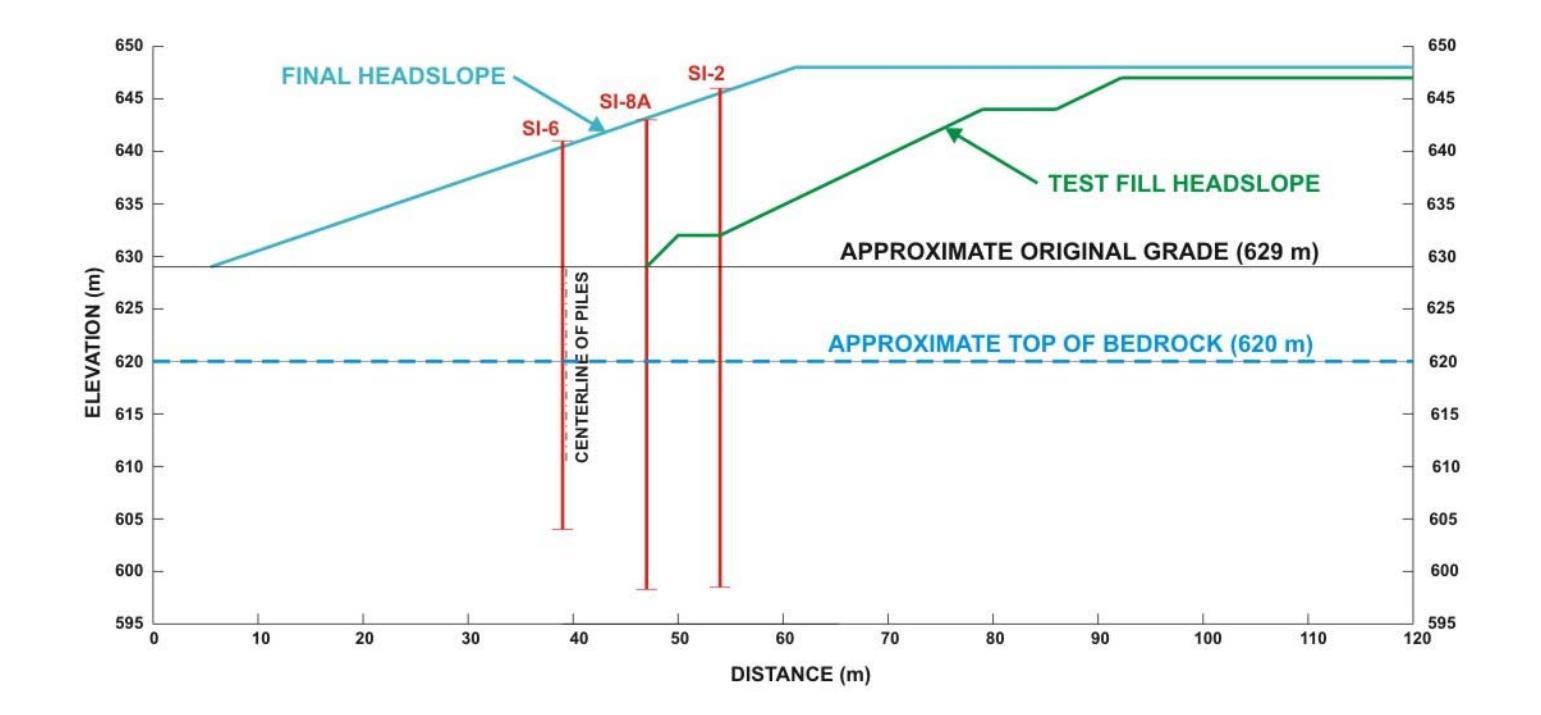
Figure 5: Layout of Slope Inclinometers Beneath the South Headslope

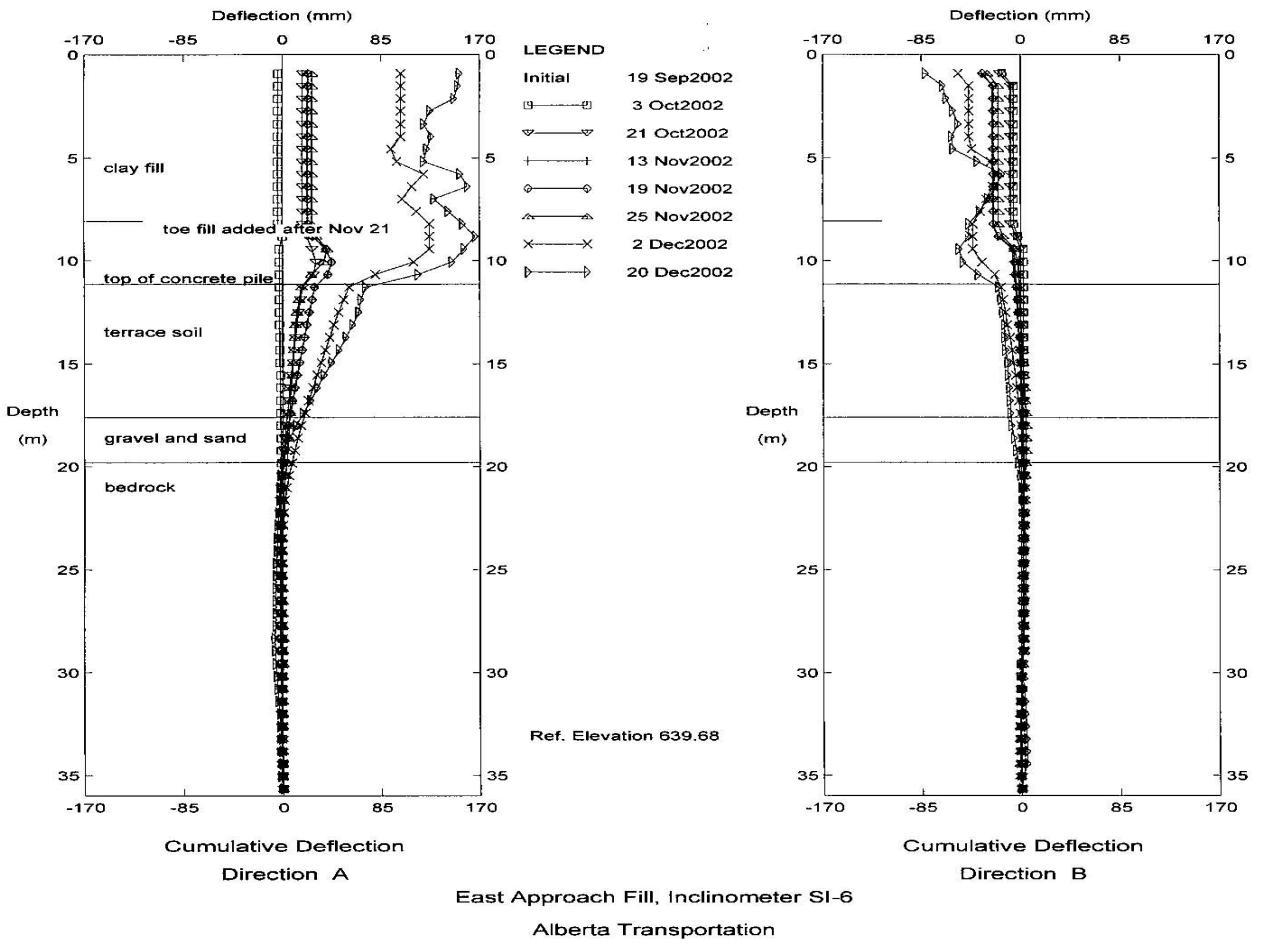
Figure 6: Displacements in SI-6 (Jan 20/03 – Mar 19/04)

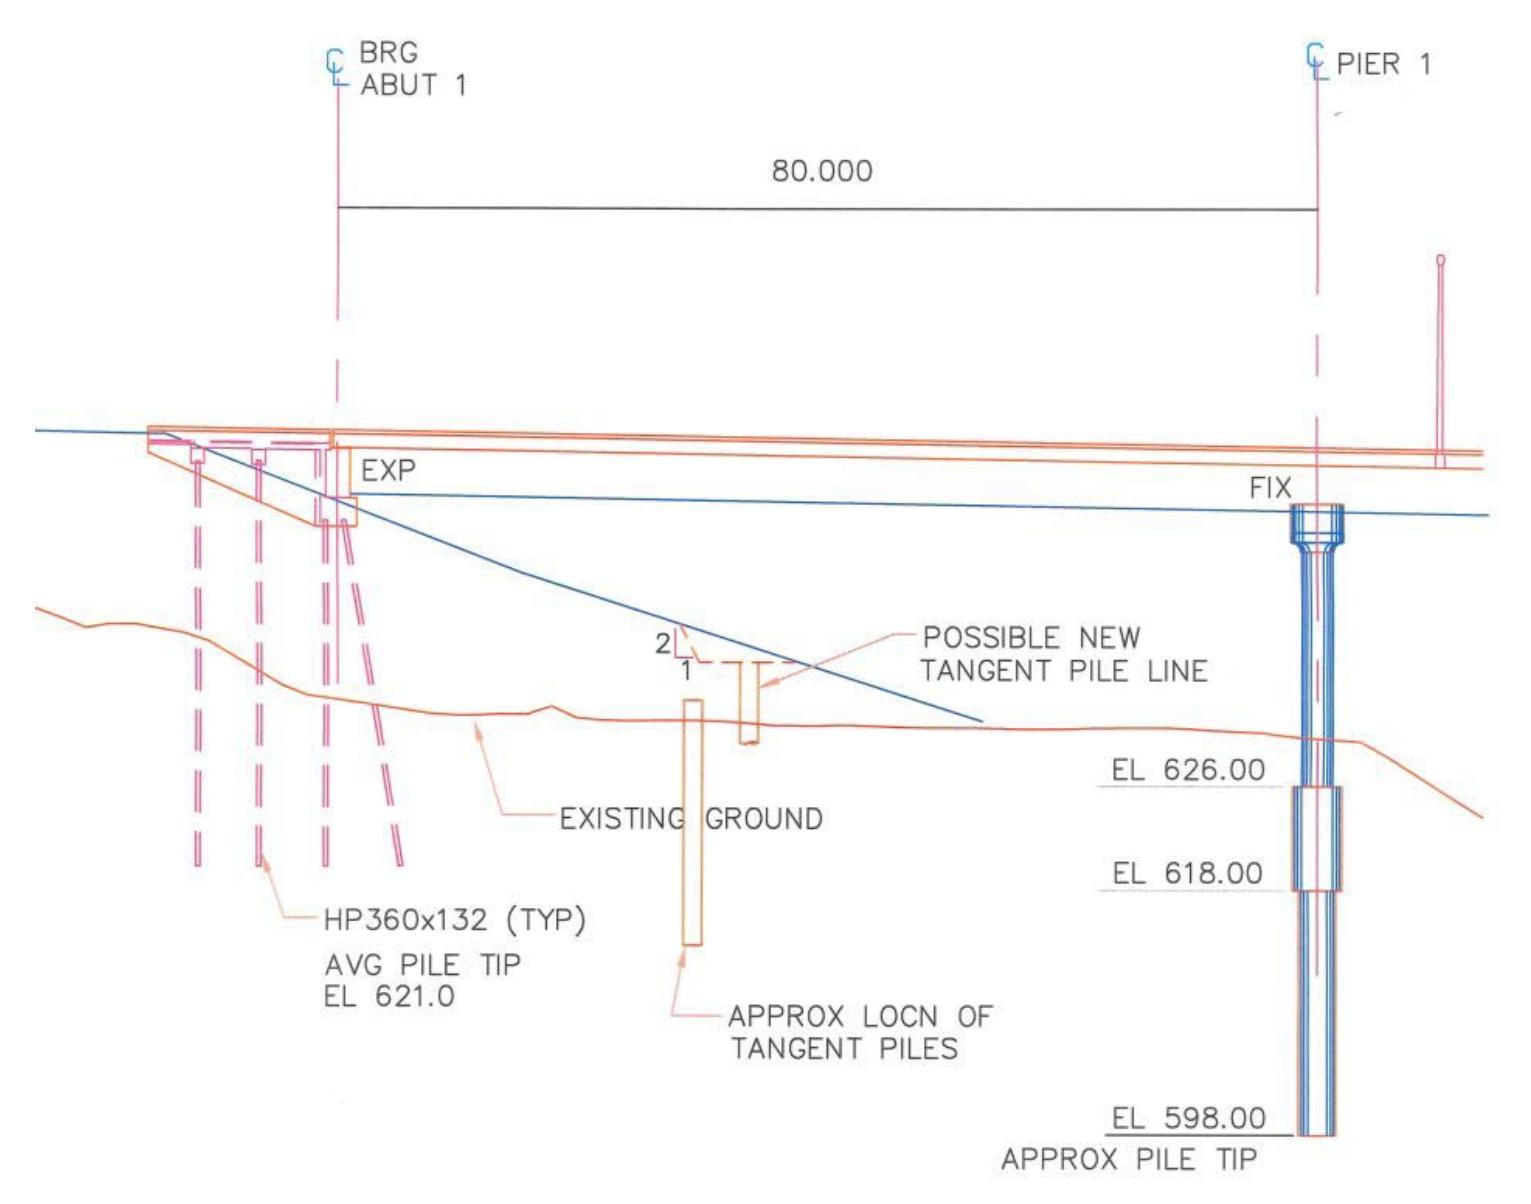
Figure 7: Typical Abutment and Tangent Piles Location

The abutments consist of an abutment seat linked to two grade beams by a wing wall and roof slabs. A sketch of a typical abutment and the location of the tangent pile walls is shown in **Figure 7**. The geotechnical design predicted a maximum 250 mm long-term movement for the North head-slope, either laterally or towards the river or a combination of both. The Designers overcame this by providing a solution whereby the abutment girder diaphragm of the centre bay was strengthened and attached to restrainers on each abutment. The system relies on bridge inspectors to check if the abutments are moving. Should the abutments move, it allows adjustments of 50 mm increments at a time. The adjustment process involves jacking the girders to the correct alignment and shifting shims to keep the girders aligned. The contractor had to plan his construction procedure carefully to ensure that this portion of the project was understood and installed correctly.

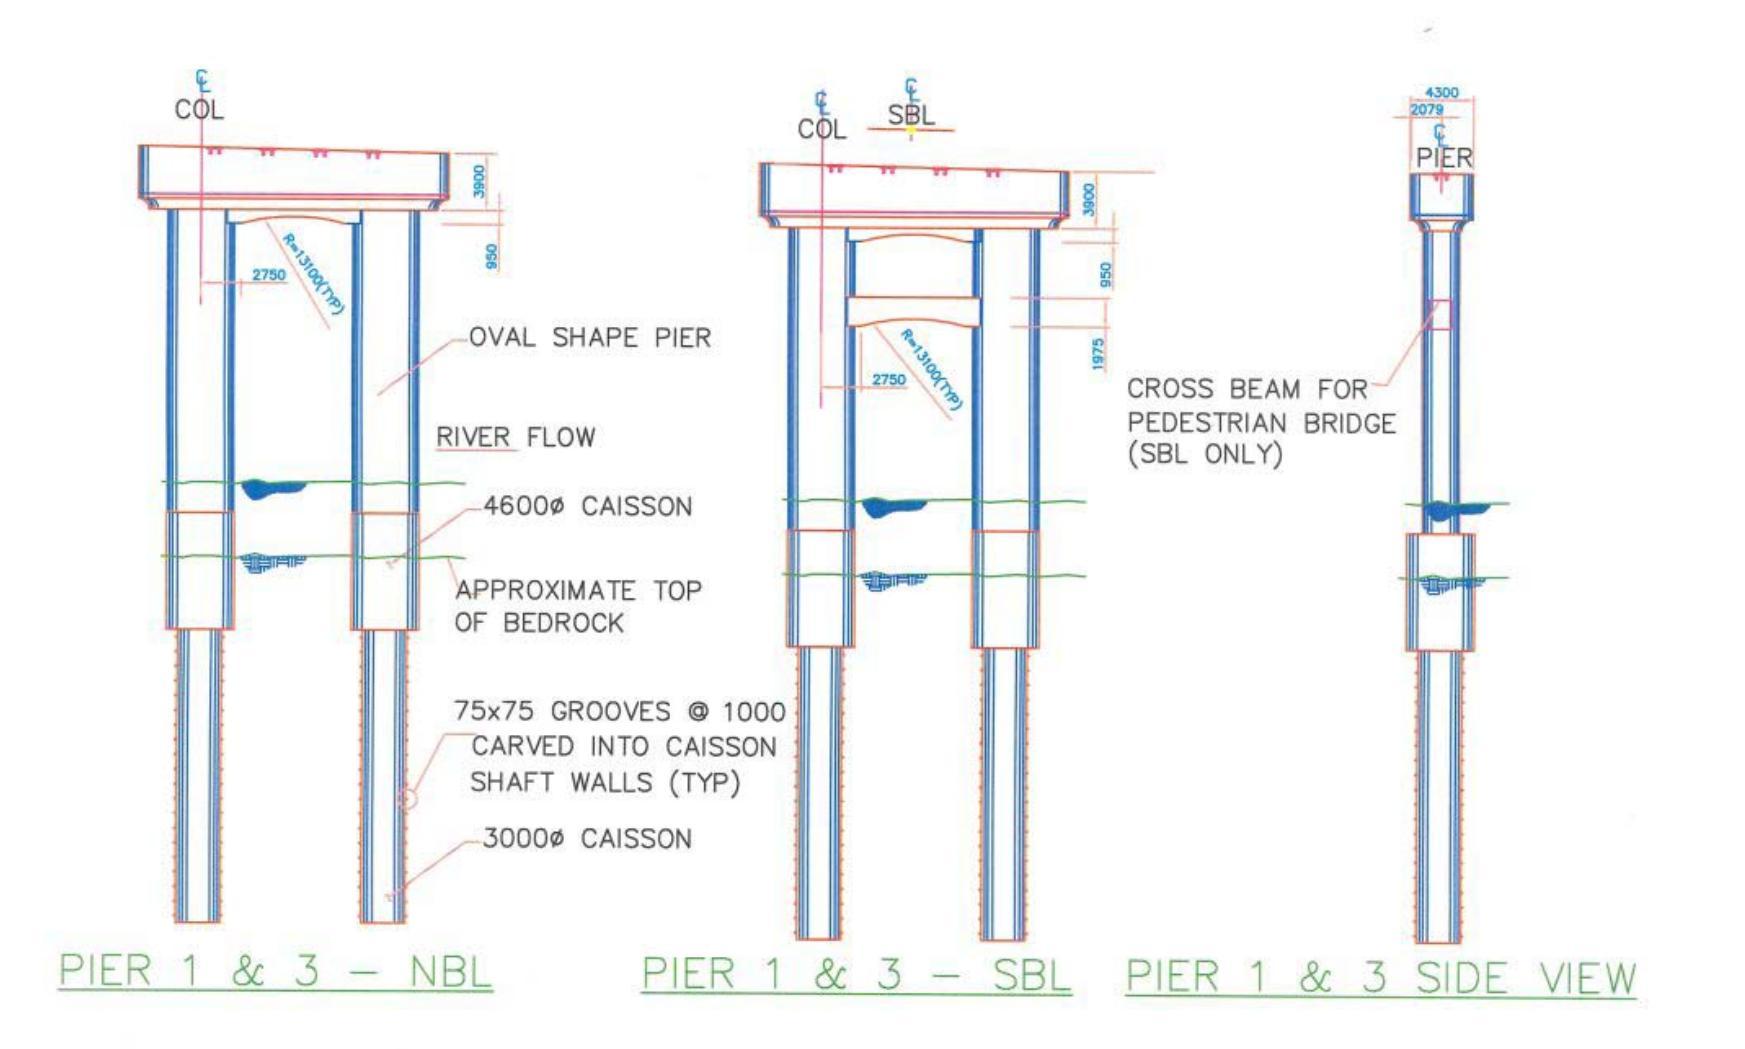
Figure 8: North Saskatchewan River Bridge Piers

A sketch of the NSRB piers is presented in **Figure 8** and a photo during the construction of Pier 3 is shown in **Figure 9**. Each pier consists of two pier shafts joined at the top by a pier cap. The pier foundations consist of a 3.0 metre diameter caisson, embedded in bedrock for the bottom 16 to 20 metres of the foundations. A 4.6 metre diameter caisson, placed on the top of the 3.0 metre caisson, extends to the foundation to ground level. Oval shaped pier shafts are tied into the 4.6 metre diameter caisson with steel reinforcing dowels. The contractor's construction sequence consisted of pouring the caisson concrete

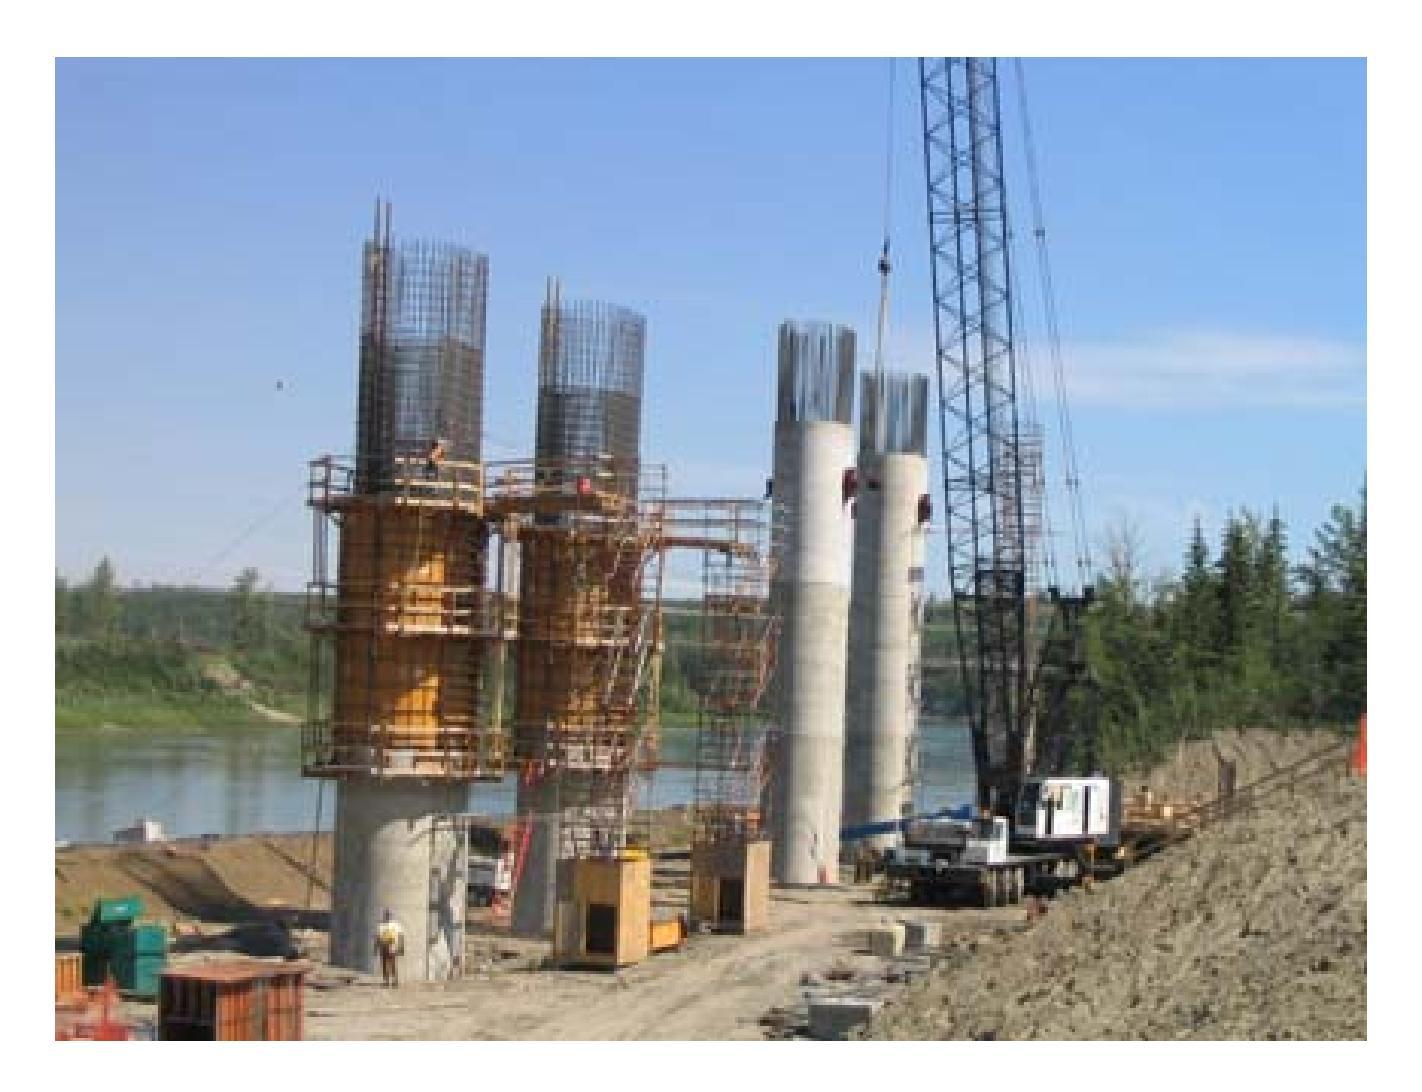
Figure 9: NBL Pier Shafts Completed and Preparing to Pour Second Lift on the SBL Pier Shafts at Pier 3

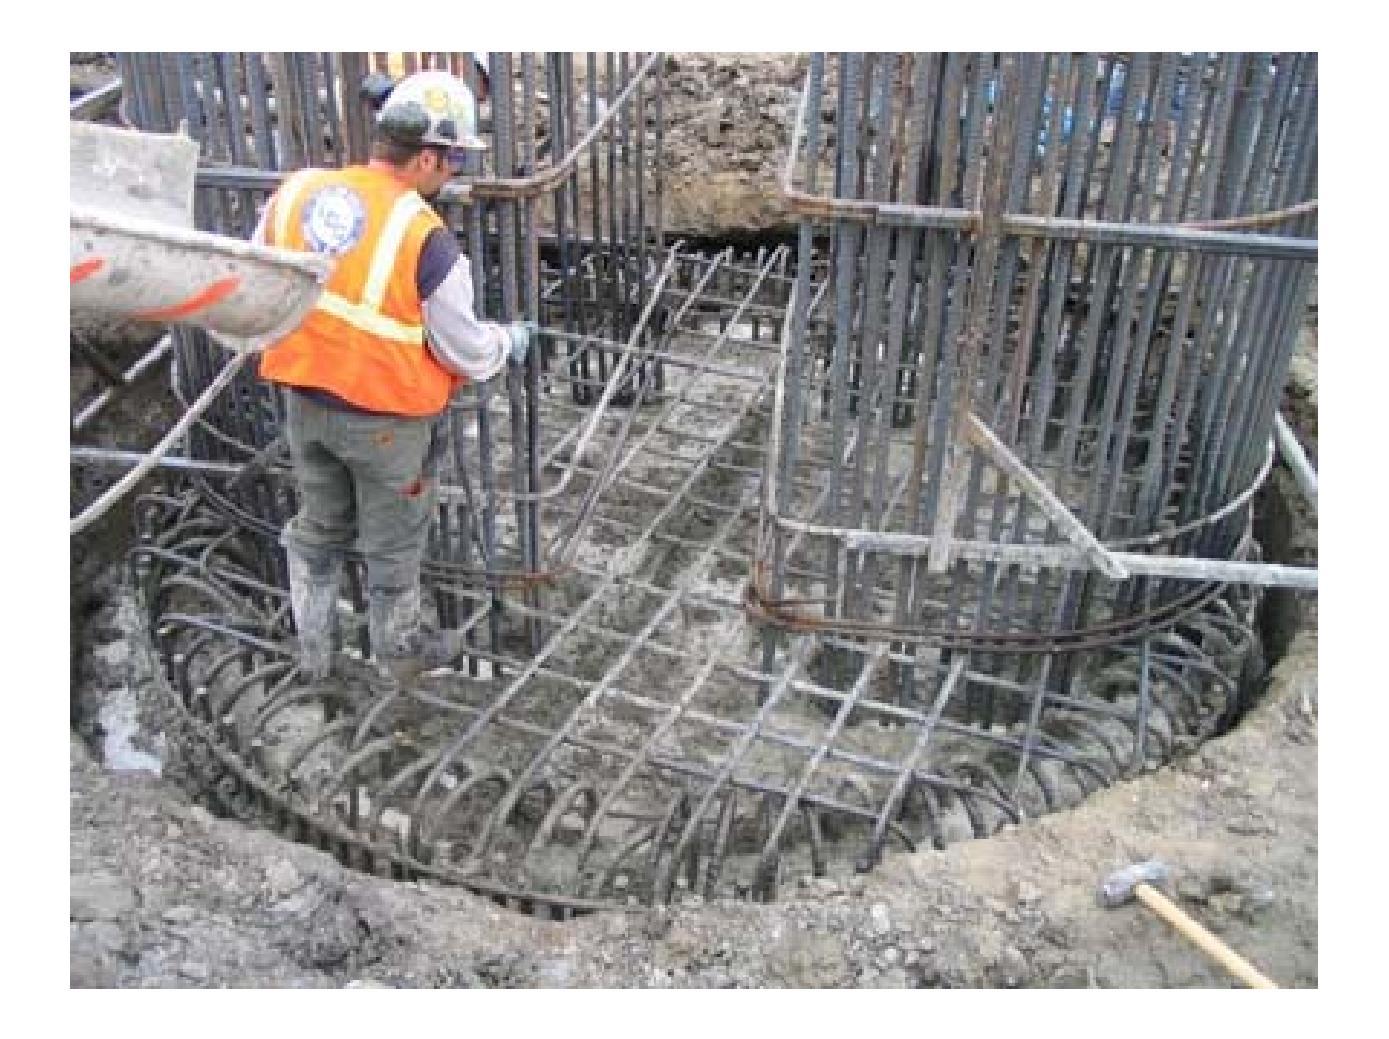
Figure 10: Dowels are Put in After The Pour When The Concrete is Still Fresh.

to final elevations and then setting the dowels in the wet concrete using a template as shown in **Figure 10**. Pier shafts were then poured in four segments each, followed by the pier cap and cross beam (SBL only).

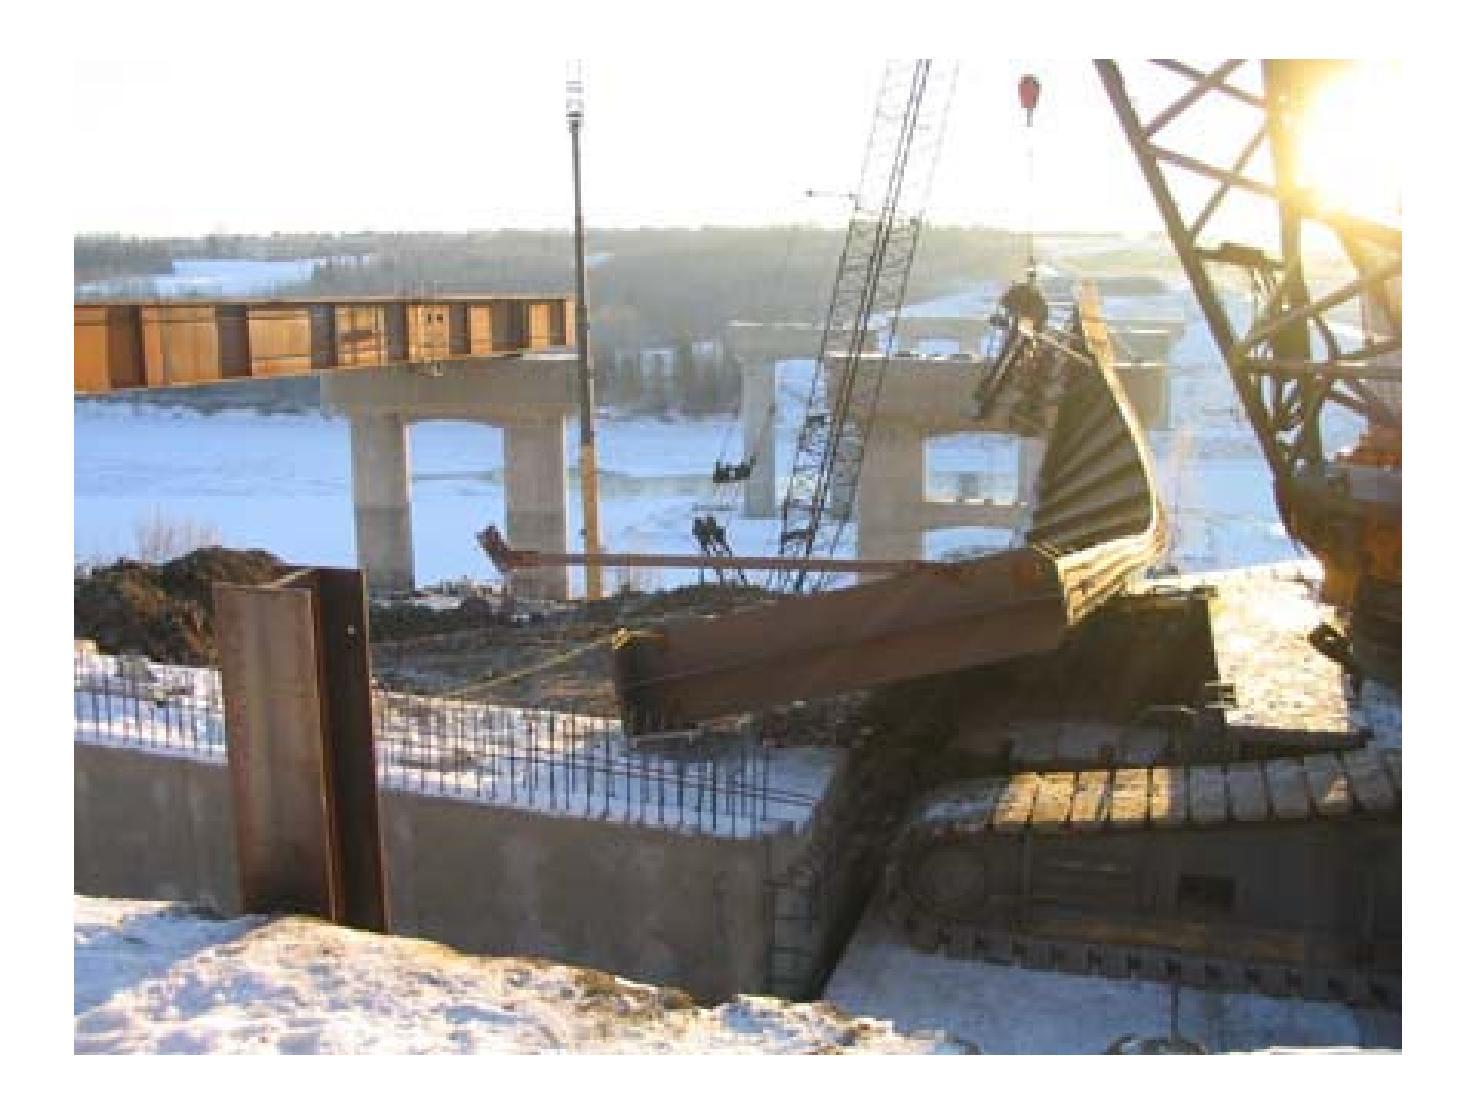
Figure 11: Girder Collapse

On 14 December 2003, the first girder line on span 1 of the SBL collapsed as shown in **Figure 11**. This occurred after all girders for the NBL span 1 had been erected successfully. It appeared that the girder rotated counter to the curvature of the bridge and collapsed due to bending failure about its minor axis. The cause of the collapse is still being investigated by the erection firm's insurer, and has not yet been revealed.

It appears that the proposed erection method, while stable, was new to the erection firm's ironworkers. This unfamiliarity could have led to a situation where changes made during the erection procedure were not fully evaluated, nor were the implications thereof understood.

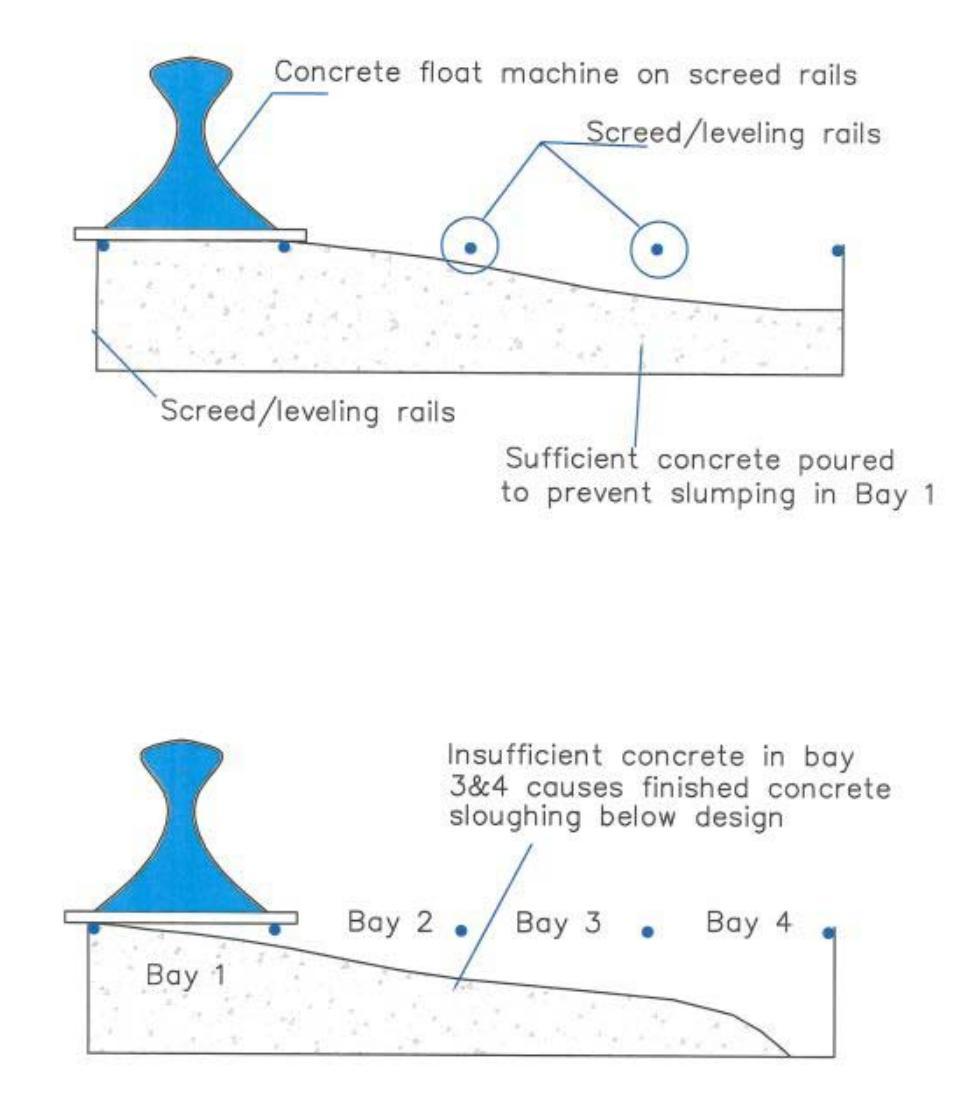
Figure 12. Pouring Actual and proposed sequence

After the first pour it was noted that the slab top surface had settled visibly, by approximately 50 mm, as shown in **Figure 12**. This was not picked up during the pour as the levelling screed rails were removed immediately after the relevant bay was complete.

Initially it was assumed that the formwork had settled, however the contractor found that he had to wait until concrete filled three adjacent bays before he could screed the first bay to its final elevation. The vibrating activities during concrete placement in the adjacent bays caused the completed bays to slump, resulting in additional finishing work; and the distance (more than 6 meters) affected by this vibration was greater than expected. Accordingly, the authors recommend that when using screed rails in large slabs, the rails be kept in place as long as possible to ensure that the concrete does not slump when adjacent bays are poured.
