2006 TAC Environmental Achievement Awards Award Submission

St. John's Sideroad / McKenzie Wetland Project

Title: St. John's Sideroad / McKenzie Wetland Improvements

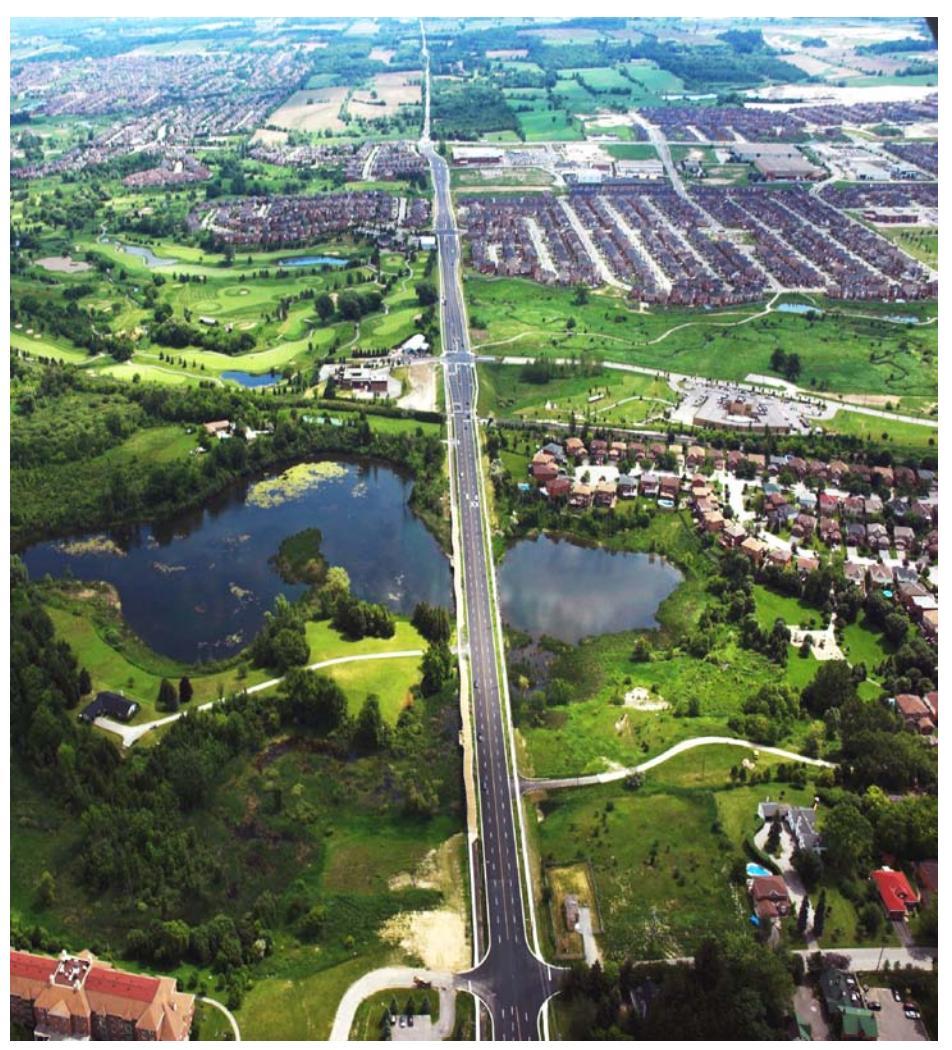
Aerial view of the completed St. John's Sideroad / McKenzie Marsh project

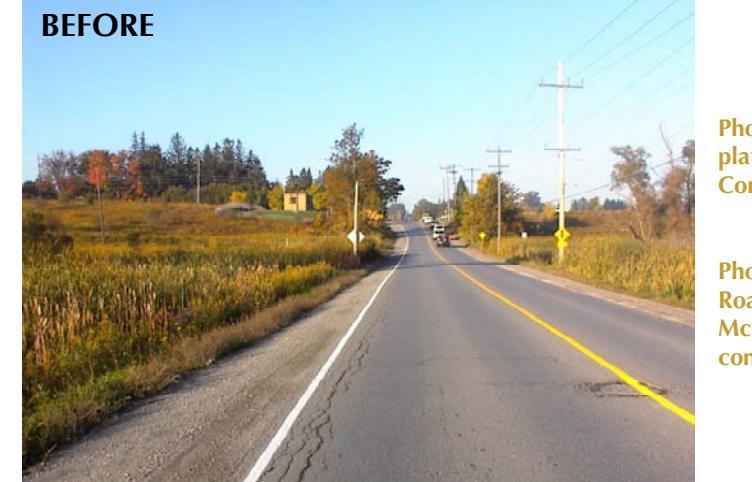
Photo 2A (LEFT): Available road platform at the McKenzie Wetland Complex prior to construction.

Photo 2B (RIGHT): Road improvements through the McKenzie Wetland following construction

The road bisected the McKenzie Wetland Complex and its original profile was not more than a half metre above the water level on either side. The road profile did not meet road design standards and therefore had to be raised up to 2.5 metres above the original profile to meet those standards. Photo 2A depicts the original road section with the McKenzie Wetland Complex on either side. Photo 2B presents the improvements following construction.

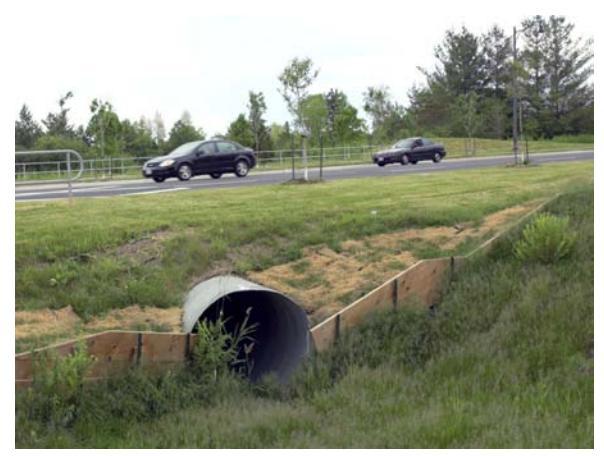
Photo 4: Dry culvert – providing a road crossing for wildlife

To facilitate the passage of fish and wildlife under the newly widened and raised road platform, three culverts – two wet and one dry - were included in the design. The wet culverts comprised of a 4-metre wide concrete box culvert and a 1.2 metre diameter corrugated steel pipe culvert that provided crossings for fish and waterfowl. A 1.2 metre diameter dry culvert, as shown in Photo 4, was also strategically constructed on higher ground beyond the wetland to provide crossings for wildlife, particularly turtles, frogs and small mammals. Drift fencing was used to redirect the wildlife from crossing up the road embankment and guided them towards the dry culvert crossing.

The 4-metre concrete box culvert and 1.2 metre diameter CSP culverts also improved the water circulation of the wetland by enhancing the connectivity and balancing the water levels on each side of the road.

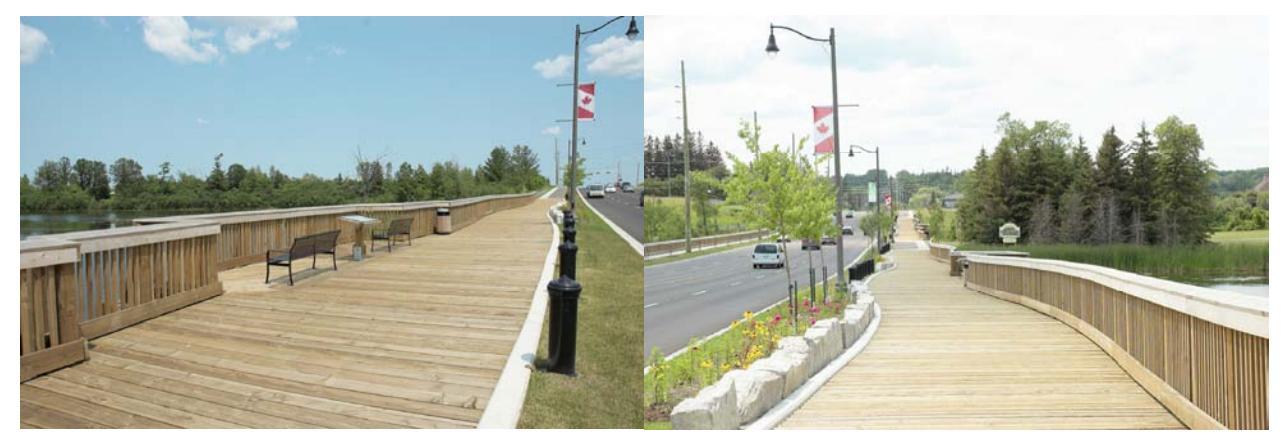
Photos 5 and 6: Viewing platform and boardwalk at the McKenzie Wetland Complex.

To accommodate these highly valued and traditional human uses of the area, while avoiding direct intrusion into the sensitive wetland ecosystem, a 3.6-metre wide

timber boardwalk was constructed to provide an elevated viewpoint along the north side of the road over the wetland environment.

The boardwalk is used by pedestrians as well as cyclists and has lookouts that provide excellent views of the wetland. The boardwalk is meandered so that its distinctive curves will promote interest, and relaxation for the public. Since the boardwalk is elevated, it prevents human access into the wetland itself, and provides a safe environment for walking and cycling that is separated from vehicular traffic, and establishes a key east-west link in the Town's walking and bicycle trail system through the East Holland River valley.

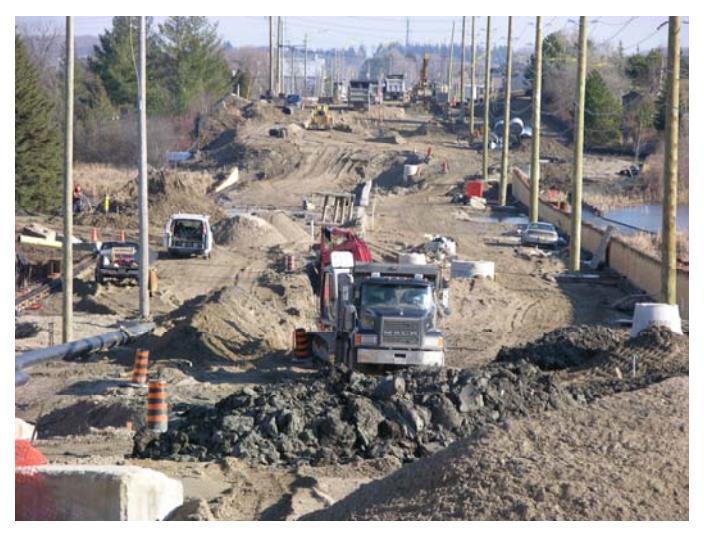
Photo 7: Construction activities at McKenzie Wetland.

Within the wetland area itself, a surficial zone of peat material was sub-excavated after the pile-driving operation and replaced with clear stone backfill material wrapped in geotextile filter material. The project team devised a method of excavation 'in the wet' that avoided pumping large volumes of water out from behind the retaining wall, so that a permit for pumping water was not needed.

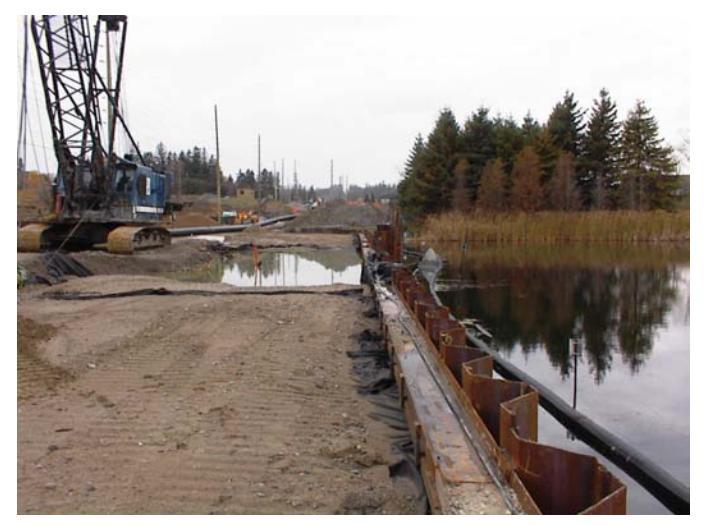
Photo 8: Pile driving in the McKenzie Wetland in the background. Sub-excavation and the placing of granular backfill in the foreground. Note the condition of the wetland adjacent to the work area.

Sheet-pile retaining walls were selected over other retaining wall systems such as gravity or cantilever retaining walls for several reasons. First, due to the consolidation of the sensitive material underlying the road platform, it was necessary to select the lightest structure possible. Second, sheet-pile walls could be driven by equipment positioned on the existing road platform, and therefore disturbance to the wetland by equipment or by workers was avoided. Third, once the sheet-pile walls were driven, they immediately formed a barrier between the construction work zone and the wetland environment for the remainder of the project, as shown in Photo 8.

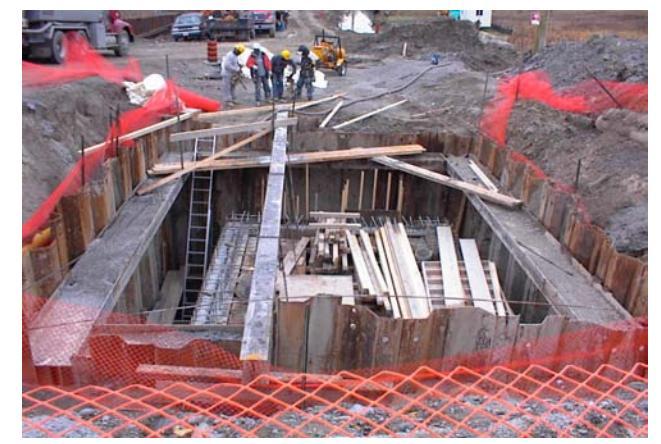
Photo 9: Construction of a sanitary sewer chamber around the existing sewer to complete the connections

Sanitary Trunk Sewer – A large diameter concrete pipe sanitary trunk sewer is located under the existing pavement within the McKenzie Wetland Complex. It was expected that the additional settlement due to the increase in road profile would cause the pipe joints to open. To address this, the sanitary sewer was replaced with a 1050 mm diameter concrete pressure pipe having extra deep joints that could tolerate the anticipated joint movement as the pipe settled during the consolidation of the underlying soil. The replacement and construction of the connection chambers (Photo 9) around the existing sewer at each end were carefully staged to avoid sewer flows being interrupted.

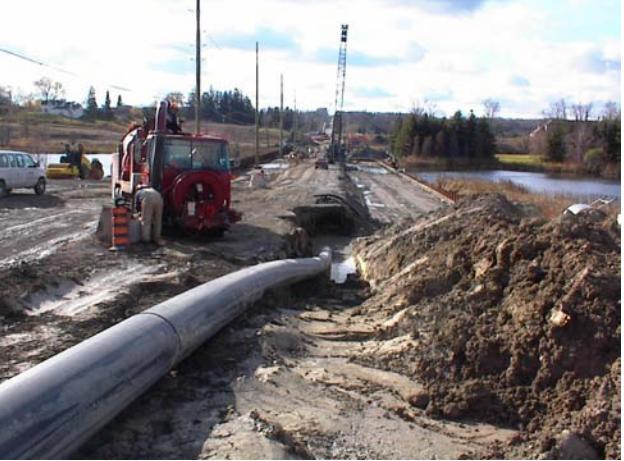
Photo 10: Installation of watermain under the road platform within the wetland using horizontal directional drilling.

Watermain – The Town required a new 500 mm diameter watermain be constructed on St. John's Sideroad under the McKenzie Wetland Complex. It was important that the watermain have the flexibility to tolerate the anticipated consolidation that would commence when the additional fills were placed. High density polyethylene pipe was selected to address this issue, since it would be butt-fused together to eliminate all joints under the wetland. The watermain was also installed successfully by horizontal directional drilling to avoid any disturbance to the wetland, as shown in Photo 10.

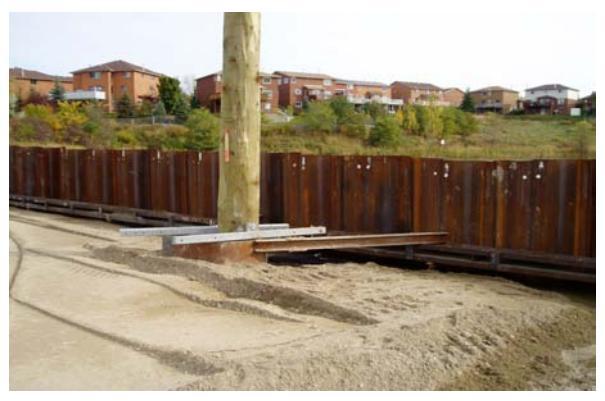
Photo 11: Temporary support of new hydro pole

the future road fills and open water meeting the existing shoulders. Therefore the construction contract required that the relocations be included within the overall construction staging when the road would be closed to the public. The retaining walls on the south side would first be constructed, but not yet backfilled to the design elevations. This was followed by a six-week planned interruption in construction to allow new poles to be installed on the south side with unique foundation details, designed to be temporarily supported within the existing peat material, and extra-deep embedment to account for the placement of future road fills. Once the overhead lines were transferred from the existing poles on the north side to the new poles on the south side, the poles on the north side were removed to permit pile-driving for the retaining wall.

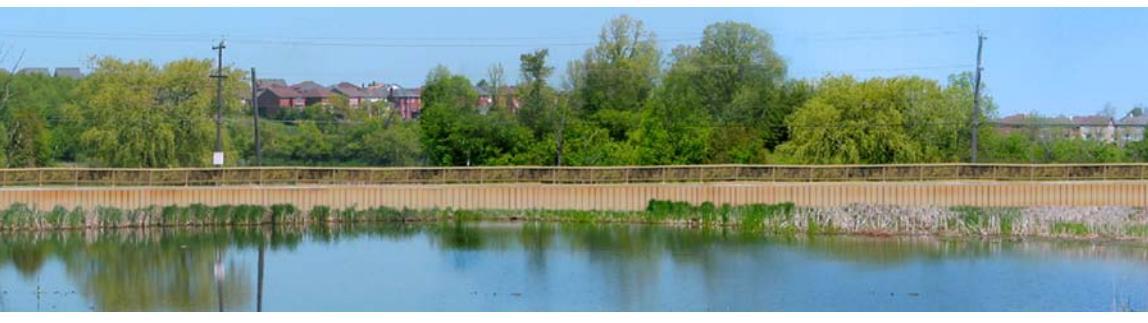
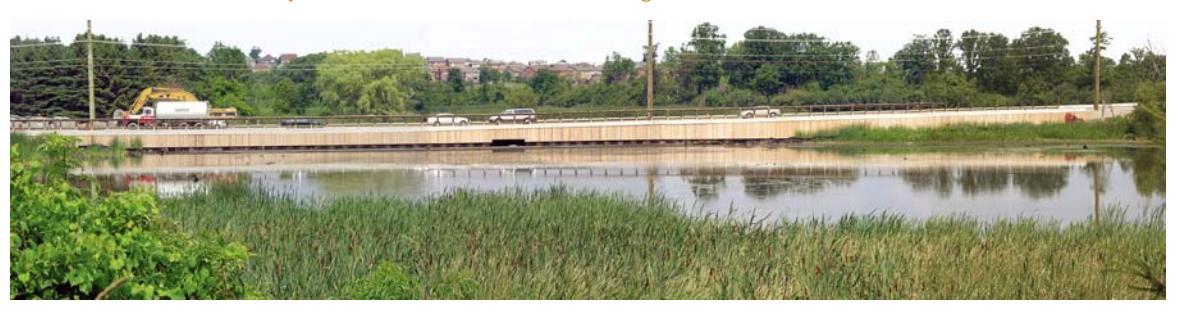
Photos 12 and 13: Rendering of the proposed improvements at the McKenzie Wetland Complex (above) and photo of the actual work following construction (below).

The use of a rendering which showed guiderails and concrete walkways were very effective in achieving a common understanding of what would not be acceptable for this project. It was only then that we were able to direct the participants towards developing various features that were believed necessary to make this a special project. We came prepared to present ideas on what features could be added, however the real value was how the participants came up with most of the enhanced features themselves. Once the team had developed a list of enhancements that should be considered further, we committed to preparing cost estimates to these enhancements and prepare additional renderings that visually showed how the improvements might appear.
