# **Evaluation of the Use of Green Pavement Technologies in the Region of Waterloo, Ontario**

Ludomir Uzarowski, Ph.D., P.Eng., Principal, Golder Associates Ltd., Mississauga, Ontario  
Michael Halloran, C.E.T., Region of Waterloo, Ontario  
Jim Ellerman, A.Sc.T., Region of Waterloo, Ontario  
Vimy Henderson, Ph.D., P.Eng., Golder Associates Ltd. Mississauga, Ontario

Pavements: Green Technologies – Innovation to Implementation and Evaluation Session

of the 2014 Annual Conference of the  
Transportation Association of Canada  
Montreal, Quebec

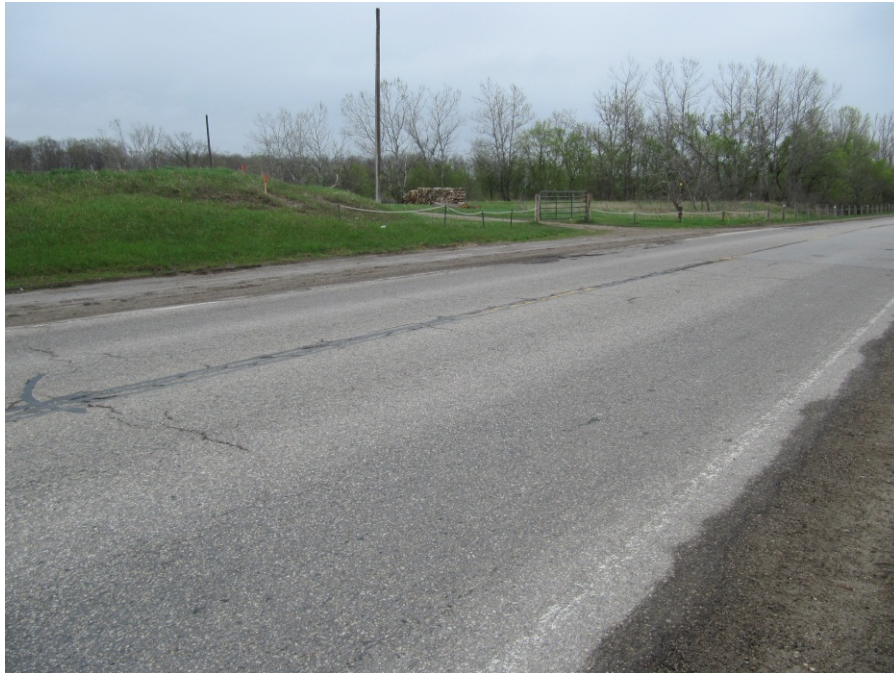
CIR was carried on the RR 16 from North of Heidelberg to RR 17 in 1996. It included CIR to a depth of 75 mm and a 40 to 50 mm thick asphalt overlay using a standard Ontario surface course Marshall HL 3 mix. The centreline construction joint has multiple cracks. The pavement also exhibits low to medium severity intermittent alligator cracking. Low to medium severity transverse cracking was observed in about 25 percent of the section. Generally, the condition of this 18 years old pavement is considered to be fair to good. Photograph 1 shows a typical pavement condition on this section.

Photograph 1 Joint and transverse cracking on 18 years old Cold In-place Recycled pavement on RR 16.

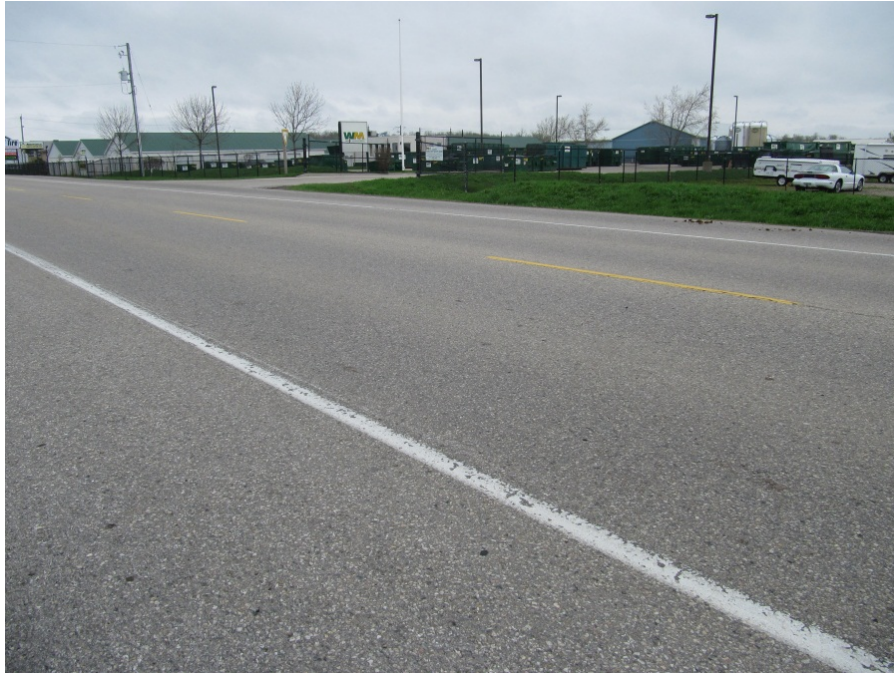
CIR was carried on RR 15 in 2004. It included CIR to a depth of 75 mm and a 60 mm thick HL 3 mix overlay. The centerline construction joint exhibits very low severity crack in about 50 percent of the length. The pavement also exhibits very low severity localized alligator cracking. Generally, the condition of this 10 years old pavement is considered to be good. Photograph 2 shows a typical pavement condition on this section.

Photograph 2 Good current condition of 10 years old Cold In-place Recycled pavement on RR 15 section between Three Bridges and RR 8.

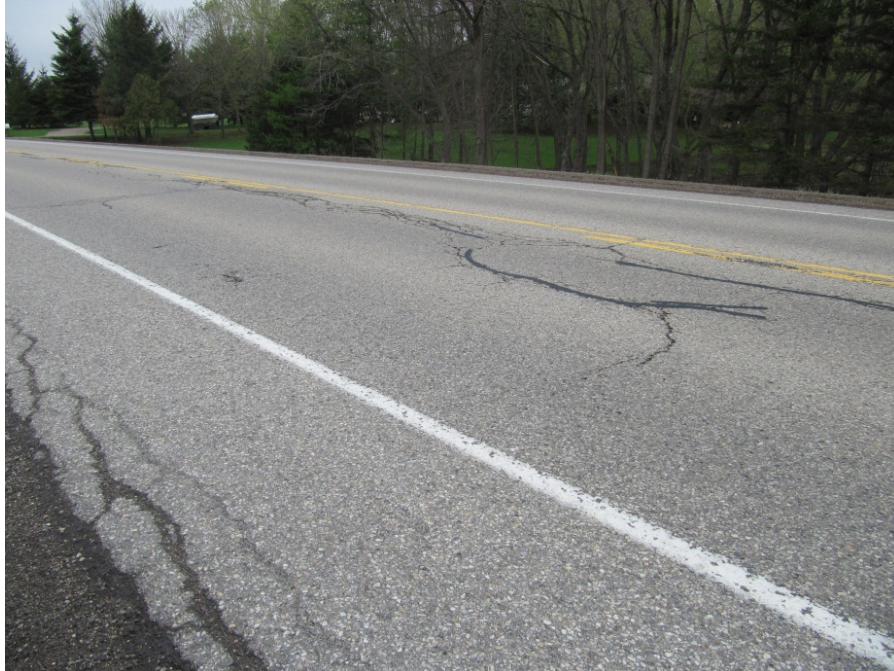
CIR was carried on the RR 15 from Martin Creek to East Limit of Heidelberg in 1995. It included CIR to a depth of 75 mm and a 40 mm thick HL 3 mix overlay. The centerline construction joint exhibits medium to high severity crack throughout. Also, medium to high severity edge cracking was observed almost throughout. The pavement also exhibits low to medium severity intermittent alligator cracking. Patching has been done in less than 10 percent of the section. Generally, the condition of this 19 years old pavement is considered to be fair. Photograph 3 shows a typical pavement condition on this section.

Photograph 3 Centerline, edge and localized alligator cracking in 19 years old pavement on RR 15 section from Martin Creek Road to East Limit of Heidelberg.

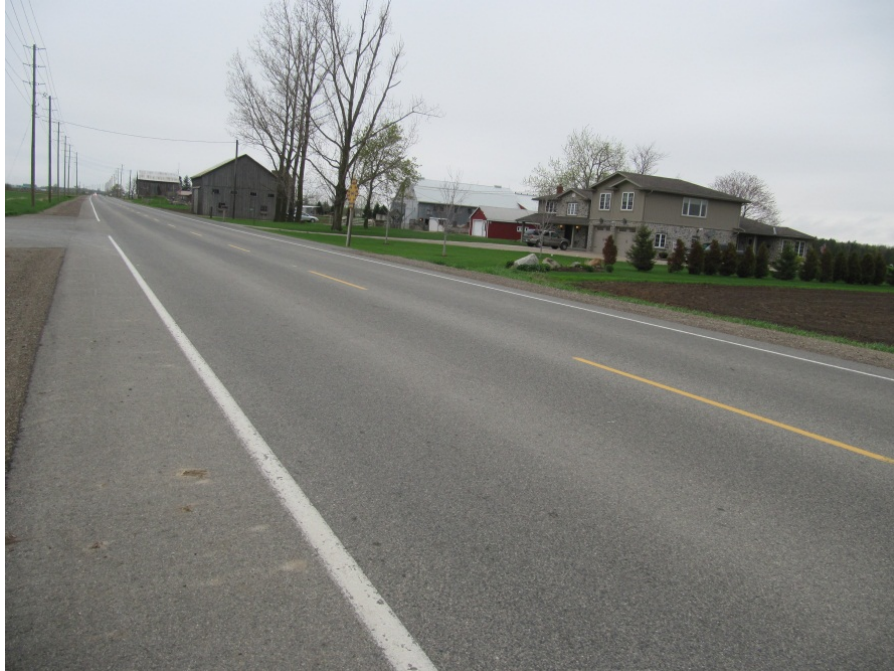
CIR was carried on the RR 22 from North of RR 86 to the Regional boundary in very early 1990s. In 2009 was re-recycled using foamed asphalt stabilization, to a depth of 150 mm over the entire length of the section. Then, 50 mm of asphalt HL 8 binder course mix and 40 mm of HL 3 surface course mix were placed. Only low severity edge cracking was observed in less than 20 percent of the length. Generally, the condition of this 5 year old pavement is considered to be excellent. Photograph 4 shows a typical pavement condition on this section.

Photograph 4 Excellent current condition of 5 years old re-recycled with foamed asphalt stabilization pavement on RR 22.

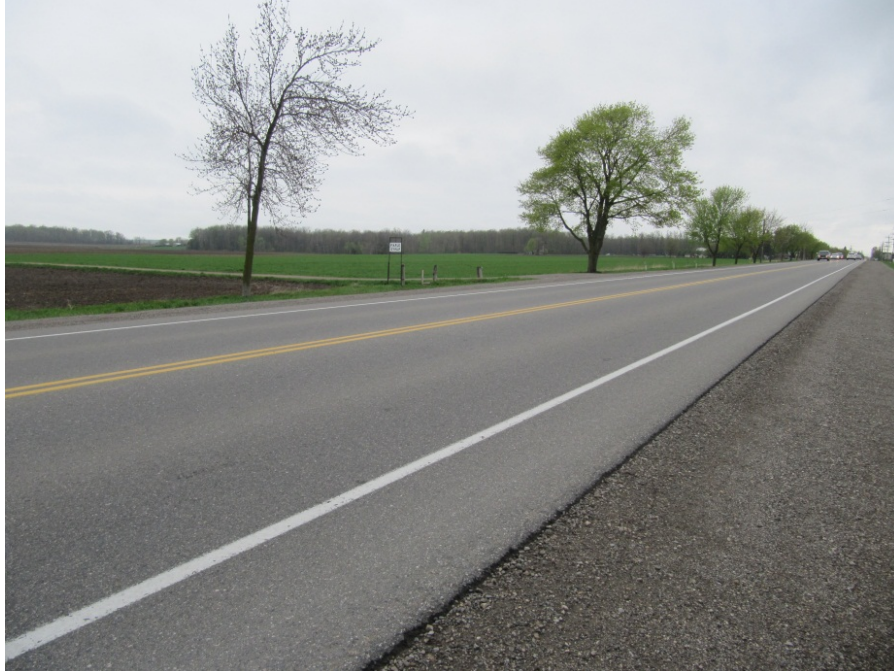
FDR with expanded asphalt stabilization was carried on the RR 8 section from RR 15 to Printery Road in 2010. The stabilization was to a depth of 125 mm and included partially underlying granular layers. Then, 50 mm of asphalt HL 8 binder course mix and 40 mm of high quality HL 1 surface course mix was placed. The pavement is in excellent condition with no distresses observed. Photograph 5 shows a typical pavement condition on this section.

Photograph 5 Excellent current condition of 4 years old foamed asphalt stabilized pavement on RR 8.

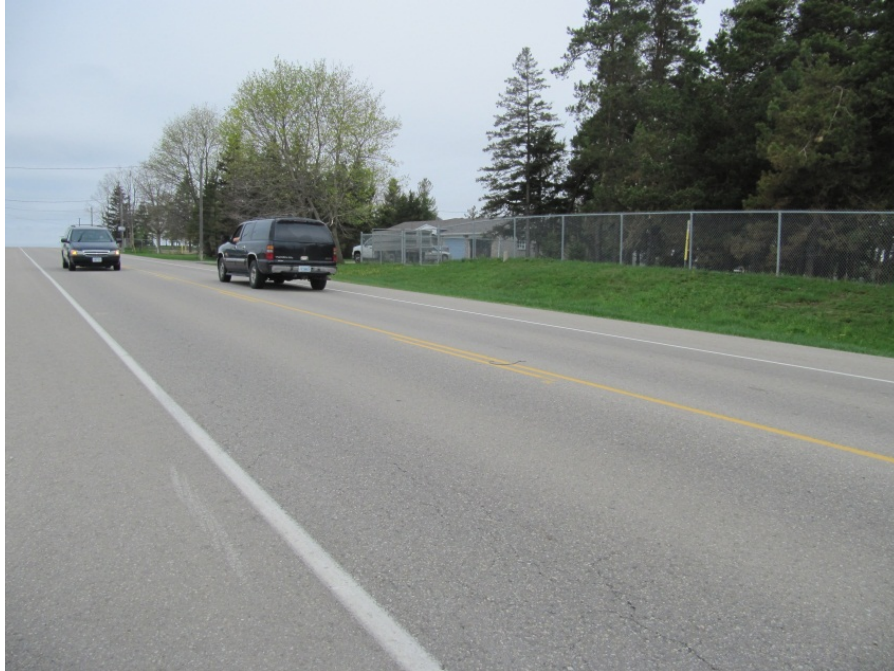
FDR with expanded asphalt stabilization was carried on the RR 6 section from RR 12 to RR 1 in 2009. The stabilization was to a depth of 150 mm and then, 50 mm of asphalt HL 8 binder course mix and 40 mm of HL 3 High Stability (HS) surface course mix was placed. The foamed asphalt stabilized layer incorporated 100 percent of Reclaimed Asphalt Pavement (RAP) material. This allowed a drastic reduction in the amount of added foamed asphalt cement from about 3.0 percent to just 1.2 percent. The pavement is in good to very good condition. It exhibits only very low severity localized alligator cracking (in less than 10 percent of the length) and very low severity localized centreline joint crack. No rutting was observed on this section. Photograph 6 shows a typical pavement condition on this section.

Photograph 6 Low severity localized alligator cracking in 5 years old foamed asphalt stabilized pavement on RR 6.

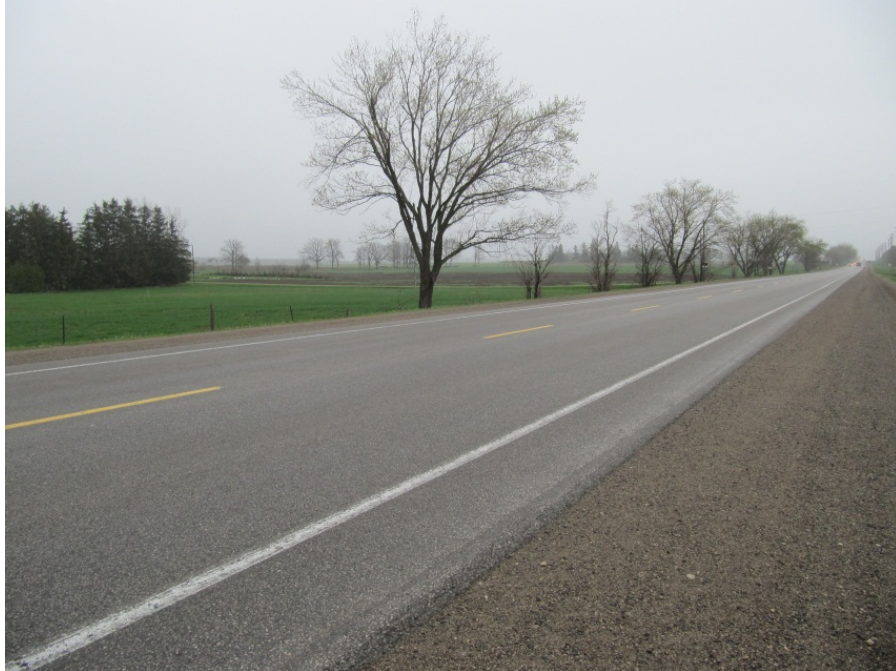
CIREAM stabilization was carried on the RR 86 section from Sloman Road to Perth County boundary in 2010. The CIREAM stabilization was to a depth of 100 mm and then, 50 mm of asphalt HL 8 binder course mix and 40 mm of HL 3 HS surface course mix was placed. The pavement is in very good condition with only very low severity localized (less than 10 percent of the length) alligator cracking observed. Photograph 7 shows a typical pavement condition on this section.

Photograph 7 Very good condition of 5 years old CIREAM stabilized pavement on RR 86.

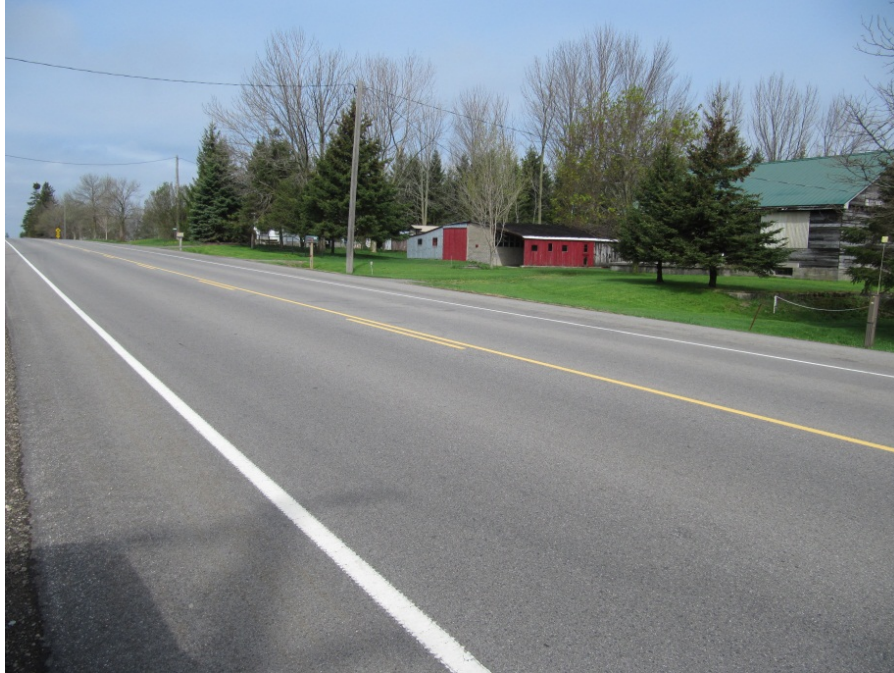
The pavement on the RR 4 section from RR 12 to RR 51 was pulverized to a depth of 250 mm in 2013. Then, 70 mm of asphalt Superpave SP 19 binder course mix and 40 mm of SP 12.5 surface course mix was placed. The pavement is in excellent condition with no distresses observed. Photograph 8 shows a typical pavement condition on this section.

Photograph 8 Excellent condition of new pavement pulverized and asphalt overlaid in 2013 on RR 4.

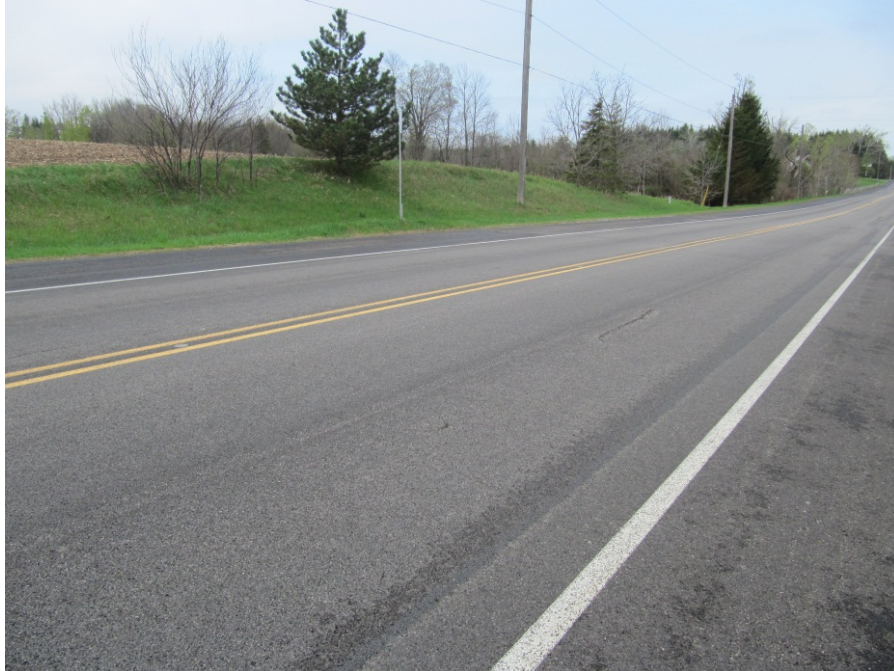
The Bonded Wearing Course (BWC) was applied on the RR 4 section from RR 12 to Manheim Bridge in 2013 in order to address premature cracking in the pavement that had foamed asphalt stabilized and overlaid with HMA. The BWC Type A included asphalt cement graded as PGAC 64-28. Although the condition of the pavement is good to very good some of the cracks have already reflected through the thin layer of BWC after the severe 2013/2014 winter. Photograph 9 shows a typical pavement condition on this section.

Photograph 9 Some of the cracks in the underlying asphalt pavement have reflected through the bonded wearing course after one winter on RR 4.

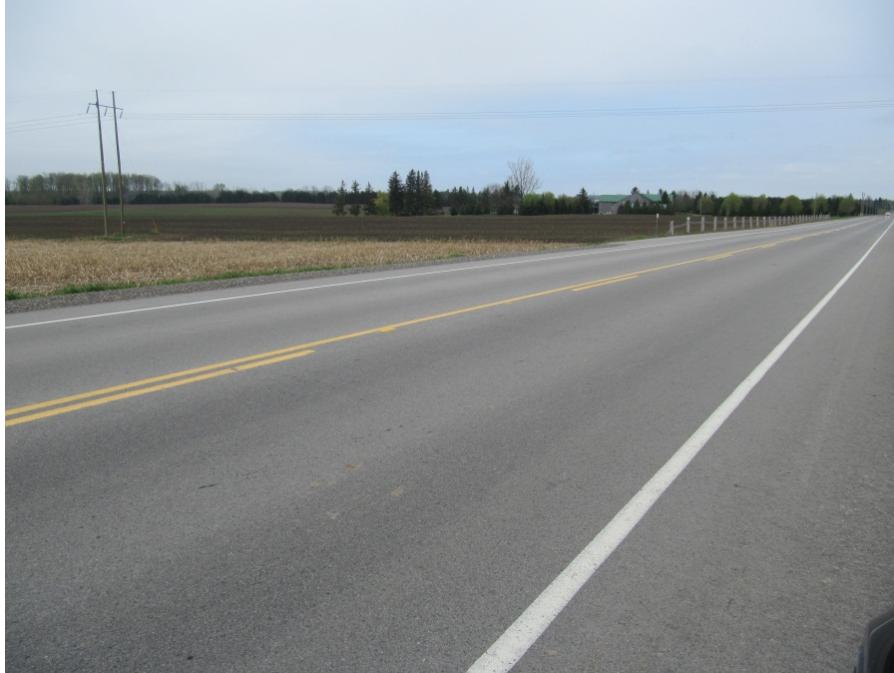
Thin asphalt overlay on RR 4 (Bleams Road) was applied in 2013 to address some surface distresses including low to medium severity early cracking. In this treatment 40 mm of Superpave SP 12.5 FC1 surface course mix was placed. The pavement is in excellent condition with no distresses observed. Photograph 10 shows a typical pavement condition on this section.

Photograph 10 Excellent pavement condition of a section of RR 4 after application of thin asphalt overlay in 2013.
