TRANSPORTATION ASSOCIATION
OF CANADA

**2002 ENVIRONMENTAL
ACHIEVEMENT AWARD
SUBMISSION**

LEDCOR ALBERTA LIMITED

ENVIRONMENTAL ACHIEVEMENT

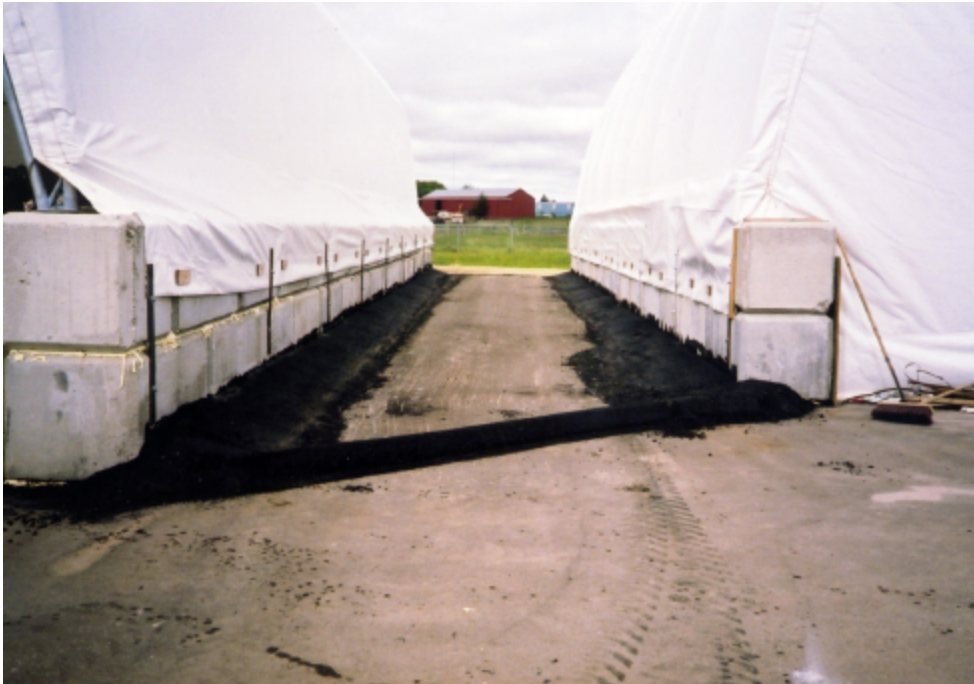
- 1). Sand and salt storage structures at Lacombe. Yellow material between blocks is expandable foam insulation to prevent water infiltration. Asphalt fillets at base of blocks provide positive drainage away from structures.

To ensure the tent type storage structures were totally effective in preventing moisture infiltration, two special steps were taken. All voids in the concrete lego-block foundations were filled with expandable foam insulation and asphalt fillets were constructed at the base of the concrete blocks around the total building perimeter.

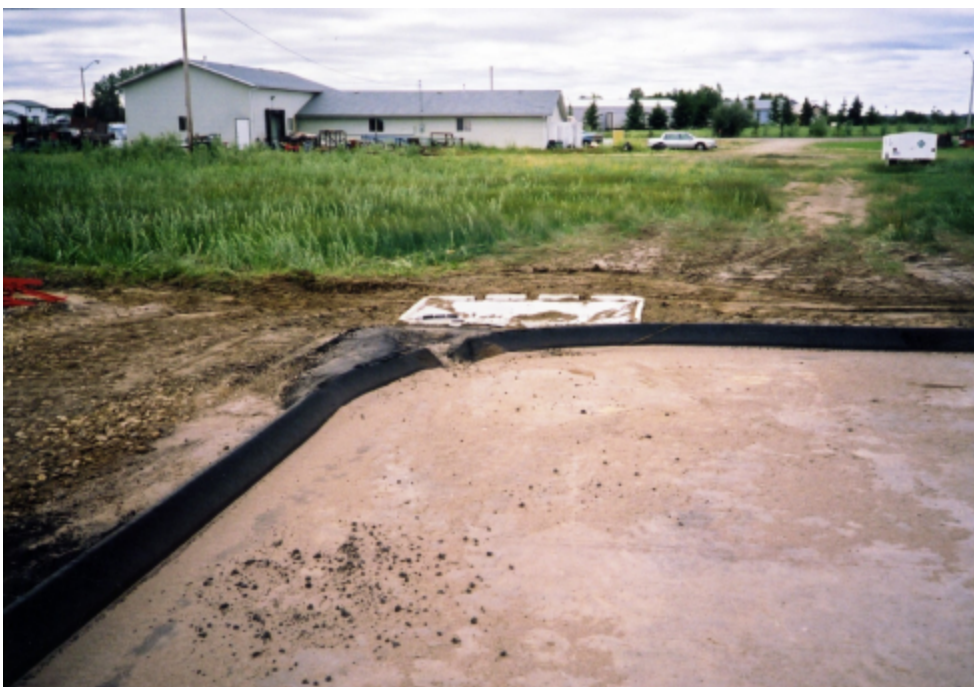
- 2). Asphalt curbing around asphalt pad with gap at low point for water to drain into buried storage tank (white tank lid visible in centre of photo).

- 3). Sand and salt mixing and storage areas are covered with a layer of asphalt concrete pavement – this prevents saline solution from seeping into the subsoil. Asphalt curbs were installed around the perimeter of all mixing / storage locations to contain saline solution on the asphalt pads. In total, over 3 km of asphalt curbing was installed. Drainage to an underground tank located adjacent to the pad was established to capture and store any saline solution. This solution will be used for dust abatement on nearby gravel roads or taken to downhole well sites for disposal.

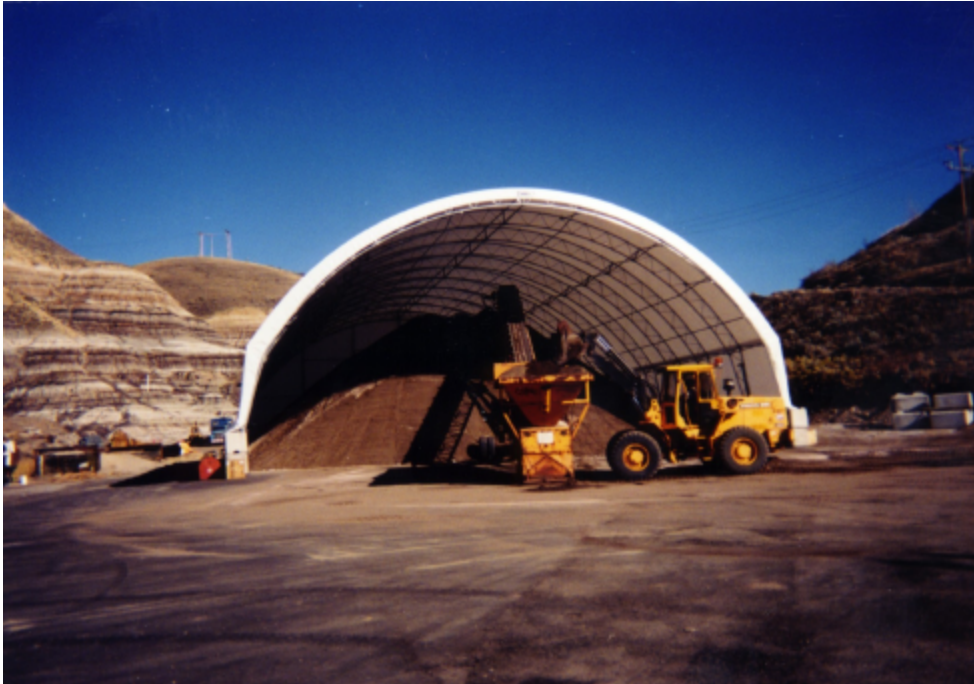
- 3). Pickling operation in progress at Drumheller. Pickled sand is being conveyed into the storage structure.

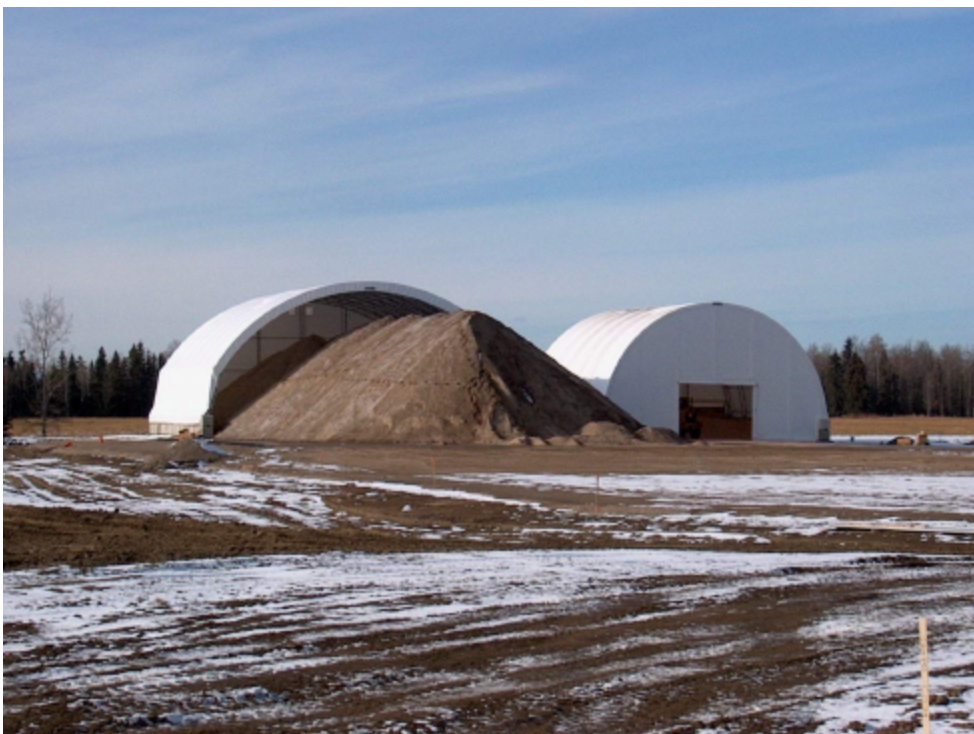
- 4). Typical site condition as shown in December, 2001 at Rocky Mountain House. Salt storage building with roll-up door shown on right of photo.

The entire winter's pickled sand quantity is shown here – most of the pile will be used up by the end of the winter season. The residual quantity will be totally enclosed inside the building over the spring and summer seasons.

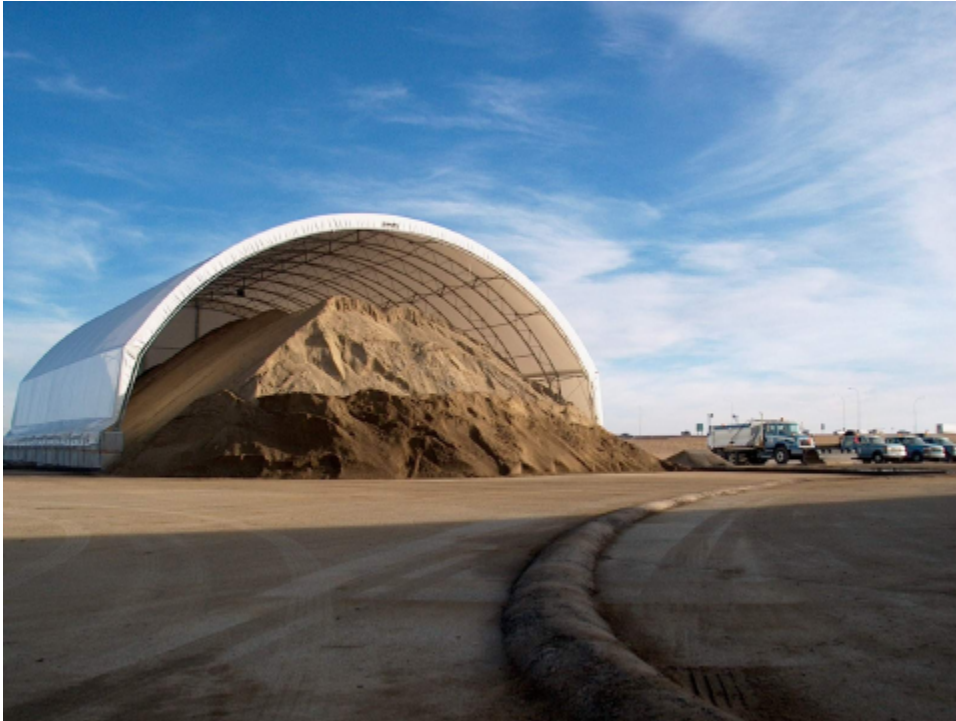
- 5). Front view of Red Deer Sand Structure – showing perimeter curbing.

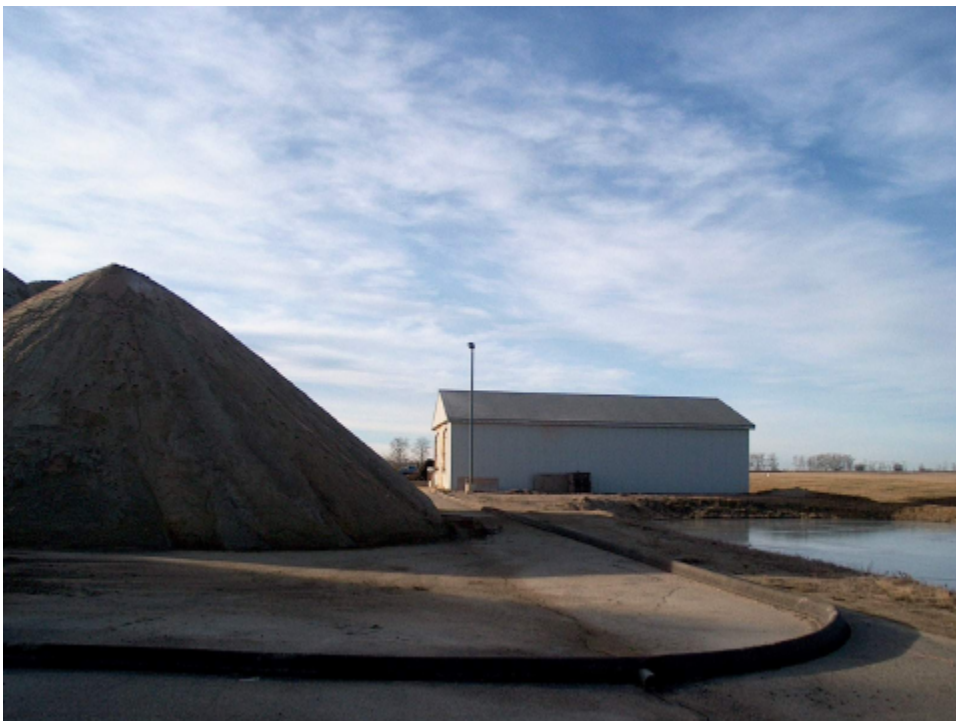
- 6). Red Deer Site – showing outlet pipe in foreground – drainage swale directs run-off to underground storage tank.
